Wyoming Estates Preliminary Plan

Filings #1 and #2

Compilation of Soils, Geology, and OWTS

Soils and Geology
And Wastewater Treatment System
Evaluation

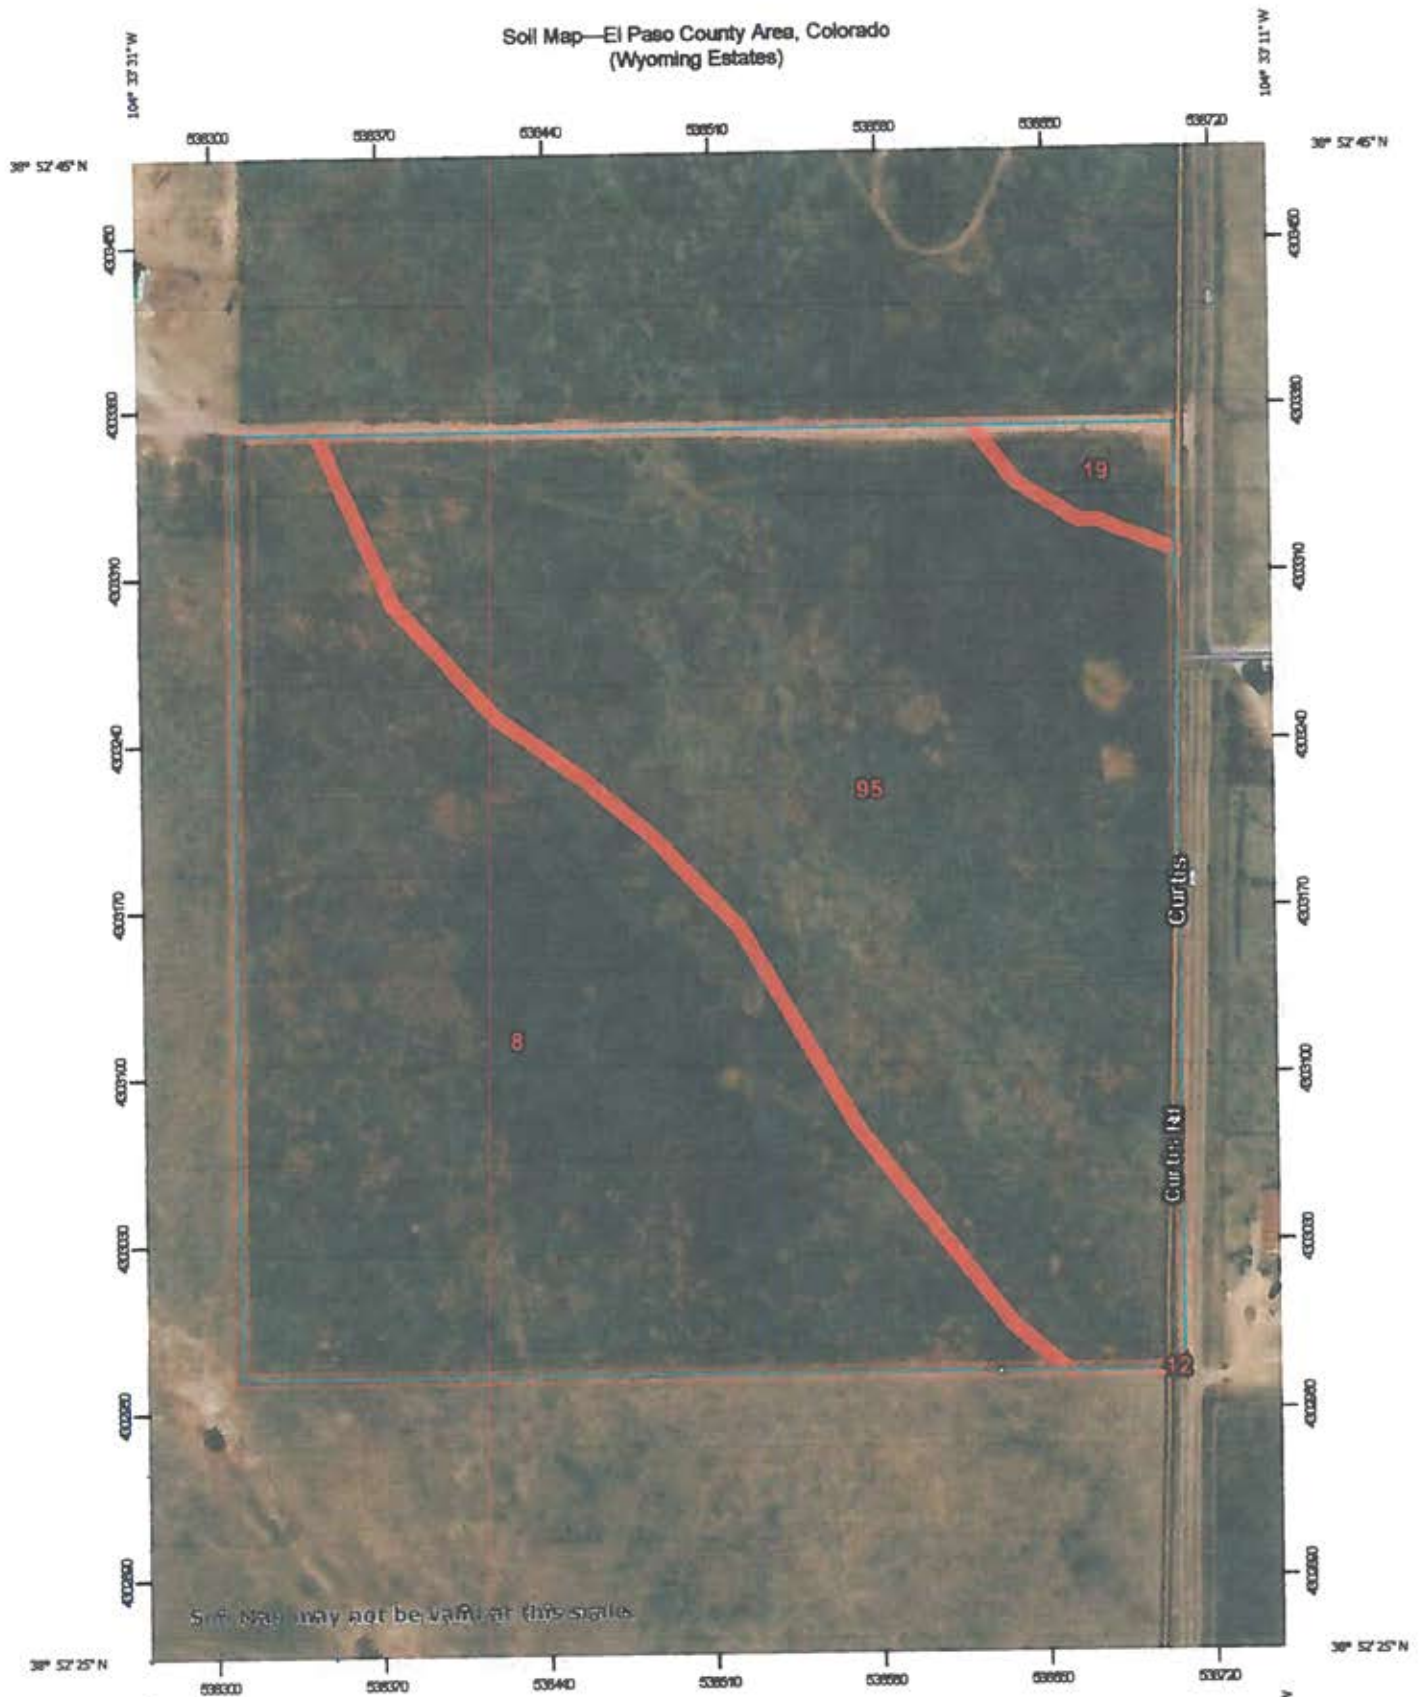
FIGURE 7
Pavement Design Test Pit Locations

Two test holes were evaluated for a proposed gravel roadway for pavement design (Raiper, 2019 Figure 7). Soil samples were collected for testing which included sieve analysis and Atterberg limits in addition to determining resistance values (R-values). The results are summarized in Table 2.

It was reported for the locations tested, "there was a very (low) potential for swell due to the sandy composition of site soils which consist of non-plastic to low plasticity silty sand and silty clayey sand soils with low percentage of particles passing the #200 sieve screen. Therefore, there is no need to provide any additional stabilization or treatments to subgrade soils" (Raiper, 2019)

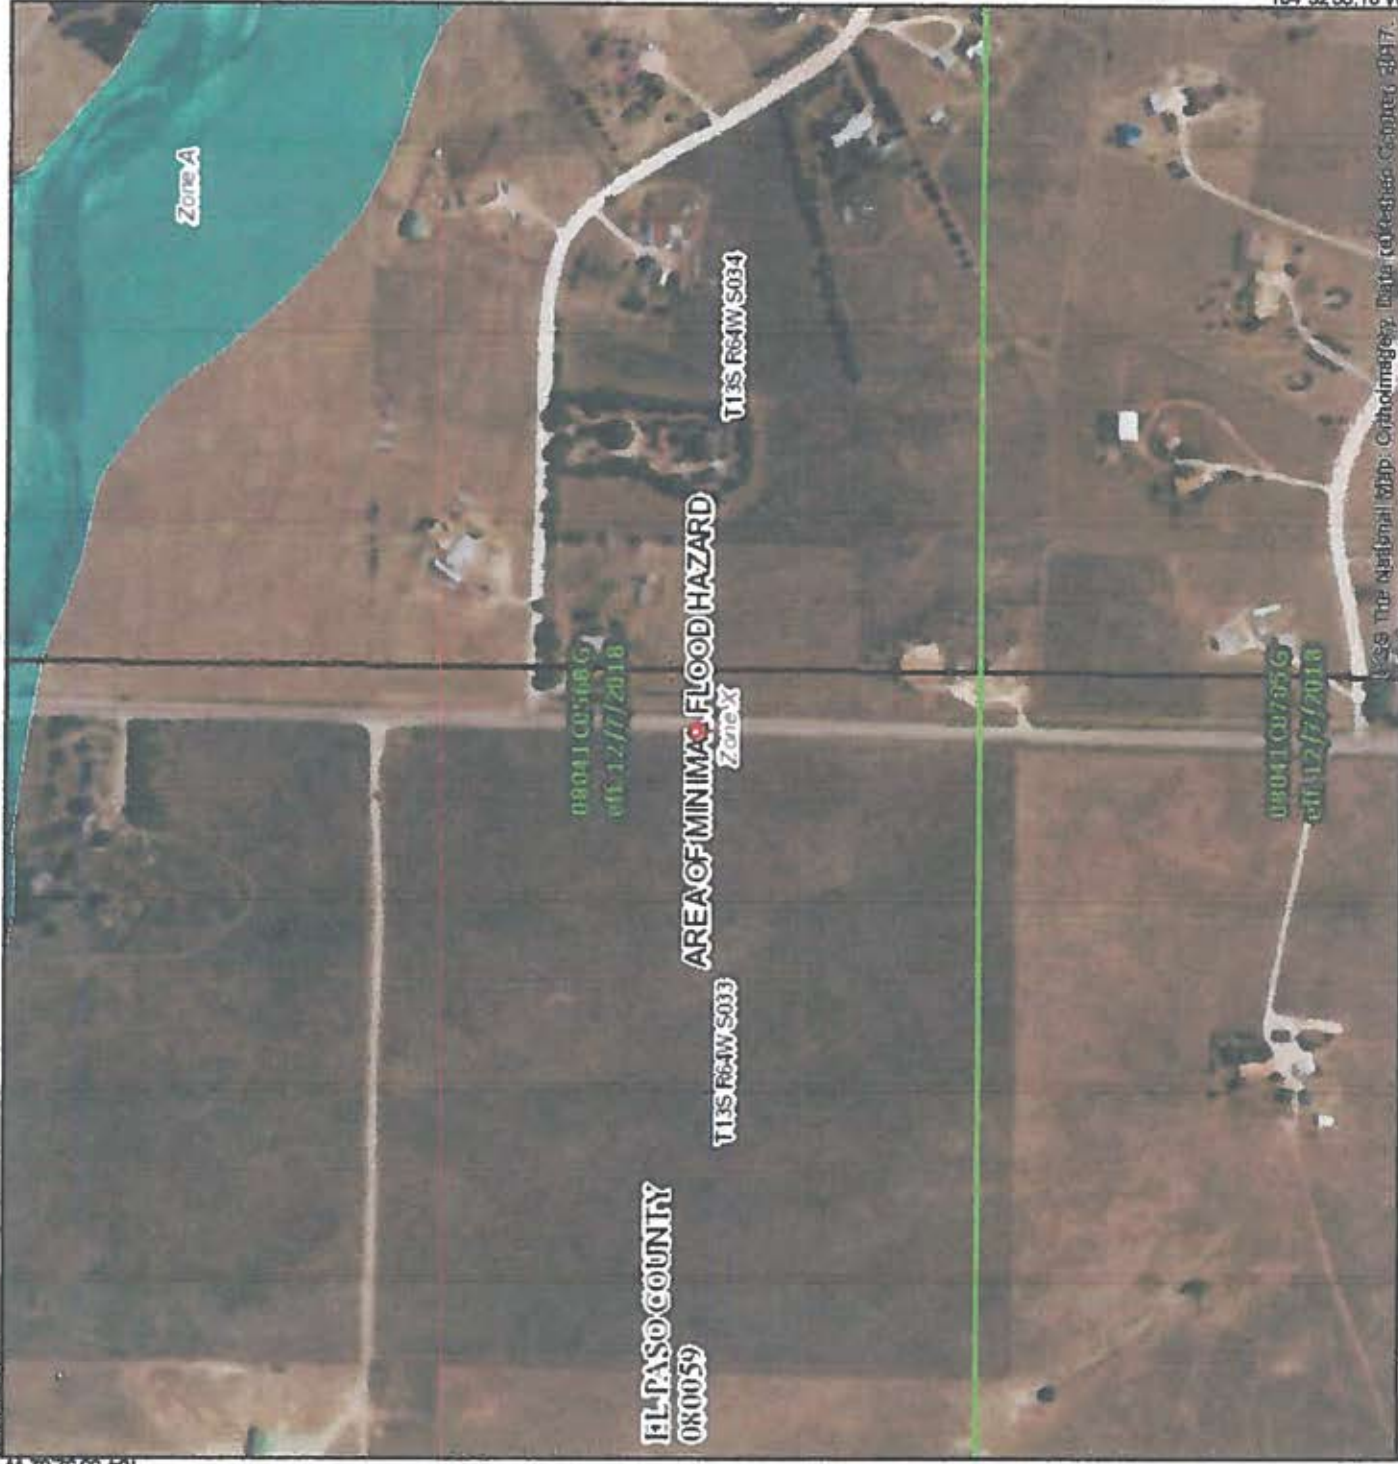
National Flood Hazard Layer FIRMette Figure 8

The Project Site was evaluated for geologic hazards that may impact development. Hazards identified in the El Paso County Land Development Code including: Mining, wildfire, highwater table or polluted water, landfills, fill areas, contamination; airports and major utility facilities, and landslides were not identified on the Project Site. The National Flood Hazard map delineated the Property and surrounding area an "area of Minimal Flood Hazard" (FEMA 2018). The Project Site is not located in a flood plain (Figure 8).

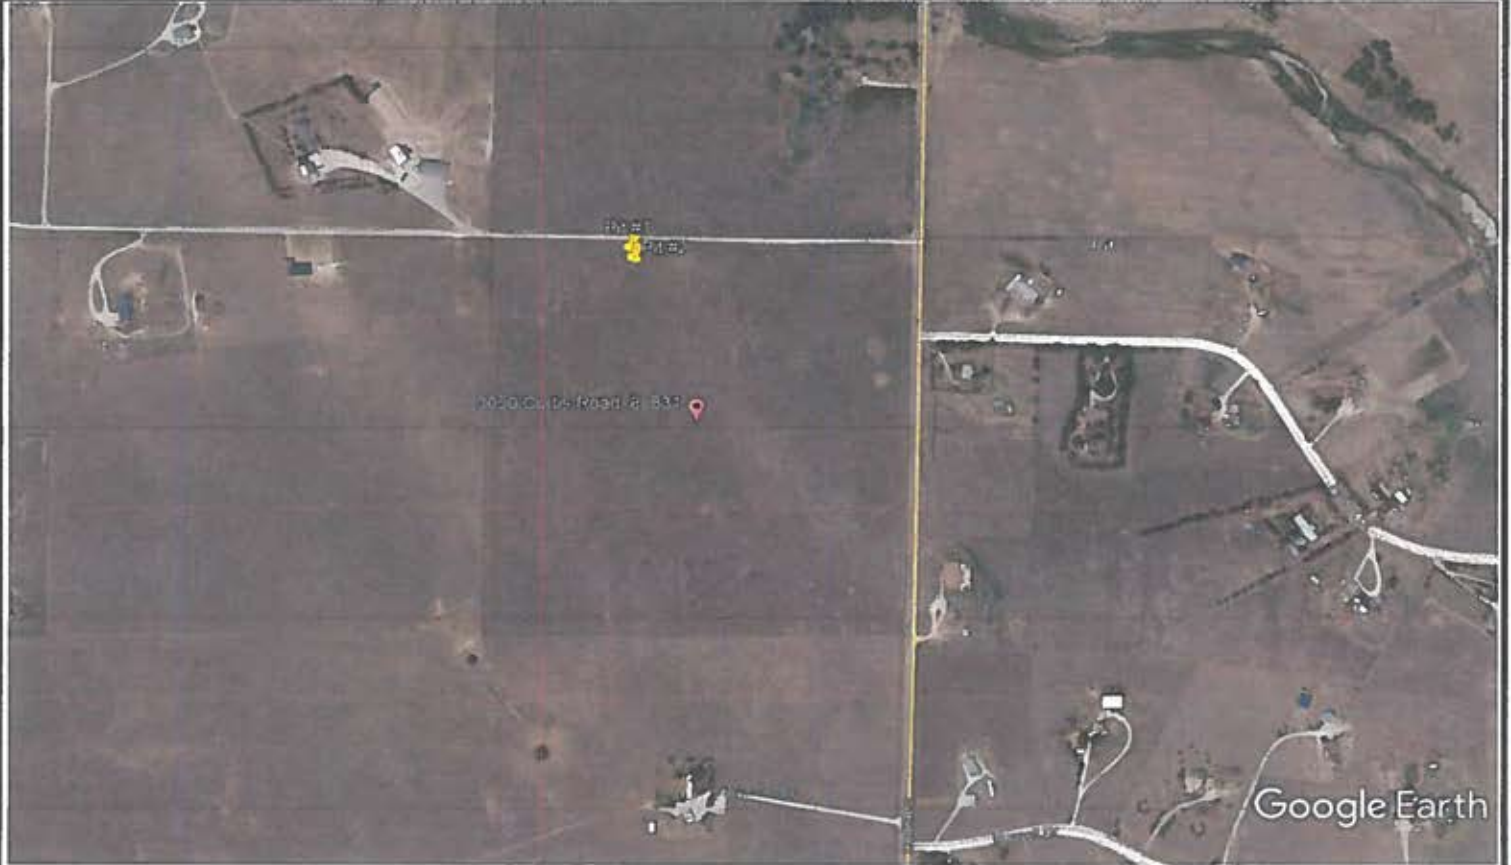
Google Site Map

Depth (ft.)	Sample Interval	3050 Curtis Road, Lot 1, 80831						
		USDA Soil Texture	USDA Soil Structure - Shape	Soil Structure Grade	Redoximorphic Features Present? (Y/N)	Soil Type (from Table 9 in O-14)	% Rock Frag.	Color
		Topsoil						
2		Sandy Loam	Granular	Moderate	No	Type 2 (LTAR = 0.60) Treatment Level 1	<35%	10YR 3/3 (Moist)
4								
6								
8		Clay	Blocky	Strong	No	Type 4 (LTAR = 0.20) Treatment Level 1	<35%	2.5Y 5/4 (Moist)
		Total Depth= 8'-6"						
10

Recommendations: (1) An Engineered On-Site Wastewater Treatment system (OWTS) is required for this location due to Soil Type 4 identified in the treatment zone of Profile Pit #1 & Profile Pit #2.

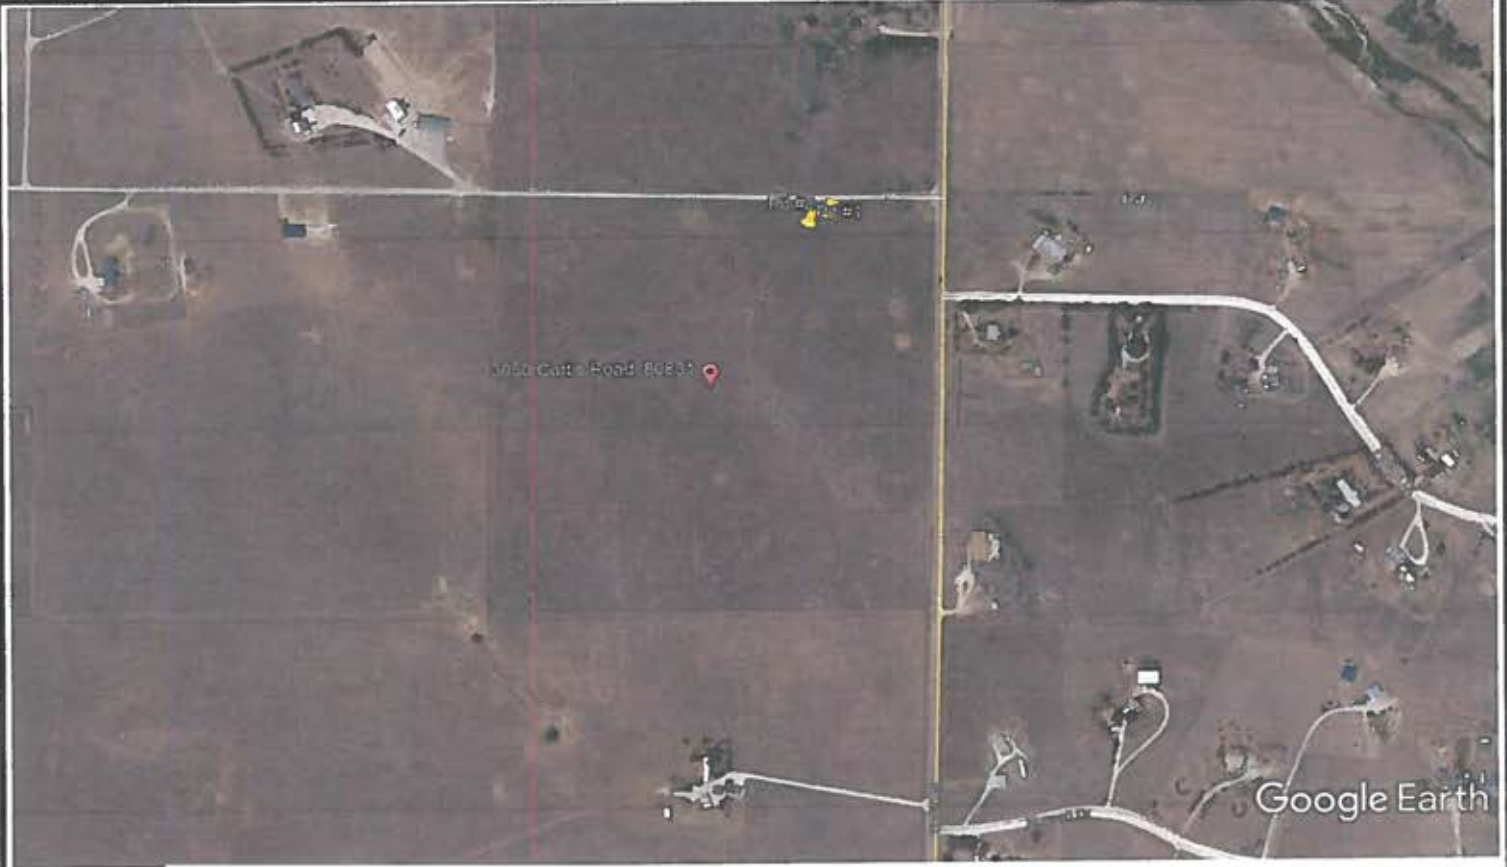
Google Site Map

Depth (ft.)	Sample Interval	3050 Curtis Road, Lot 1, 80831						
		USDA Soil Texture	USDA Soil Structure - Shape	Soil Structure Grade	Redoximorphic Features Present? (Y/N)	Soil Type (from Table 9 in O-14)	% Rock Frag.	Color
		Topsoil						
2		Sandy Loam	Granular	Moderate	No	Type 2 (LTAR = 0.60) Treatment Level 1	<35%	10YR 3/3 (Moist)
4		Clay	Blocky	Strong	No	Type 4 (LTAR = 0.20) Treatment Level 1	<35%	2.5Y 5/4 (Moist)
6								
8								
10								
		Total Depth= 8'-6"

Recommendations: (1) A conventional, non-engineered On-Site Wastewater Treatment system (OWTS) is acceptable for this site.

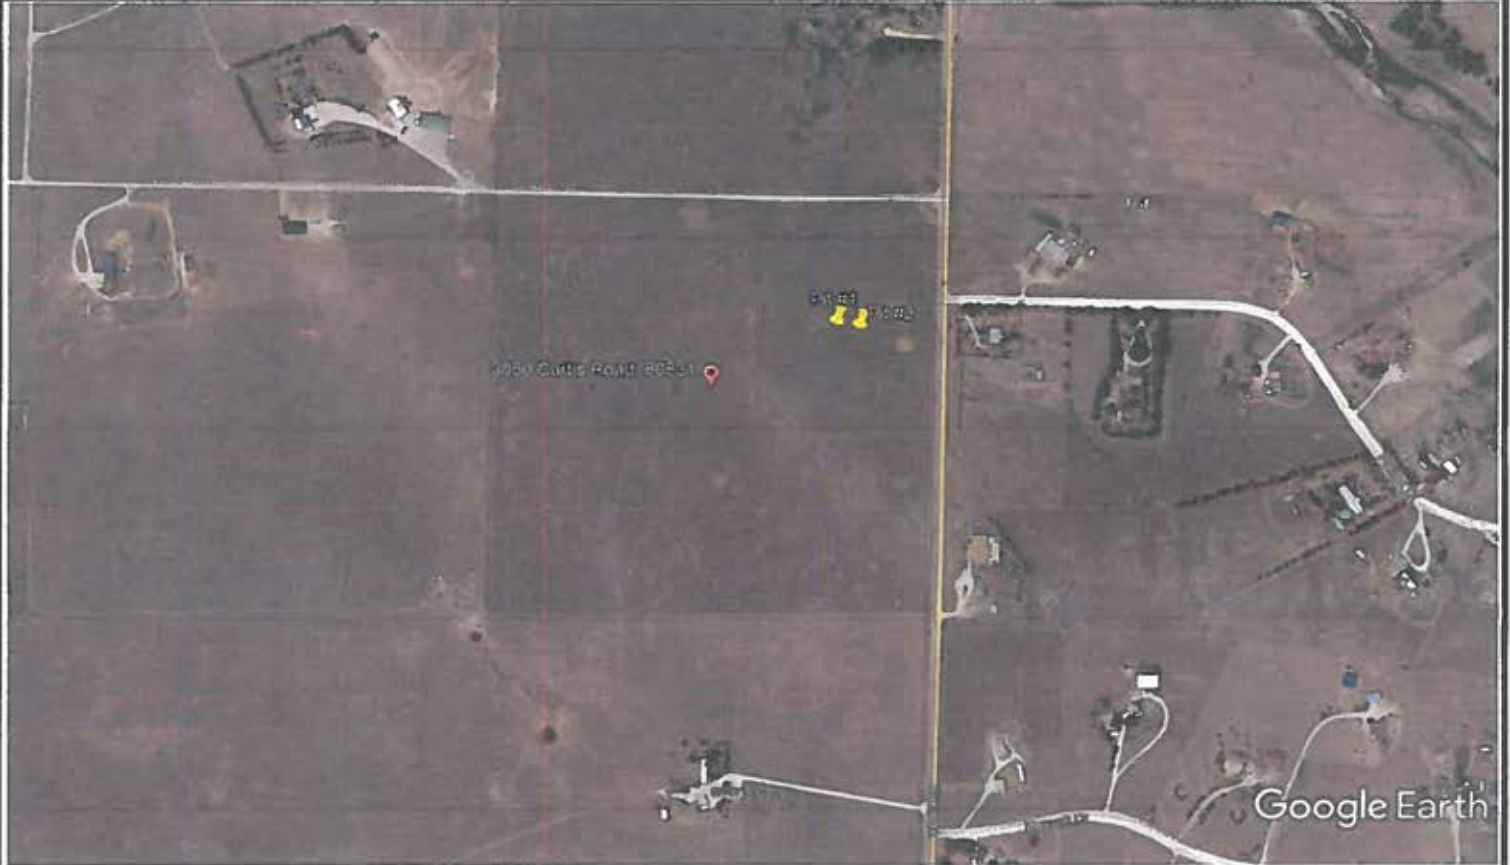
Google Site Map

Depth (ft.)	Sample Interval	3050 Curtis Road, Lot 3, 80831						
		USDA Soil Texture	USDA Soil Structure - Shape	Soil Structure Grade	Redoximorphic Features Present? (Y/N)	Soil Type (from Table 9 in O-14)	% Rock Frag.	Color
		Topsoil						
2		Sandy Clay Loam	Granular	Moderate	No	Type 3 (LTAR = 0.35)	<35%	10YR 2/2 (Moist)
4		Sandy Clay Loam	Blocky	Strong	No	Type 3 (LTAR = 0.35)	<35%	2.5Y 3/3 (Moist)
6		Sandy Clay Loam	Blocky	Moderate	No	Type 3 (LTAR = 0.35) Treatment Level 1	<35%	2.5Y 4/3 (Moist)
8								
10		Total Depth= 8'-6"

Recommendations: (1) A conventional, non-engineered On-Site Wastewater Treatment system (OWTS) is acceptable for this site.

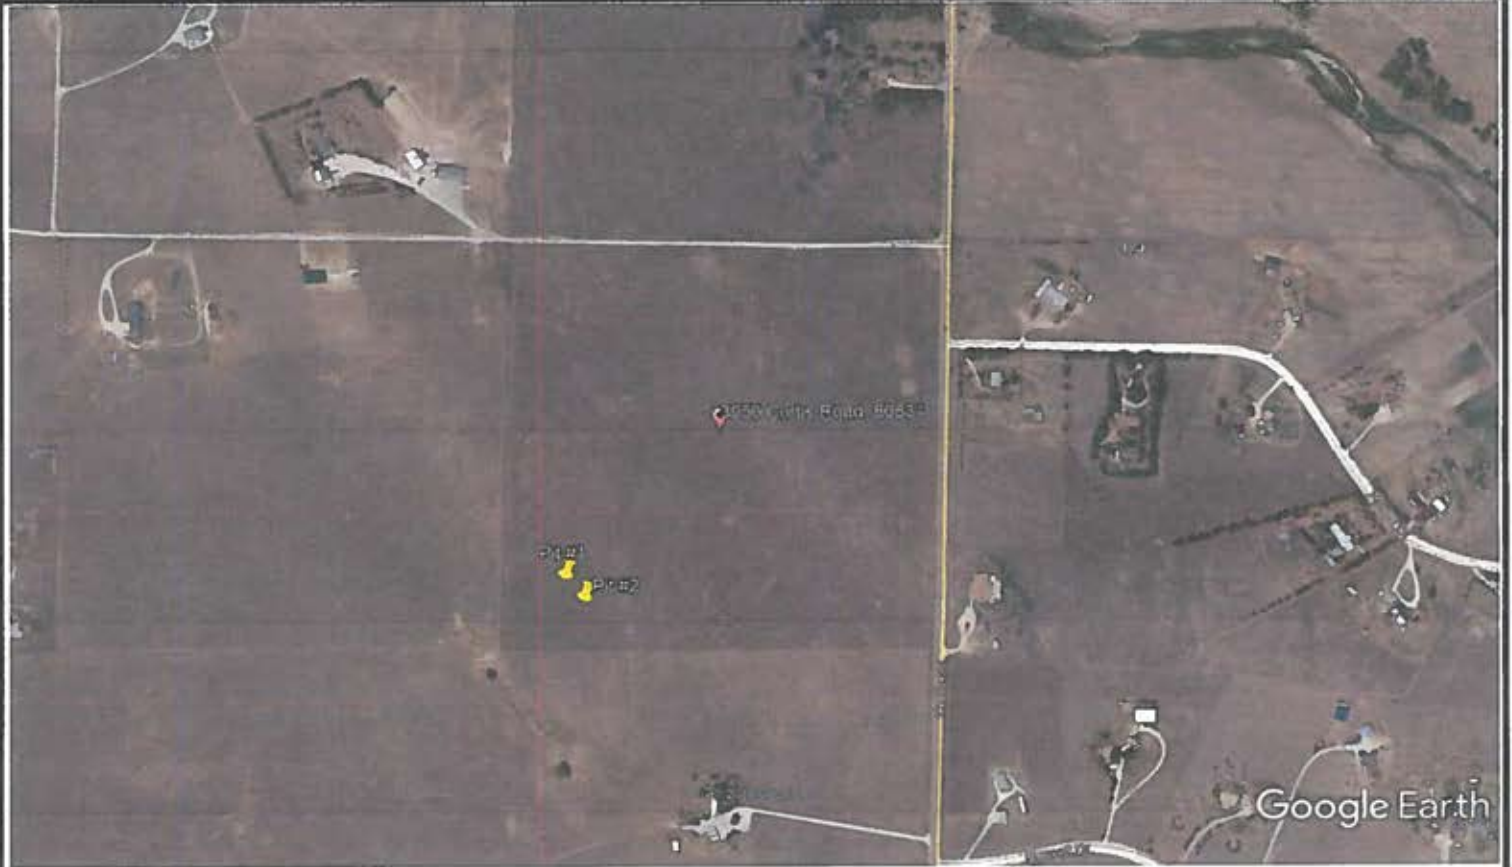
Google Site Map

Depth (ft.)	Sample Interval	3050 Curtis Road, Lot 4, 80831						
		USDA Soil Texture	USDA Soil Structure - Shape	Soil Structure Grade	Redoximorphic Features Present? (Y/N)	Soil Type (from Table 9 in O-14)	% Rock Frag.	Color
		Topsoil						
2		Sandy Clay Loam	Granular	Strong	No	Type 3 (LTAR = 0.35) Treatment Level 1	<35%	10YR 3/2 (Moist)
4								
6		Sandy Loam	Granular	Moderate	No	Type 2 (LTAR = 0.60) Treatment Level 1	<35%	10YR 5/3 (Moist)
8								
		Total Depth= 8'-0"						
10

Recommendations: (1) A conventional, non-engineered On-Site Wastewater Treatment system (OWTS) is acceptable for this site.

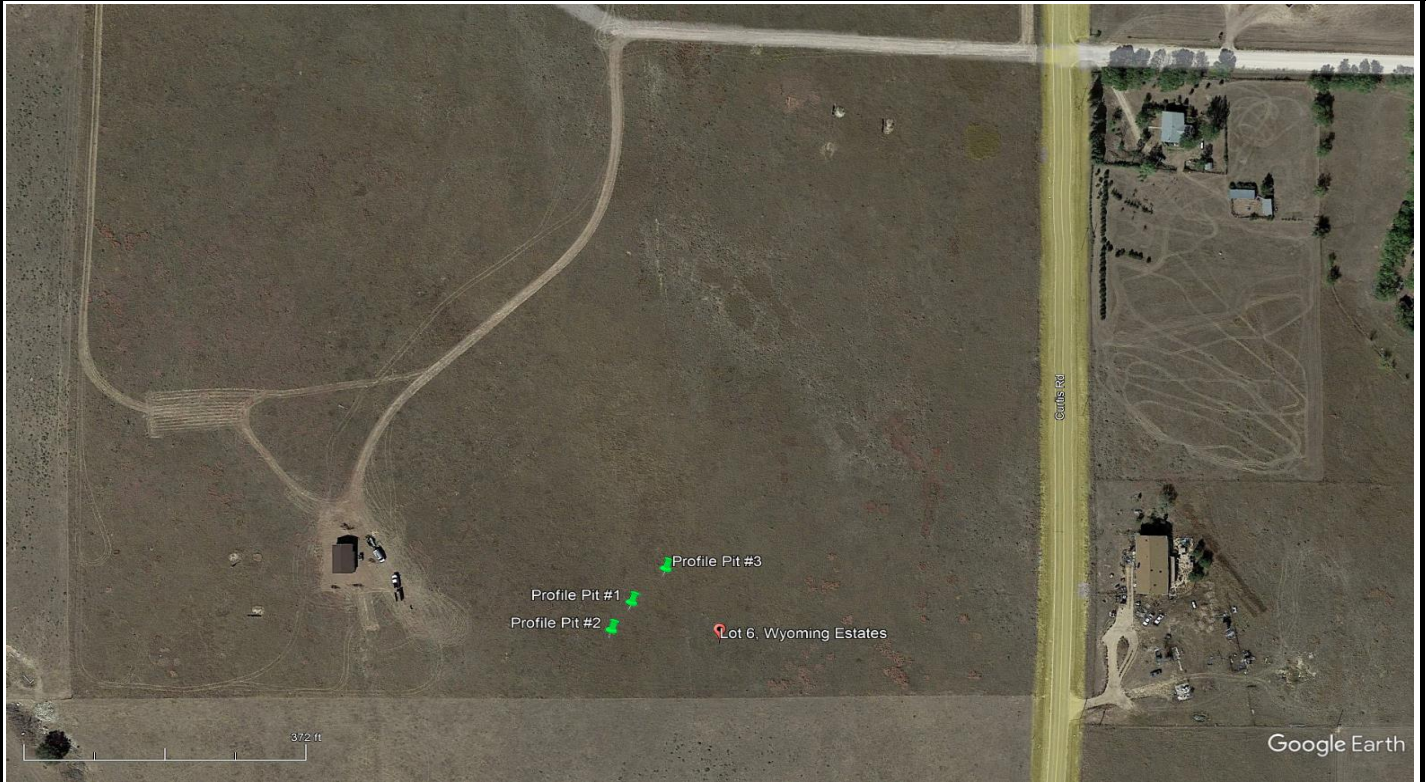
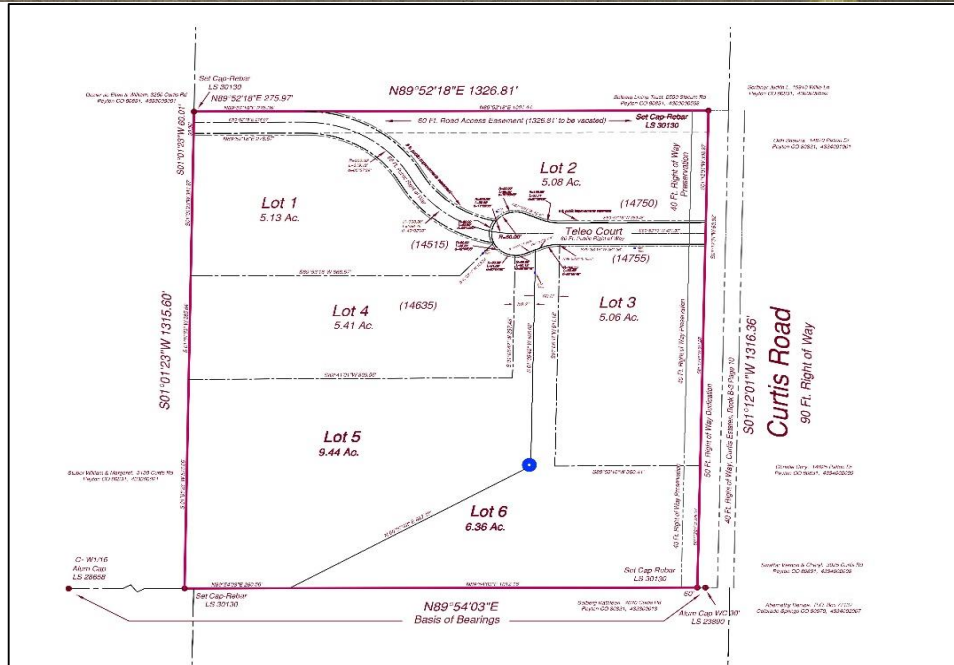
Site Map:

Profile Pit Summary		Profile Pit #1		Profile Pit #2		Profile Pit #3					
Profile Pit #1			Topsoil		Topsoil		Topsoil				
Lat:	38°52'30.52"N	1'-0"	Soil Type 2	1'-0"	Soil Type 2	1'-0"	Soil Type 2				
Long:	104°33'21.28"W										
0 - 0'-6"	Topsoil	2'-0"		2'-0"				2'-0"			
0'-6" - 8'-0"	Soil Type 2										
Profile Pit #2		3'-0"				3'-0"			3'-0"		
Lat:	38°52'30.12"N			Soil Type 2		4'-0"		Soil Type 4	4'-0"	Soil Type 2	
Long:	104°33'21.62"W	4'-0"									
0 - 0'-6"	Topsoil										
0'-6" - 3'-6"	Soil Type 2	5'-0"									
3'-6" - 5'-6"	Soil Type 4										
5'-6" - 8'-0"	Soil Type 2	6'-0"									
Profile Pit #3											
Lat:	38°52'31.01"N	7'-0"		7'-0"	Soil Type 2	7'-0"					
Long:	104°33'20.70"W										
0 - 0'-6"	Topsoil	8'-0"		8'-0"			8'-0"				
0'-6" - 2'-6"	Soil Type 2										
2'-6" - 8'-0"	Soil Type 2	9'-0"		9'-0"			9'-0"				
Existing Well (If applicable)											
Lat:	-										
Long:	-

Recommendations:
 A Conventional On-Site Wastewater Treatment System (OWTS) is acceptable for this site (single family residence) provided the following requirements can be met: The Soil Treatment Area may not be located in the area of Profile Pit #2. If these install requirements cannot be met, an Engineered On-Site Wastewater Treatment System may be required. Provided the preceding requirements can be met, Soil Type 2 (LTAR = 0.60, Treatment Level 1) will be the most restrictive soil in the treatment zone of the soil treatment area.
