GEOLOGIC HAZARD STUDY

**6165 Waterfall Loop
Site 221, Crystal Park
El Paso County, Colorado**

JOB NO. 196394

May 3, 2024

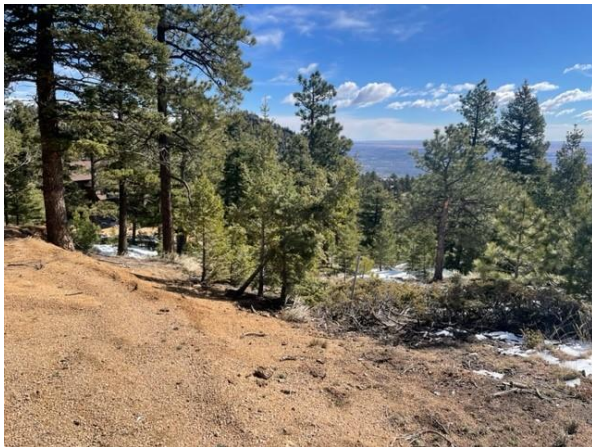
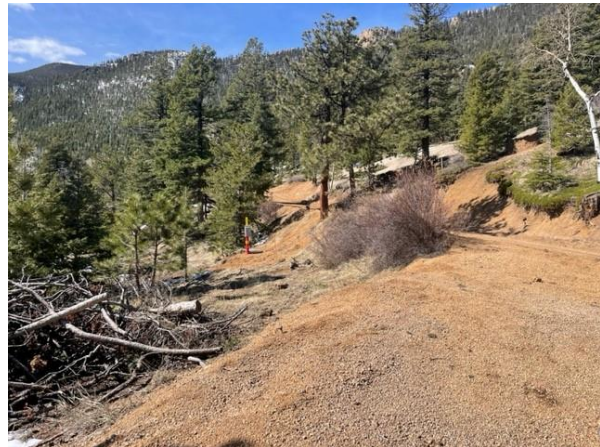
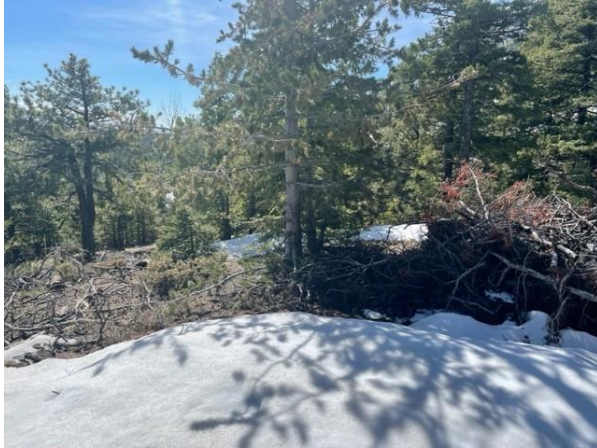
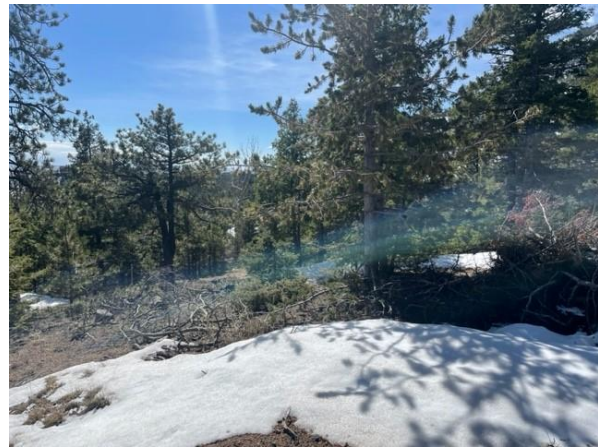
We performed a field reconnaissance on April 16, 2024. At the time of the field reconnaissance, the site consisted of vacant, undeveloped land that is near the top of the mountain, generally located about 3 miles from the gated entrance in the northeast portion of the Crystal Park subdivision. A gravel driveway slopes up to the proposed building pad.

The ground surface within the proposed building and septic area had been cleared of vegetation. Surrounding the building and septic field pads, vegetation consisted of moderate- to high-growth coniferous trees, small rocks, boulders, native grasses and weeds. Topographically, the site resides atop a mountain top which generally slopes down towards the east at approximately 27 to 30 percent. The site has generally good drainage in the form of surficial sheet flow directed to the east.
