ENTECH
ENGINEERING, INC.

July 16, 2024

Re: Soils and Geology Study
Knecht 5-Lot Subdivision
12425 Meridian Road
Parcel Nos. 42180-00-002, 42180-00-004, and 42180-00-023
El Paso County, Colorado

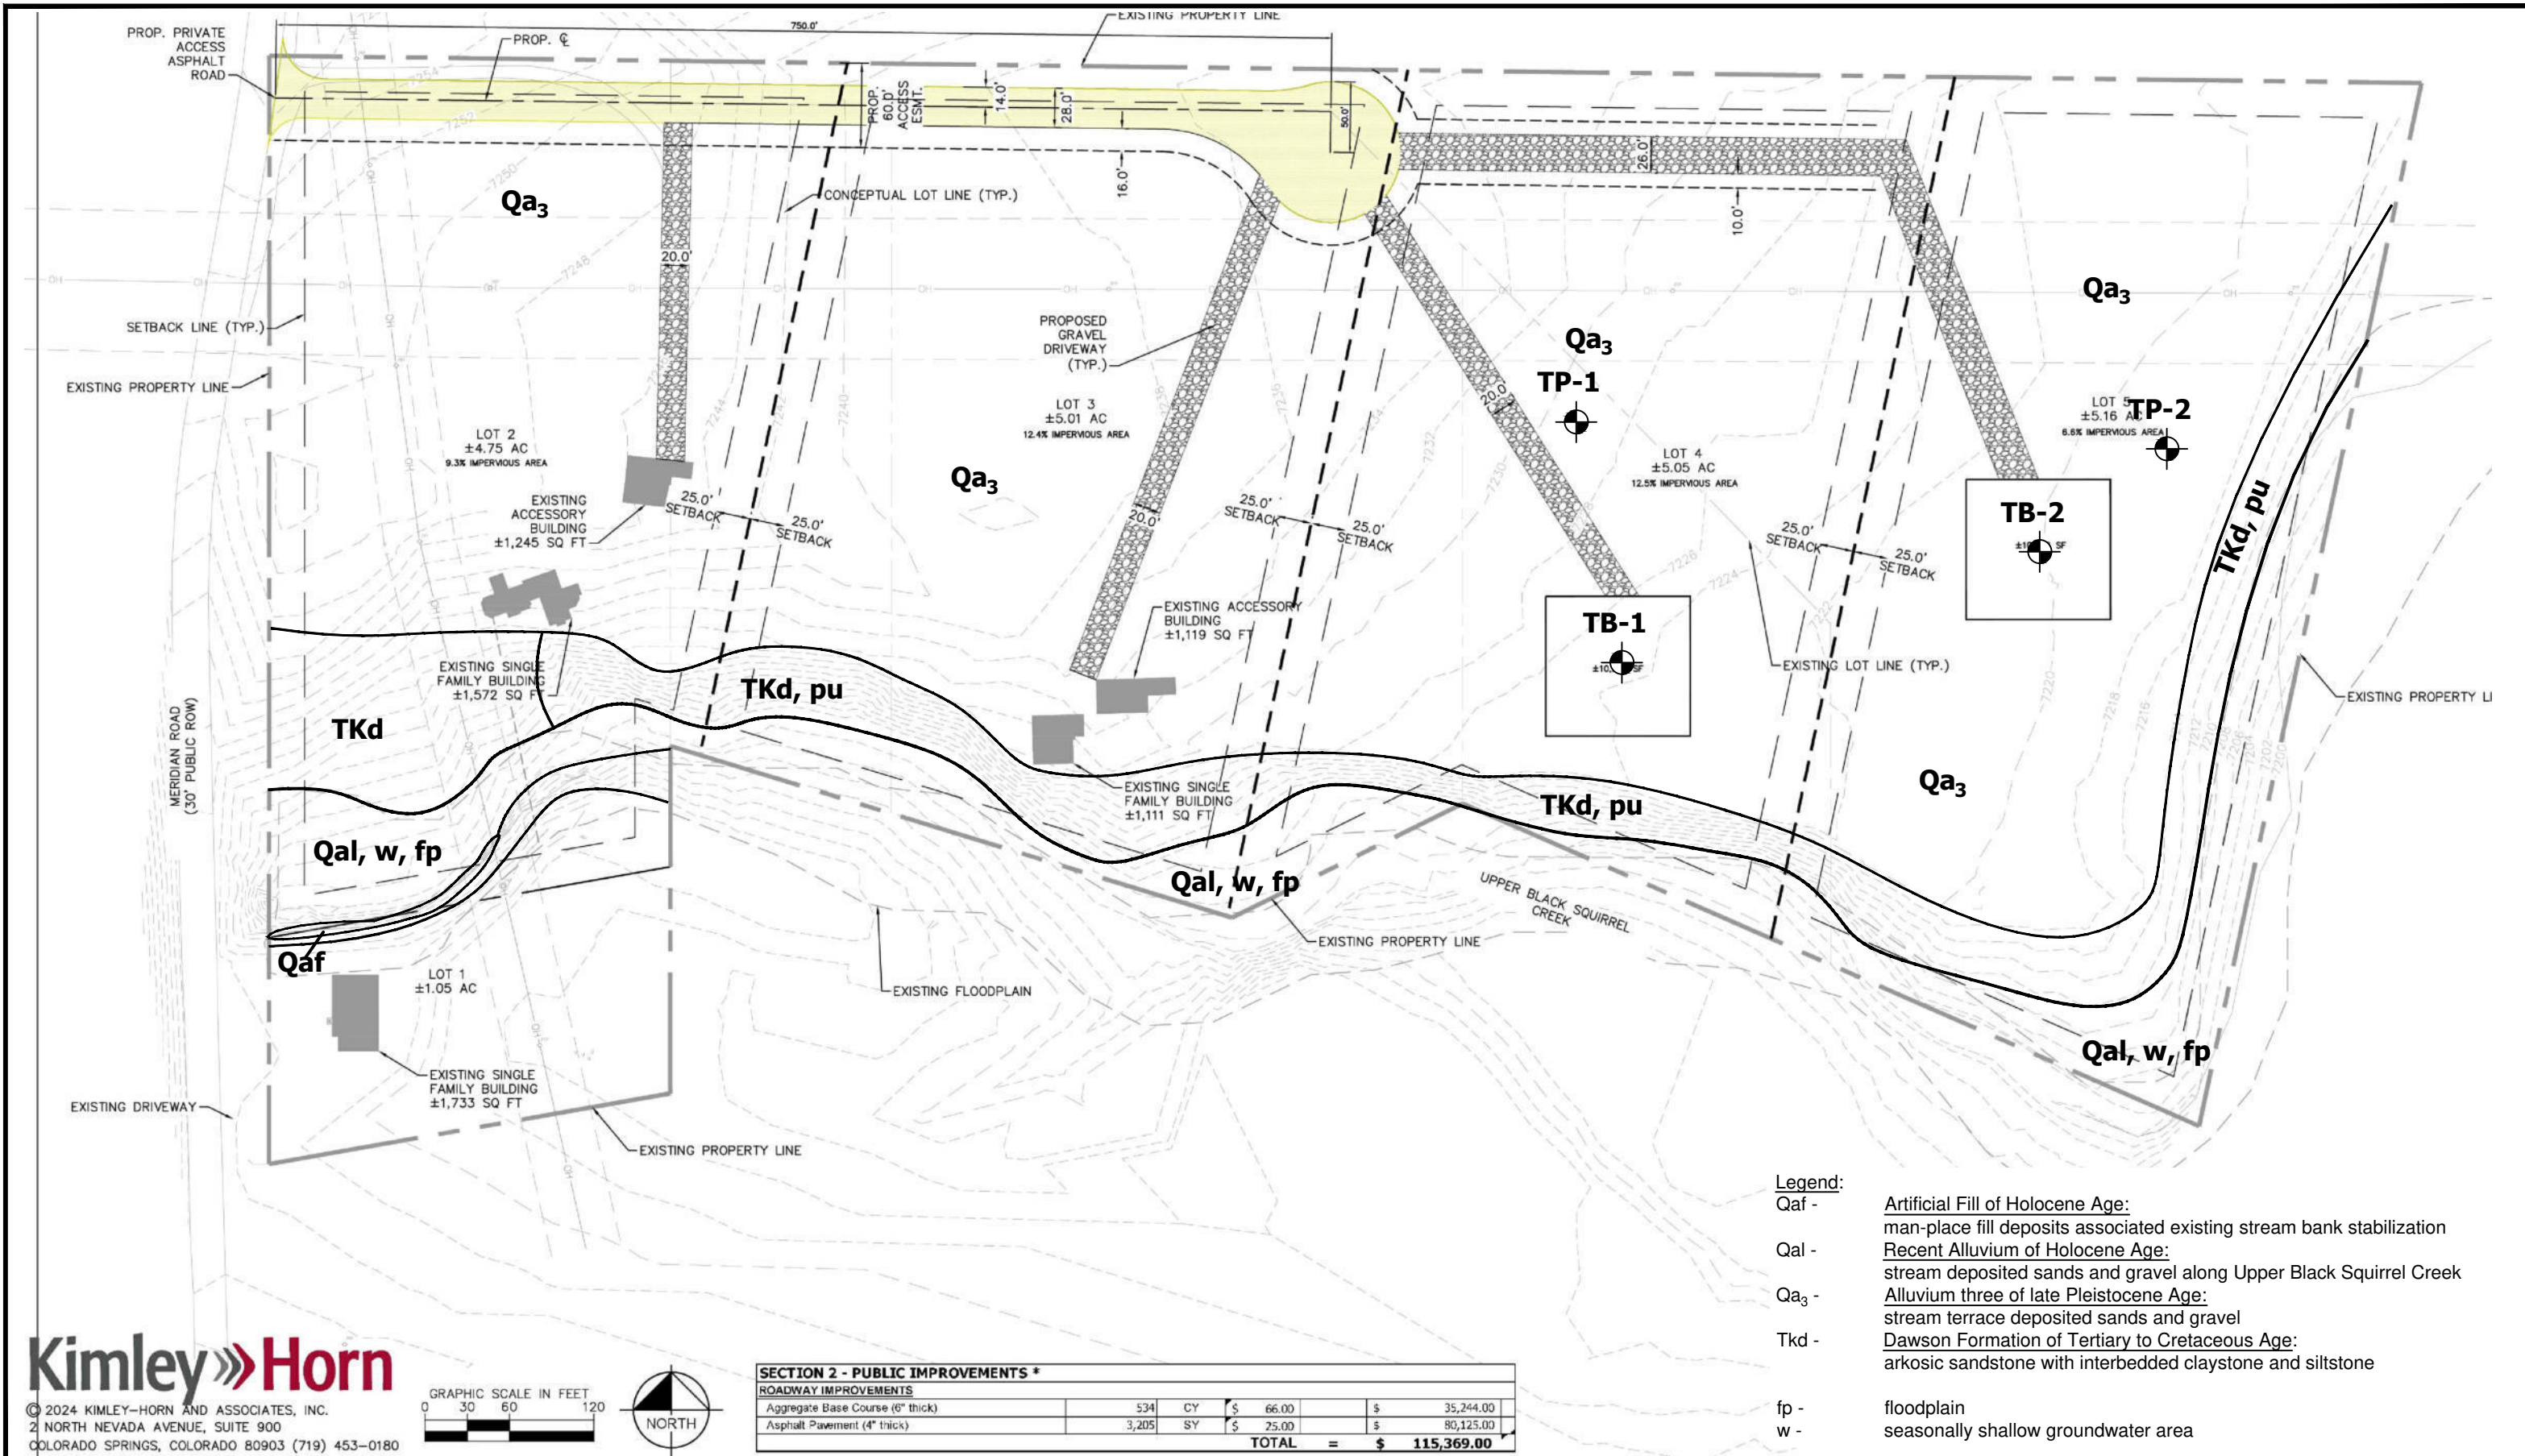
GEOLOGY / ENGINEERING MAP
12425 MERIDIAN ROAD
DAVID KNECHT
JOB NO. 240813
FIG. 6

Mapping has been performed on this site to identify areas where various geologic conditions exist of which developers should be cognizant during the planning, design and construction stages where new construction is proposed. The engineering geologic constraints/hazards identified on this site include artificial fill, potentially expansive soils, potentially unstable slopes, shallow bedrock, flowing water, and a floodplain. These hazards and recommended mitigation techniques are discussed as follows:

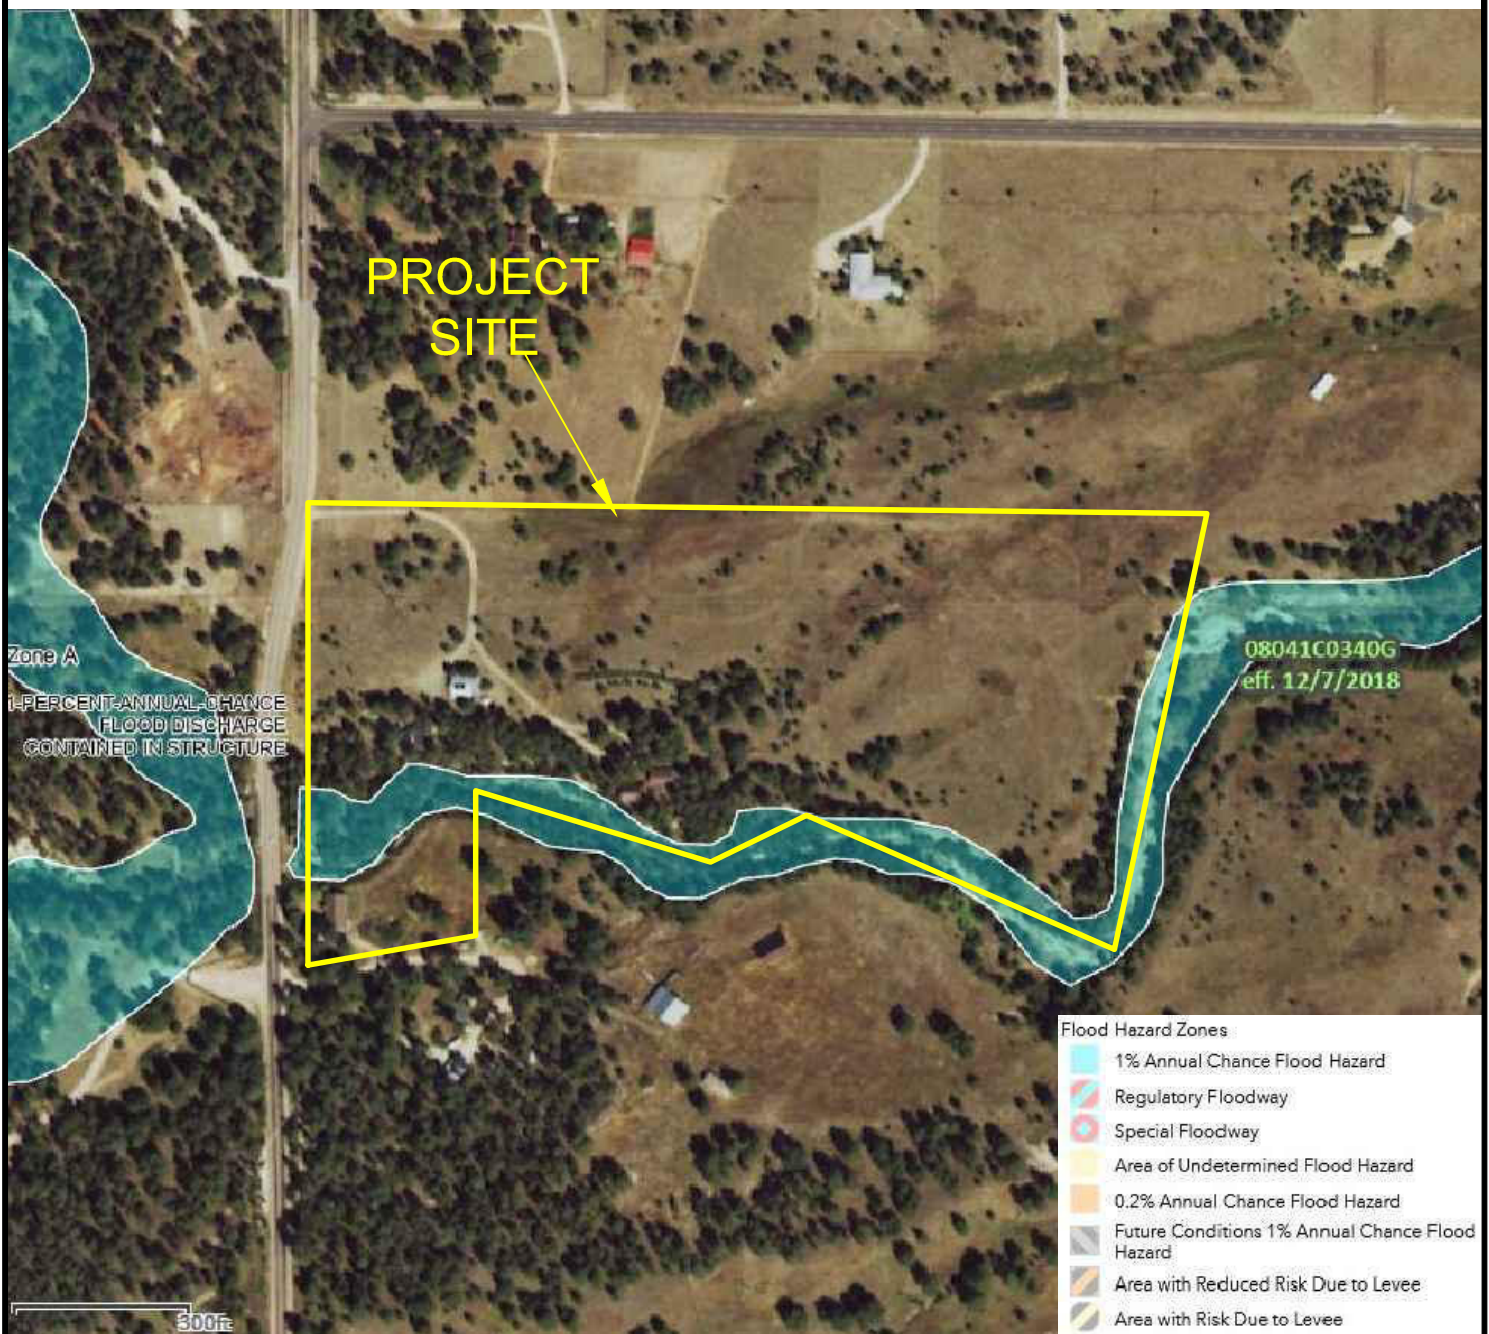
FIG. 7

Upper Black Squirrel Creek located in the southern portion of the site is a mapped floodplain according to the FEMA Map No. 08041CO340G, dated December 7, 2018 (Figure 7, Reference 7). Water was observed in any of the creek at the time of our site investigation. This area will be avoided by development on Lots 4 and 5. Groundwater was not encountered in the test borings or test pits on the site. Typical subsurface perimeter drain details are presented in Figure 8.

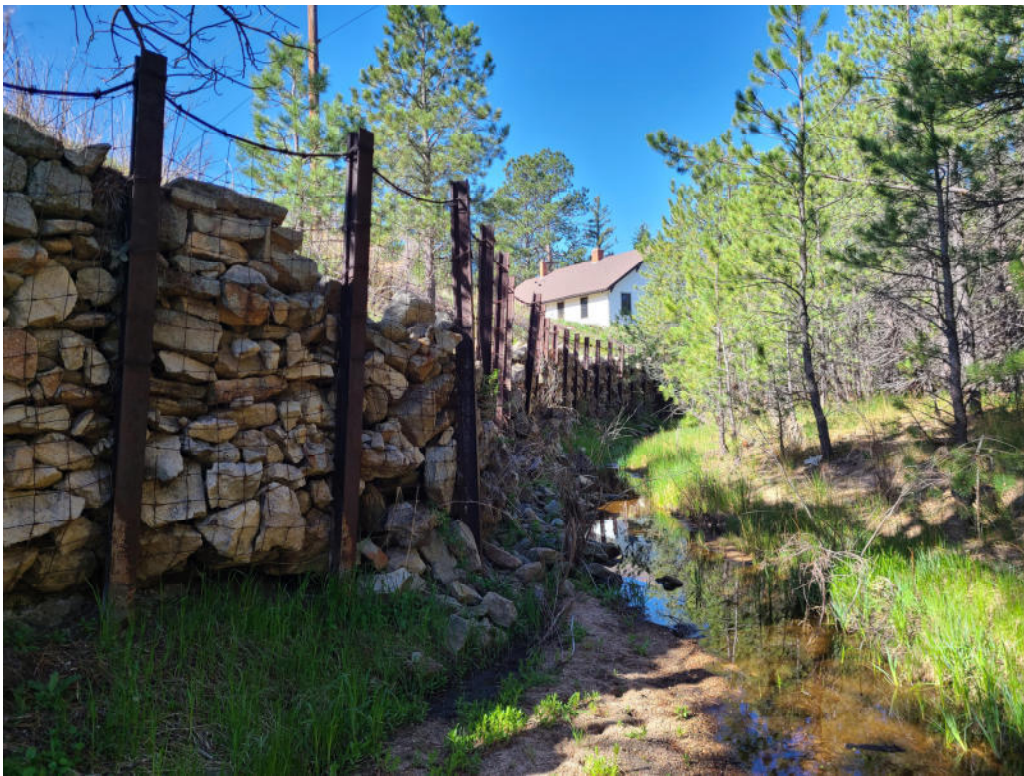
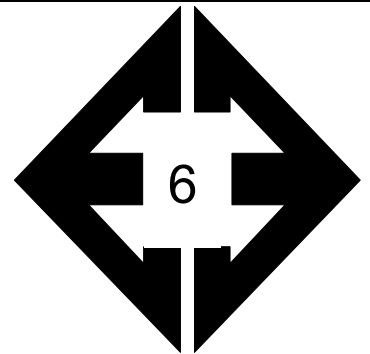
Man-place fill associated with existing erosion protection/slope stabilization on the slope north of the existing residence on Lot 1 along Upper Black Squirrel Creek in the southwestern portion of the site. Other areas of significant fill were not observed on the site.

Man-place fill associated with existing erosion protection/slope stabilization on the slope north of the existing residence on Lot 1 along Upper Black Squirrel Creek in the southwestern portion of the site. This area is not located near any new construction proposed. Periodic observations and repair of the existing mitigation measures is recommended as needed.

**Looking southwest
towards slope
stabilization along Lot
1.**

Mitigation: If uncontrolled fill is encountered beneath foundations, mitigation will be necessary. Mitigation typically involves removal and recompaction at 95% of its maximum Modified Proctor Dry Density, ASTM D-1557.

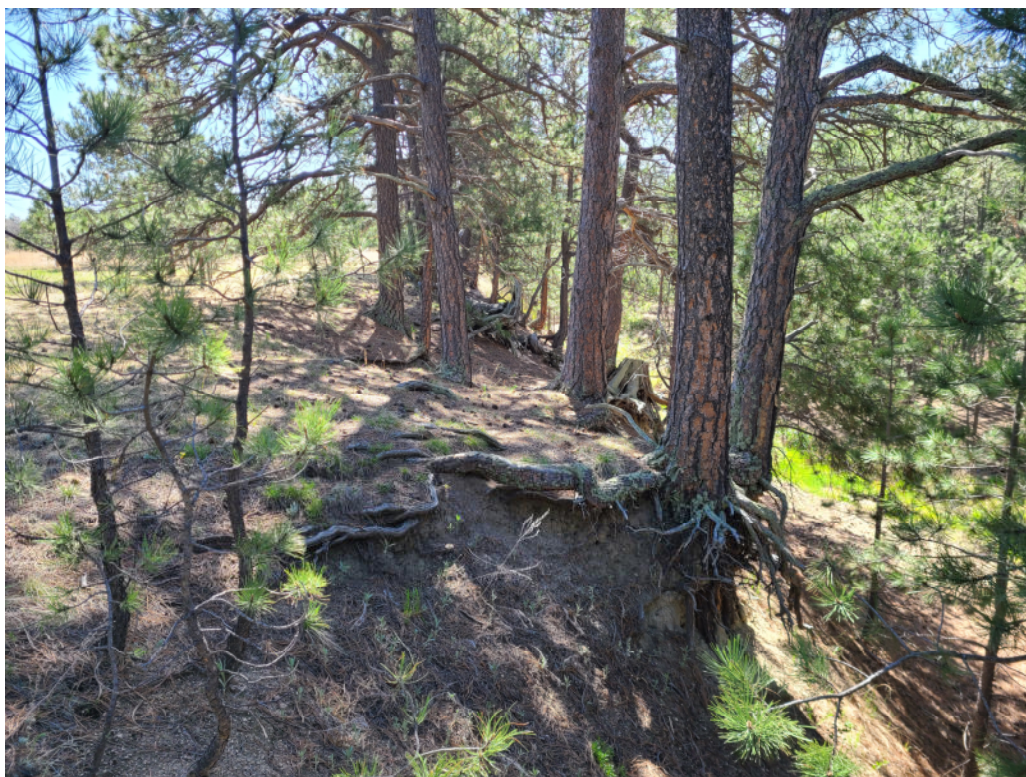
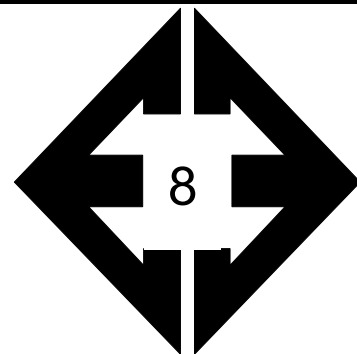
The areas identified with this hazard are the moderate to steep slopes along sections of Upper Black Squirrel Creek in the southern portion of the site. These slopes are considered stable in their present state, however, considerable care must be exercised in these areas not to create a condition which would tend to activate instability. No construction is proposed in these areas and these areas will be avoided.

The topography of the site is generally gradual to the northeast with moderate to steep slopes along Upper Black Squirrel Creek in the southern portion of the site. Portions of these slopes have been mapped as potentially unstable. No signs of slope failures or unstable slopes were not observed on the site at the time of our site reconnaissance. The areas identified with this hazard are the moderate to steep slopes along sections of Upper Black Squirrel Creek in the southern portion of the site. These slopes are considered stable in their present state, however, considerable care must be exercised in these areas not to create a condition which would tend to activate instability. No construction is proposed in these areas and these areas will be avoided.

**Looking east along
crest of potentially
unstable slope on Lot
4.**
