WASTEWATER DISPOSAL REPORT

FOR KNECHT SUBDIVISION

DECEMBER 2024 – FINAL REPORT

Project Number W0265.24026

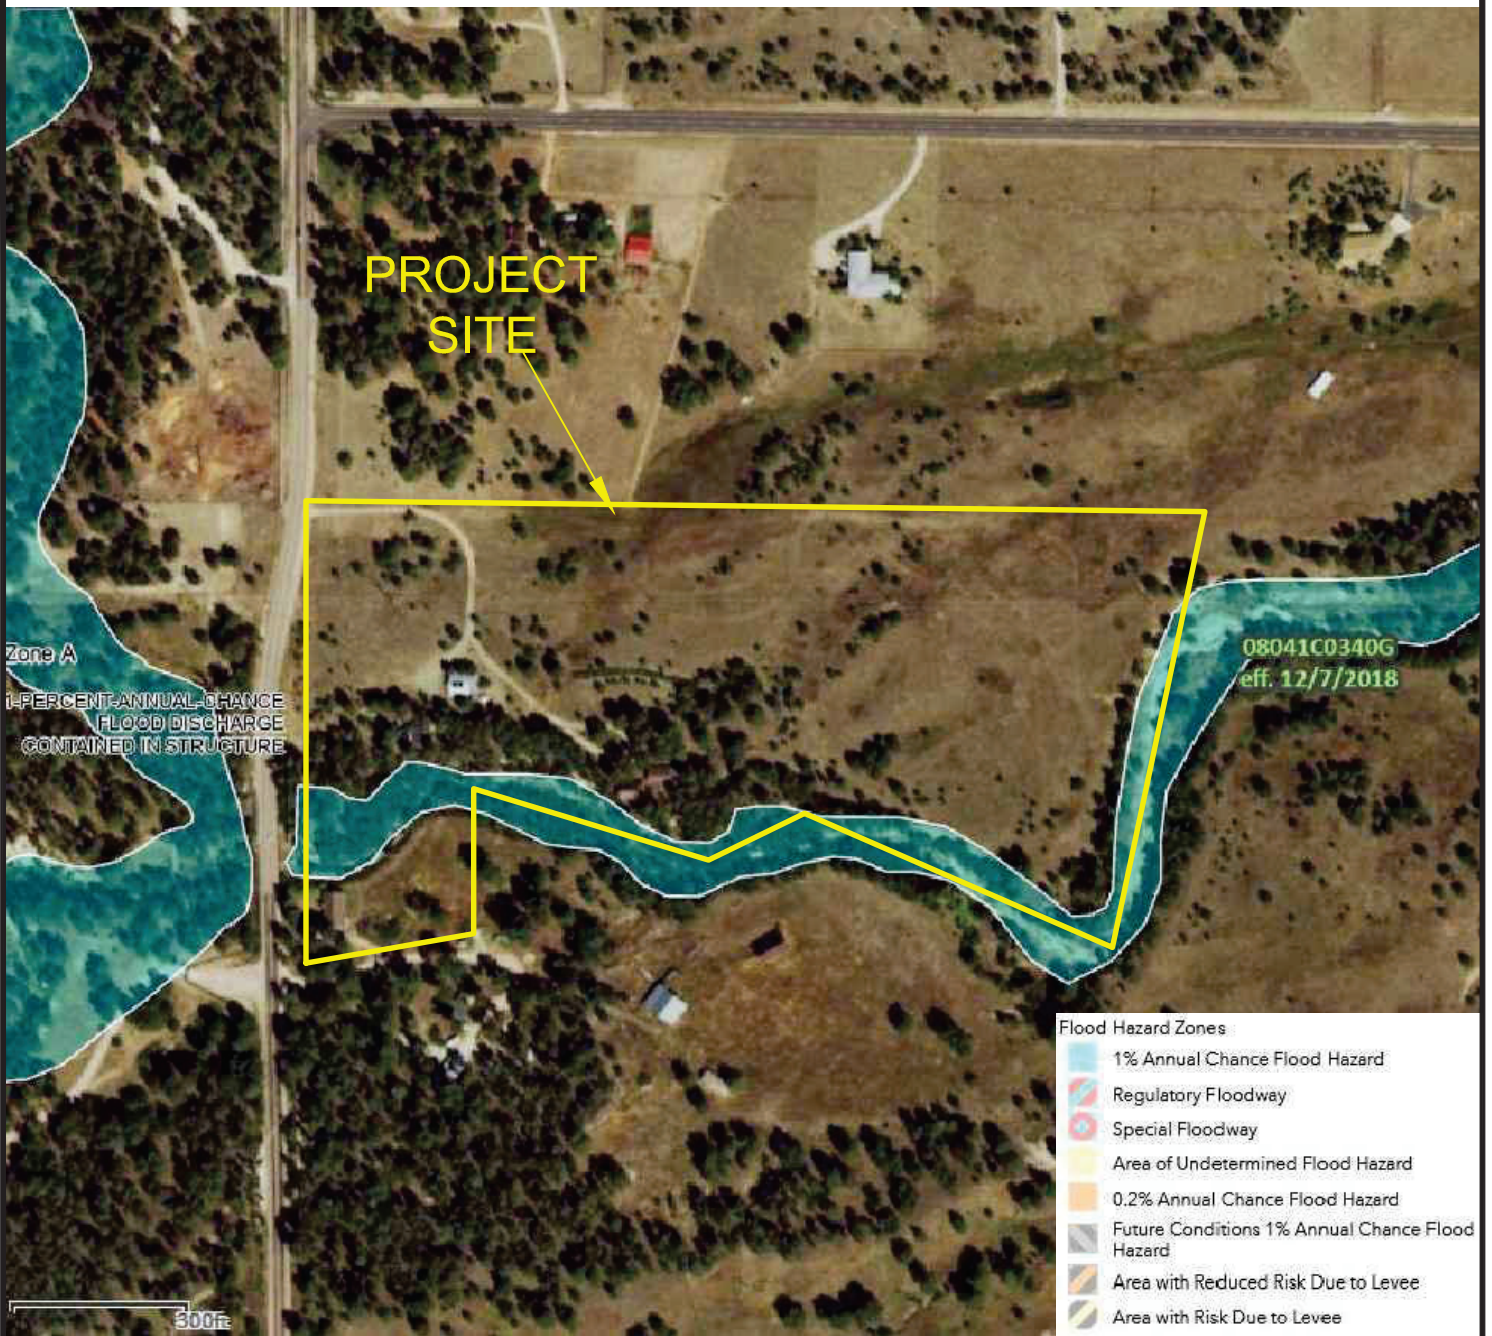
FEMA FLOODPLAIN MAP

Upper Black Squirrel Creek located in the southern portion of the site is a mapped floodplain according to the FEMA Map No. 08041CO340G, dated December 7, 2018 (Figure 7, Reference 7). Water was observed in any of the creek at the time of our site investigation. This area will be avoided by development on Lots 4 and 5. Groundwater was not encountered in the test borings or test pits on the site. Typical subsurface perimeter drain details are presented in Figure 8. **Specific drainage studies are beyond the scope of this report.**

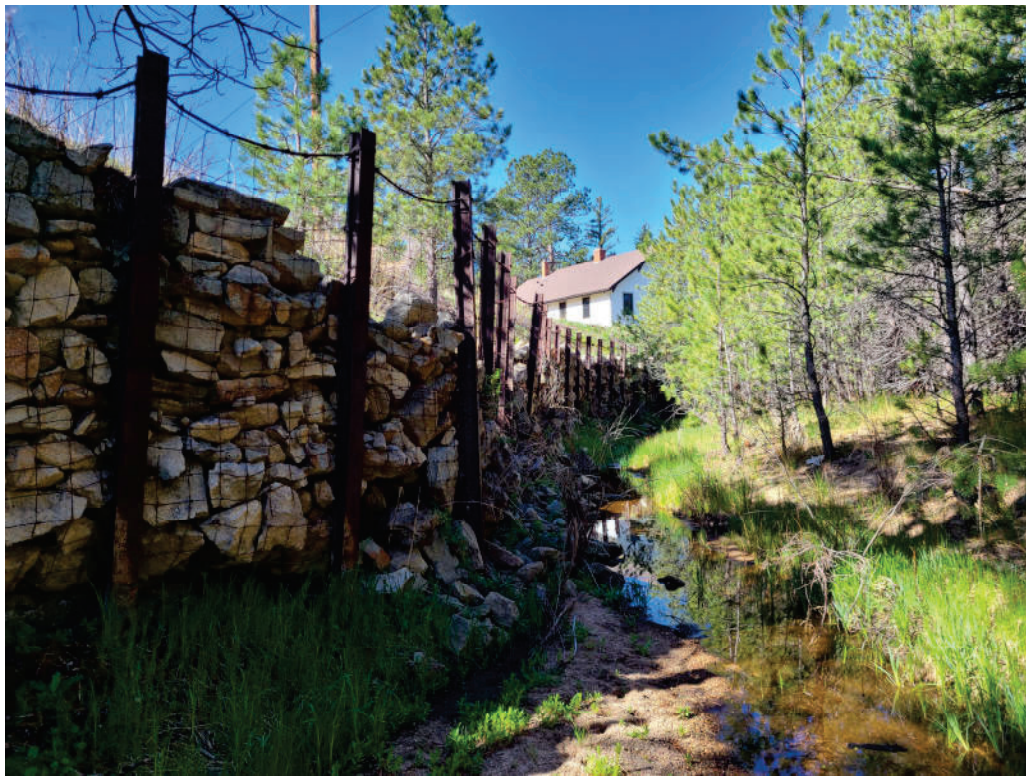
Man-place fill associated with existing erosion protection/slope stabilization on the slope north of the existing residence on Lot 1 along Upper Black Squirrel Creek in the southwestern portion of the site. Other areas of significant fill were not observed on the site.

Looking southwest towards slope stabilization along Lot 1.

Mitigation: If uncontrolled fill is encountered beneath foundations, mitigation will be necessary. Mitigation typically involves removal and recompaction at 95% of its maximum Modified Proctor Dry Density, ASTM D-1557.

Man-place fill associated with existing erosion protection/slope stabilization on the slope north of the existing residence on Lot 1 along Upper Black Squirrel Creek in the southwestern portion of the site. This area is not located near any new construction proposed. Periodic observations and repair of the existing mitigation measures is recommended as needed.

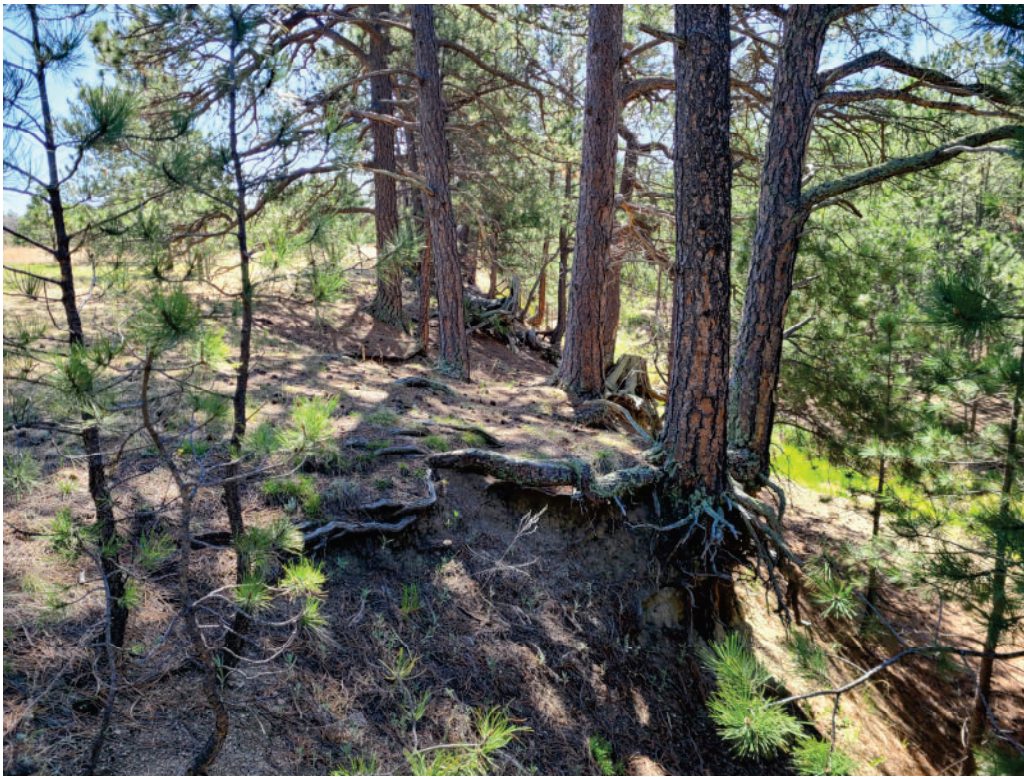
The areas identified with this hazard are the moderate to steep slopes along sections of Upper Black Squirrel Creek in the southern portion of the site. These slopes are considered stable in their present state, however, considerable care must be exercised in these areas not to create a condition which would tend to activate instability. No construction is proposed in these areas and these areas will be avoided.

**Looking east along
crest of potentially
unstable slope on Lot
4.**

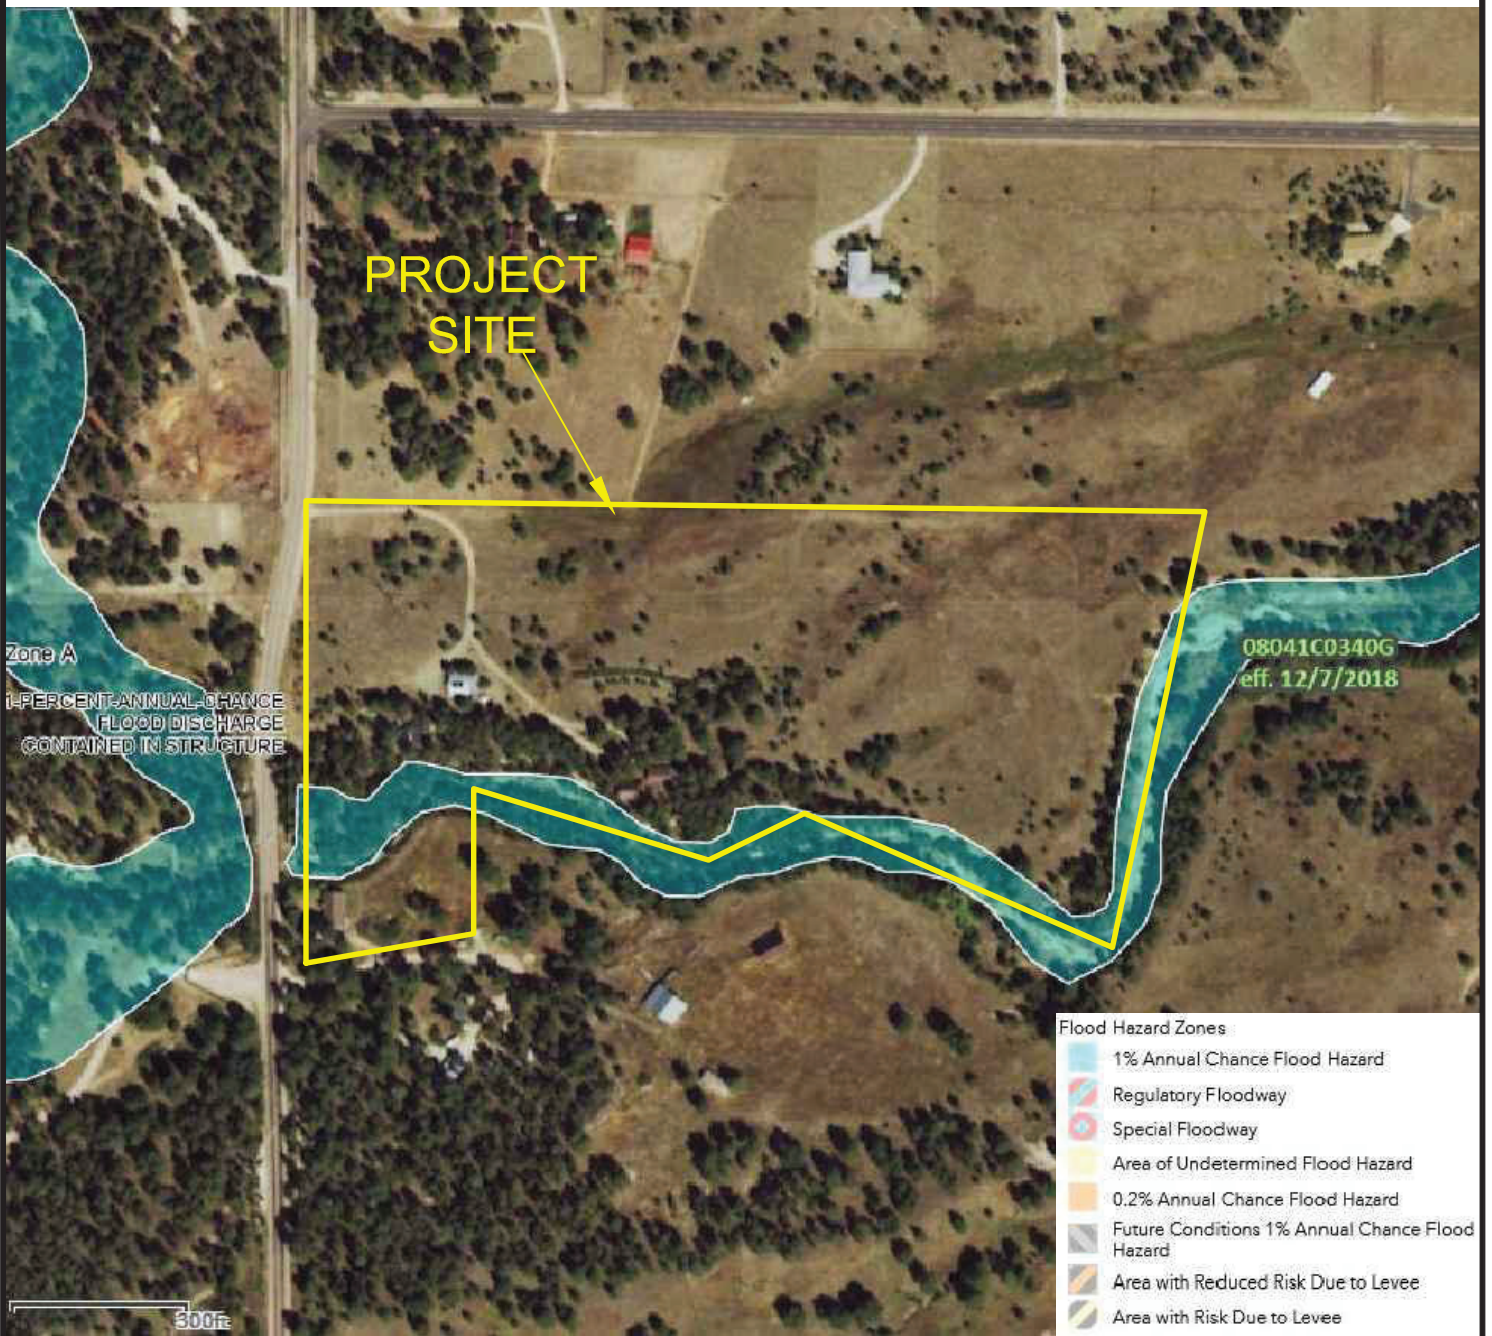
FIG. 7

Upper Black Squirrel Creek located in the southern portion of the site is a mapped floodplain according to the FEMA Map No. 08041CO340G, dated December 7, 2018 (Figure 7, Reference 7). Water was observed in any of the creek at the time of our site investigation. This area will be avoided by development on Lots 4 and 5. Groundwater was not encountered in the test borings or test pits on the site. Typical subsurface perimeter drain details are presented in Figure 8. **Specific drainage studies are beyond the scope of this report.**

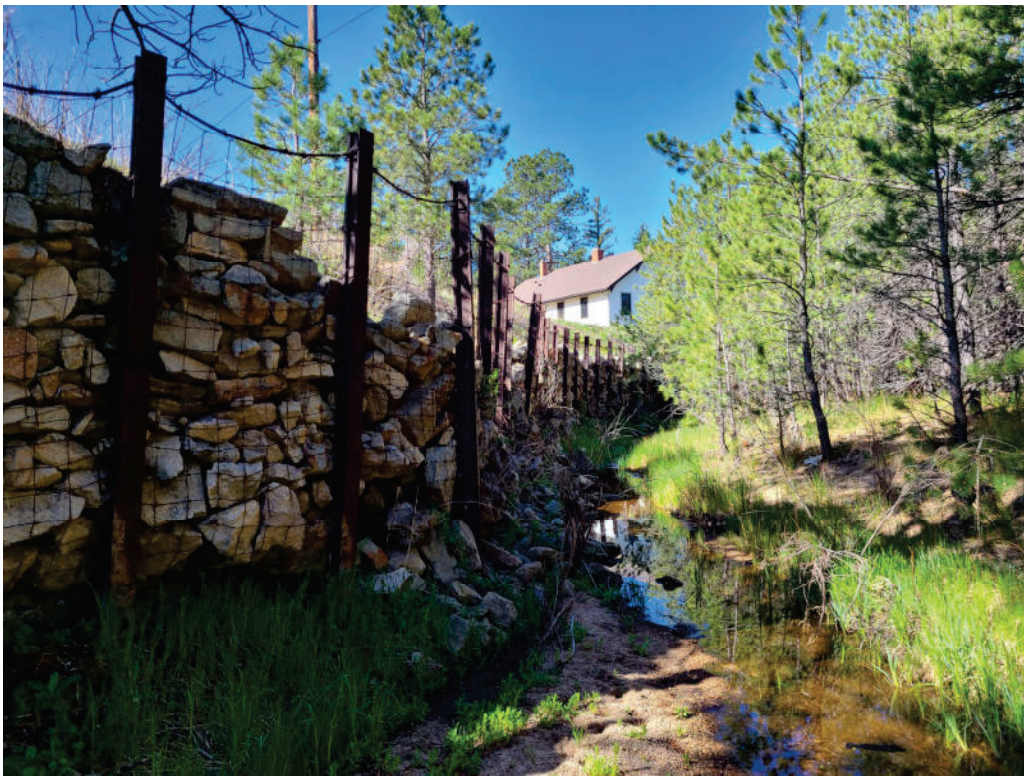
Looking southwest towards slope stabilization along Lot 1.

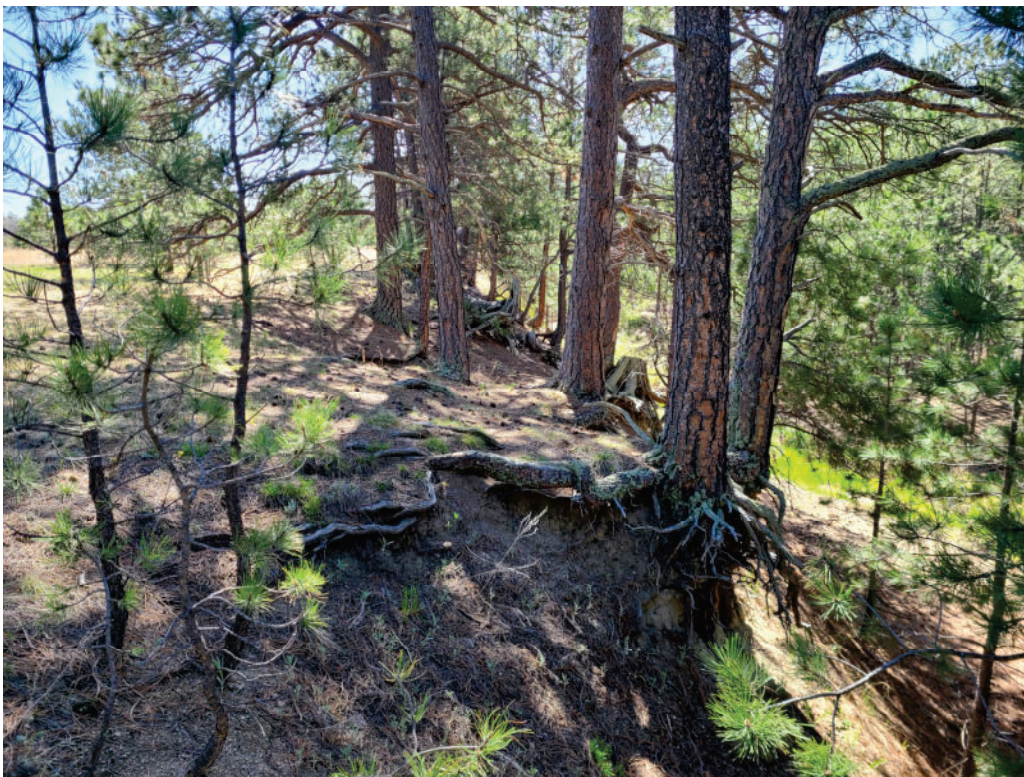
**Looking east along
crest of potentially
unstable slope on Lot
4.**
