**ENTECH**  
ENGINEERING, INC.

March 24, 2020

Re: Soil, Geology and Geologic Hazard Evaluation  
7765 Electronic Drive  
El Paso County, Colorado

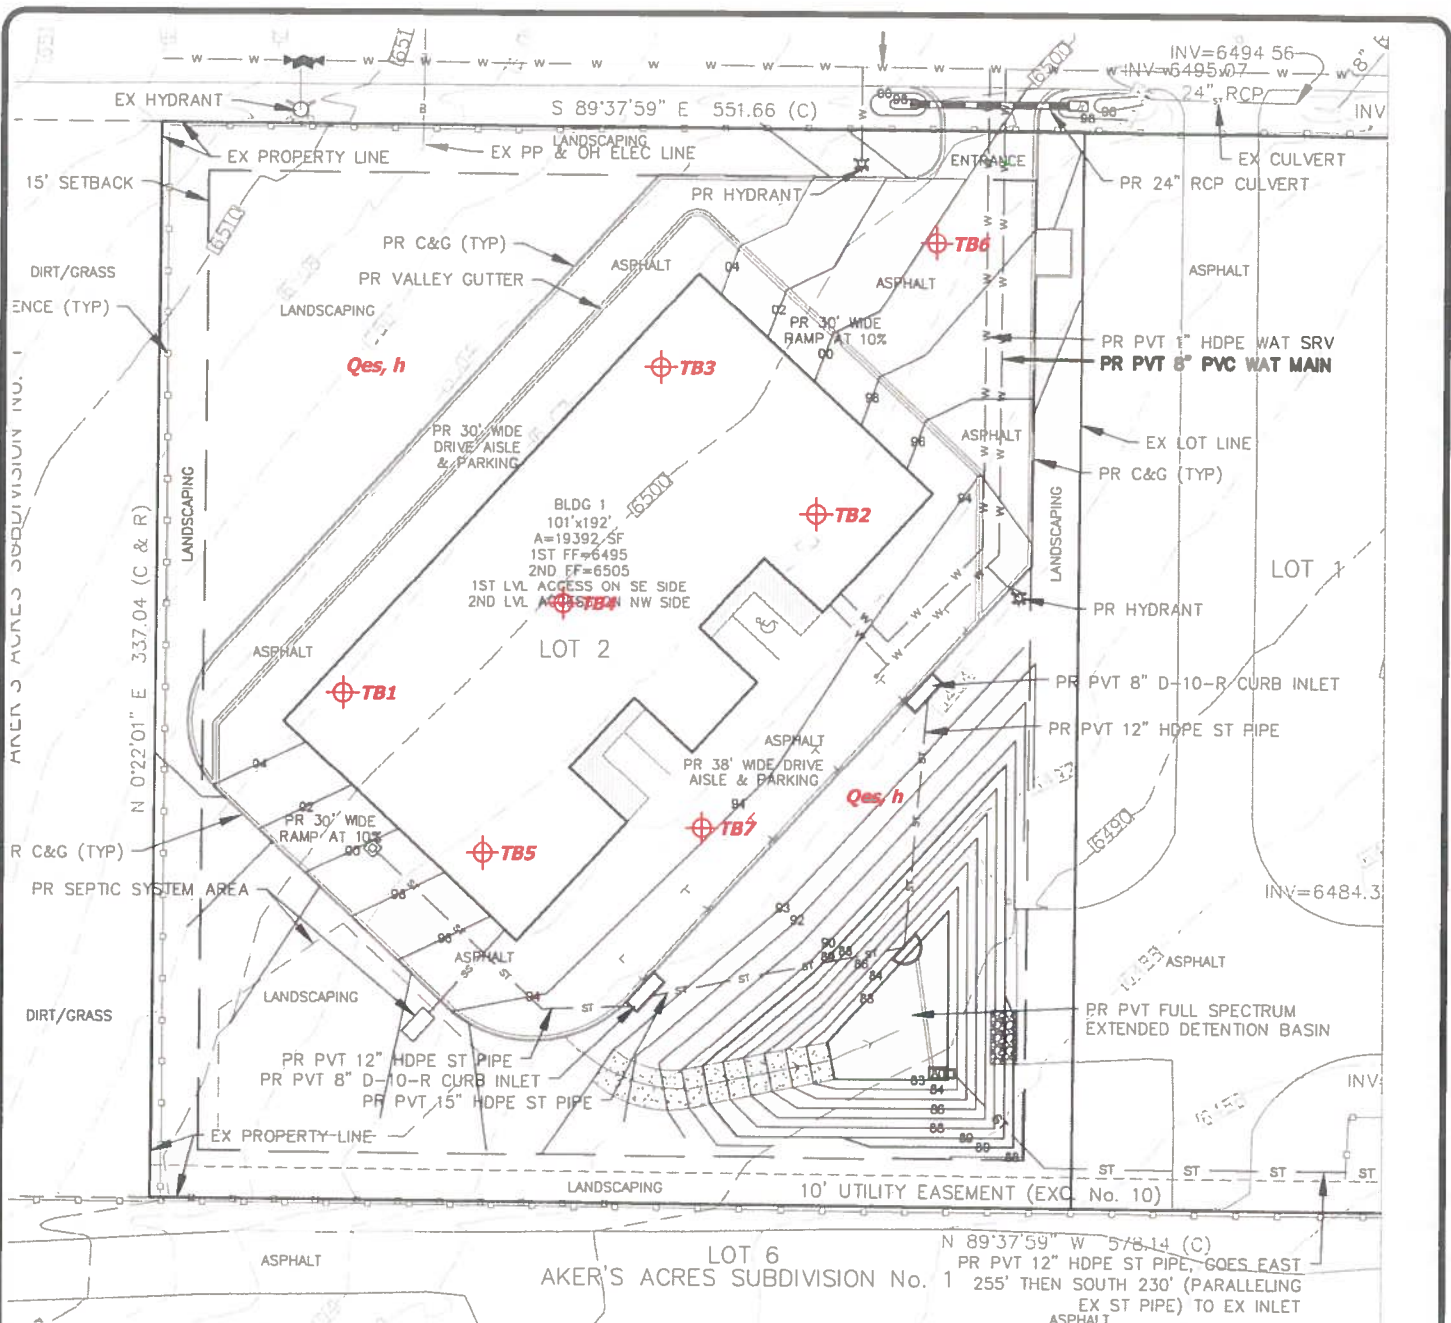
FIG NO.:  
**6**

The geology of the site was evaluated using the *Geologic Map of the Elsmere Quadrangle*, by Madole and Thorson in 2003, (Reference 4, Figure 5). The Geology for the site is presented in Figure 5. Five mappable units were identified on this site which, are described as follows:

**Qes<sub>2</sub>**      **Older Eolian Sands of Holocene to Late Pleistocene Age:** These are wind-blown sands deposited by the action of prevailing winds. The materials typically consist of silty sands and may contain sandy silt layers.

Some of the sandy soils encountered on site exhibit low density and may be subject to settlement under a load (Reference 2). The potential for loose or collapsible soils exists anywhere in areas mapped as Eolian Sand (Qes). Loose soils encountered beneath the foundation or floor slabs will require mitigation.

Mitigation: Loose soils encountered beneath the foundations or floor slabs; will require mitigation consisting of recompaction. Overexcavation and recompaction at a minimum of 95% of its maximum Modified Proctor Dry Density, ASTM D-1557 is typical. An overexcavation depth of 2 to 4 feet is anticipated.

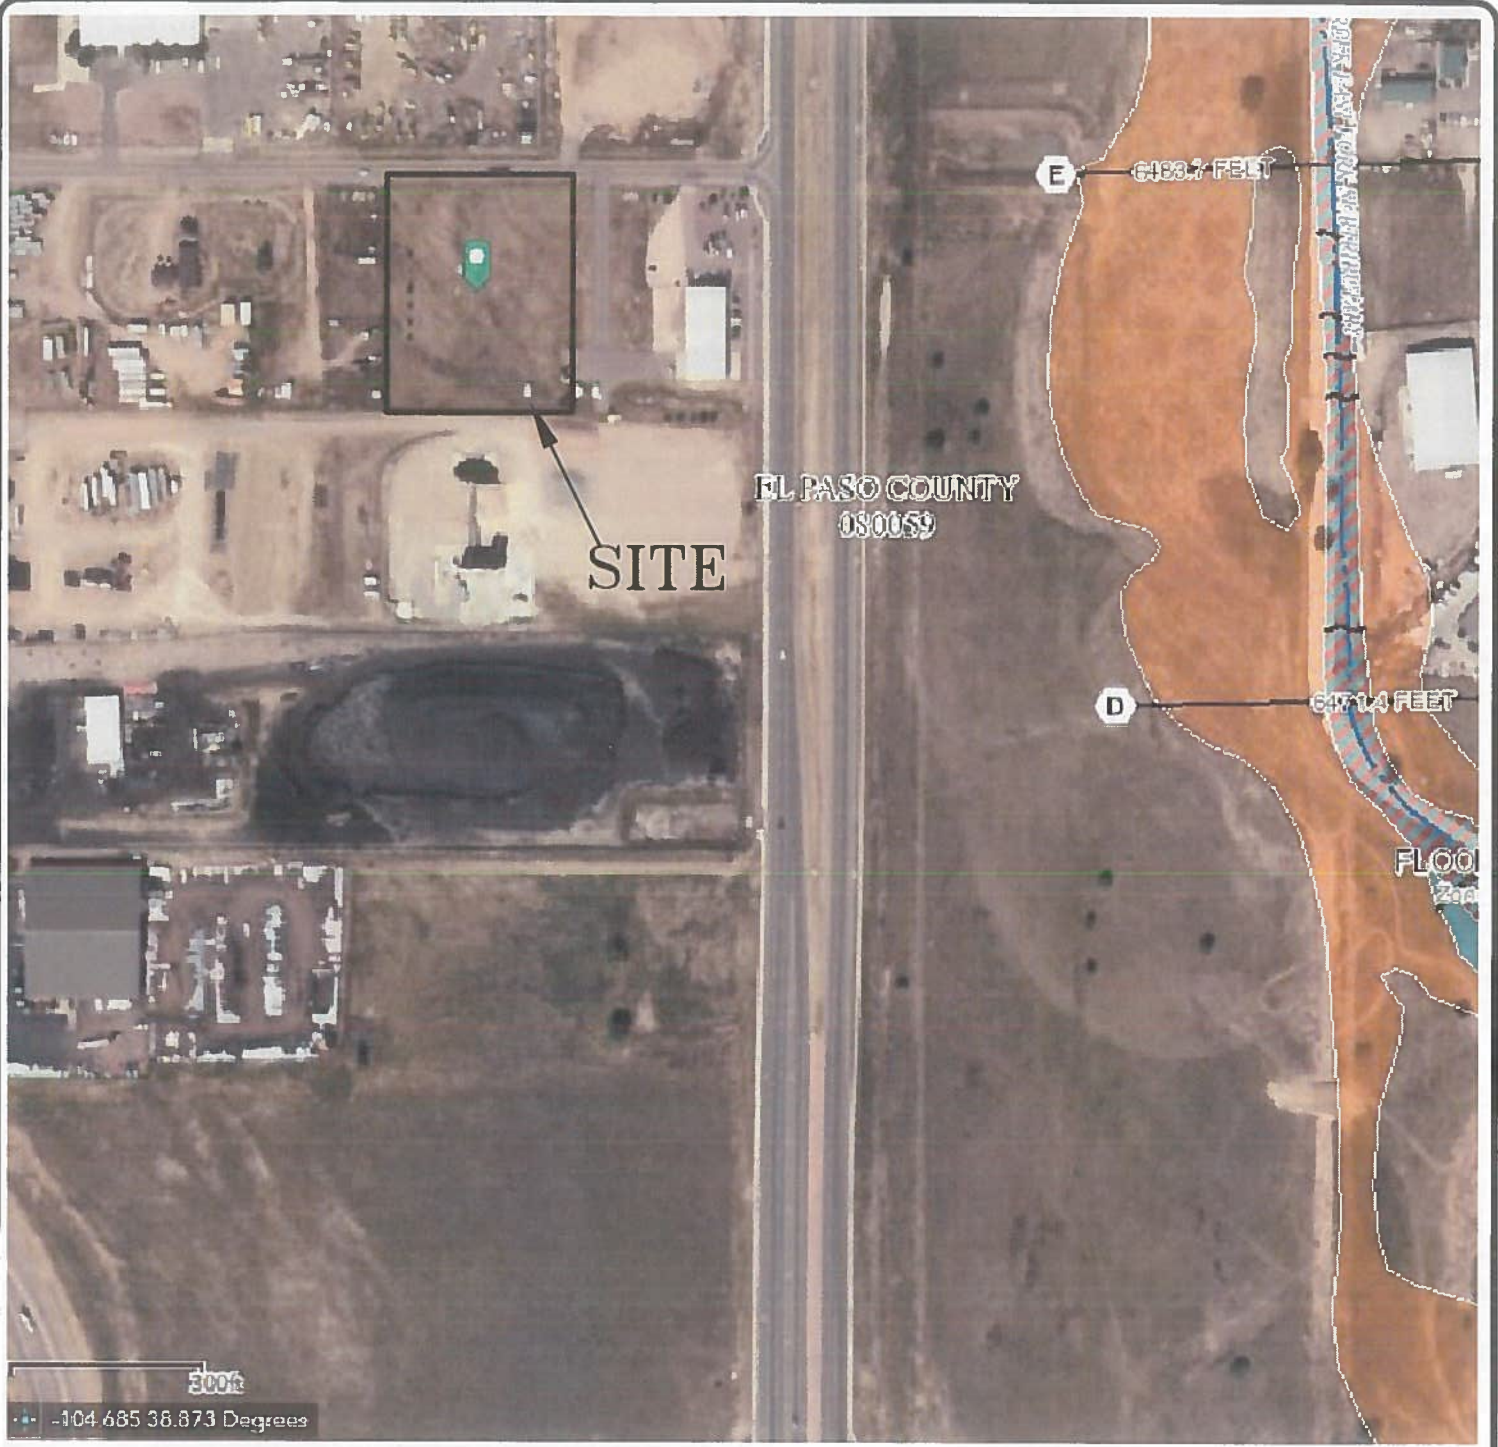
FIG NO.:  
7

The site does not lie within a floodplain according to the FIRM Map, No. 08041CO756G (Reference 9, Figure 7). Any site grading considered should be modified to direct surface flows around the structures or roads, or carried off-site so as to not produce any areas of ponded water. Additionally, subsurface perimeter drains may be required. Specific drainage studies and exact floodplain locations are beyond the scope of this report.

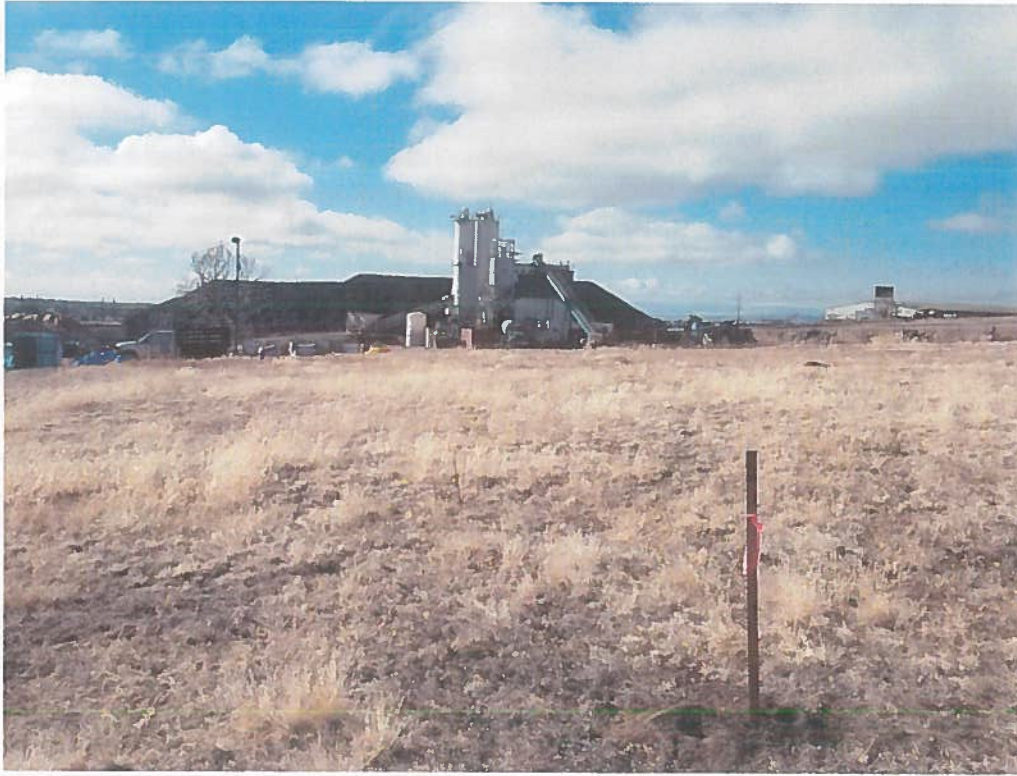
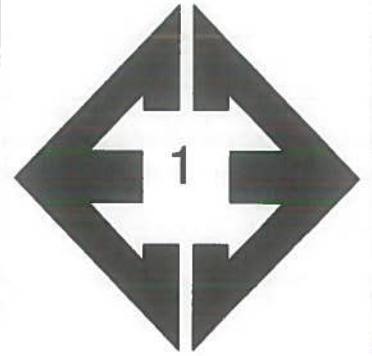
**Looking south from the northeast portion of the site.**

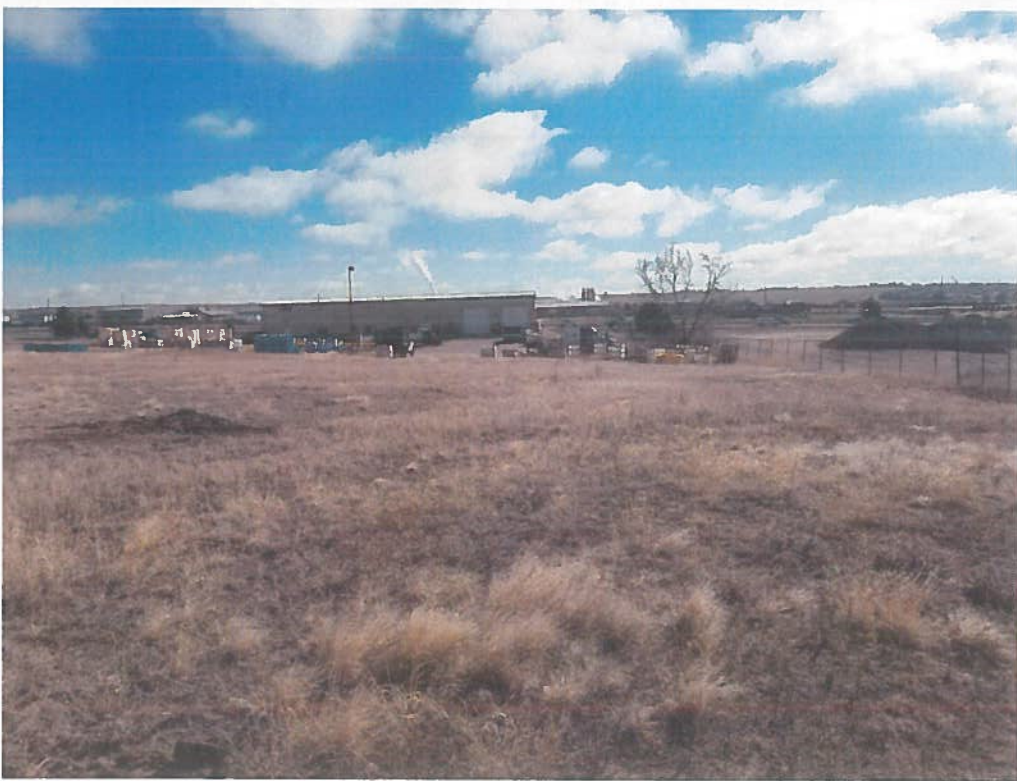
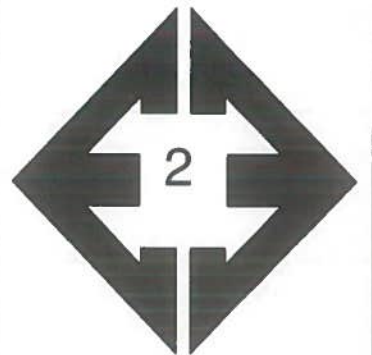
**Looking east from the southwest portion of the site.**

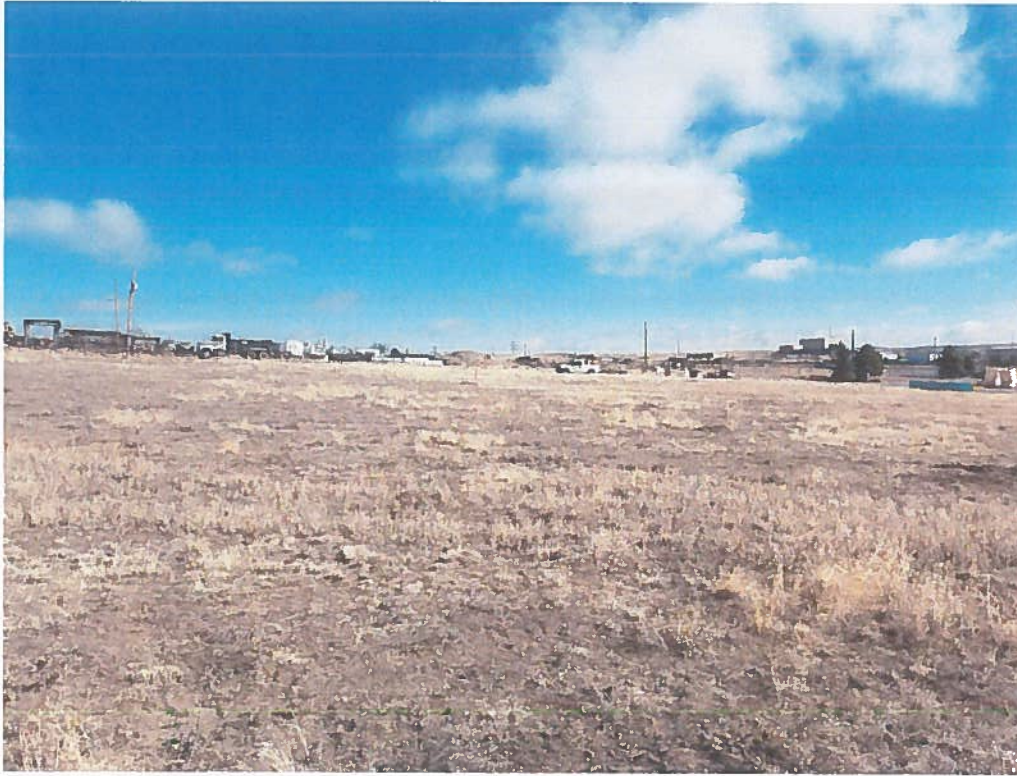
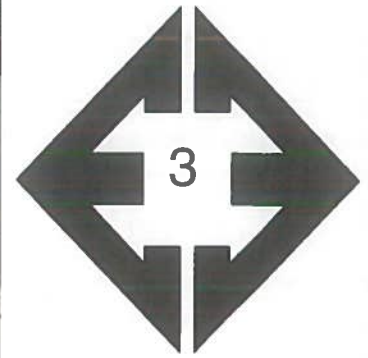
**Looking northeast  
from the southwest  
portion of the site.**

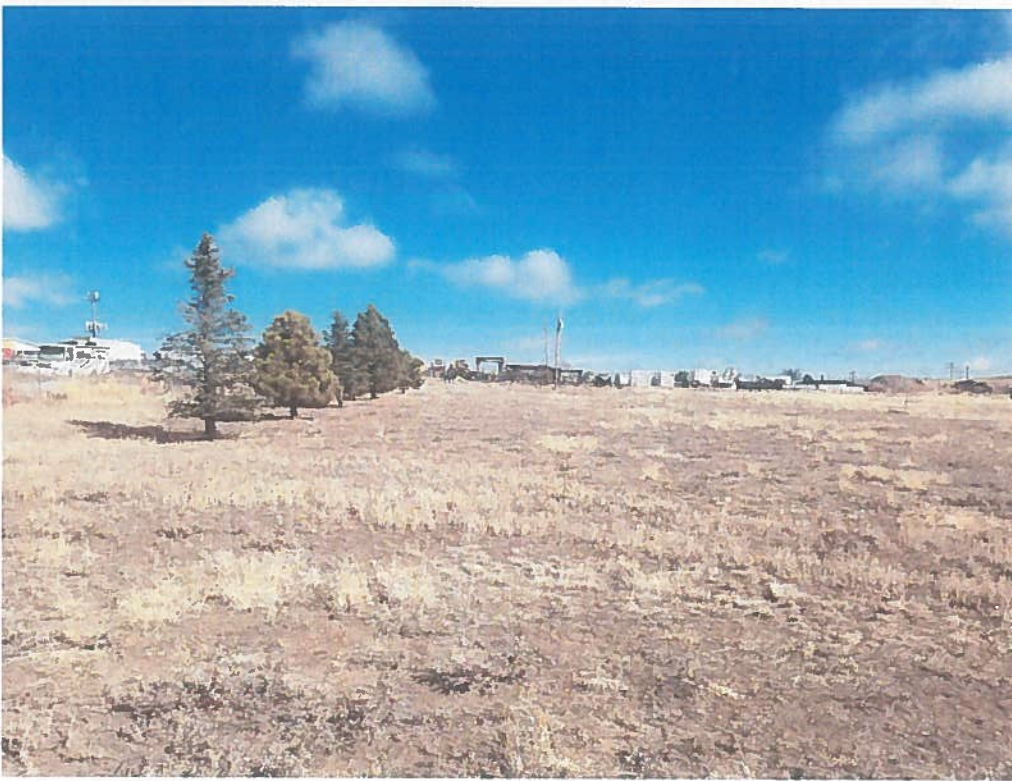
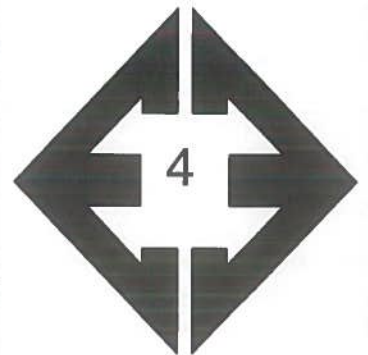
**Looking north from the  
southwest portion of  
the site.**
