**GEOLOGIC HAZARD INVESTIGATION
SPRINGS RANCH
TAX SCHEDULE NOS. 53301-00-009,
AND 53301-00-020
COLORADO SPRINGS, COLORADO**

September 5, 2019

Job No. 191264

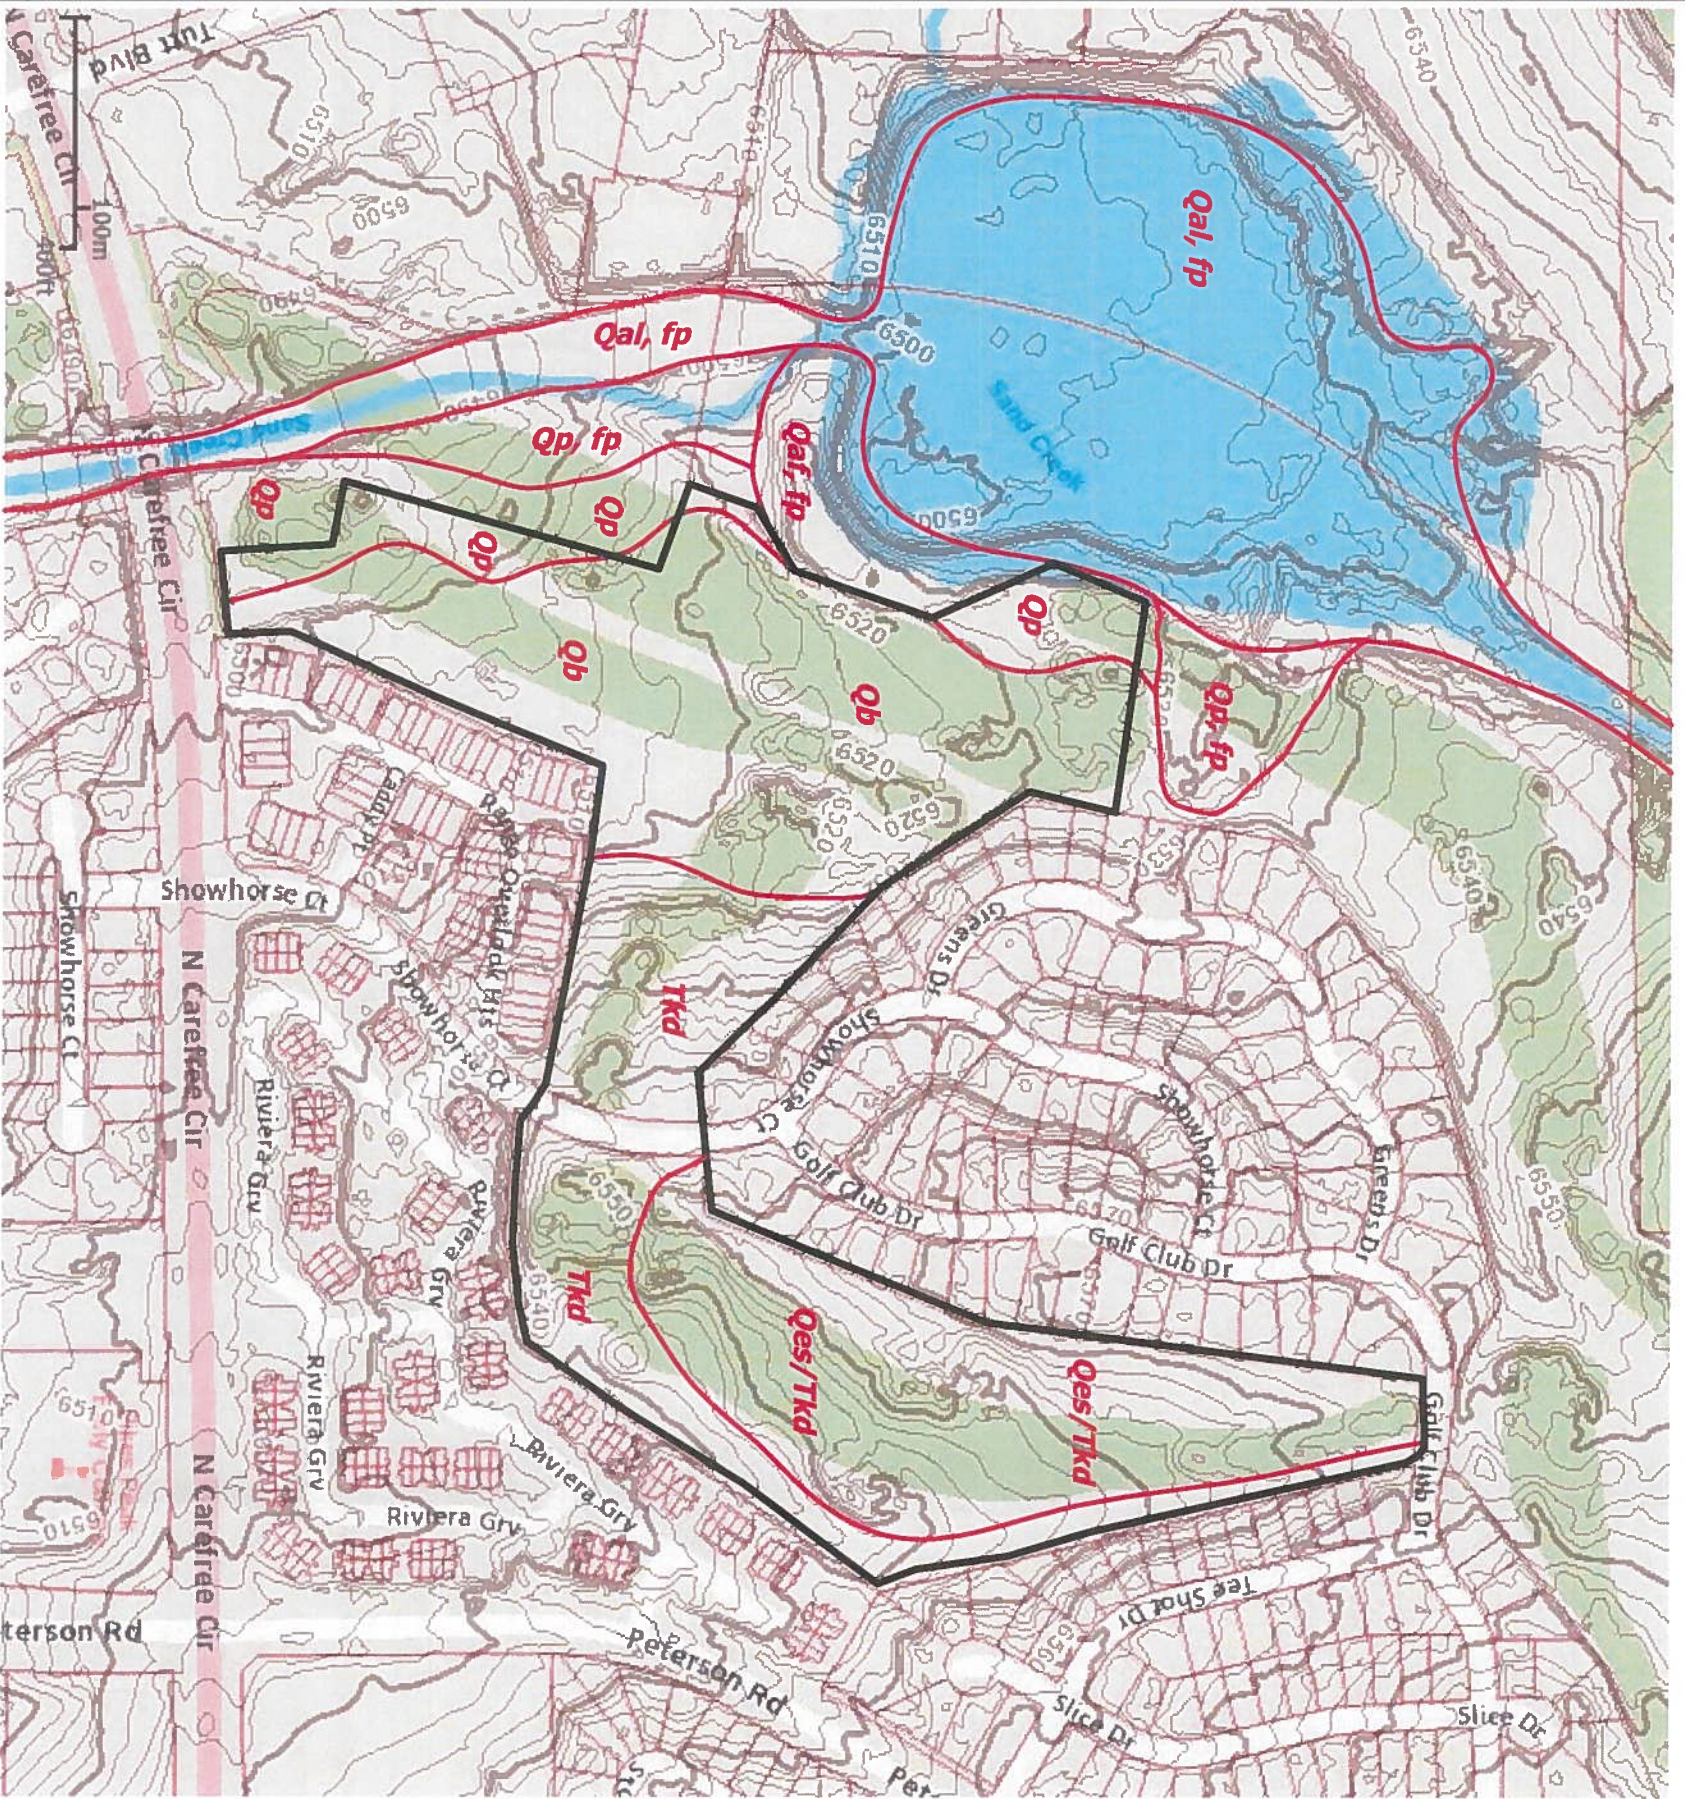
The geologic hazards identified on this site, include the potential for artificial fill, loose soils, expansive soils, and a floodplain which are indicated on the Geology/Engineering Geology Map, Figure 6. In accordance with the Geologic Hazards Ordinance of the City of Colorado Springs, the following geologic hazards have been addressed:

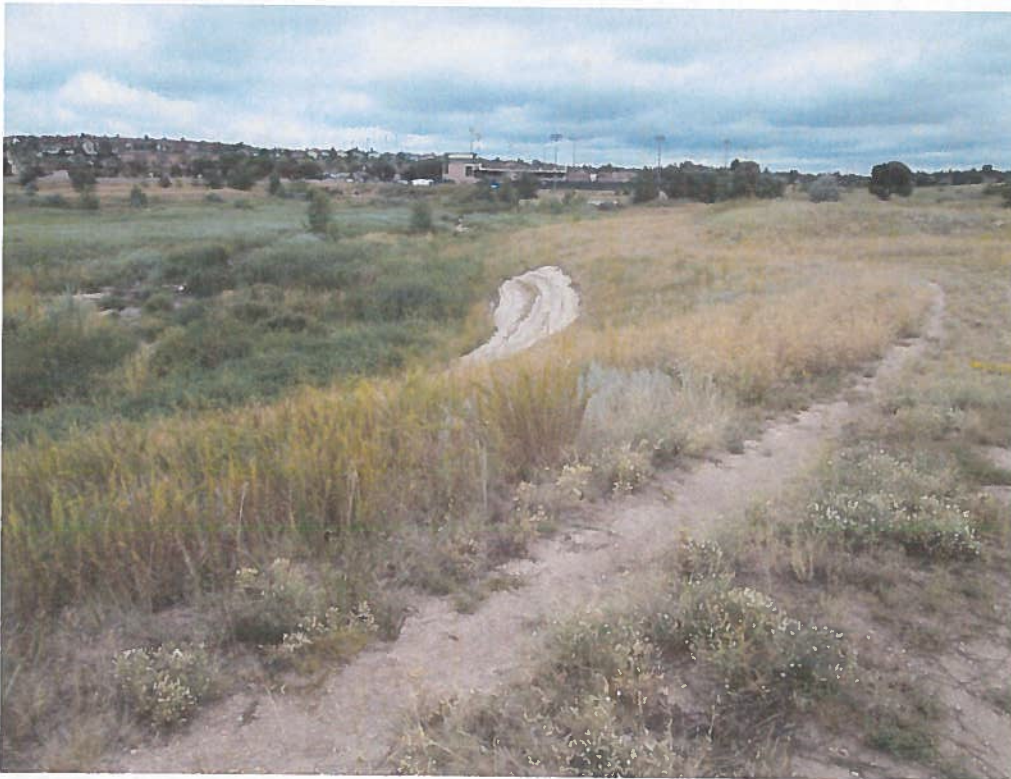
**Looking north at
slopes along Sand
Creek floodplain, west
of the site.**
