**SOIL, GEOLOGY, AND GEOLOGIC HAZARD
SPRINGS AT WATERVIEW
GRINNELL BOULEVARD AND BRADLEY ROAD
EL PASO COUNTY, COLORADO**

Dakota Springs Engineering, Inc.
31 North Tejon Street, Suite 500
Colorado Springs, Colorado 80903

March 15, 2017

Entech Job No. 170008

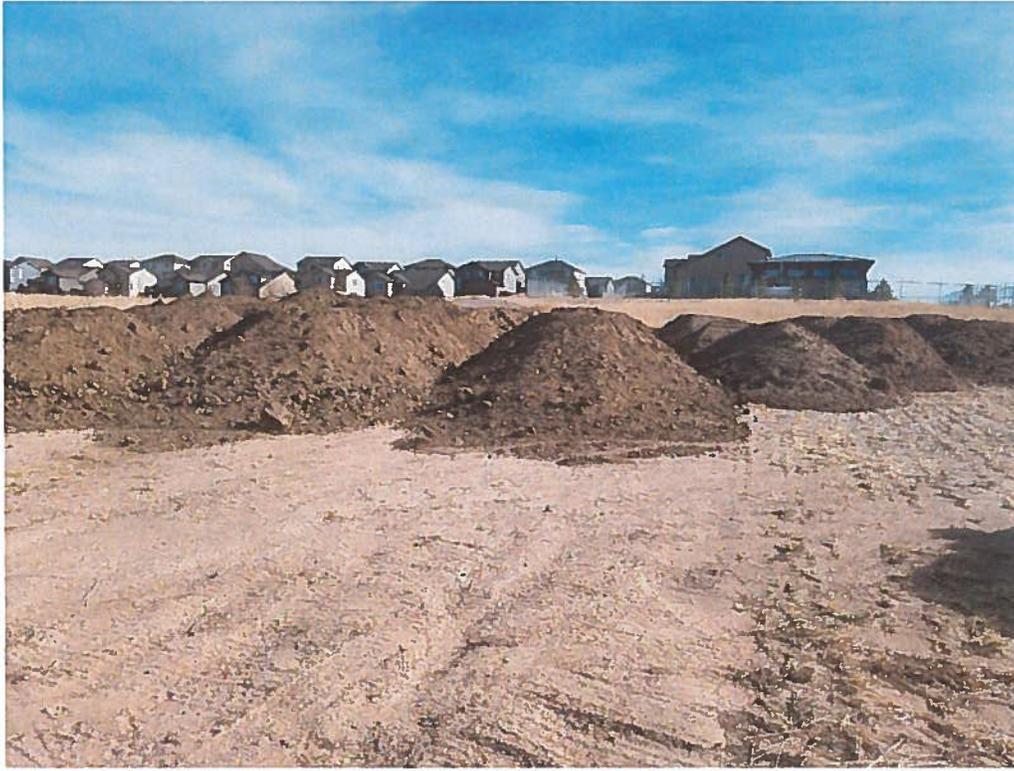
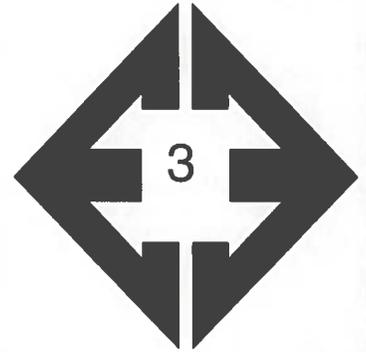
These are recent man-made fill deposits associated with fill piles located in the southern portion of the site.

Looking east from the southern portion of the site towards fill piles.

Mitigation This area will likely be mitigated by site grading. All uncontrolled fill encountered beneath foundation members will require removal and recompaction at 95% of Modified Proctor Dry Density, ASTM D-1557.

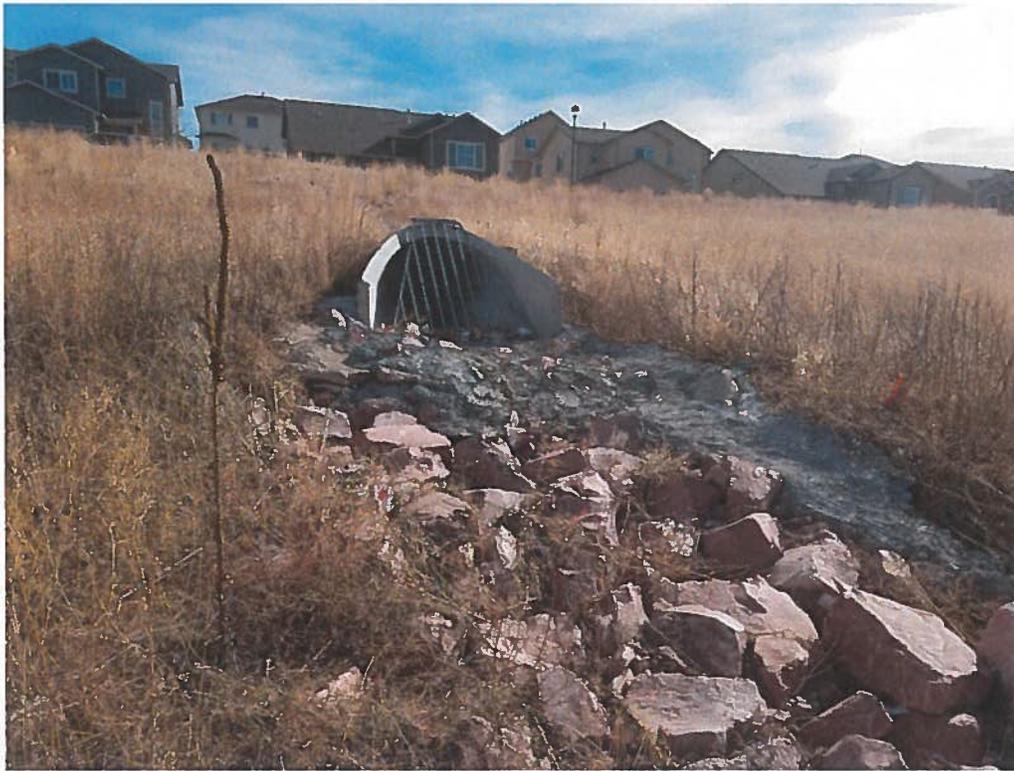
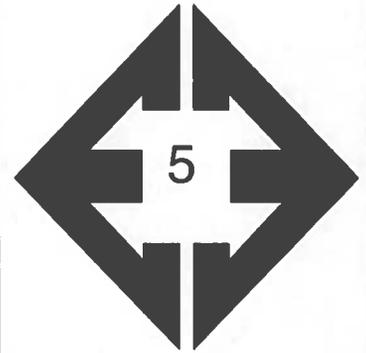
**48" stormwater outlet
in the eastern side of
the site.**
