November 28, 2006  
Revised January 9, 2009

Subject: Revised Geologic Hazard Study, **The Westgate at Powers**, Vicinity of  
Troy Hill Road and Airport Road, Colorado Springs, Colorado

Project No. 062-213.1

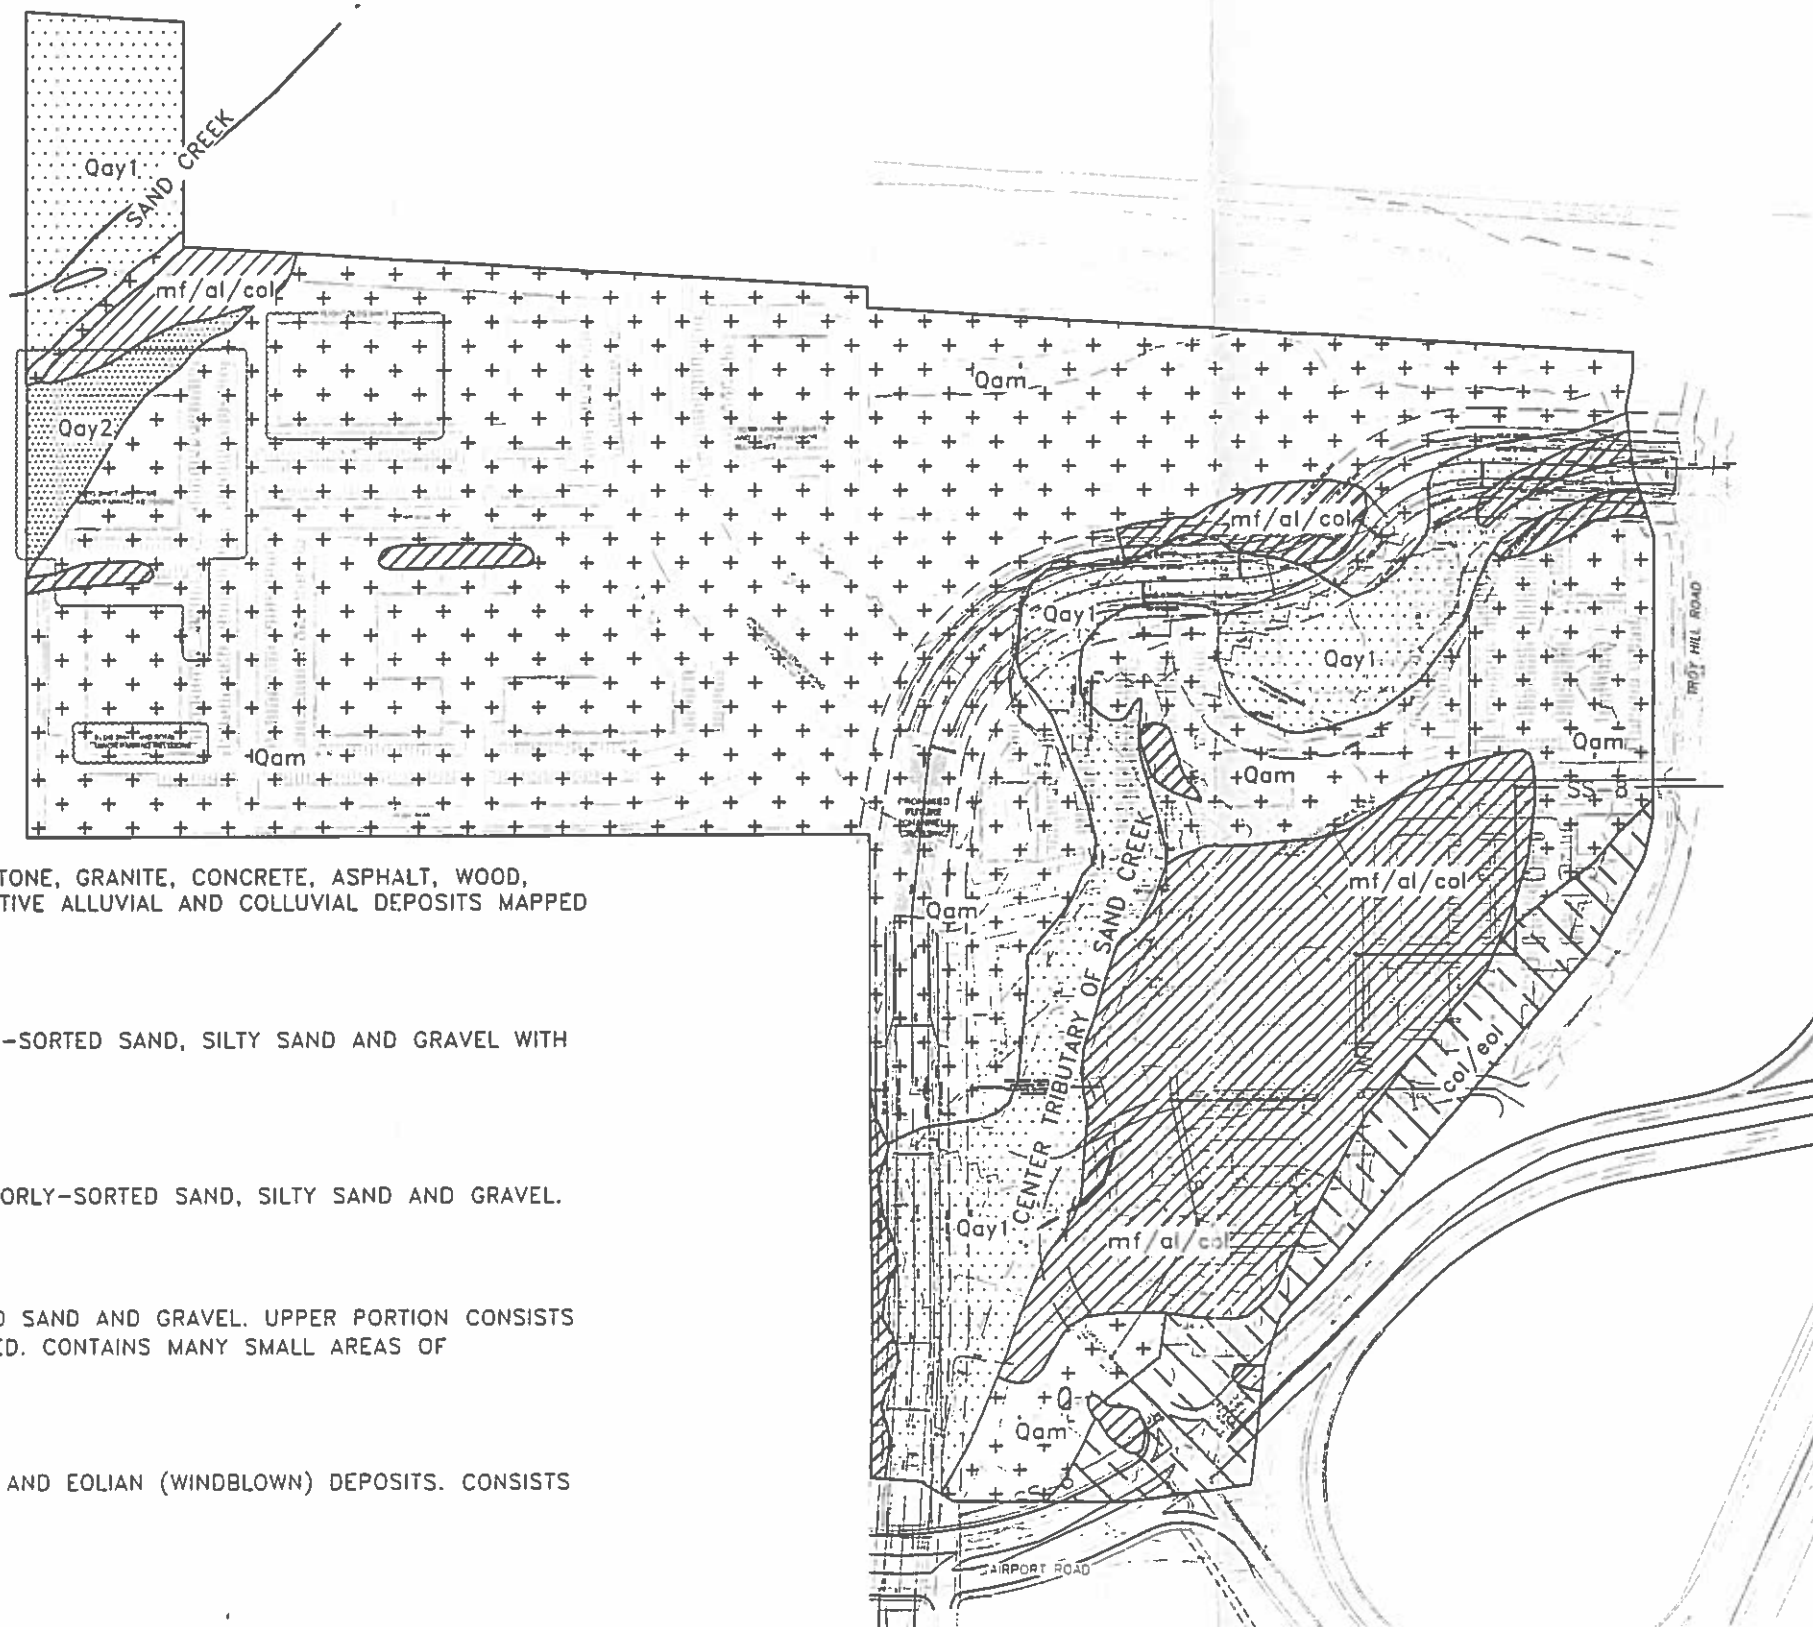
Site Geology: The attached Surficial Geologic Map, Fig. 1, depicts the surficial geology at the site. The map is based on a review of published geologic maps, literature and the results of our field reconnaissance.

Our field reconnaissance indicates silty to clayey sand fill with fragments of sandstone, claystone, concrete, asphalt, and other debris are present on portions of the property and are more widespread on the eastern half of the property. Much of the remainder of the site appears to consist of native alluvium consisting of poorly-

*Man-placed Fill:* Areas of man-placed fill, located approximately as shown on Figs. 1 and 2, were observed on the site during our field reconnaissance on July 31,

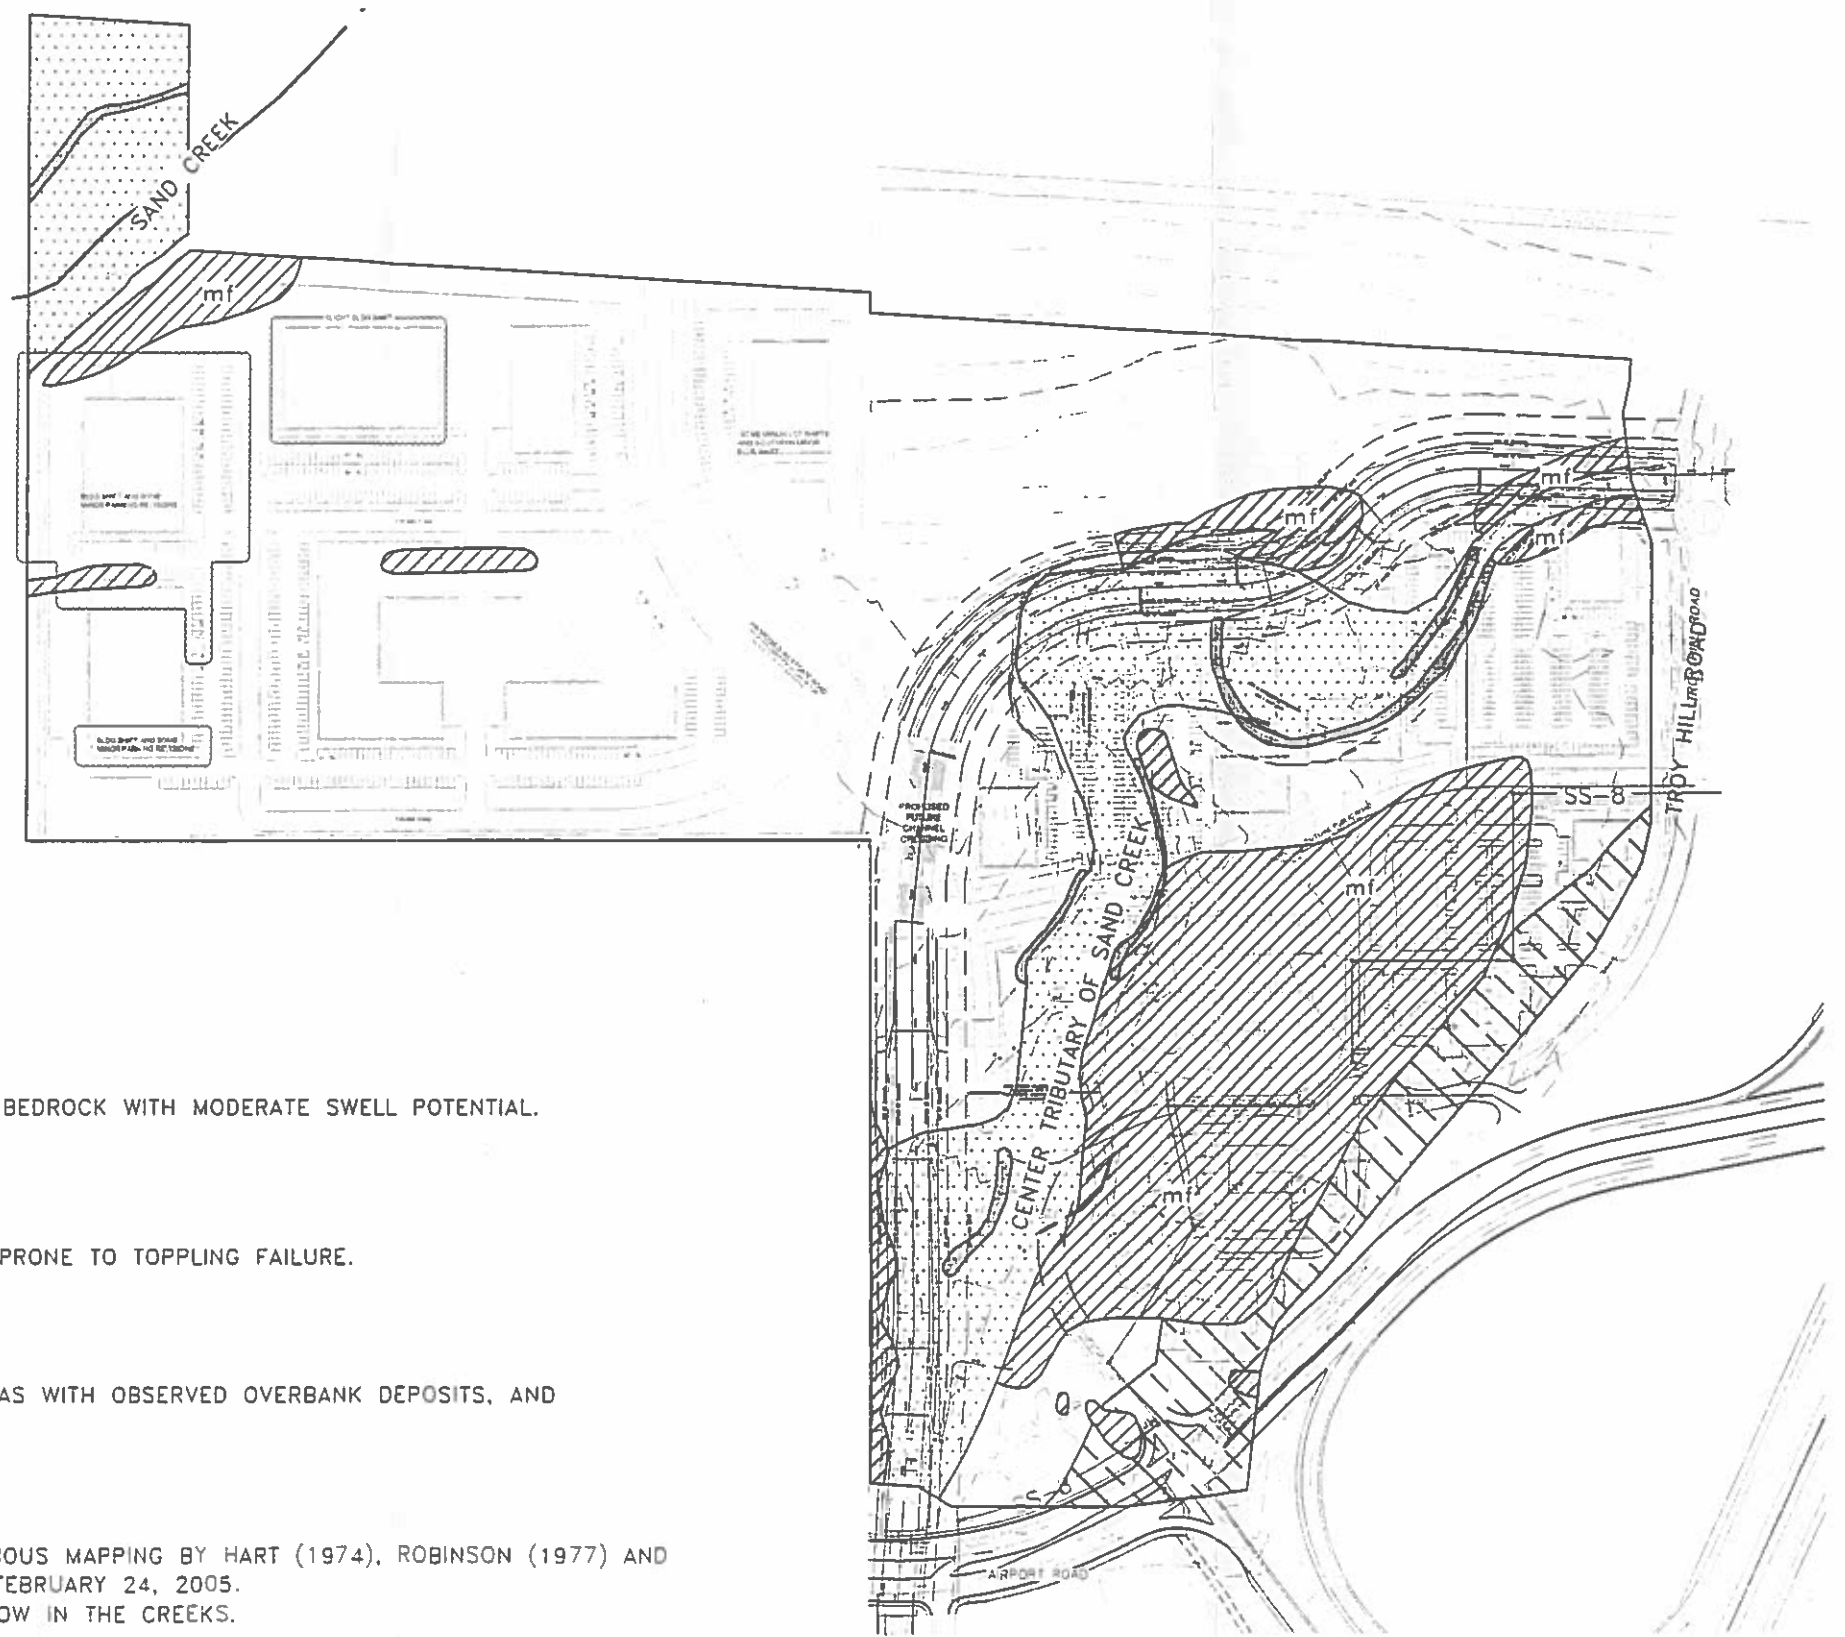
*Potentially Unstable Slopes:* We observed evidence of recent erosion, undercutting and regression of the banks of both Sand Creek and the center tributary of Sand Creek. We believe that the banks of Sand Creek and especially those of the center tributary of Sand Creek will be prone to erosion and regression during storm events. The near vertical, vertical and undercut banks have a potential to topple due to a coarse blocky structure within the soils. A previous attempt to stabilize the channel the Sand Creek near Airport Road appears to have failed due to the erosion of its east bank. The channel of the center tributary of Sand Creek appears to have shifted as much as 100 feet to the east at the southern edge of the subject site. Stabilization of the banks of the center tributary of Sand Creek near Troy Hill Road appears to have been successful.

UNSTABLE BANKS. STEEP, VERTICAL AND UNDERCUT BANKS THAT ARE PRONE TO TOPPLING FAILURE.
-

1. BASE MAP PROVIDED BY LDC, INC.
2. GEOLOGIC HAZARD MAP BASED ON OUR FIELD OBSERVATIONS, PREVIOUS MAPPING BY HART (1974), ROBINSON (1977) AND MADOLE AND THROSON (2002), AND OUR PREVIOUS STUDY DATED FEBRUARY 24, 2005.
3. ALL BANKS ARE SUBJECT TO EROSION AND REGRESSION DURING FLOW IN THE CREEKS.
4. ALL BOUNDARIES ARE APPROXIMATE.
5. SHALLOW GROUND WATER MAY BE PRESENT ON SITE ESPECIALLY EAST OF THE SAND CREEK CENTER TRIBUTARY.

*Flooding and Potentially Unstable Slopes:* We understand that the center tributary of Sand Creek is to be realigned and will be designed by JPS Engineering. At the time of this report, we have not reviewed the hydrologic study or discussed the channel mitigation proposed by JPS Engineering. We recommend the new channel of the center tributary of Sand Creek be designed based on an adequate hydrologic analysis to safely allow the transmittance of flow through the development. We also recommend that the design include erosion control measures such as riprap armoring, gabions or channel paving. All proposed development should be either raised above the floodplain, protected from flooding by levees, or the new channel should be designed to contain the 100-year flood. Based on our review of the site plan, we anticipate that the potentially unstable banks of the center tributary of Sand Creek will be regraded during the realignment of the creek, the construction of the roadways, and during grading for the development.

*Man-placed Fill:* The on-site fill appears to have been dumped on the site and should be assumed unsuitable for the support of foundations or floor slabs. Removal of the existing fill and replacement with new structural fill may be used to

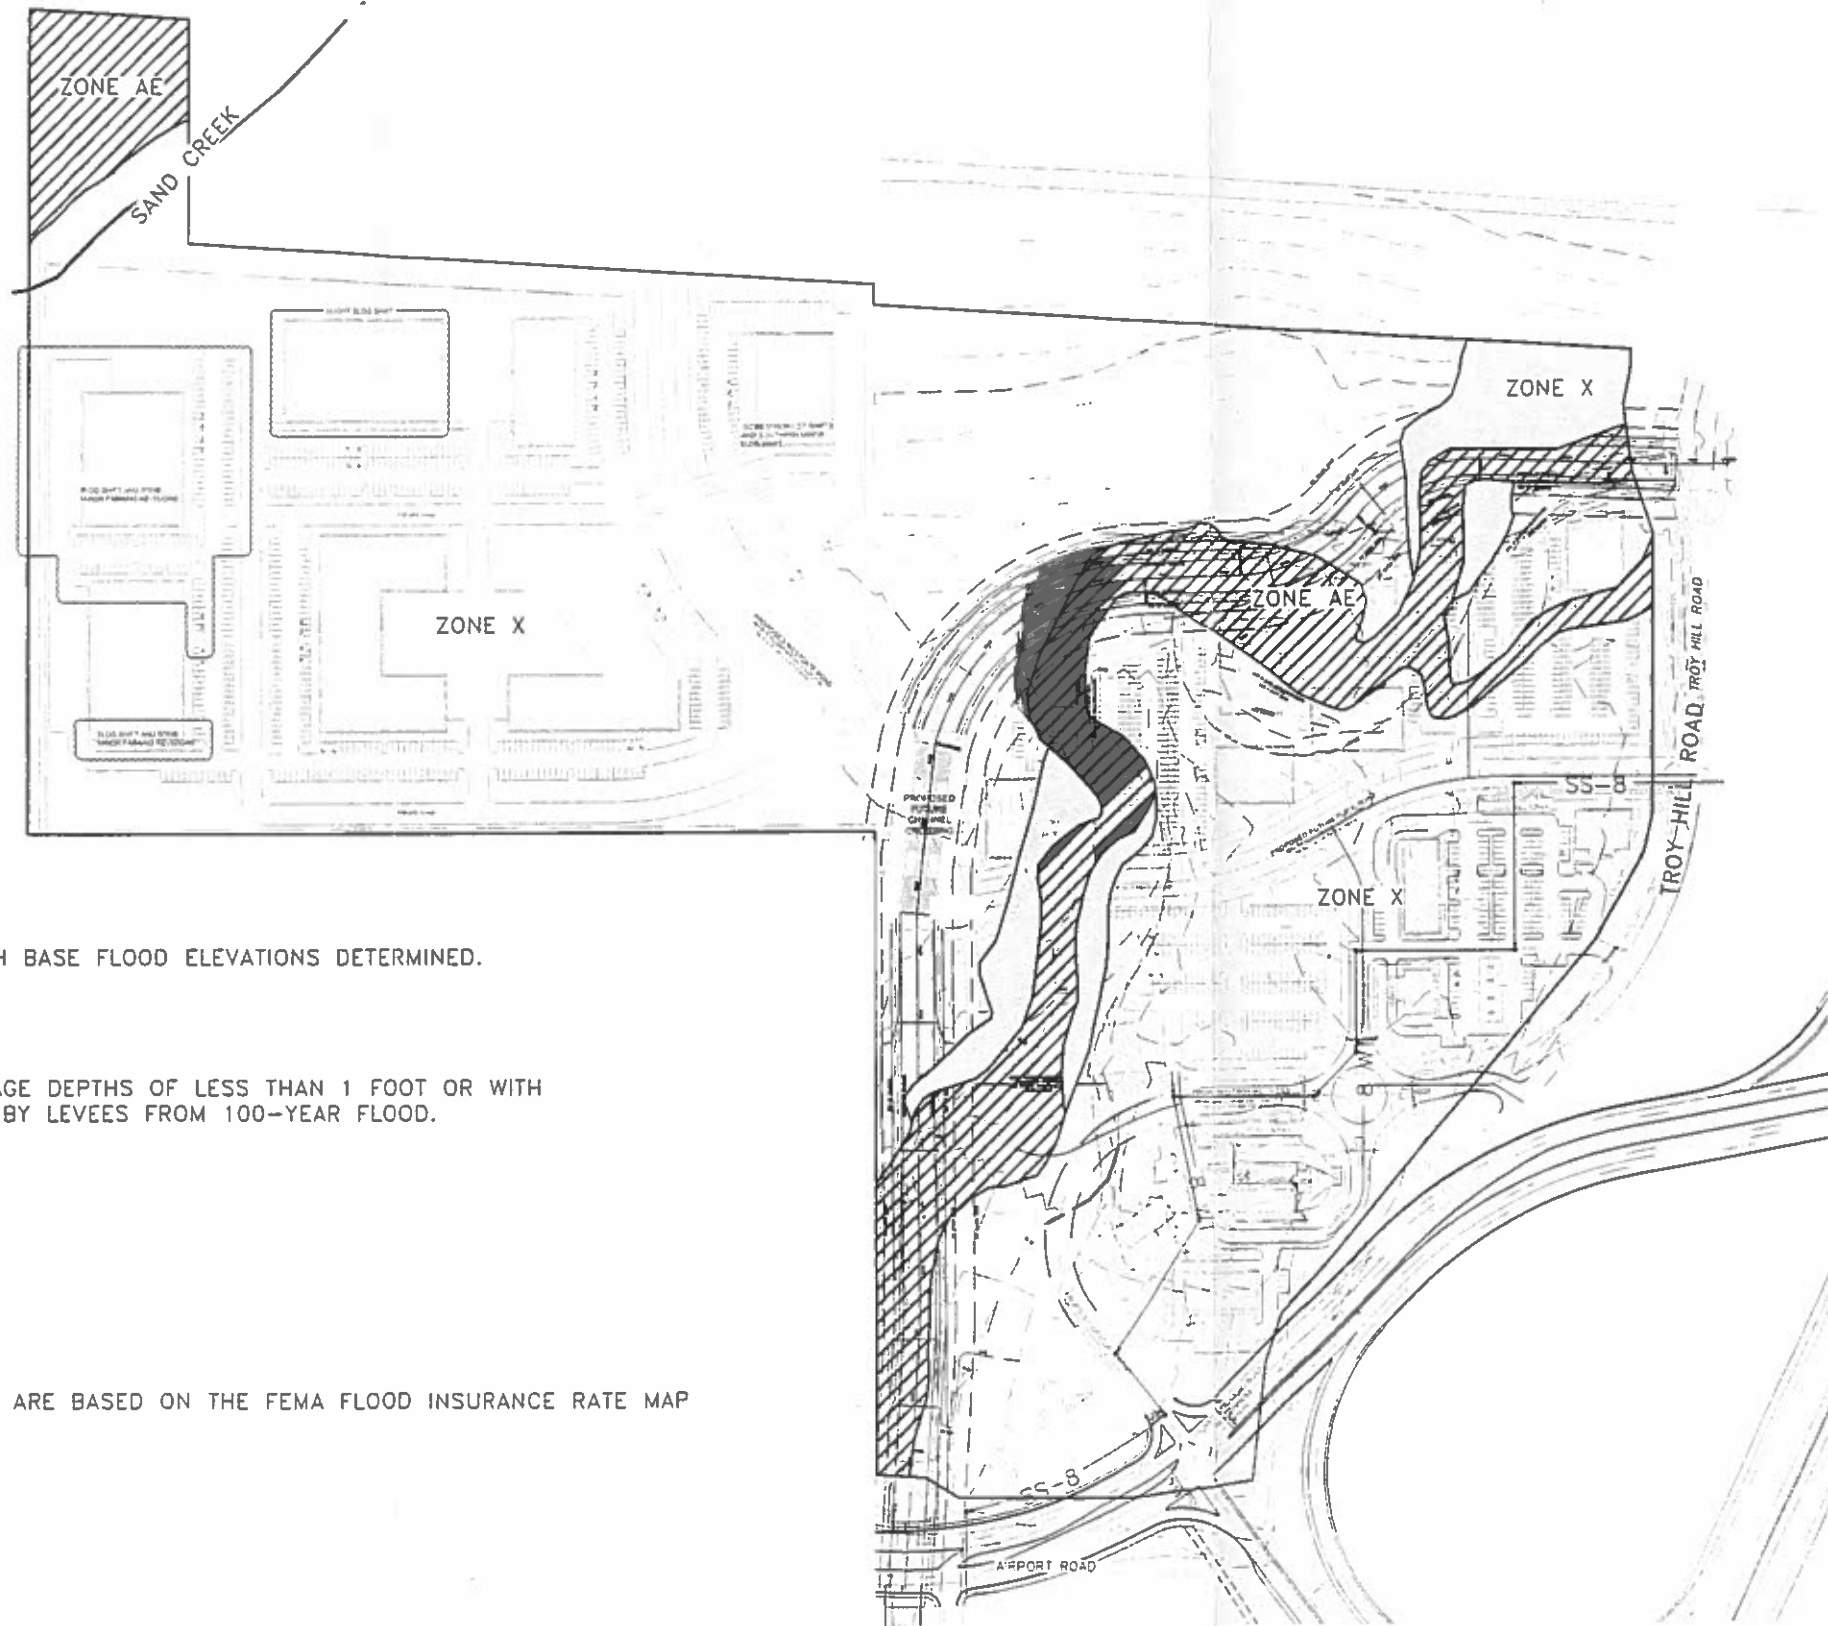
*Flooding:* According to the Federal Emergency Management Agency (1997) "Flood Insurance Rate Map", map number 08041C0753F, portions of the subject site along Sand Creek and the center tributary of Sand Creek are in Zone AE, a special flood hazard area inundated by the 100-year flood. Other flood areas present on the subject site include Zone X (shaded), areas of the 500-year flood, areas of 100-year flood with average depths of less than 1 foot or with drainage areas less than 1 square mile, and areas protected by levees from the 100-year flood; and Zone X (unshaded), areas determined to be outside the 500-year floodplain. Additional flood-prone areas not mapped by FEMA exist where we observed flood debris and in areas where the channel of the center tributary of Sand Creek has migrated from its course mapped during the creation of the FEMA map. Areas where we observed flood deposits and debris are shown on Fig. 2 as physiographic floodplain. A hydrologic study should be performed to determine the actual floodplain. The FEMA floodplain boundaries are approximately overlain on the base map as shown on Fig. 3.

Areas within the physiographic floodplain of Sand Creek (at the northwestern corner of the site) are at risk of flooding and erosion. Development within this area should not occur unless the grade is raised above the floodplain and proper channel erosion control measures, such as those listed above, are provided. The channel erosion control measures should also be utilized if development outside the physiographic floodplain is planned near the edge of the channel of Sand Creek.

Construction within the floodplains will require a Floodplain Development Permit.
