ENTECH
ENGINEERING, INC.

**SOIL, GEOLOGY, AND GEOLOGIC HAZARD STUDY
THE RETREAT AT TIMBER RIDGE
VOLLMER ROAD AND ARROYA LANE
EL PASO COUNTY, COLORADO**

April 12, 2017

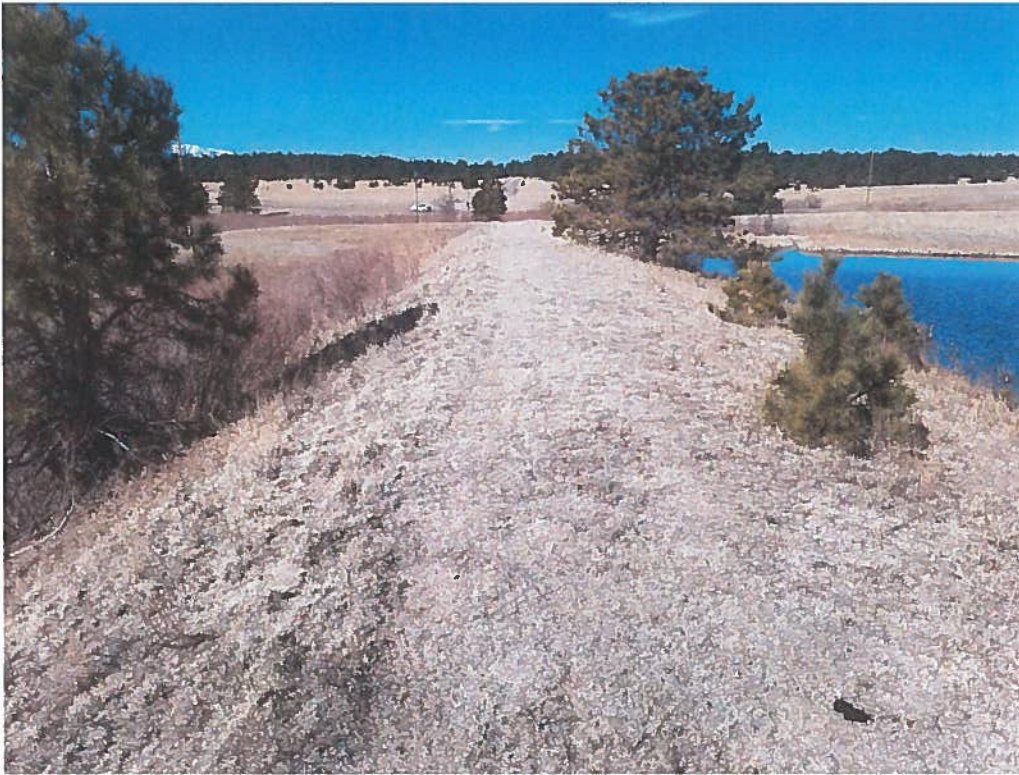
These are recent man-made fill deposits associated with the two dams located across the site. One of the dam is located north of Arroya Lane and is not within the proposed developed area. One dam is located on the eastern side of Parcel C. It is anticipated that this dam will be removed and filled during the site grading process. At the time of the investigation the condition of the dams was observed, and appeared to be in good condition.

**Looking west along
the crest of the dam in
the northern portion of
the site.**

Mitigation: The earthen dams lie within defined drainages and should be avoided as building sites. The fill on this site is considered uncontrolled for construction purposes. Any uncontrolled fill encountered beneath foundations will require removal and recompaction at a minimum of 95% of its maximum Modified Proctor Dry Density, ASTM D-1557.

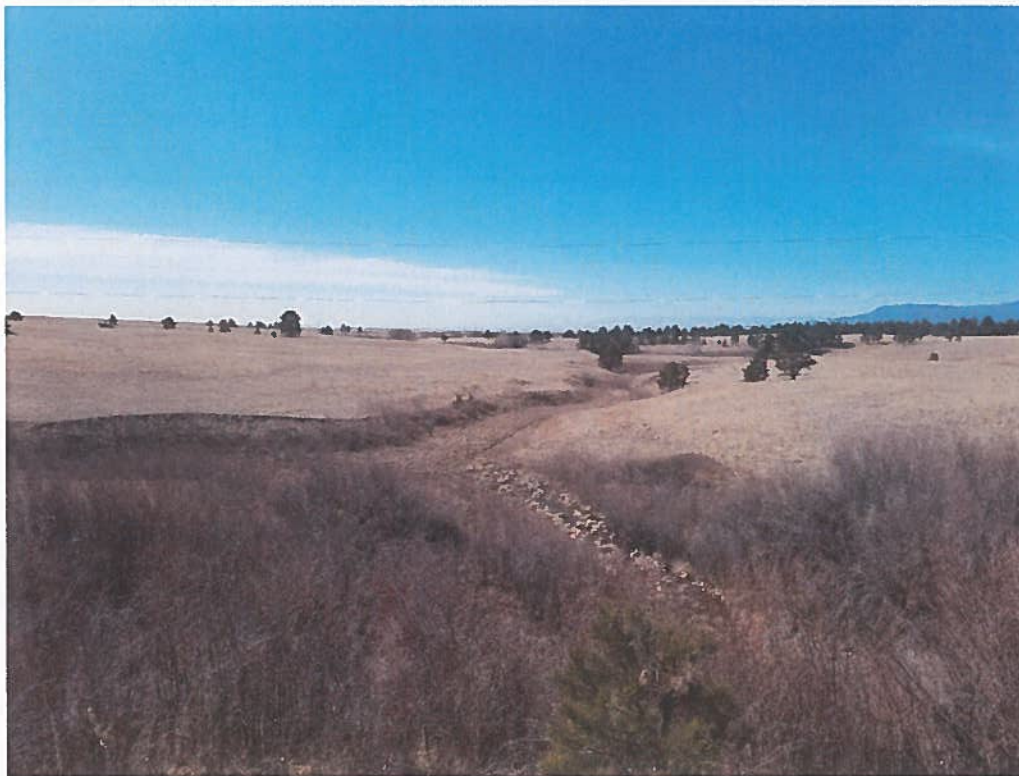
**Looking south from
the dam in the
northern portion of
site.**

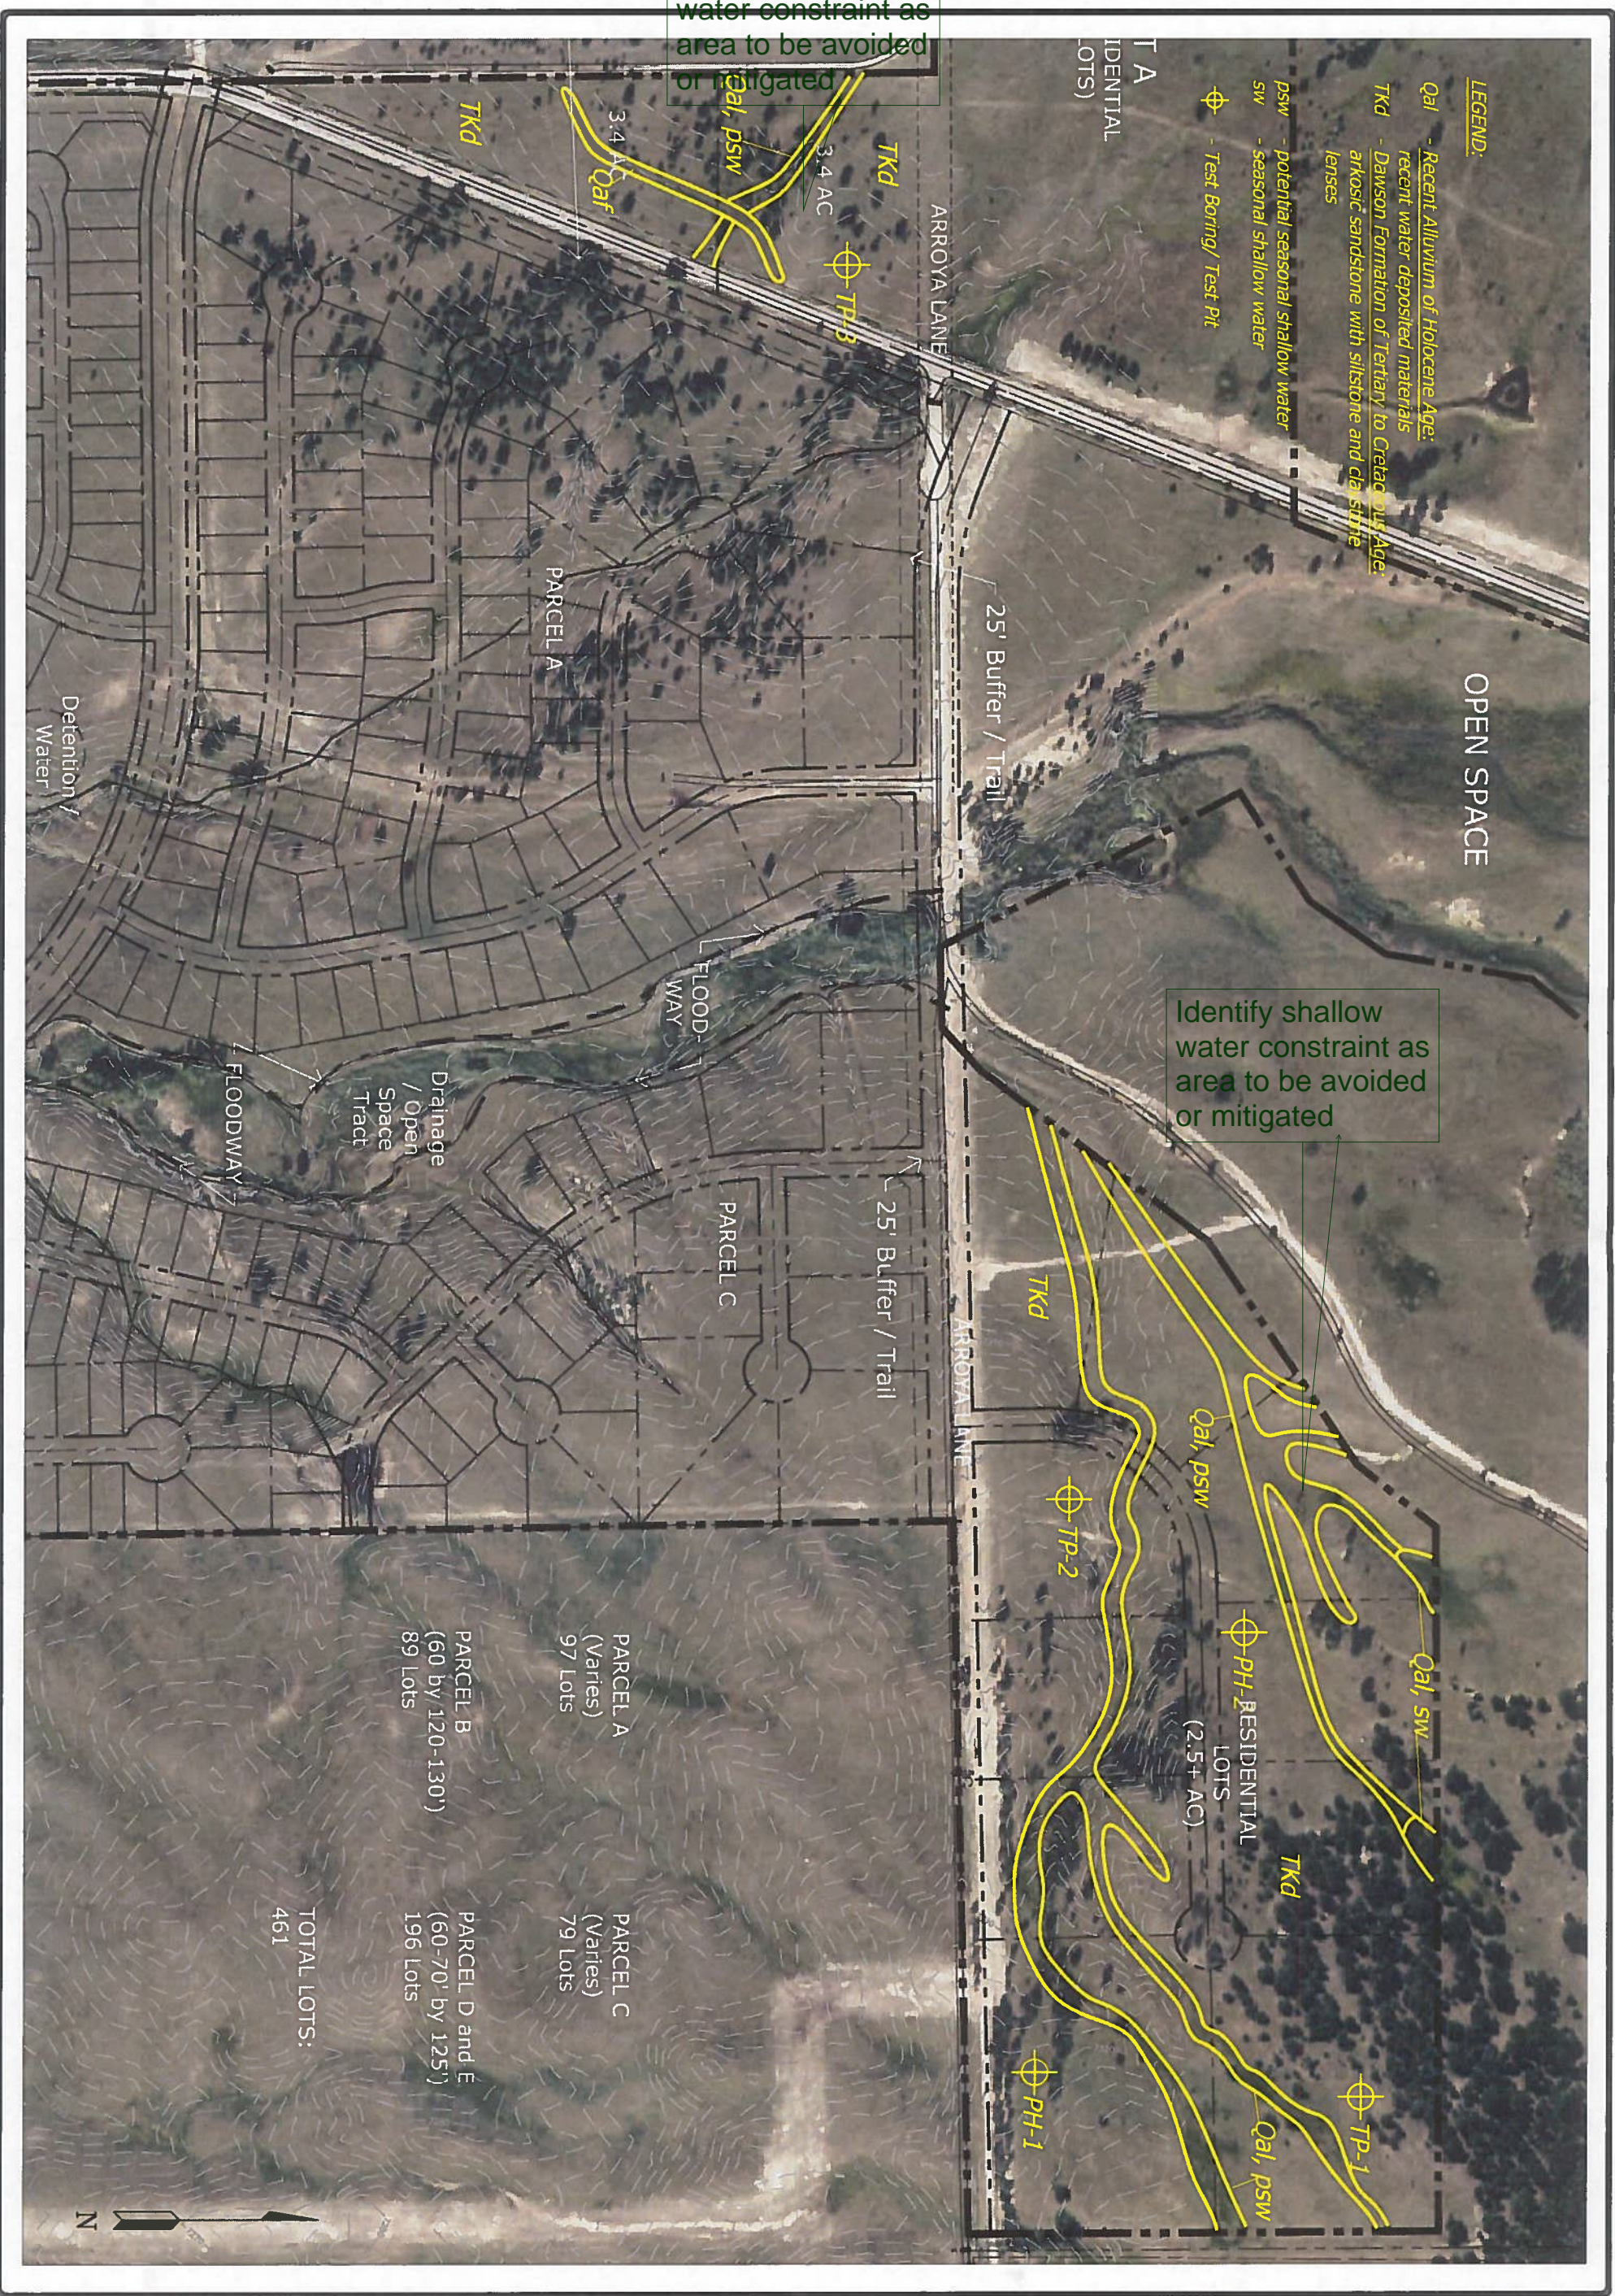
Identify shallow water constraint as area to be avoided or mitigated
