ENTECH
ENGINEERING, INC.

**SOILS AND GEOLOGY STUDY
OVERLOOK AT HOMESTEAD – FILING NO. 1
ELBERT ROAD
EL PASO COUNTY, COLORADO**

June 7, 2024

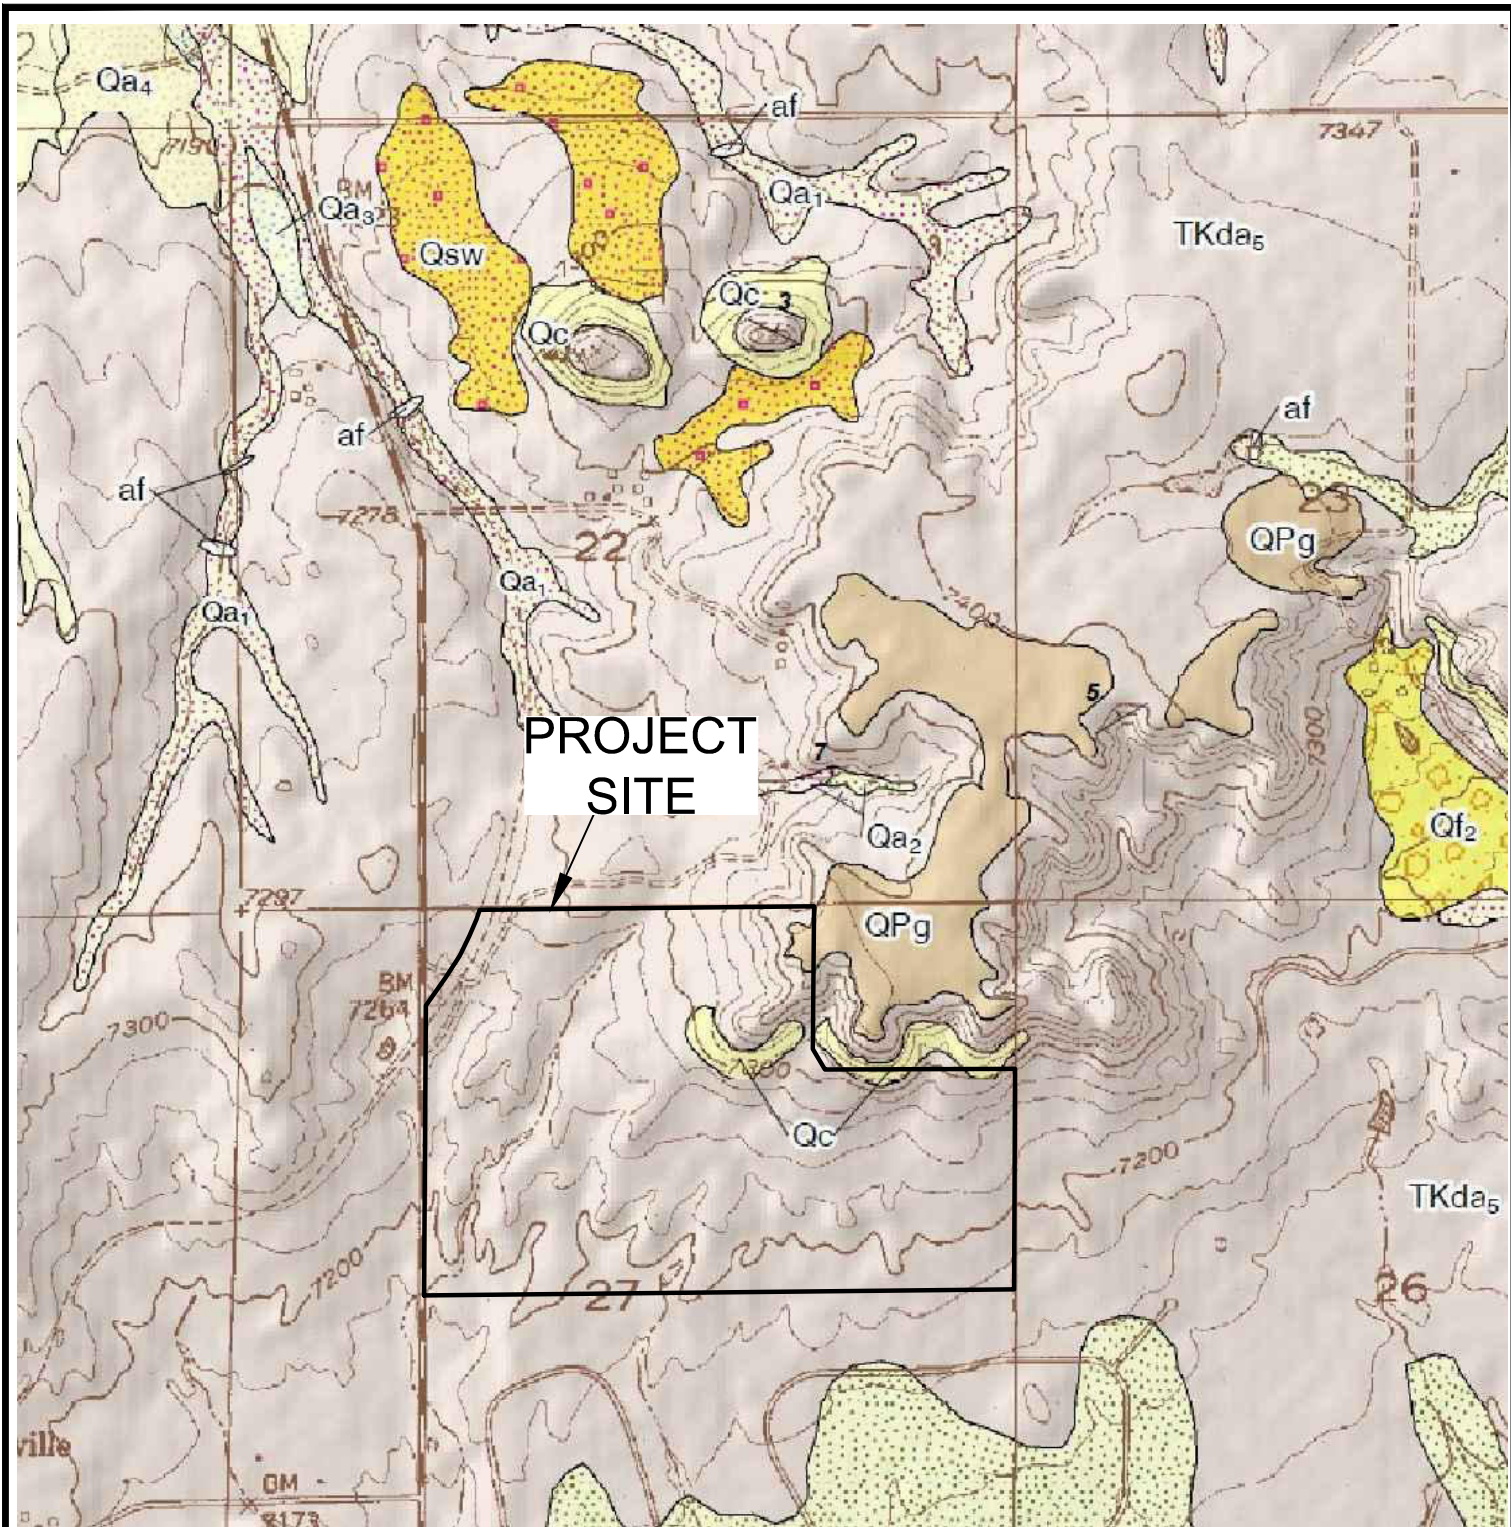
JOB NO.
230677
FIG. 7

Detailed mapping has been performed on this site to produce an Engineering Geology Map Figure 7. This map shows the location of various geologic conditions of which the developers should be cognizant during the planning, design and construction stages of the project. These hazards and the recommended mitigation techniques are as follows:

Two springs were observed in the west-central portion of the site. The springs should be avoided by development and will likely be located within drainage easements. Springs other than those indicated on Figure 7 may be present on the site.

Based on our site observation, some of the rock outcrops along the mesa have the potential for minor rockfall hazards. These areas are associated with the cliff-forming portions of the Dawson Formation along the slopes of the mesa. These areas have been identified on the Geology/Engineering Geology Map, Figure 7.

Mitigation: Based on the proposed lot sizes in these areas, there should be sufficient room on the lots to avoid the potential hazard with designated preservation/no-build easements. Additional investigation is recommended on a lot specific basis once building locations have been determined.

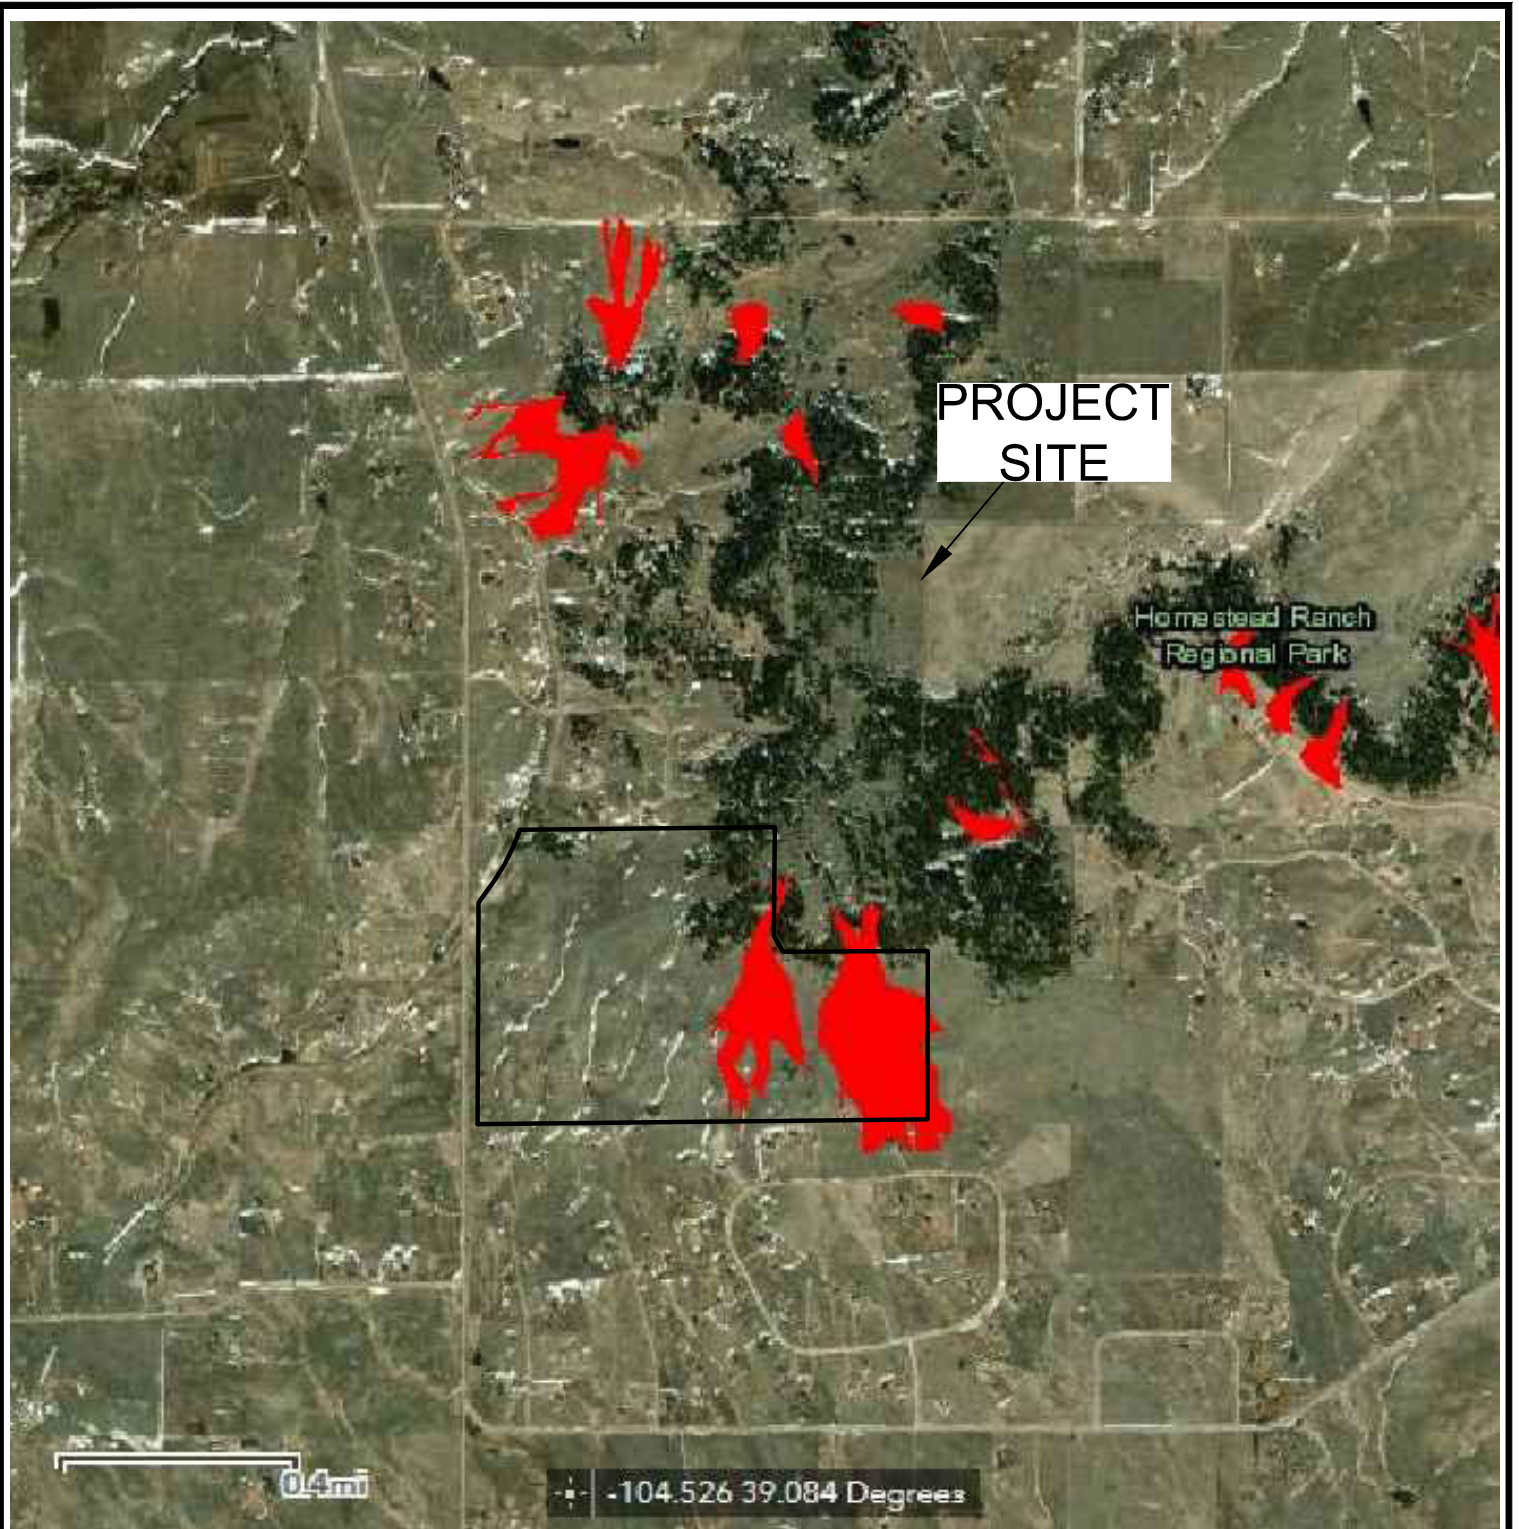
FIG. 9

The site is mapped within an area susceptible to debris flows according to the *Debris Flow Susceptibility Map of El Paso County, Colorado*, by McCoy, Morgan, and Berry (Reference 14, Figure 9). Based on site observations, recent minor debris fans/erosion were observed on the site along minor drainages originating off of the mesa in the southeastern portion of the site. Due to the material type and steepness of the slopes, the potential for significant erosion and sediment laden flows originating along the heads of these drainages in the southeastern portion of the site following significant precipitation events exist. Any site grading should direct surface flows around the structures in a non-erosive manor. Drainage culverts and other drainage infrastructure should

The site is mapped within an area susceptible to debris flows according to the *Debris Flow Susceptibility Map of El Paso County, Colorado*, by McCoy, Morgan, and Berry (Reference 14, Figure 8). Based on site observations, recent minor debris fans/erosion were observed on the site along minor drainages originating off of the mesa in the southeastern portion of the site. Due to the material type and steepness of the slopes, the potential for significant erosion and sediment laden flows originating along the heads of these drainages in the southeastern portion of the of the site following significant precipitation events exist. Any site grading should direct surface flows around the structures in a non-erosive manor. Drainage culverts and other drainage infrastructure should be adequately sized for the potential sediment laden flows. Lots 23 – 35 are located within the area indicated as Debris Flow Susceptible, Figure 9.

Channel armoring consisting of riprap and/or other forms of erosion protection should be utilized in areas of concentrated flows to include permanent channel armoring to prevent accelerated erosion, creating unstable conditions. Building sites in these areas can be elevated lowering the effect of potential for sediment laden flows, and grading improvements diverting surface flows around the foundations are recommended for these affected lots. Any diversion swales should be created up gradient of the structures and should have permanent channel armoring. Riprap sizing should be based off potential flow velocities. The erosion protection must utilize proper fabric/grid grading to prevent piping and undermining. Erosion control measures and riprap sizing should be determined by a qualified professional.

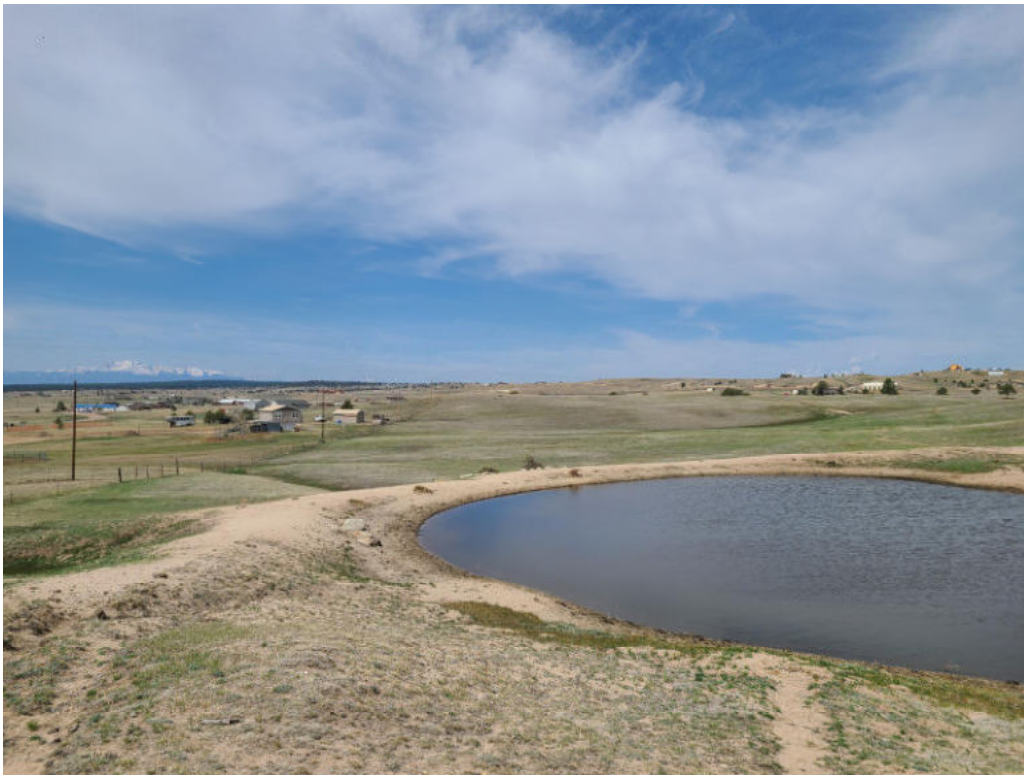
Looking west towards pond in the southern side of the site.

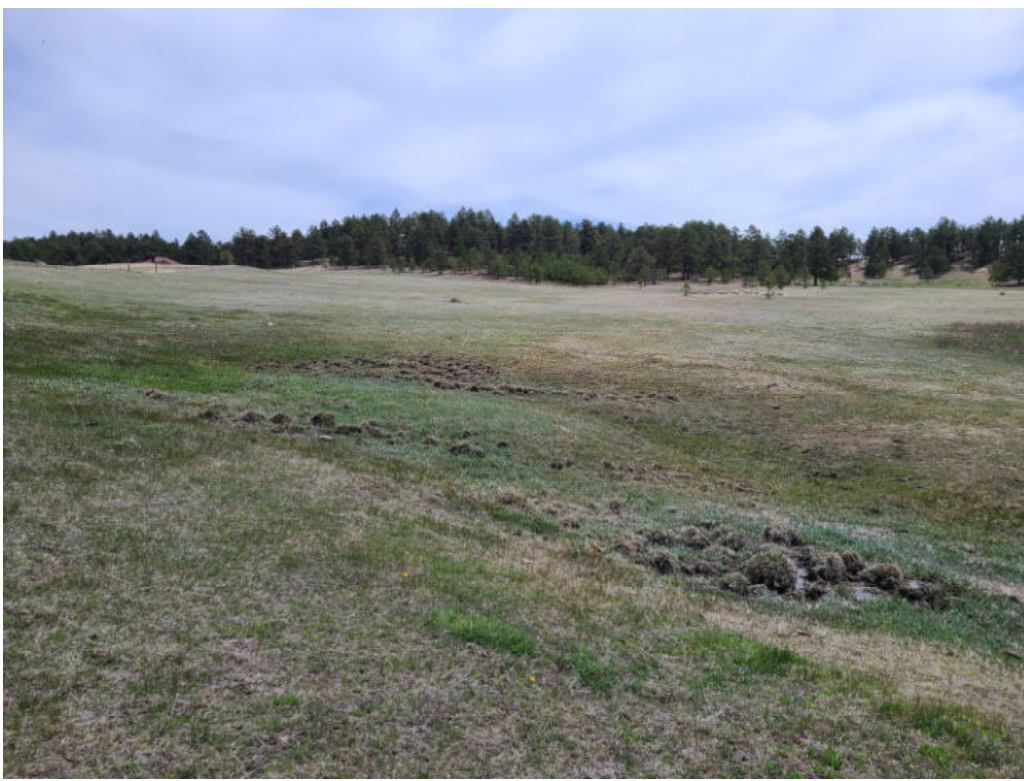
Looking east towards spring in the area of Lots 47 and 55.

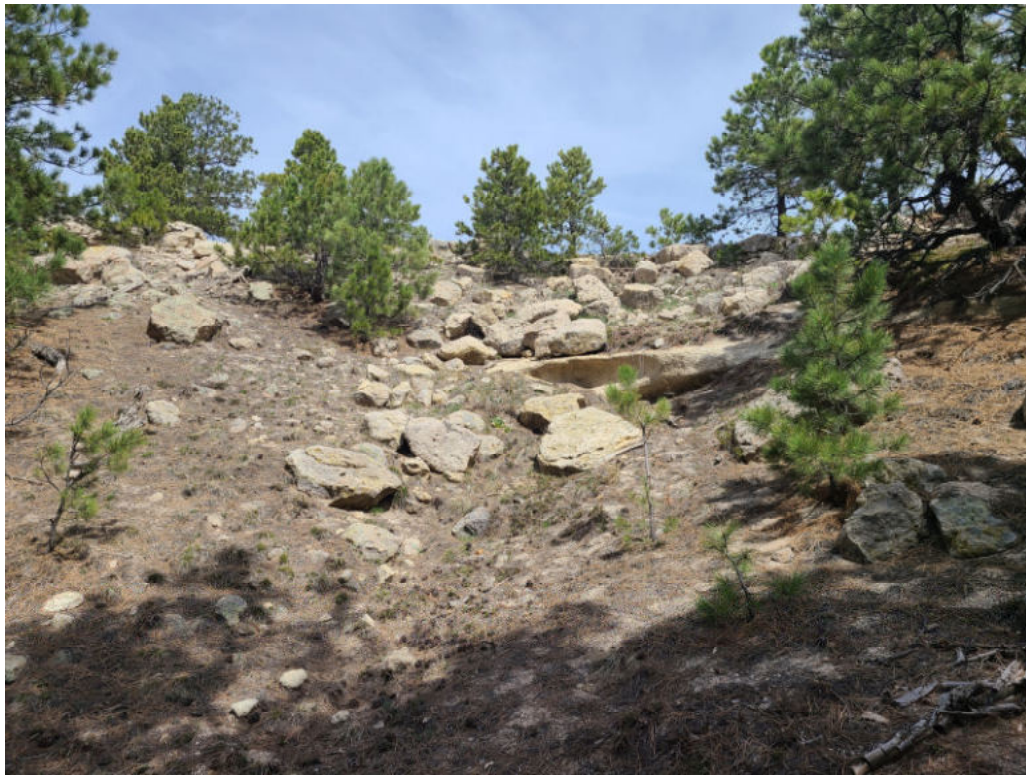
**Looking towards cliff
in the southeastern
portion of the site.**

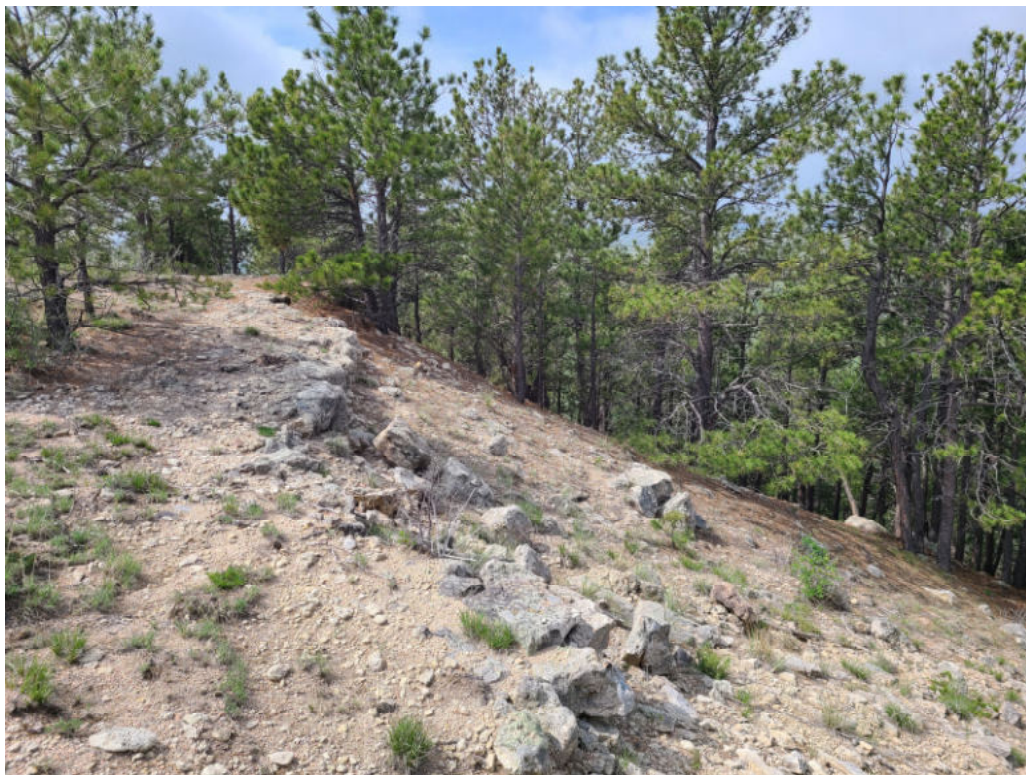
Looking south along steep slope in the area of Lot 20.

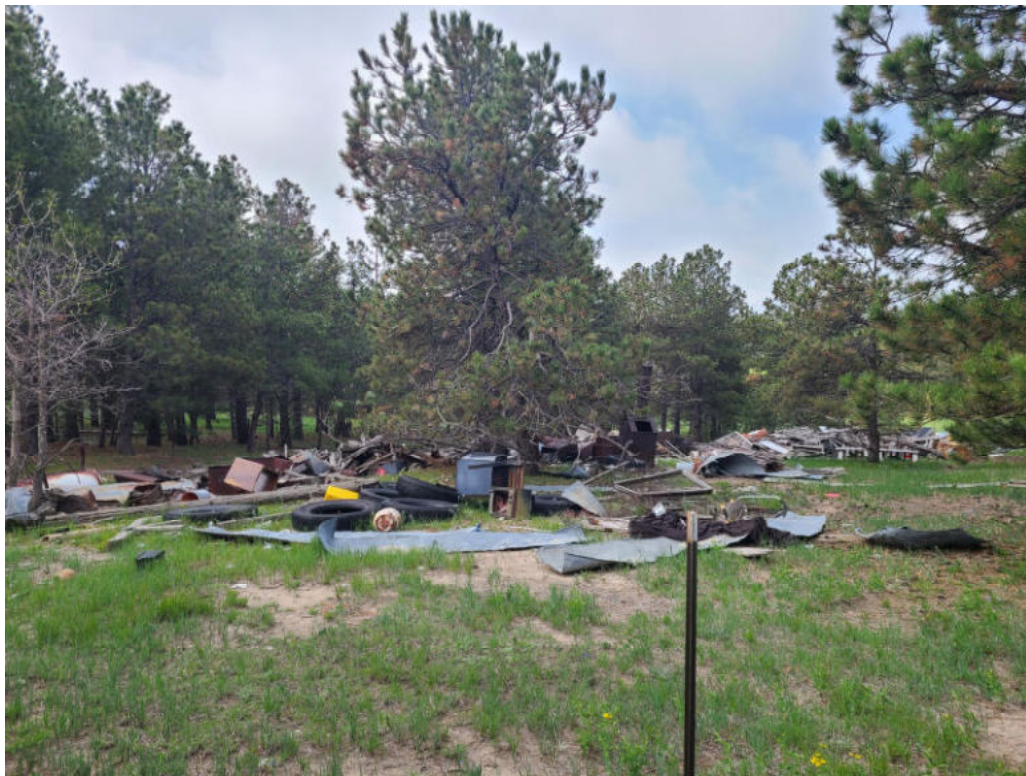
**Looking southwest
toward trash pile on
Lot 12.**

Mitigation: The fill on this site is considered uncontrolled for construction purposes. Any uncontrolled fill encountered beneath foundations will require removal and recompaction at a minimum of 95% of its maximum Modified Proctor Dry Density, ASTM D-1557.

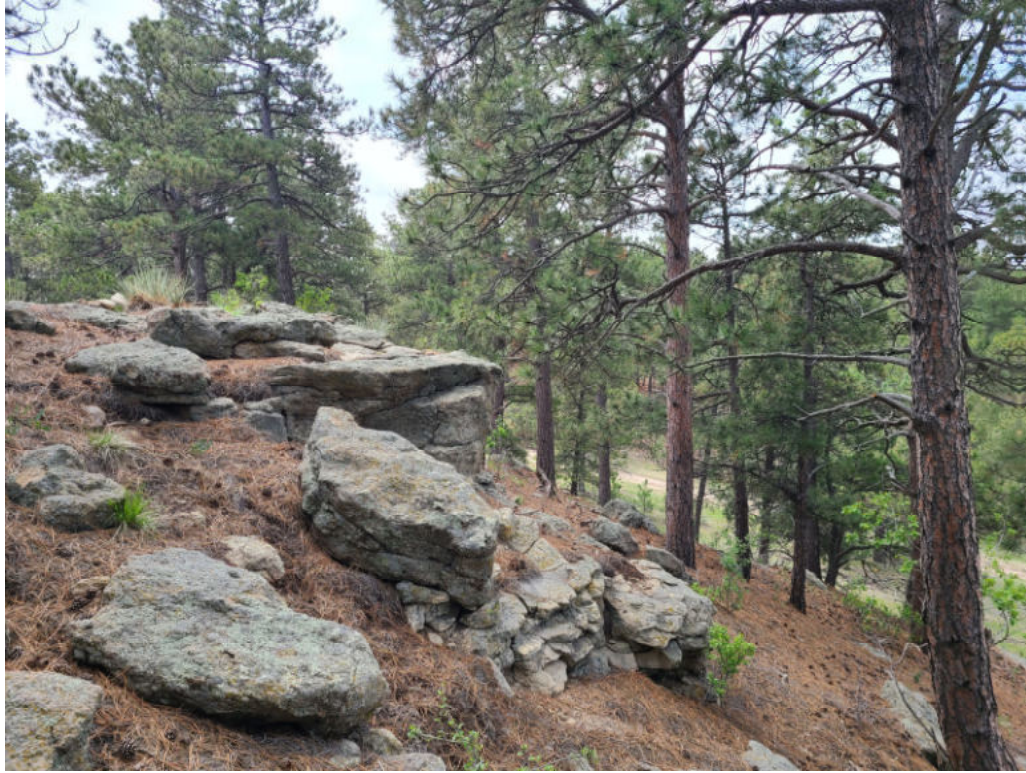
**Looking southwest
along cliff and slope
northern portion of the
site.**
