**SOILS AND GEOLOGY STUDY
OVERLOOK AT HOMESTEAD – FILING NO. 1
ELBERT ROAD
EL PASO COUNTY, COLORADO**

June 7, 2024
Revised December 5, 2024

PCD No. SF2425

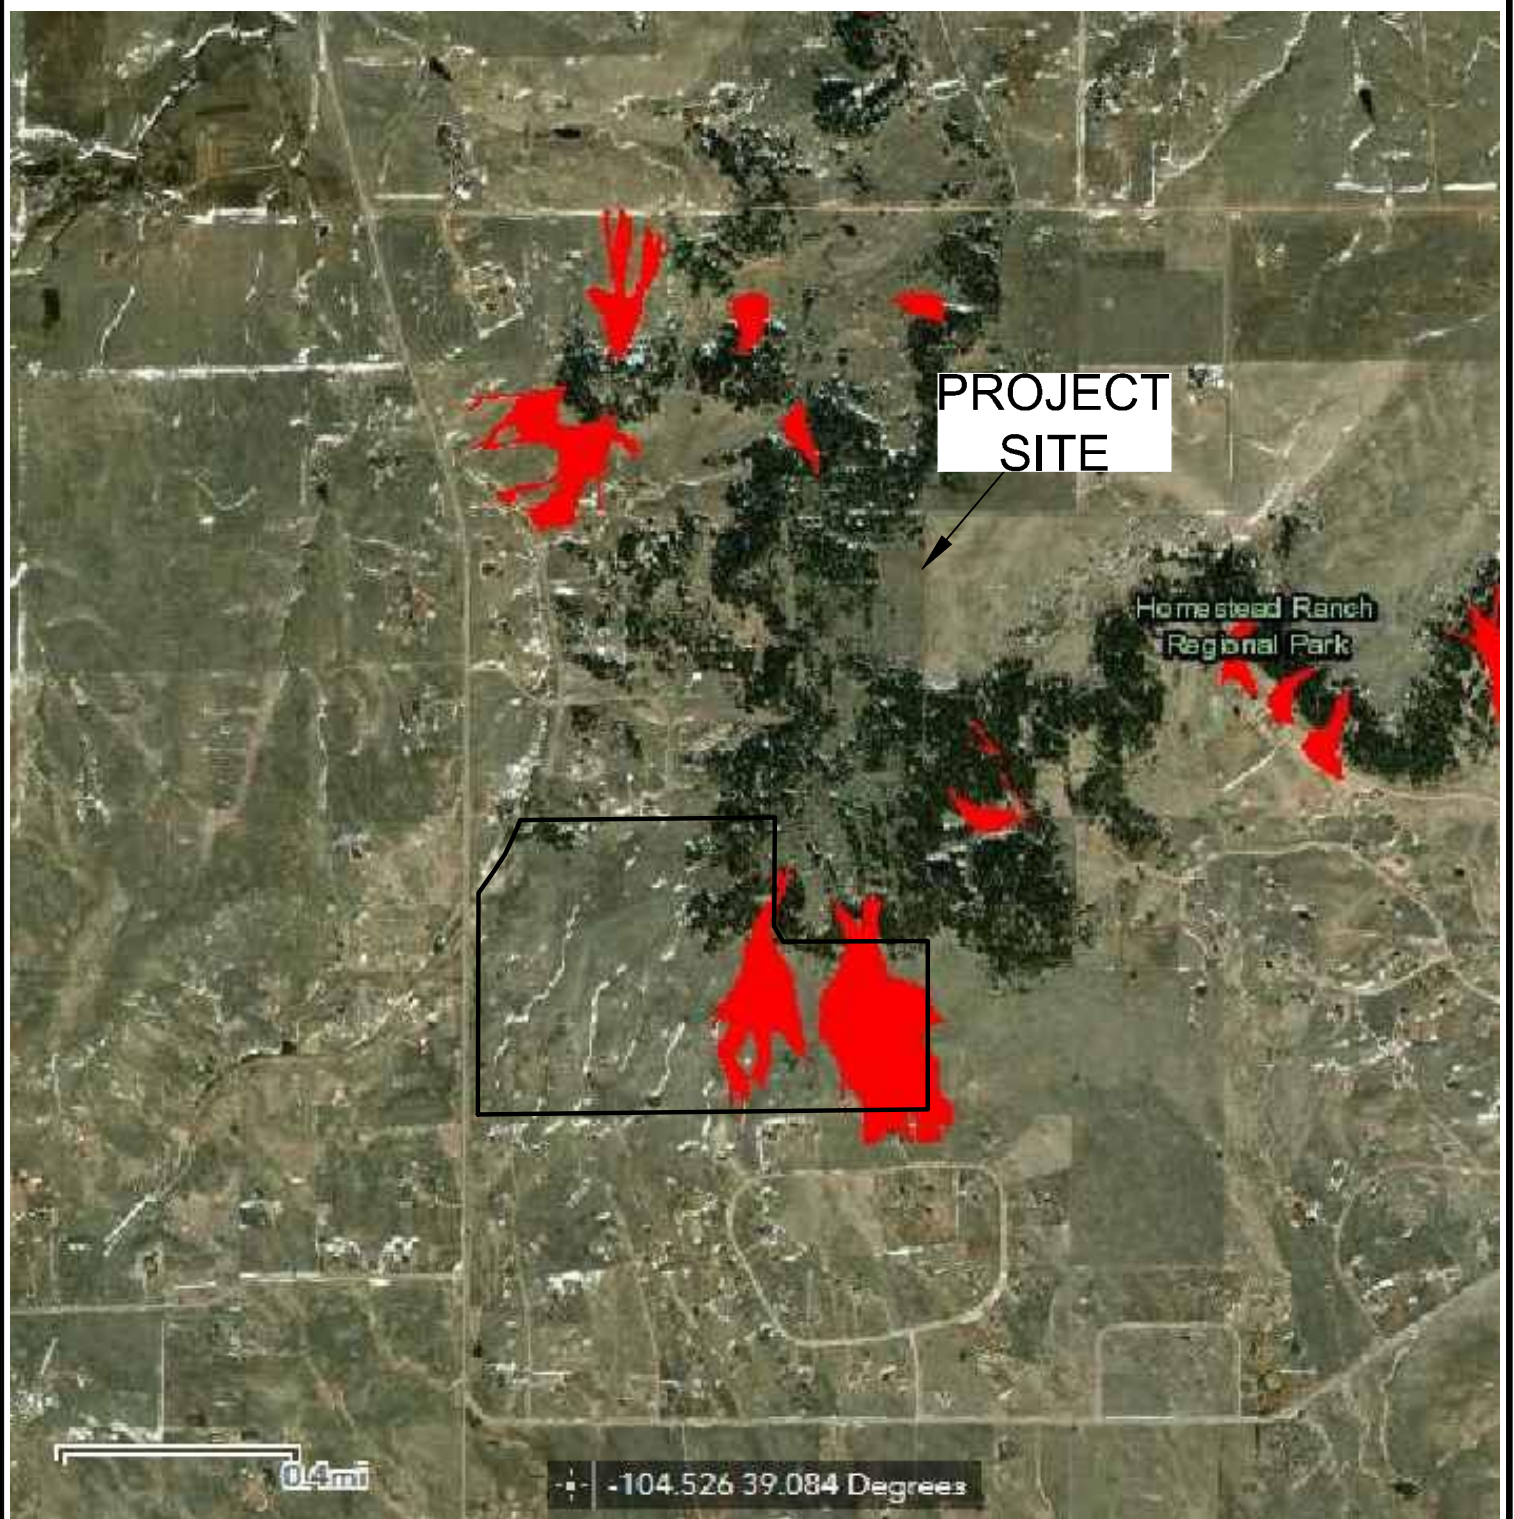
DEBRIS FLOW SUSCEPTIBILITY MAP

The site is mapped within an area susceptible to debris flows according to the *Debris Flow Susceptibility Map of El Paso County, Colorado*, by McCoy, Morgan, and Berry (Reference 14, Figure 9). Based on site observations, recent minor debris fans/erosion were observed on the site along minor drainages originating off of the mesa in the southeastern portion of the site. Due to the material type and steepness of the slopes, the potential for significant erosion and sediment laden flows originating along the heads of these drainages in the southeastern portion of the site following significant precipitation events exist. Any site grading should direct surface flows around the structures in a non-erosive manor. Drainage culverts and other drainage infrastructure should be adequately sized for the potential sediment laden flows. Lots 11 – 25 are located within the area indicated as Debris Flow Susceptible (Figure 9).

Mitigation: Channel armoring consisting of riprap and/or other forms of erosion protection should be utilized in areas of concentrated flows to include permanent channel armoring to prevent accelerated erosion, creating unstable conditions. Building sites in these areas can be elevated lowering the effect of potential for sediment laden flows, and grading improvements diverting surface flows around the foundations are recommended for these affected lots. Any diversion swales should be created up gradient of the structures and should have permanent channel armoring. Riprap sizing should be based off potential flow velocities. The erosion protection must utilize proper fabric/grid grading to prevent piping and undermining. Erosion control measures and riprap sizing should be determined by a qualified professional.

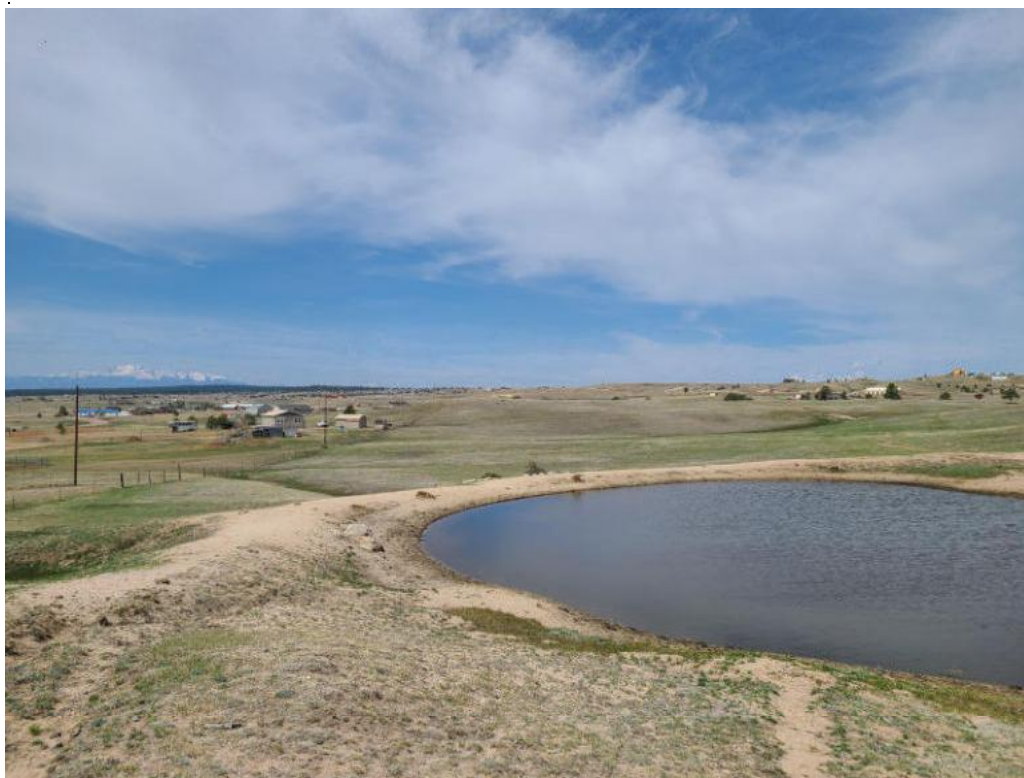
**Looking west towards
pond in the southern
side of the site.**

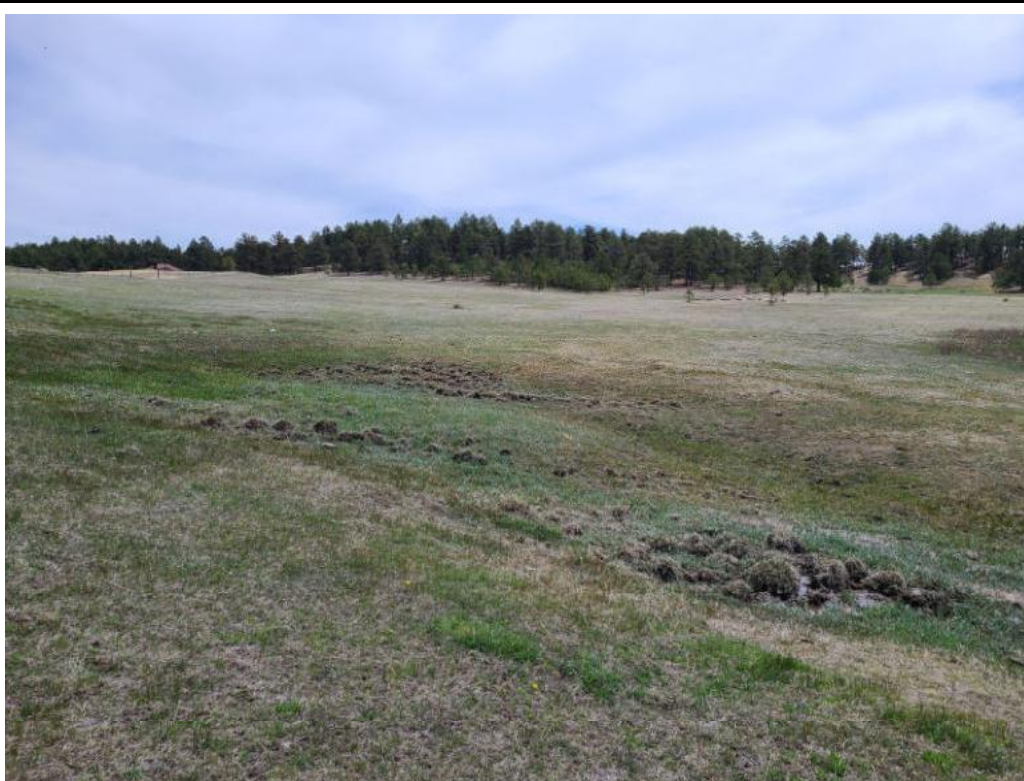
**Looking east towards
spring in the area of
Lots 47 and 55.**

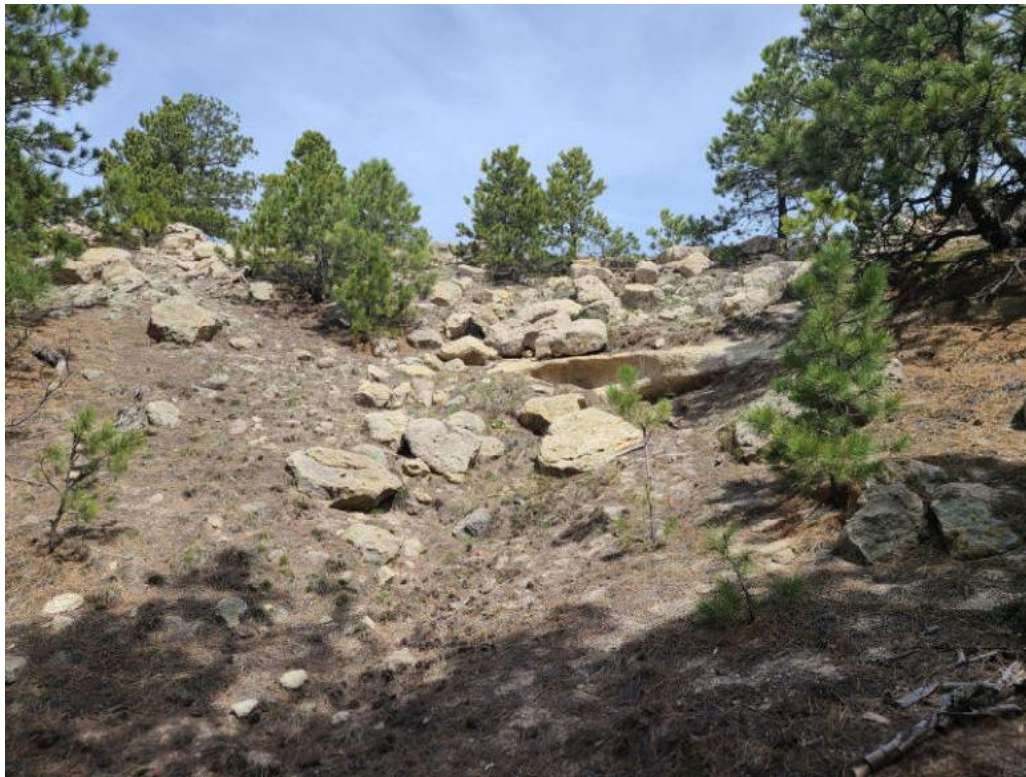
Based on our site observation, some of the rock outcrops along the mesa have the potential for minor rockfall hazards. These areas are associated with the cliff-forming portions of the Dawson Formation along the slopes of the mesa. These areas have been identified on the Geology/Engineering Geology Map, Figure 7.

**Looking towards cliff
in the southeastern
portion of the site.**

Mitigation: Based on the proposed lot sizes in these areas, there should be sufficient room on the lots to avoid the potential hazard with designated preservation/no-build easements. Additional investigation is recommended on a lot specific basis once building locations have been determined.

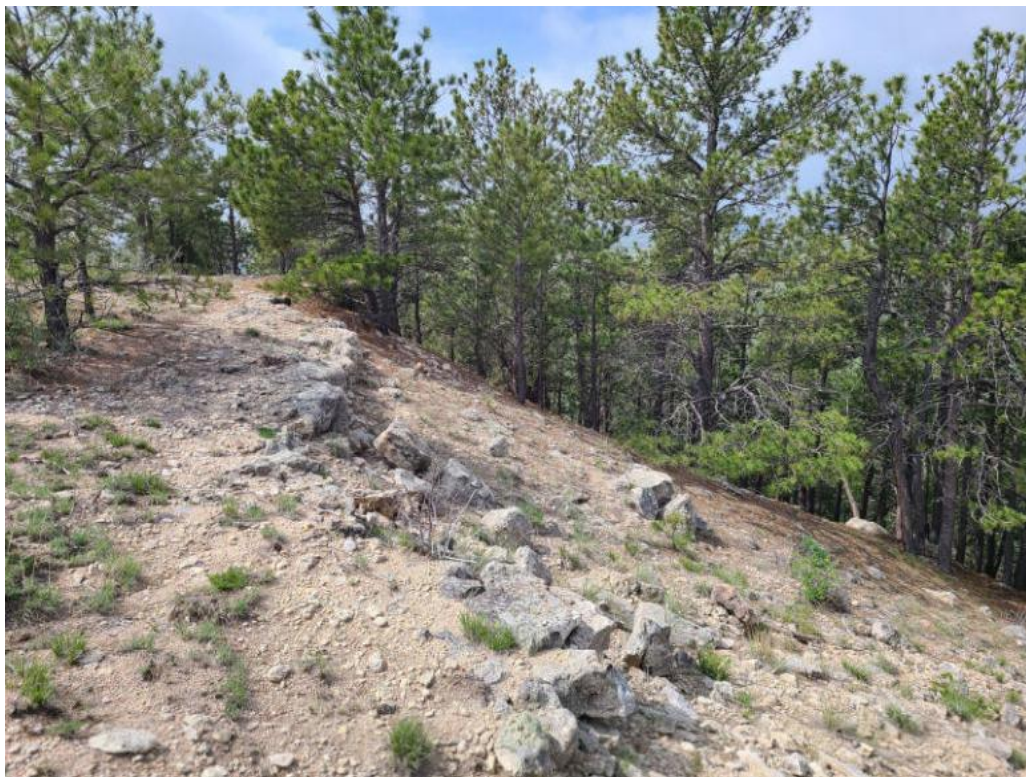
These slopes are considered stable in their present condition; however, care must be exercised in these areas not to create a condition which would tend to activate instability. The steeper slopes along mesa should be avoided by development. A minimum setback of 30 feet from the crest of the cliffs/steep slopes is recommended. Structures can also be placed at a sufficient distance from the potentially unstable slopes. Additional investigation may be warranted once building locations are determined on the lots with this constraint. Based on the size of the site and anticipated development these areas can likely be avoided or mitigated.

**Looking south along
steep slope in the area
of Lot 20.**

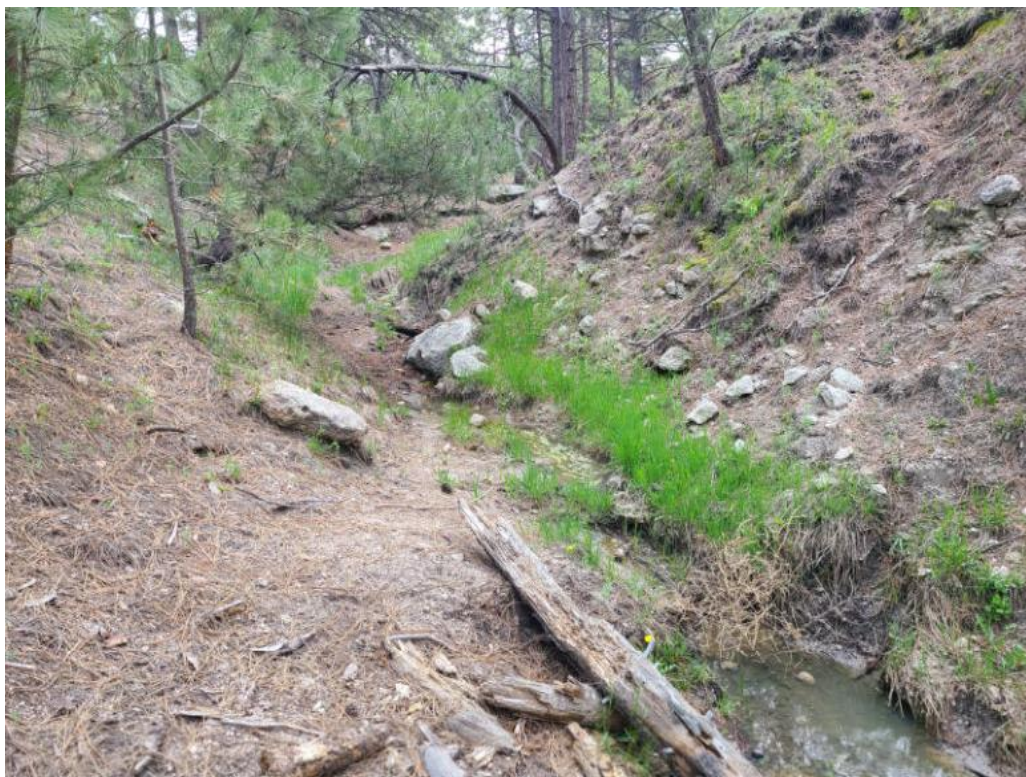
**Looking east along
drainage on Lot 59.**

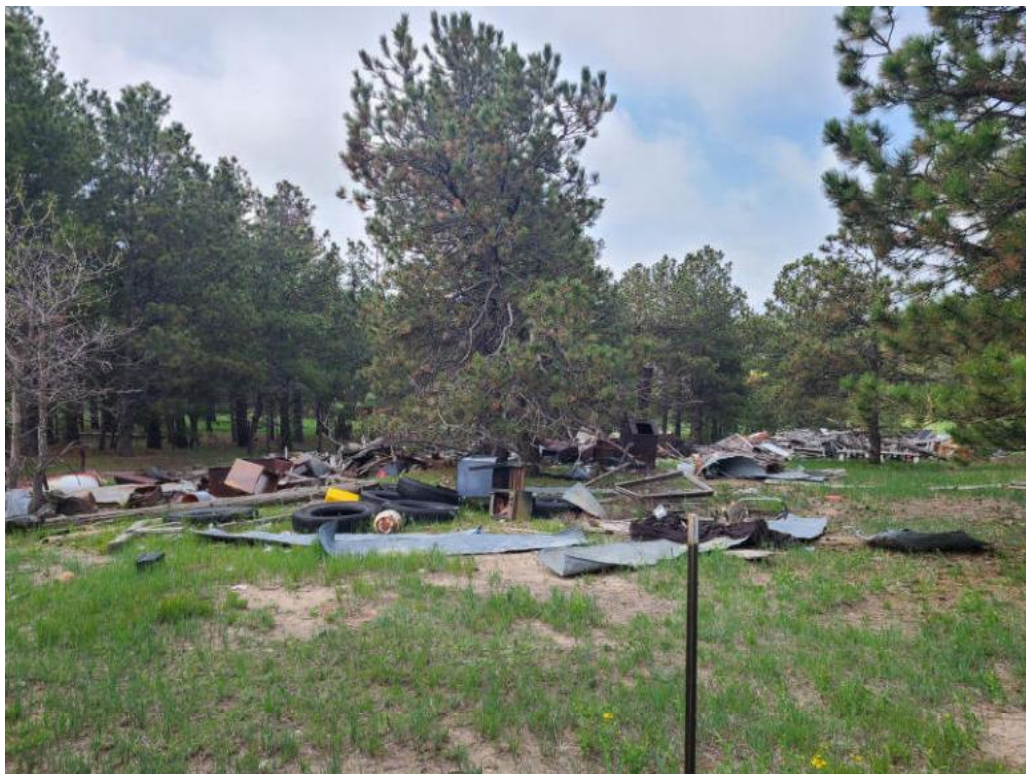
**Looking southwest
toward trash pile on
Lot 12.**

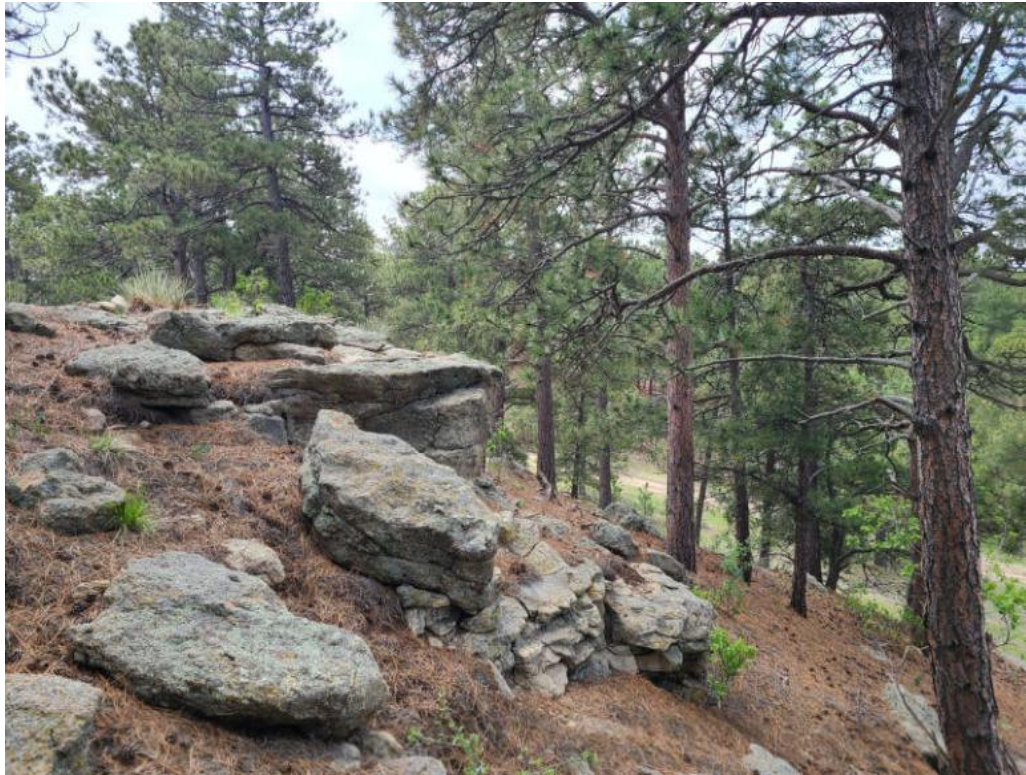
**Looking southwest
along cliff and slope
northern portion of the
site.**

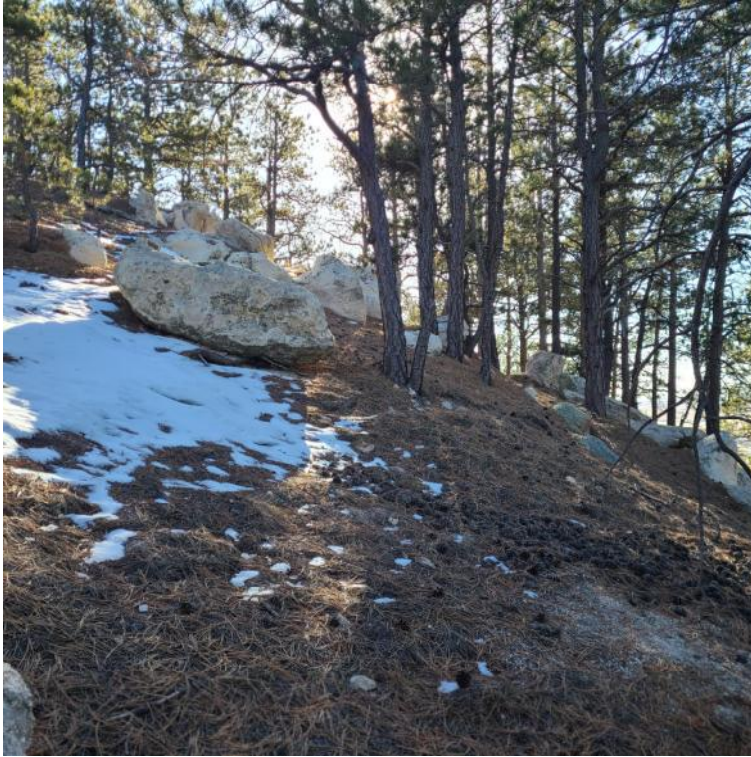
**Looking south along
slope below the
rockfall source area
Lot 24/25.**
