**SOIL, GEOLOGY AND WASTEWATER STUDY
SW CORNER OF DAVIS AND CURTIS ROADS
EL PASO COUNTY, COLORADO**

United Planning and Engineering, Inc.
4575 Galley Road, Suite 200
Colorado Springs, Colorado 80915

July 22, 2005

Entech Job No. 42455
2MSW/rep2005/42455gws

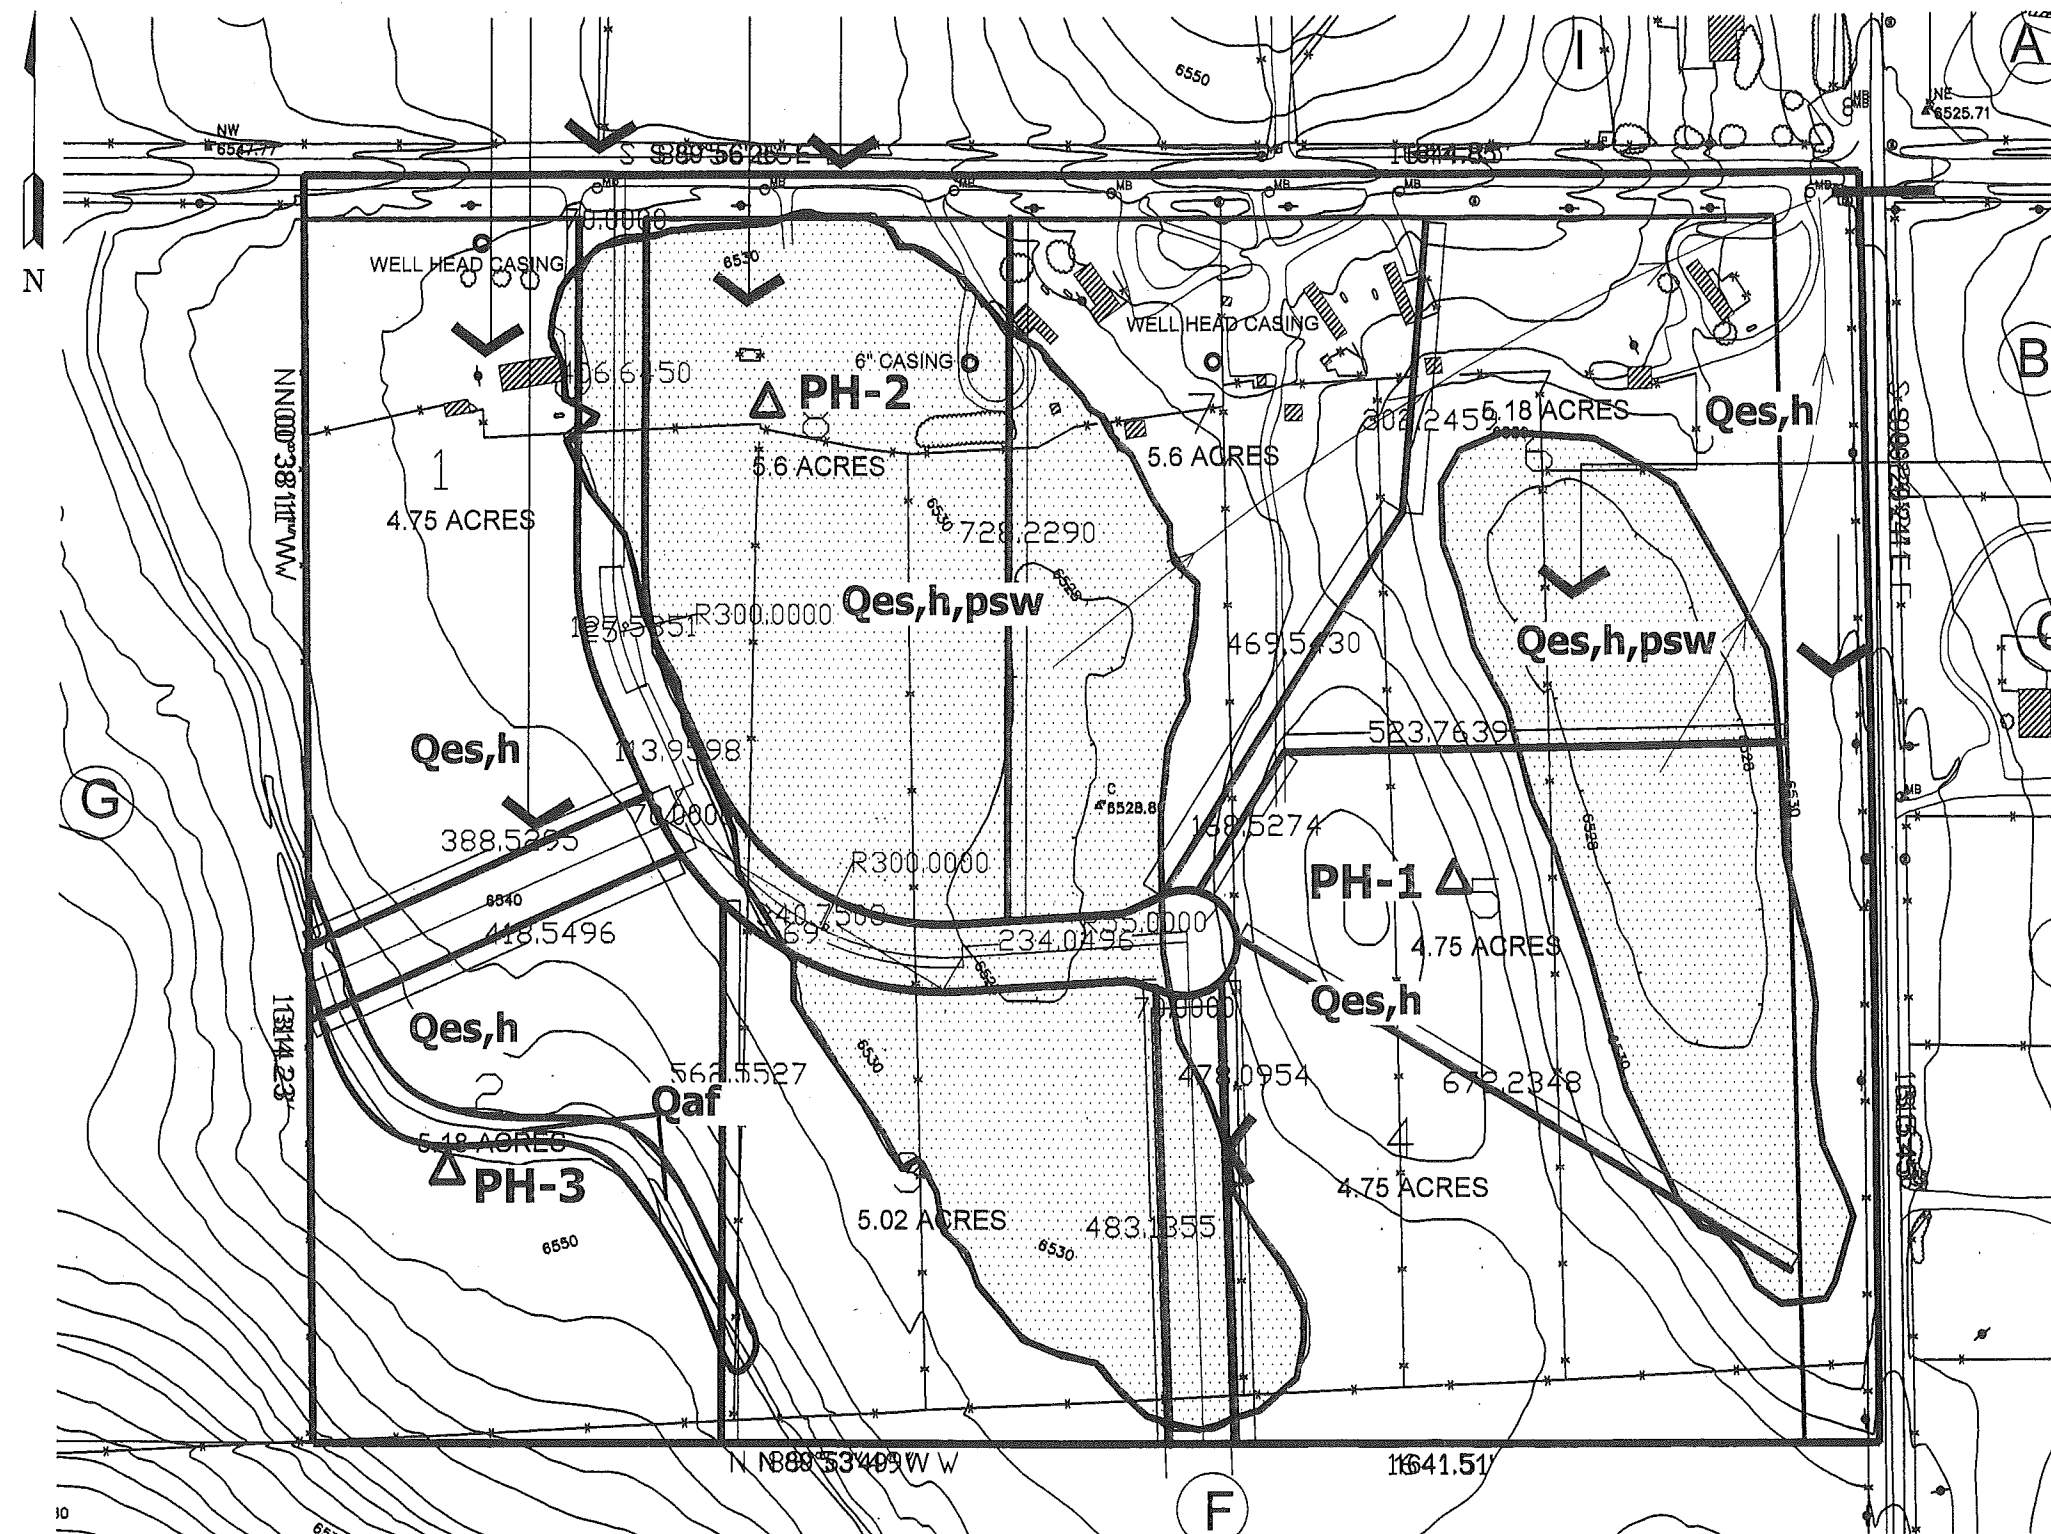
As mentioned previously, detailed mapping has been performed on this site to produce an Engineering Geology Map (Figure 7). This map shows the location of various geologic conditions of which the developers should be cognizant during the planning, design and construction stages of the project. These hazards and the recommended mitigation techniques are as follows:

psw Potentially Seasonal High Groundwater Area

In these areas, we would anticipate the potential for periodically high subsurface moisture conditions. The areas of internal drainage are mapped as having the potential for seasonal shallow groundwater on a seasonal basis. These areas appear to be associated with older blowout features and surrounded by older sand dune ridges. Should construction be necessary in portions of these areas the following precautions should be taken. No areas of the site have been mapped in any floodplain zones, according to FEMA Map No. 08041CO800F (Reference 4, Figure 8).

af Artificial Fill

These are areas of man-made fill associated with erosion berms on site.

- h* Hydrocompaction: Areas in which this hazard has been identified are acceptable as building sites. However, in areas identified for this hazard classification, we anticipate a potential for settlement movements upon saturation of these surficial soils. The low density, uniform grain sized, windblown sand deposits are particularly susceptible to this type of phenomenon.

- c* Collapsible Soils: Some of the soils encountered in the profile holes indicated collapsible characteristics such as pinholes and low density. These areas are very sporadic, therefore, none have been indicated on the maps. The potential for collapsible soils exists anywhere on the site.

ex Expansive Soils

The site is mapped within an area of windblown sand or silt. This mapping generally has low swell potential, but the upper 6 to 12 inches may locally have moderate swell potential. Minor areas of expansive clays were encountered in the subsurface soils in one of the test borings drilled on-site. These soils are sporadic; therefore, none have been indicated on the map. These clays can cause differential movement in the structure foundations. These occurrences should be identified and dealt with on an individual basis.

Mitigation: In these locations, foundation in areas subject to severe frost heave potential should penetrate to a sufficient depth so as to discourage the formation of ice lenses beneath foundations. At this location and elevation, a foundation depth for frost protection of 30 inches is recommended. In areas where high subsurface moisture conditions are anticipated periodically, a subsurface perimeter drain will be necessary to help prevent the seepage of water into areas located below grade. Typical drain details are presented in Figure 9. Any grading in these areas should be done in a manner that directs surface flow around construction to avoid areas of ponded water. Areas of organic material will require removal before any filling is done. Specific recommendations should be made after additional investigation of each building site. The groundwater level may be at sufficient depth not to affect construction.

Mitigation: The small erosion berms could be penetrated by foundations. Should any uncontrolled fill be encountered beneath foundations, removal and recompaction at a minimum of 90% of its maximum Modified Proctor Dry Density, ASTM D-1557 will be required.

Mitigation: The potential for settlement movement is directly related to saturation of the soils below the foundation areas. Therefore, good surface and subsurface drainage is extremely critical in these areas in order to minimize the potential for saturation of these soils. The ground surface around all permanent structures should be positively sloped away from the structure to all points, and water must not be allowed to stand or pond anywhere on the site. We recommend that the ground surface within 10 feet of the structures be sloped away with a minimum gradient of ten percent. If this is not possible on the upslope side of the structures, then a well-defined swale should be created to intercept the surface water and carry it quickly and safely around and away from the structures. Roof drains should be made to discharge well away from the structures and into areas of positive drainage. Where several structures are involved, the overall drainage design should be such that water directed away from one structure is not directed against an adjacent building. Planting and watering in the immediate vicinity of the structures, as well as general lawn irrigation, should be minimized.

Mitigation: Should collapsible soils be encountered beneath foundations, removal and recompaction of the upper 2 to 4 feet with thorough moisture conditioning at a minimum of 90% of its maximum Modified Proctor Dry Density, ASTM D-1557 will be necessary. If very loose conditions are encountered at foundation grade, recompaction of the upper 2

Mitigation: Mitigation of expansive soils on this site will require special foundation design. Overexcavation of the expansive material encountered beneath foundations and replacement with non-expansive material encountered beneath foundations and replacement with non-expansive soils at a minimum of 90% of its maximum Modified Proctor Dry Density STM D-1557 is a suitable mitigation which is common in the area. Floor slabs on expansive soils should be expected to experience movement. Overexcavation and replacement has been successful in minimizing slab movements. Final recommendations should be determined after additional investigation of each building site.

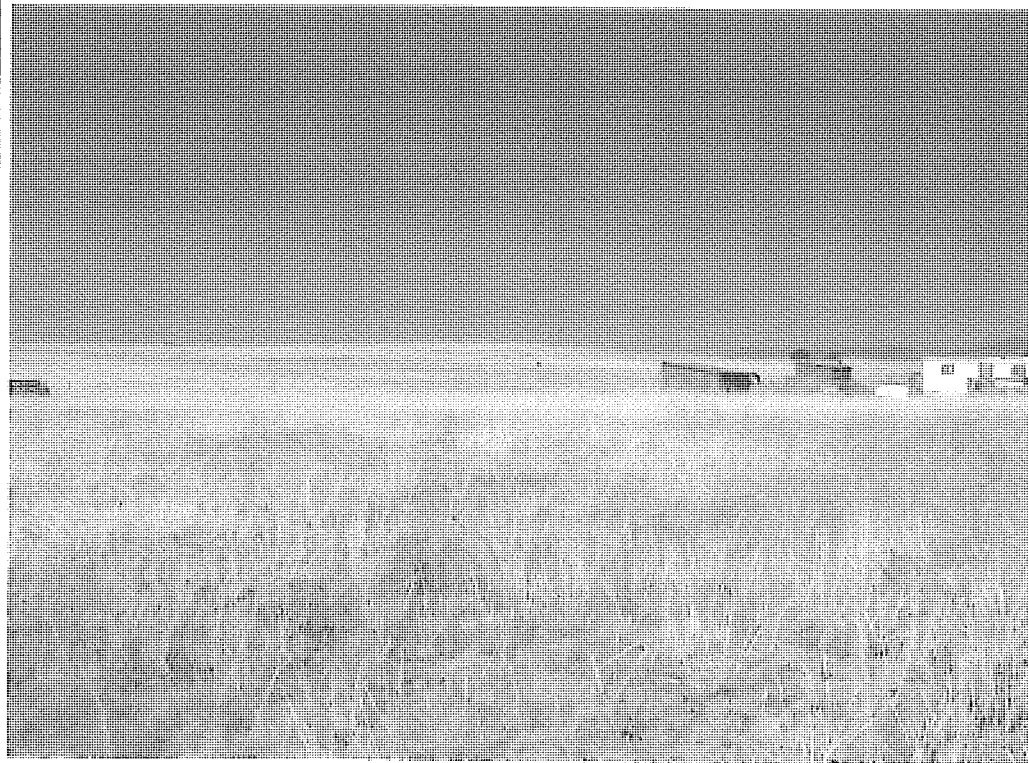
**From northeast
portion of site,
looking southwest.**

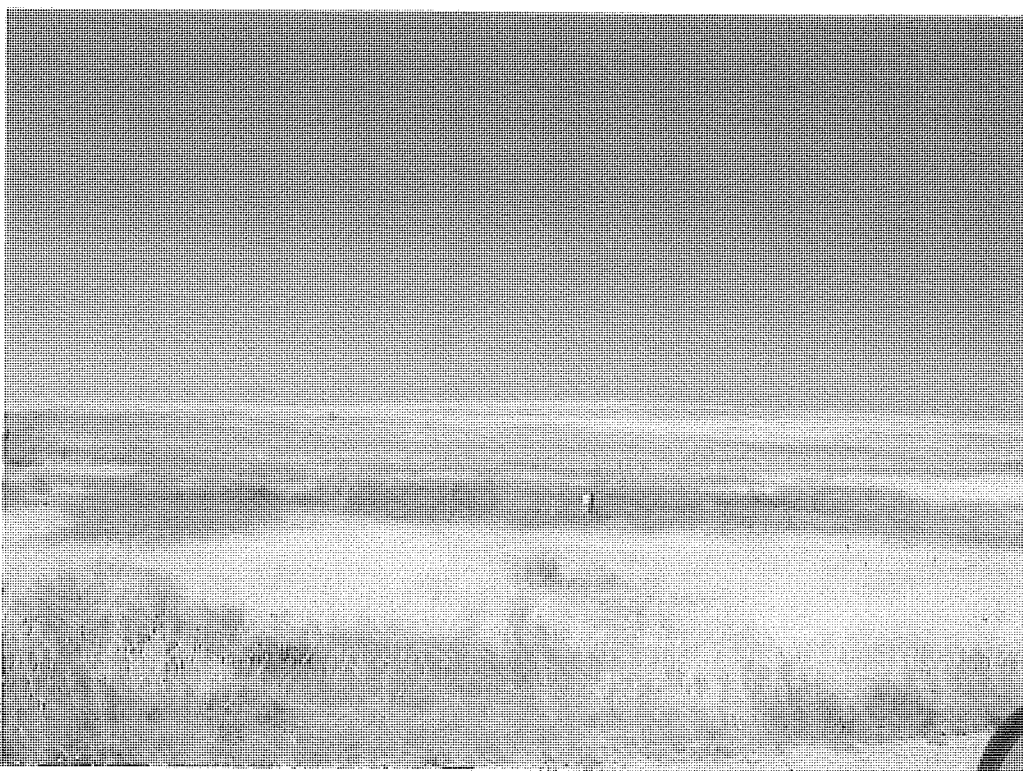
**From north central
portion of site,
looking south.**

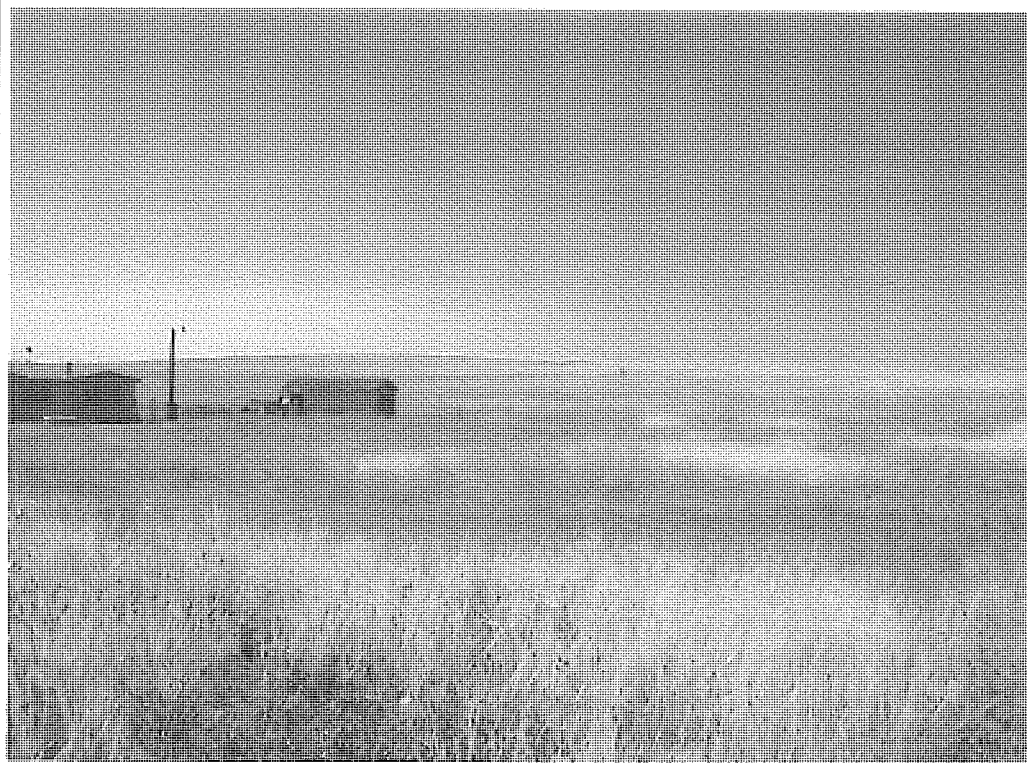
**From northwest
corner of site,
looking southeast.**

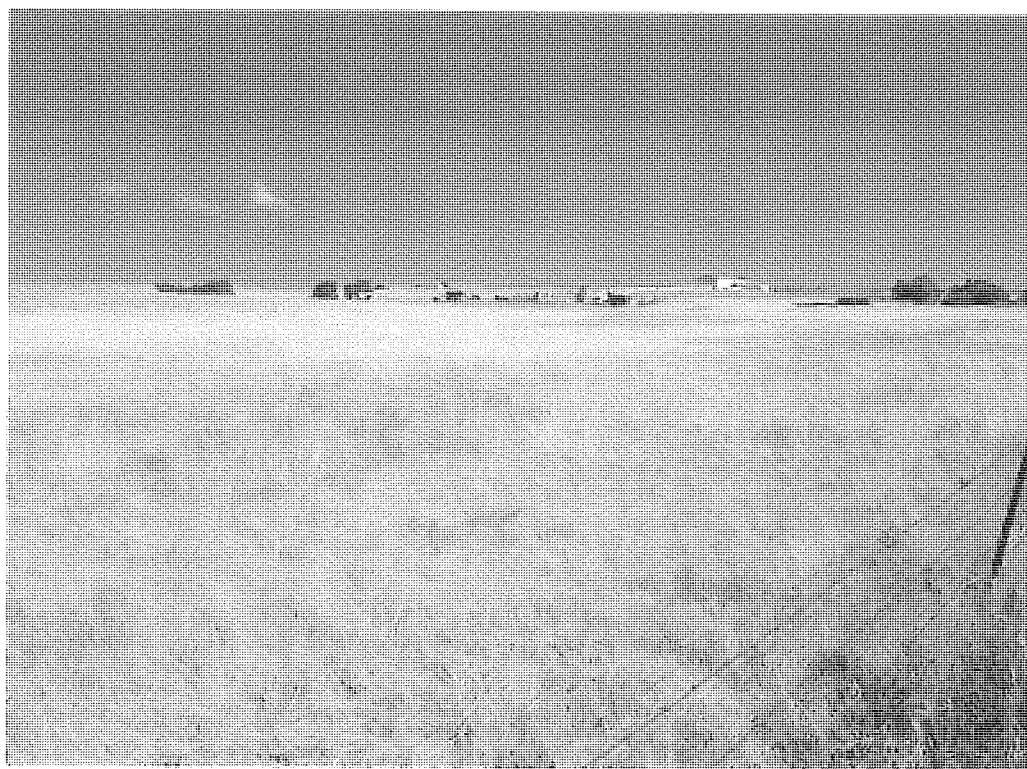
**From southeast
corner of site,
looking northwest.**
