June 23, 2021

ENTECH
ENGINEERING, INC.

Re: Soil, Geology, and Geologic Hazard Study
Manley Subdivision Filing No. 2
Curtis Road and Jones Road
El Paso County, Colorado

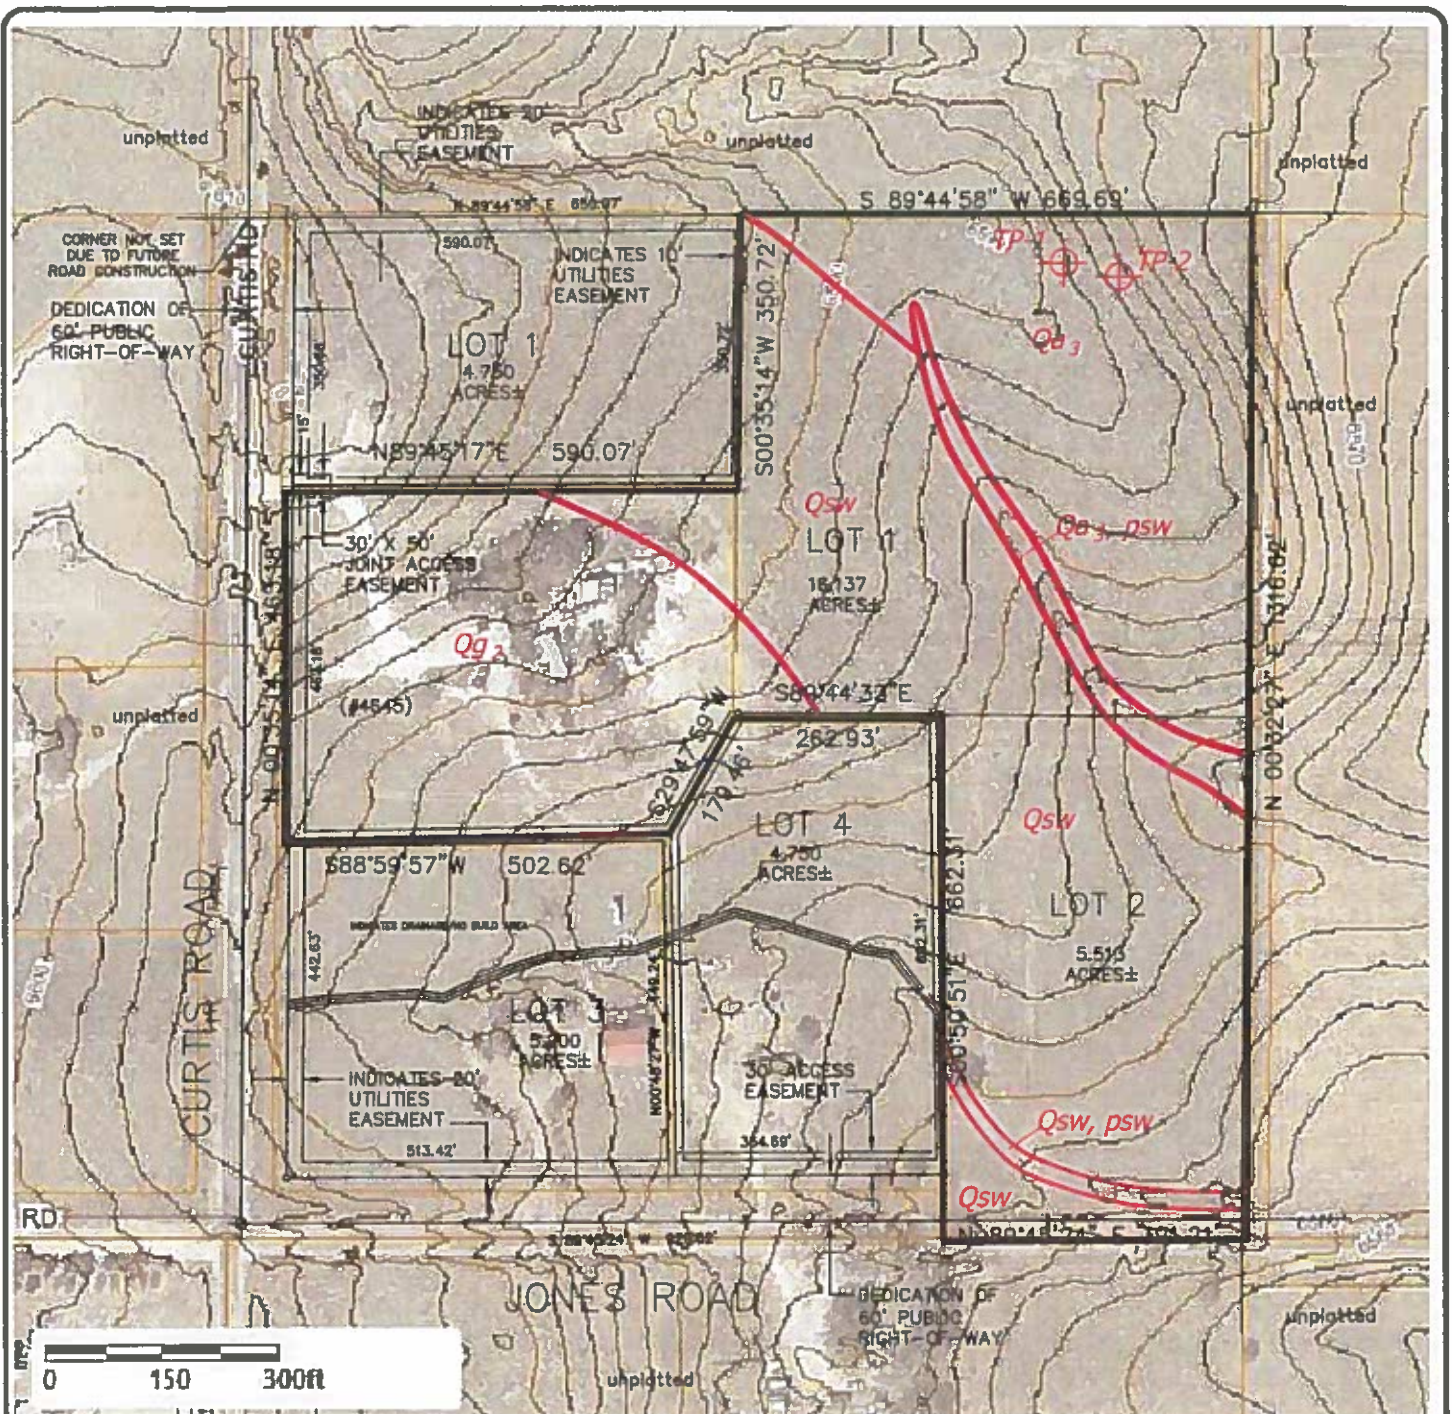
FIG NO.:
6

Minor drainage areas exist in the northeastern portion of Lot 1 and southern portion of Lot 2. No water was observed flowing in the drainages at the time of the investigation, however, these areas have the potential for seasonal shallow groundwater. These areas are indicated in the Geology/Engineering Geology Map (Figure 6) and are discussed below. Due to the size of the proposed lots these areas can be avoided or redirected around proposed structures or proposed soil treatment areas. The proposed building areas are not affected by these areas. The site does not lie within any floodplain zones according to the FEMA Map No. 08041CO568G dated December 7, 2018 (Figure 7, Reference 6). Exact locations of floodplain and specific drainage studies are beyond the scope of this report.

In these areas, we would anticipate the potential for periodically high subsurface moisture conditions, frost heave potential and highly organic soils. These areas lie within defined minor drainages and can be avoided by the proposed development. Construction in any portions of these areas, if required, or immediately adjacent to these areas should follow these precautions.

Mitigation: Foundations must have a minimum 30-inch depth for frost protection. In areas where high subsurface moisture conditions are anticipated periodically, subsurface perimeter drains are recommended to help prevent the intrusion of water into areas below grade. Typical drain details are presented in Figure 8. Any grading in these areas should be done to direct surface flow around construction to avoid areas of ponded water. All organic material would be

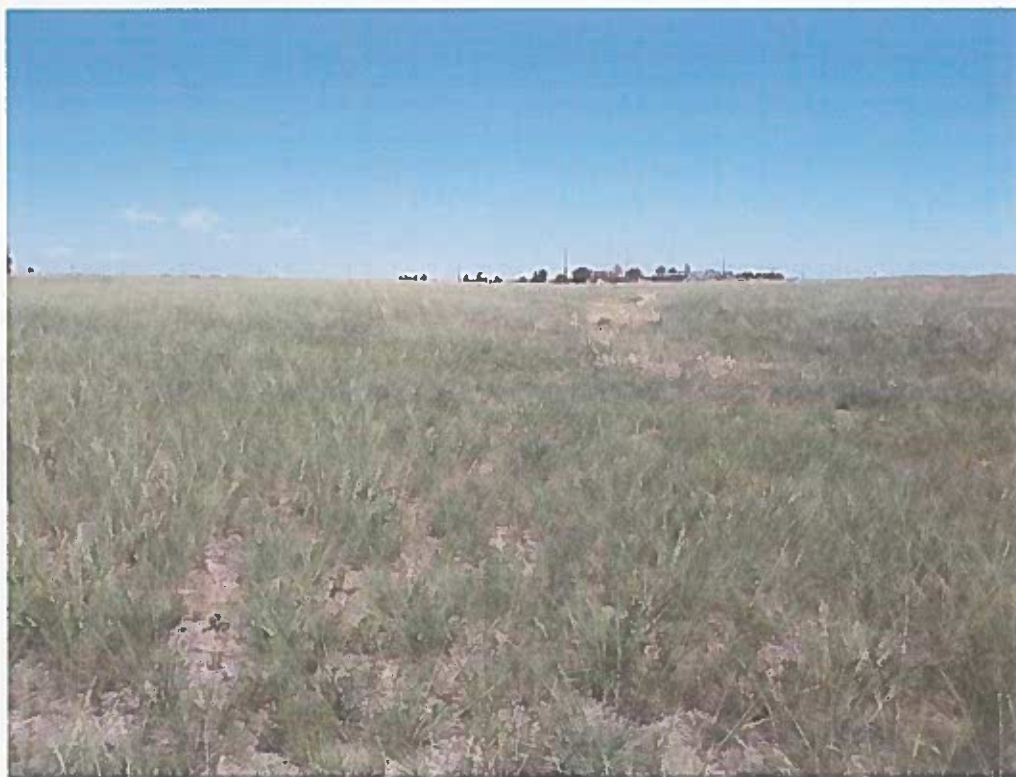
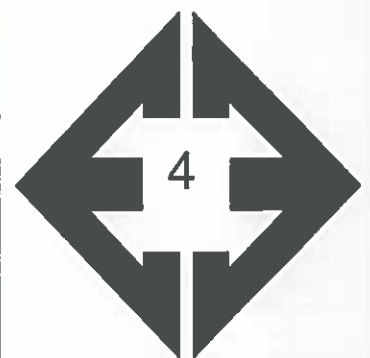
**Looking northwest
along minor drainage
swale in the east
central portion of the
property.**
