SOIL AND GEOLOGY STUDY

**New Breed Ranch
Lots 1-7, Filing No. 3
Colorado Springs
El Paso County, Colorado**

JOB NO. 192449

May 23, 2023

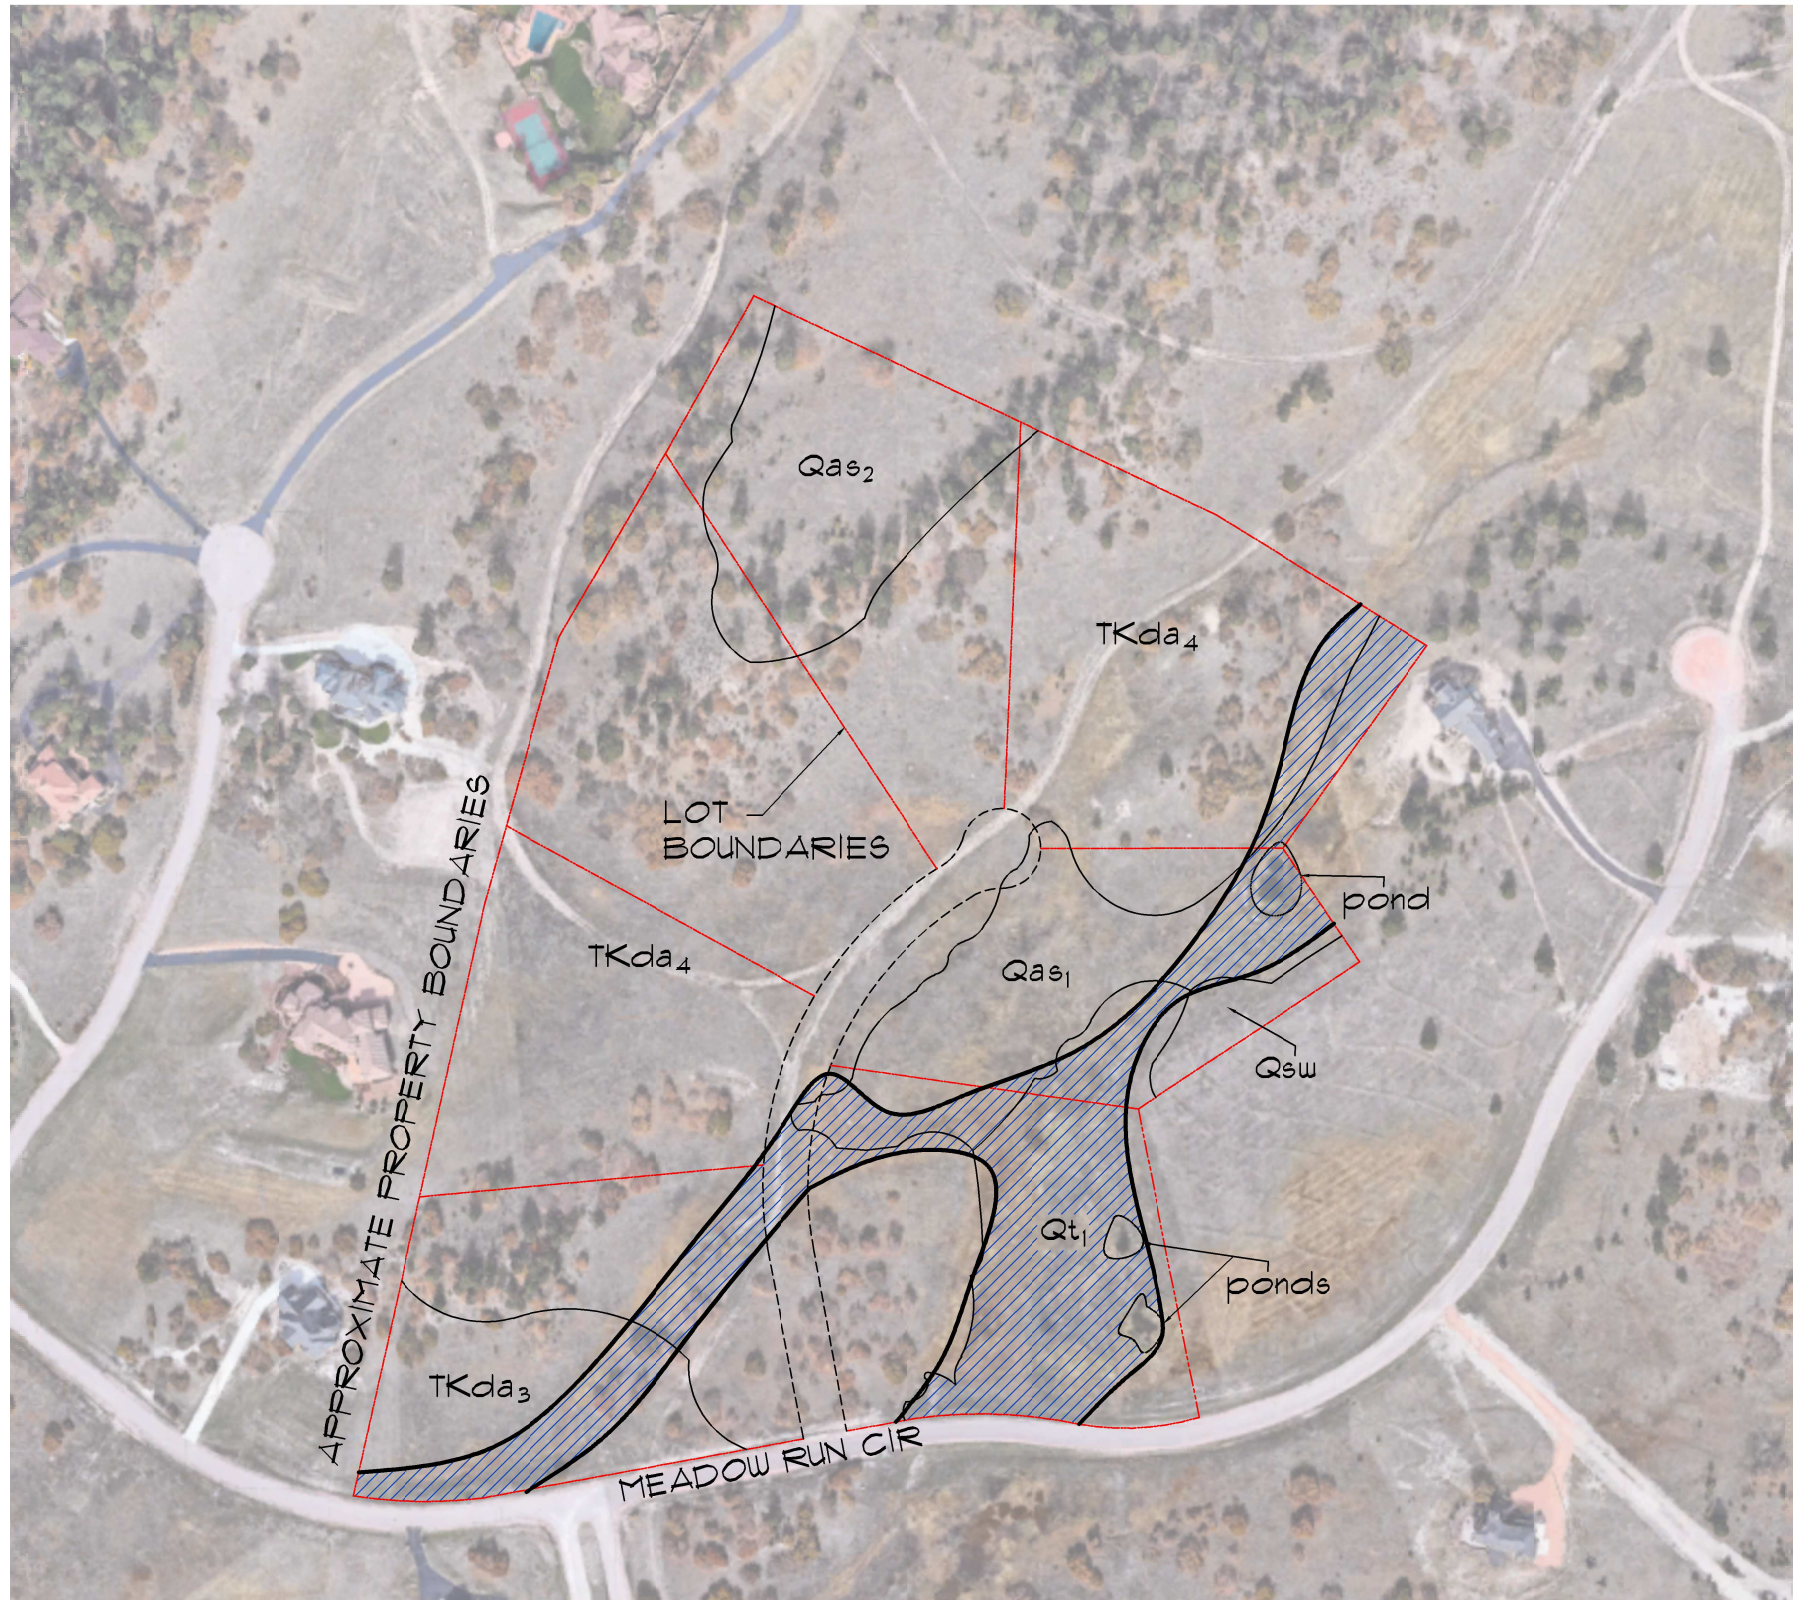
SHEET No.
FIG-11

- *psw* – potential seasonally wet - areas that may collect surface water during high moisture events.

A natural drainage feature was observed near the eastern portion of the site. It's anticipated that the area serves as a conduit for surface runoff water during periods of rain and snowmelt. As such, this area is mapped on Figure 11 as potentially seasonally wet.

Foundations must have a minimum 30-inch depth for frost protection. Perimeter drains are recommended around portions of the structures which will have habitable or storage space located below the finished ground surface. This includes crawlspace areas but not the walkout trenches, if applicable. Perimeter drains are recommended for portions of the structures which will have below-grade spaces to help reduce the intrusion of water into areas below grade. A typical perimeter drain detail is presented in Figure 12.

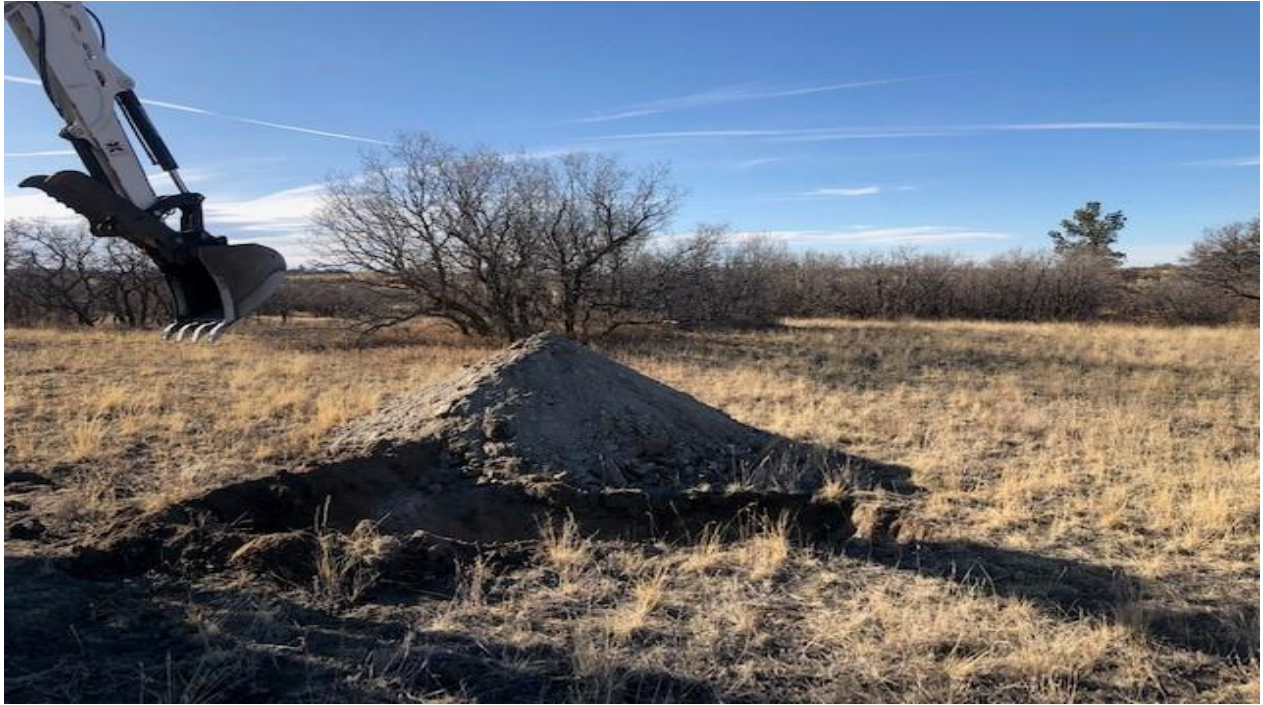
Test Pit near southwest corner of property

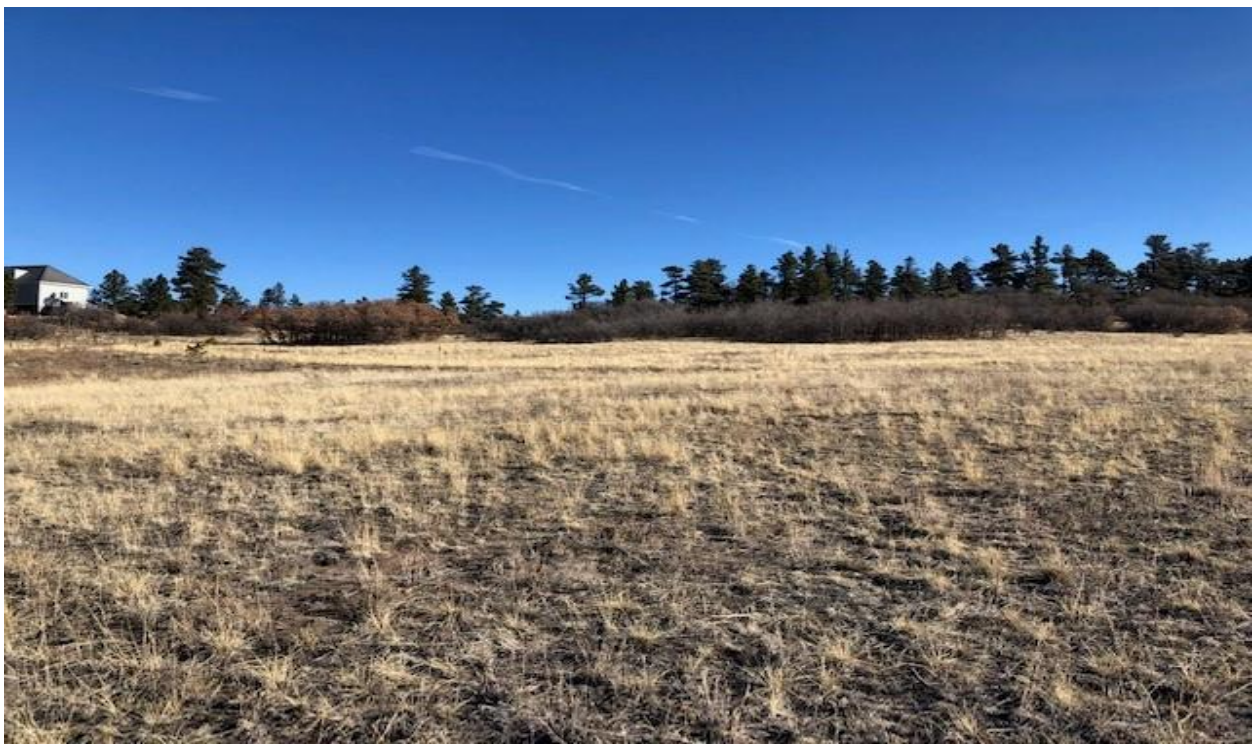
Looking west across grasslands and rolling hills

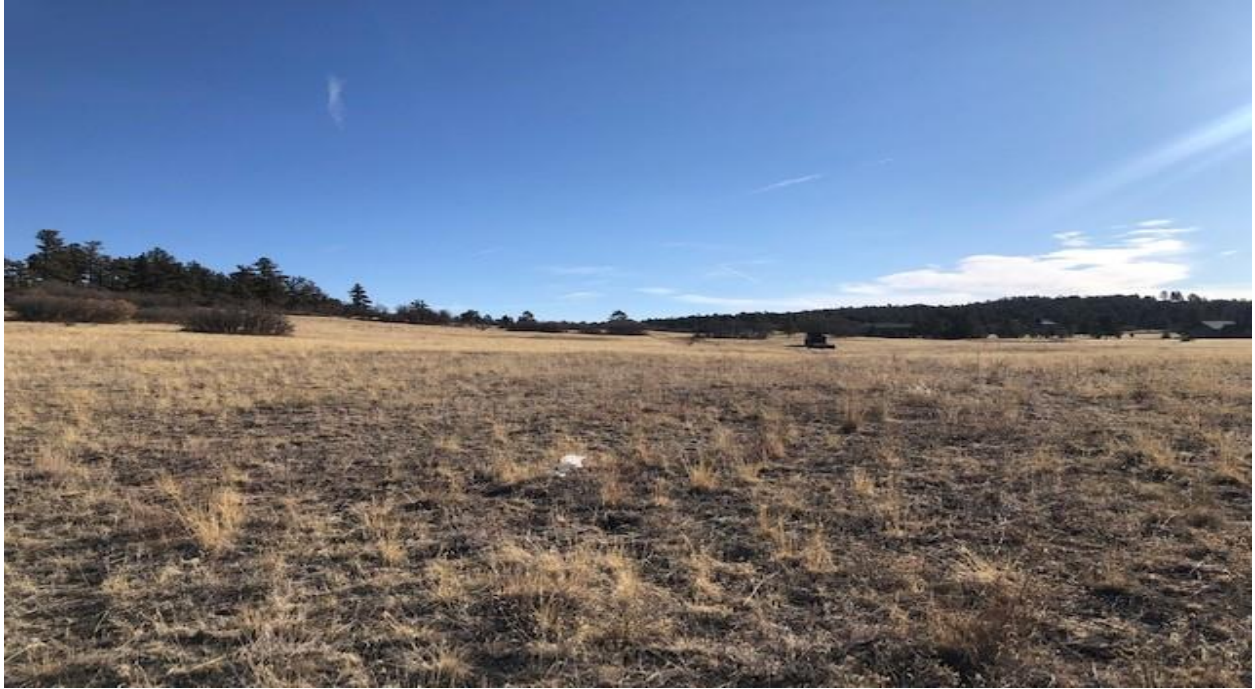
Looking north

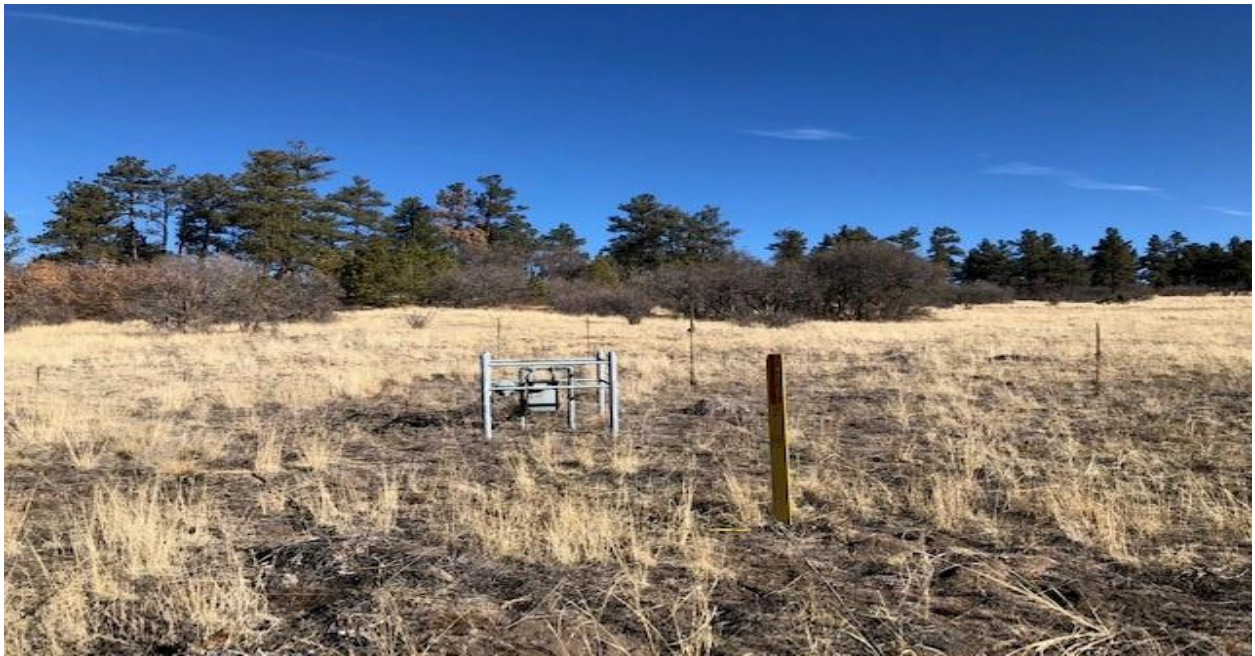
Near center of property

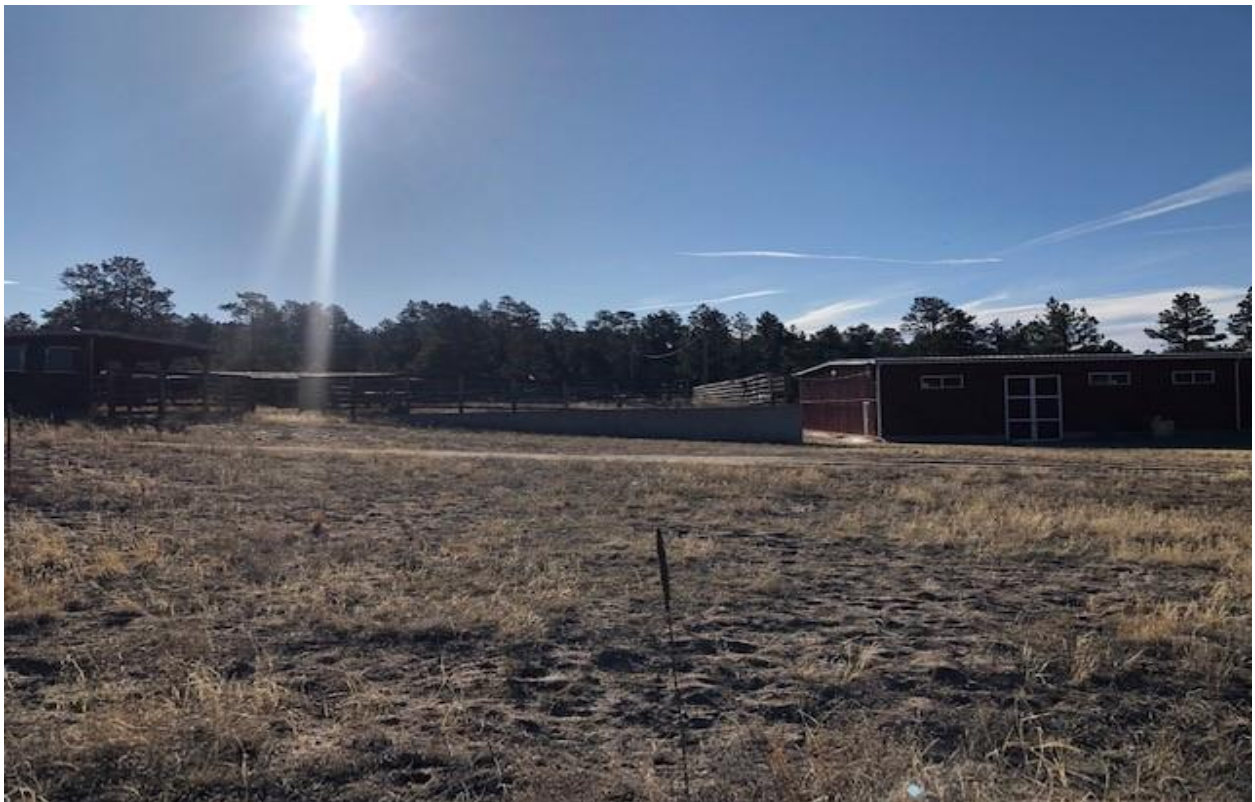
Northern boundary

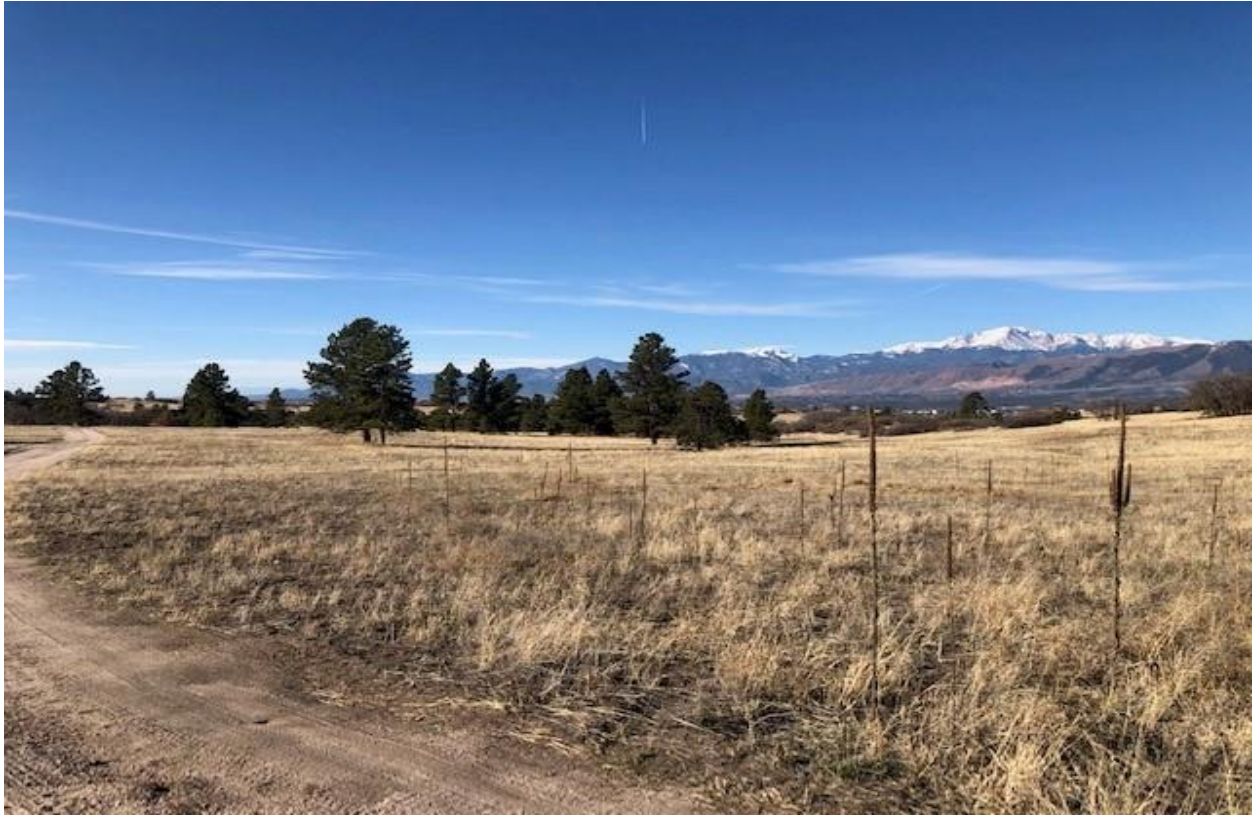
Looking southwest near center of property
