**SOIL, GEOLOGY, GEOLOGIC HAZARD STUDY
EAGLE RISING SUBDIVISION
PARCEL NOS. 52290-00-034 & 52290-00-035
EL PASO COUNTY, COLORADO**

**Casas Limited Partnership #4
IQ Investors, LLC
P.O. Box 2076
Colorado Springs, Colorado 80901**

June 29, 2022
Revised January 25, 2023

Entech Job No. 221458
AAprojects/2022/221458/sgghs

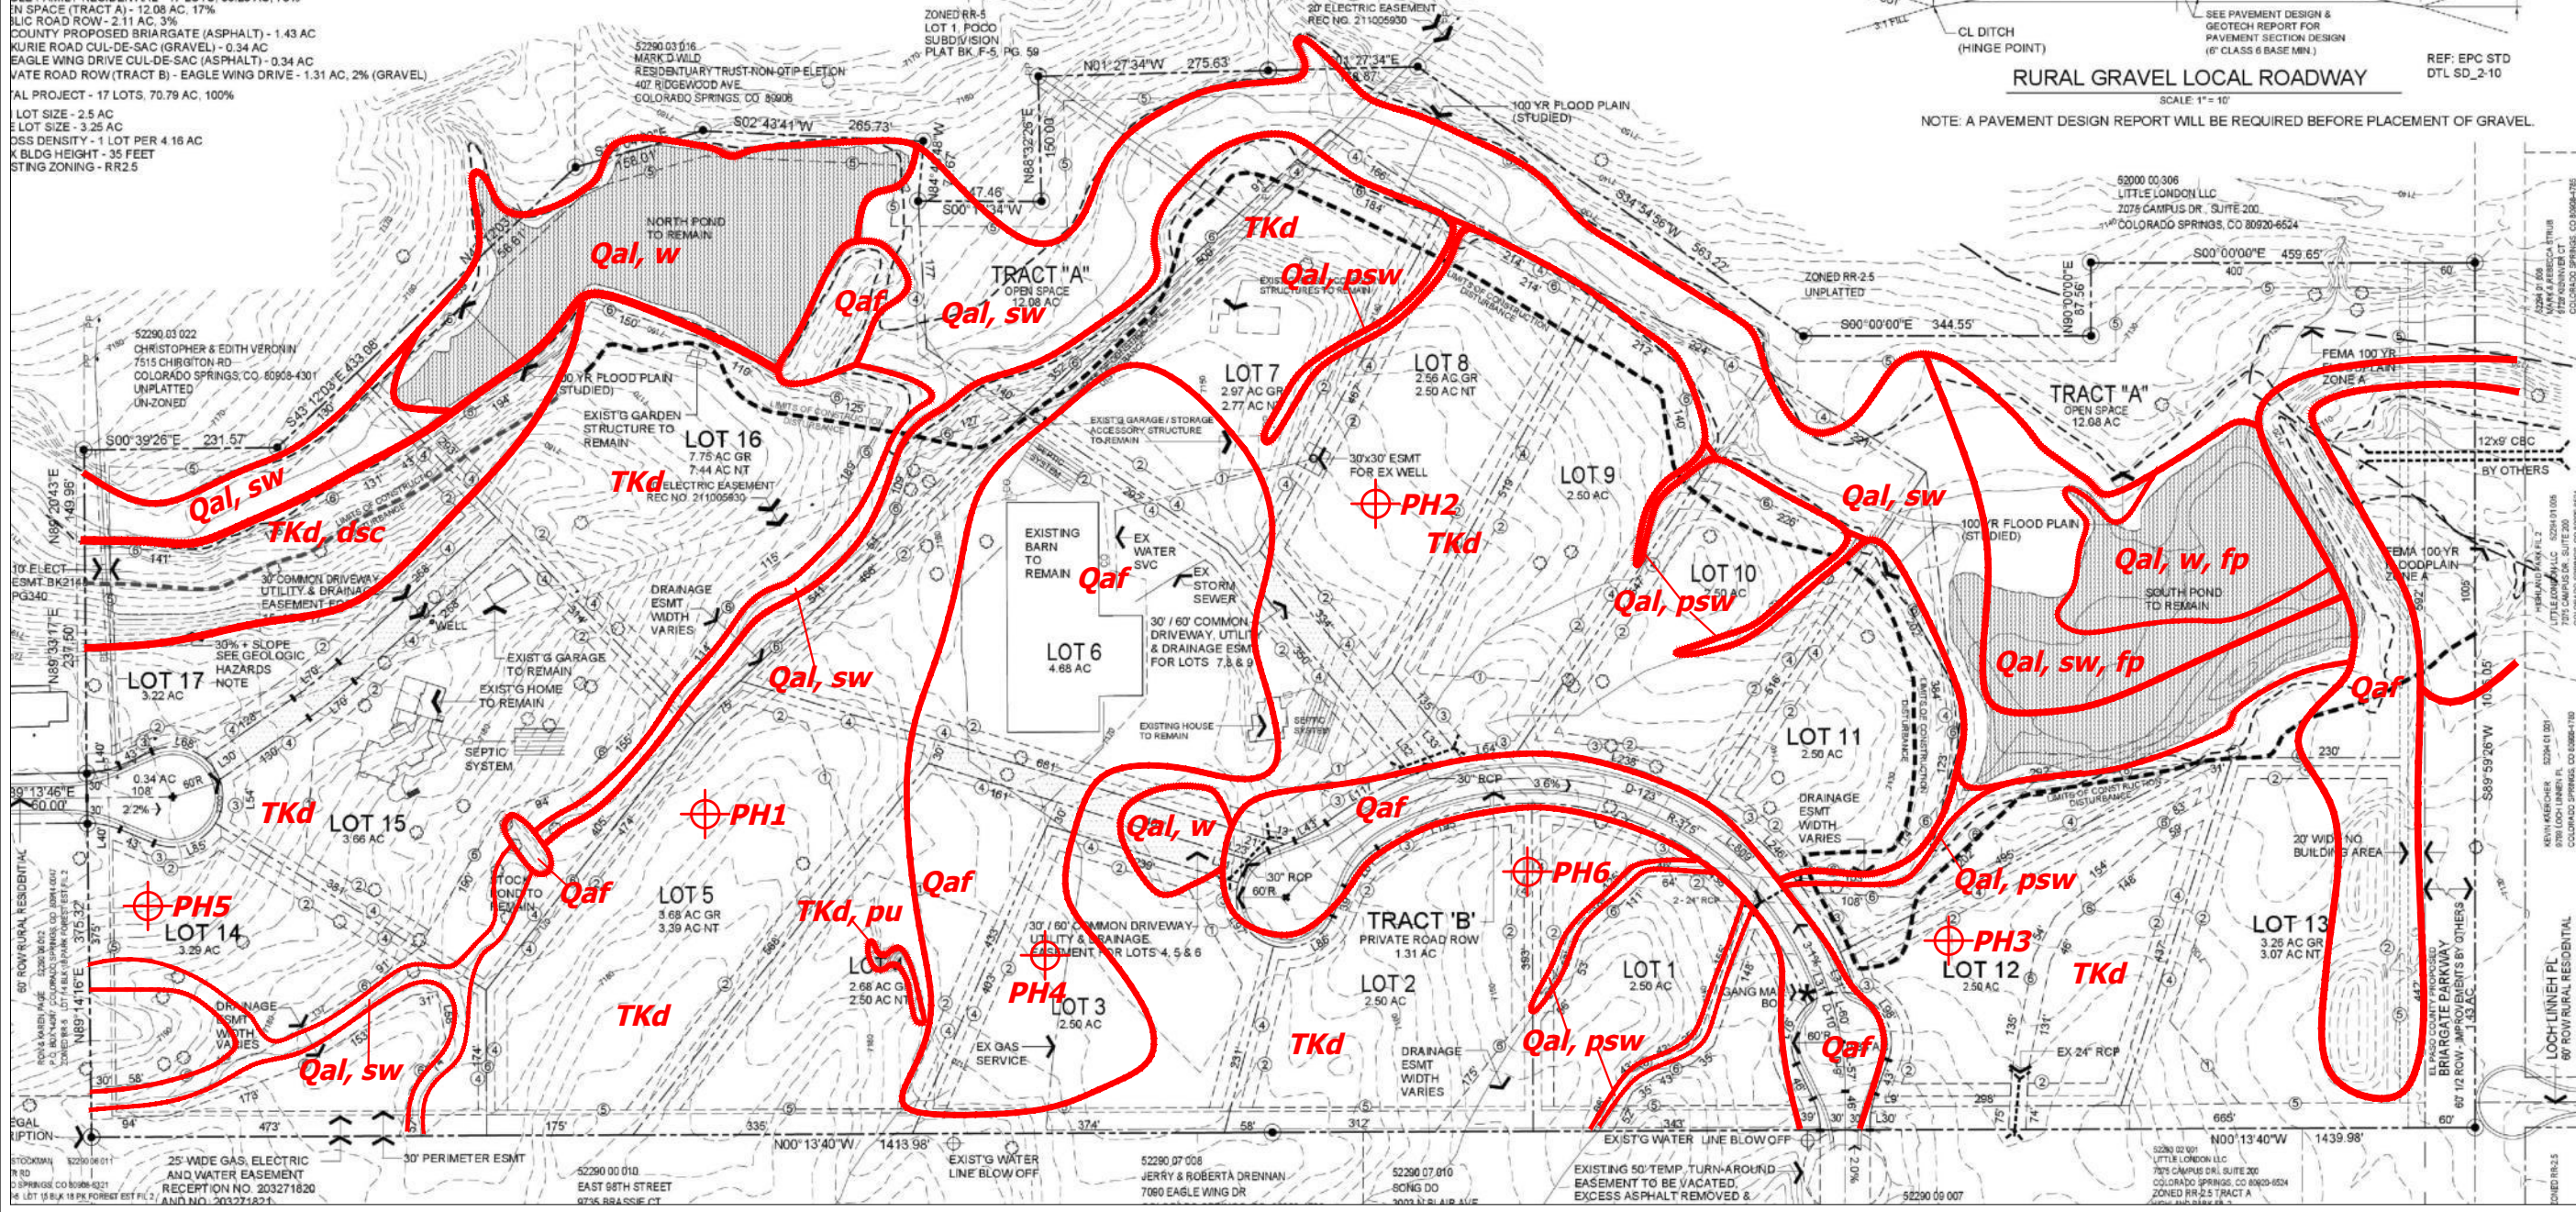
DRAWN L.L.L.
CHECKED
DATE 1/25/23
SCALE AS SHOWN
JOB NO. 221458
FIGURE NO. 6

As mentioned previously, detailed mapping has been performed on this site to produce an Engineering Geology Map (Figure 6). This map shows the location of various geologic conditions of which the developers should be cognizant during the planning, design and construction stages of the project. These hazards and the recommended mitigation techniques are as follows:

A cut-slope in the central area of Lot 4 has been identified as potentially unstable. Considerable care must be exercised in these areas not to create a condition which would tend to activate instability.

Fill associated with earthen dams, fill piles and fill associated with existing structures were observed on site. Additionally, other areas of artificial fill may be encountered in areas other than those mapped. These areas of fill are considered uncontrolled for construction purposes.

Mitigation: The earthen dams are in the area designated as open space and can be avoided by development. The fill piles are limited and it is anticipated they will be removed during site grading. Any uncontrolled fill encountered beneath foundation will require removal and recompaction at a minimum of 95% of its maximum Modified Proctor Dry Density, ASTM D-1557.

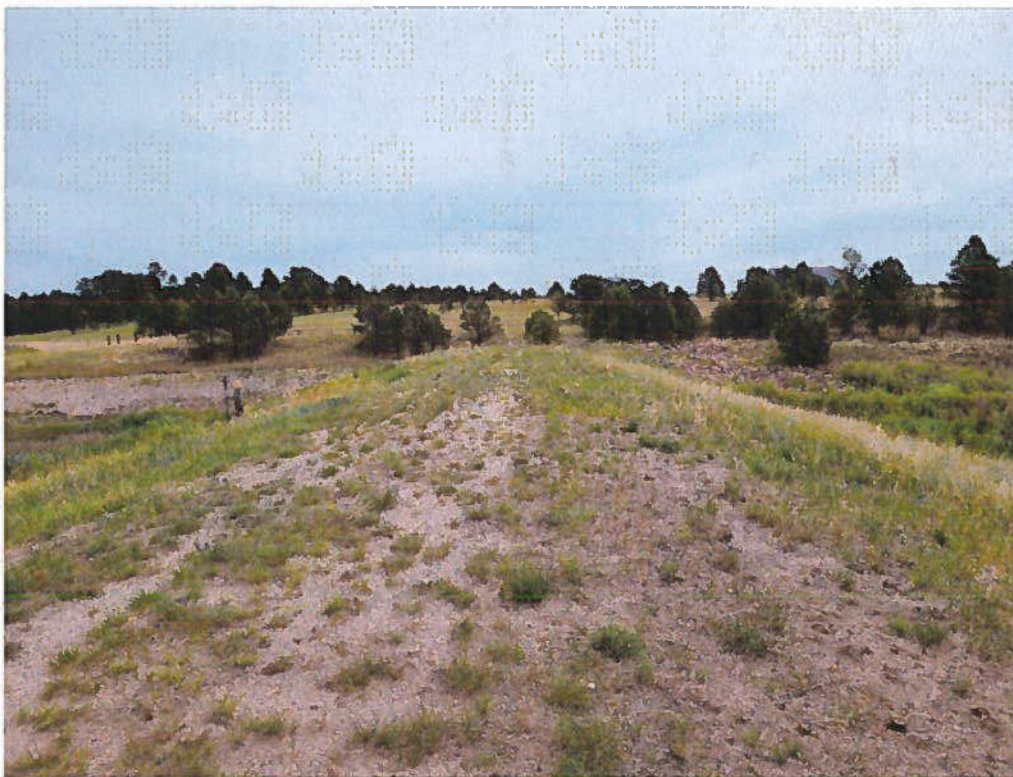
Looking east along earthen dam in the southern portion of the site.
