ENTECH
ENGINEERING, INC.

**SOILS AND GEOLOGY STUDY
FLYING HORSE NORTH, FILING NO. 4
EL PASO COUNTY, COLORADO**

September 11, 2024

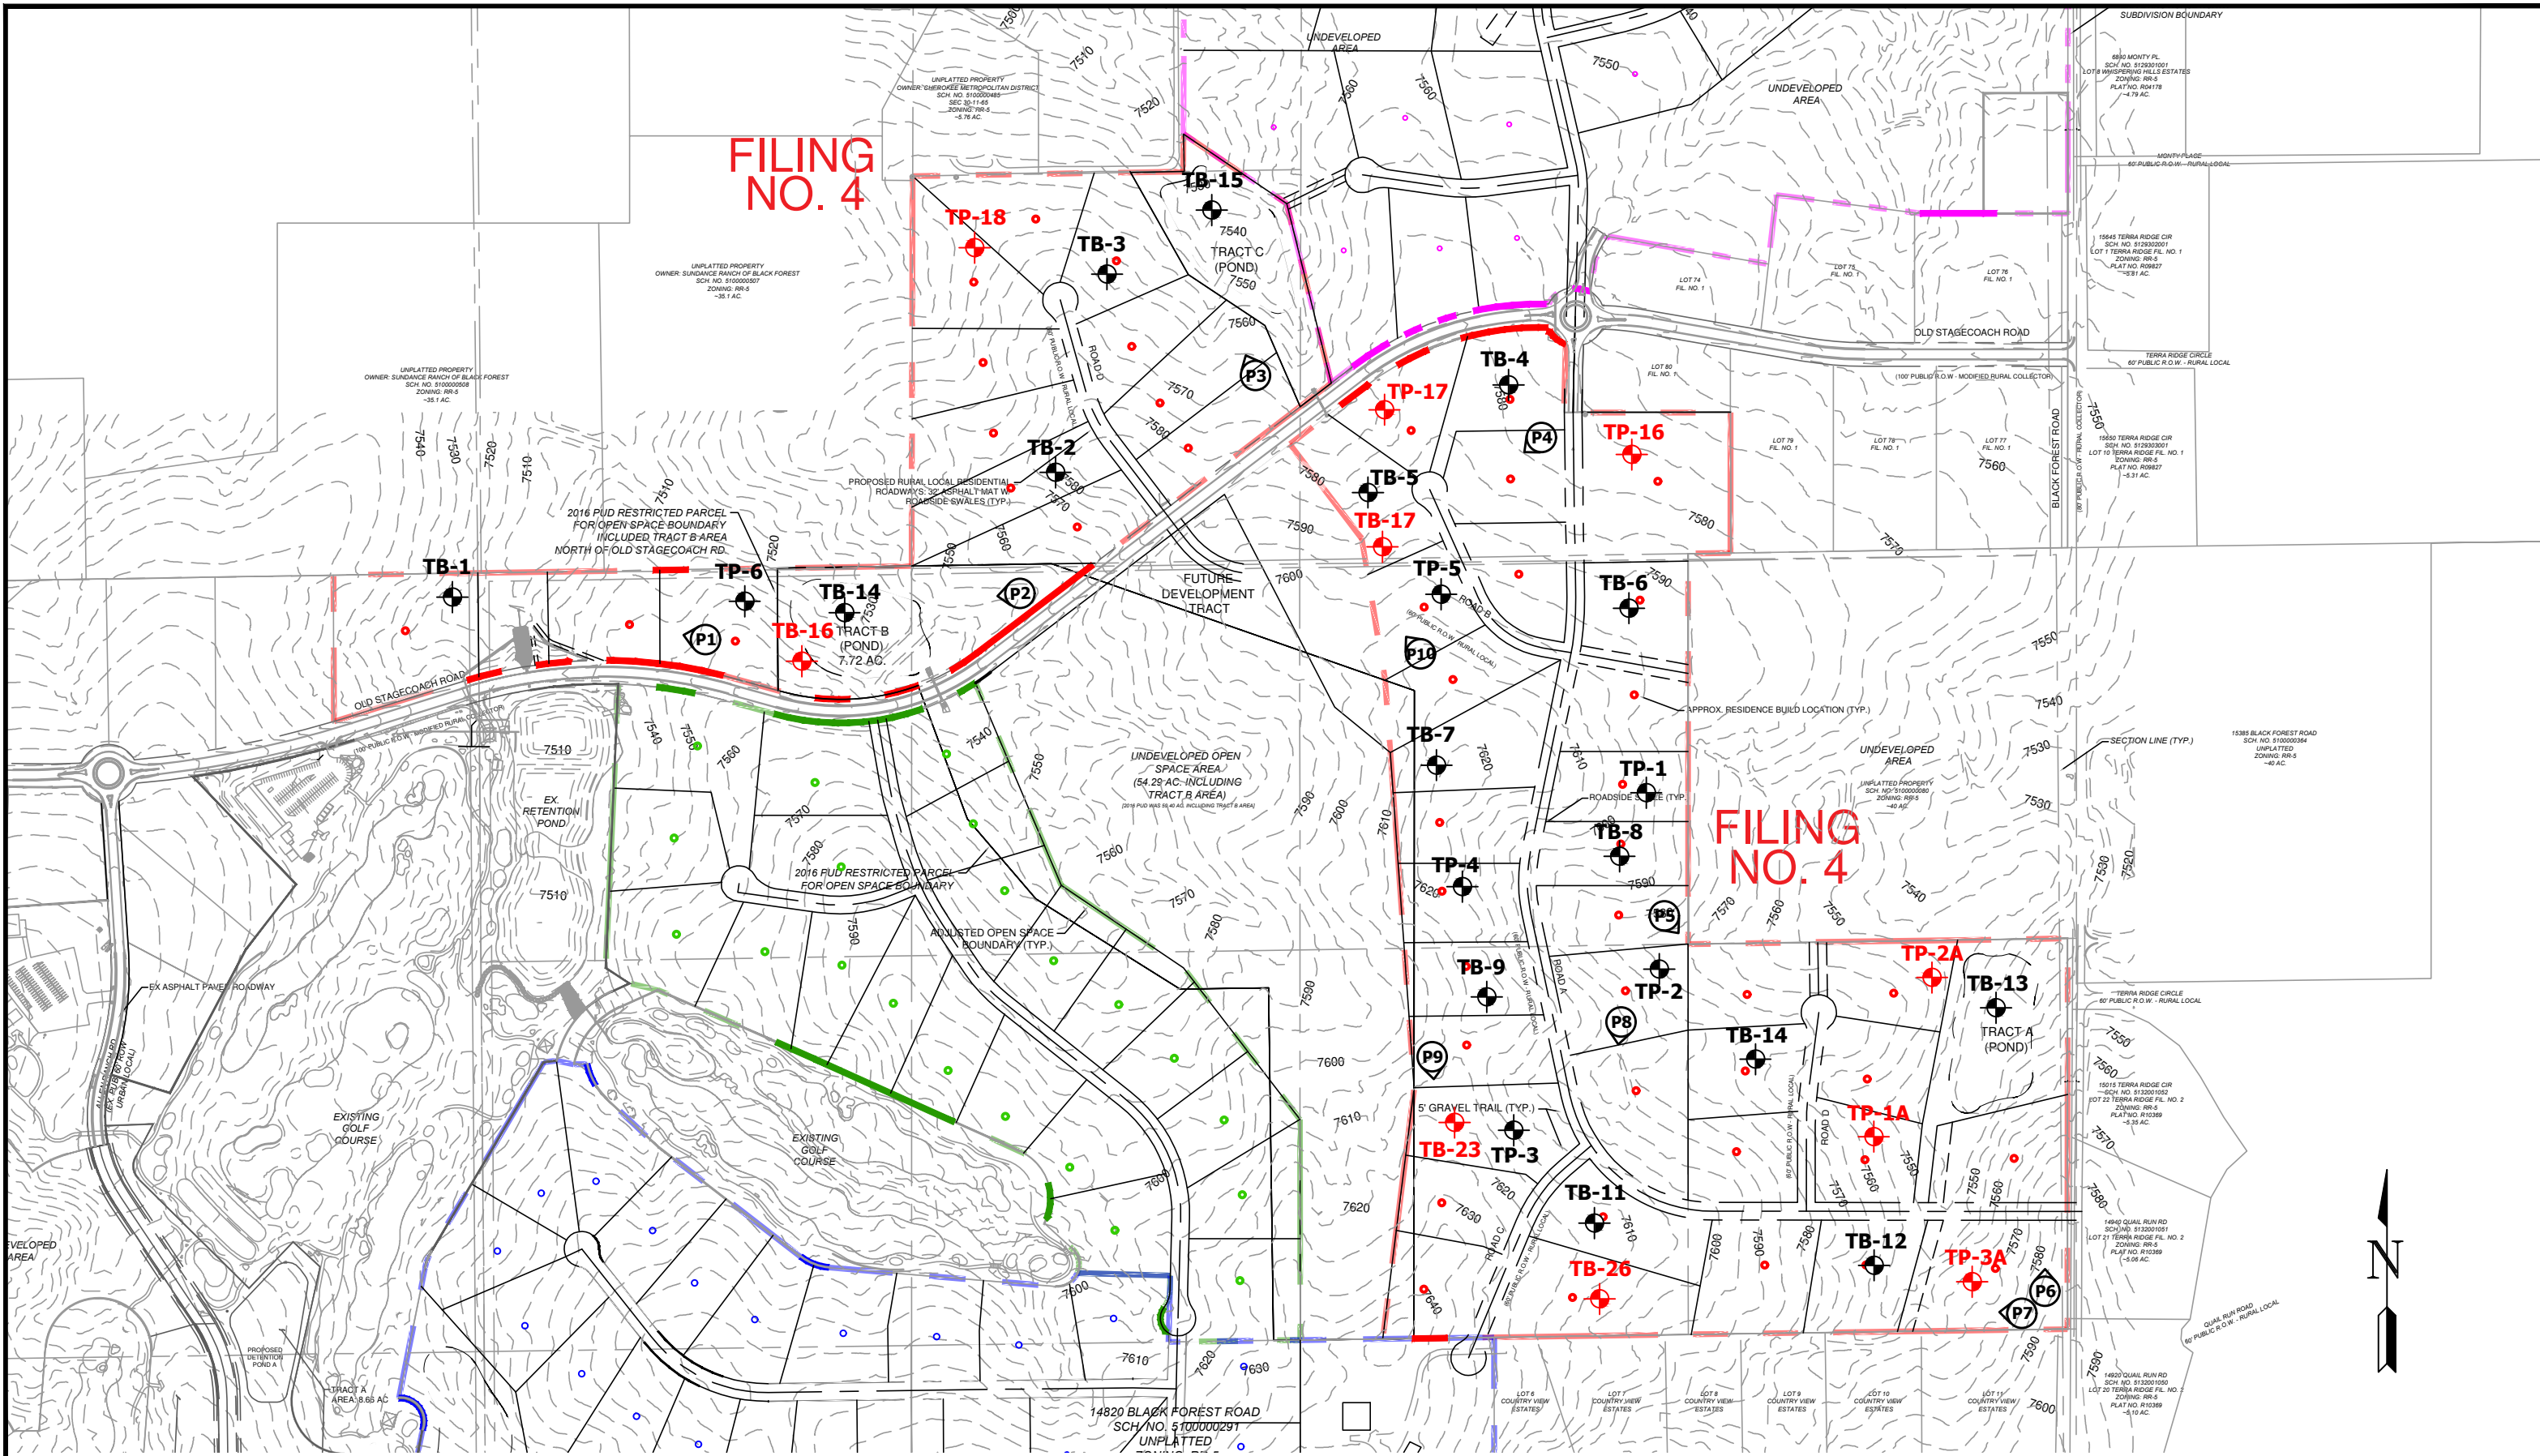
JOB NO.
241144
FIG. 3

The topography of the site varies from gently to moderately sloping generally to the east and north with some steeper slopes along the drainages in portions of the site. Palmer Divide is located to the west of Filing No. 4. The drainages on site generally flow in a northerly direction through the site. Water was not observed in any of the drainages or ponds within Filing No. 4 at the time of our site investigation. The site contains primarily field grasses and weeds in with areas of scattered ponderosa pine trees in the northern portion of the site along Old Stagecoach Road. Site photographs are included in Appendix A. The locations and directions of the photographs are indicated in Figure 3.

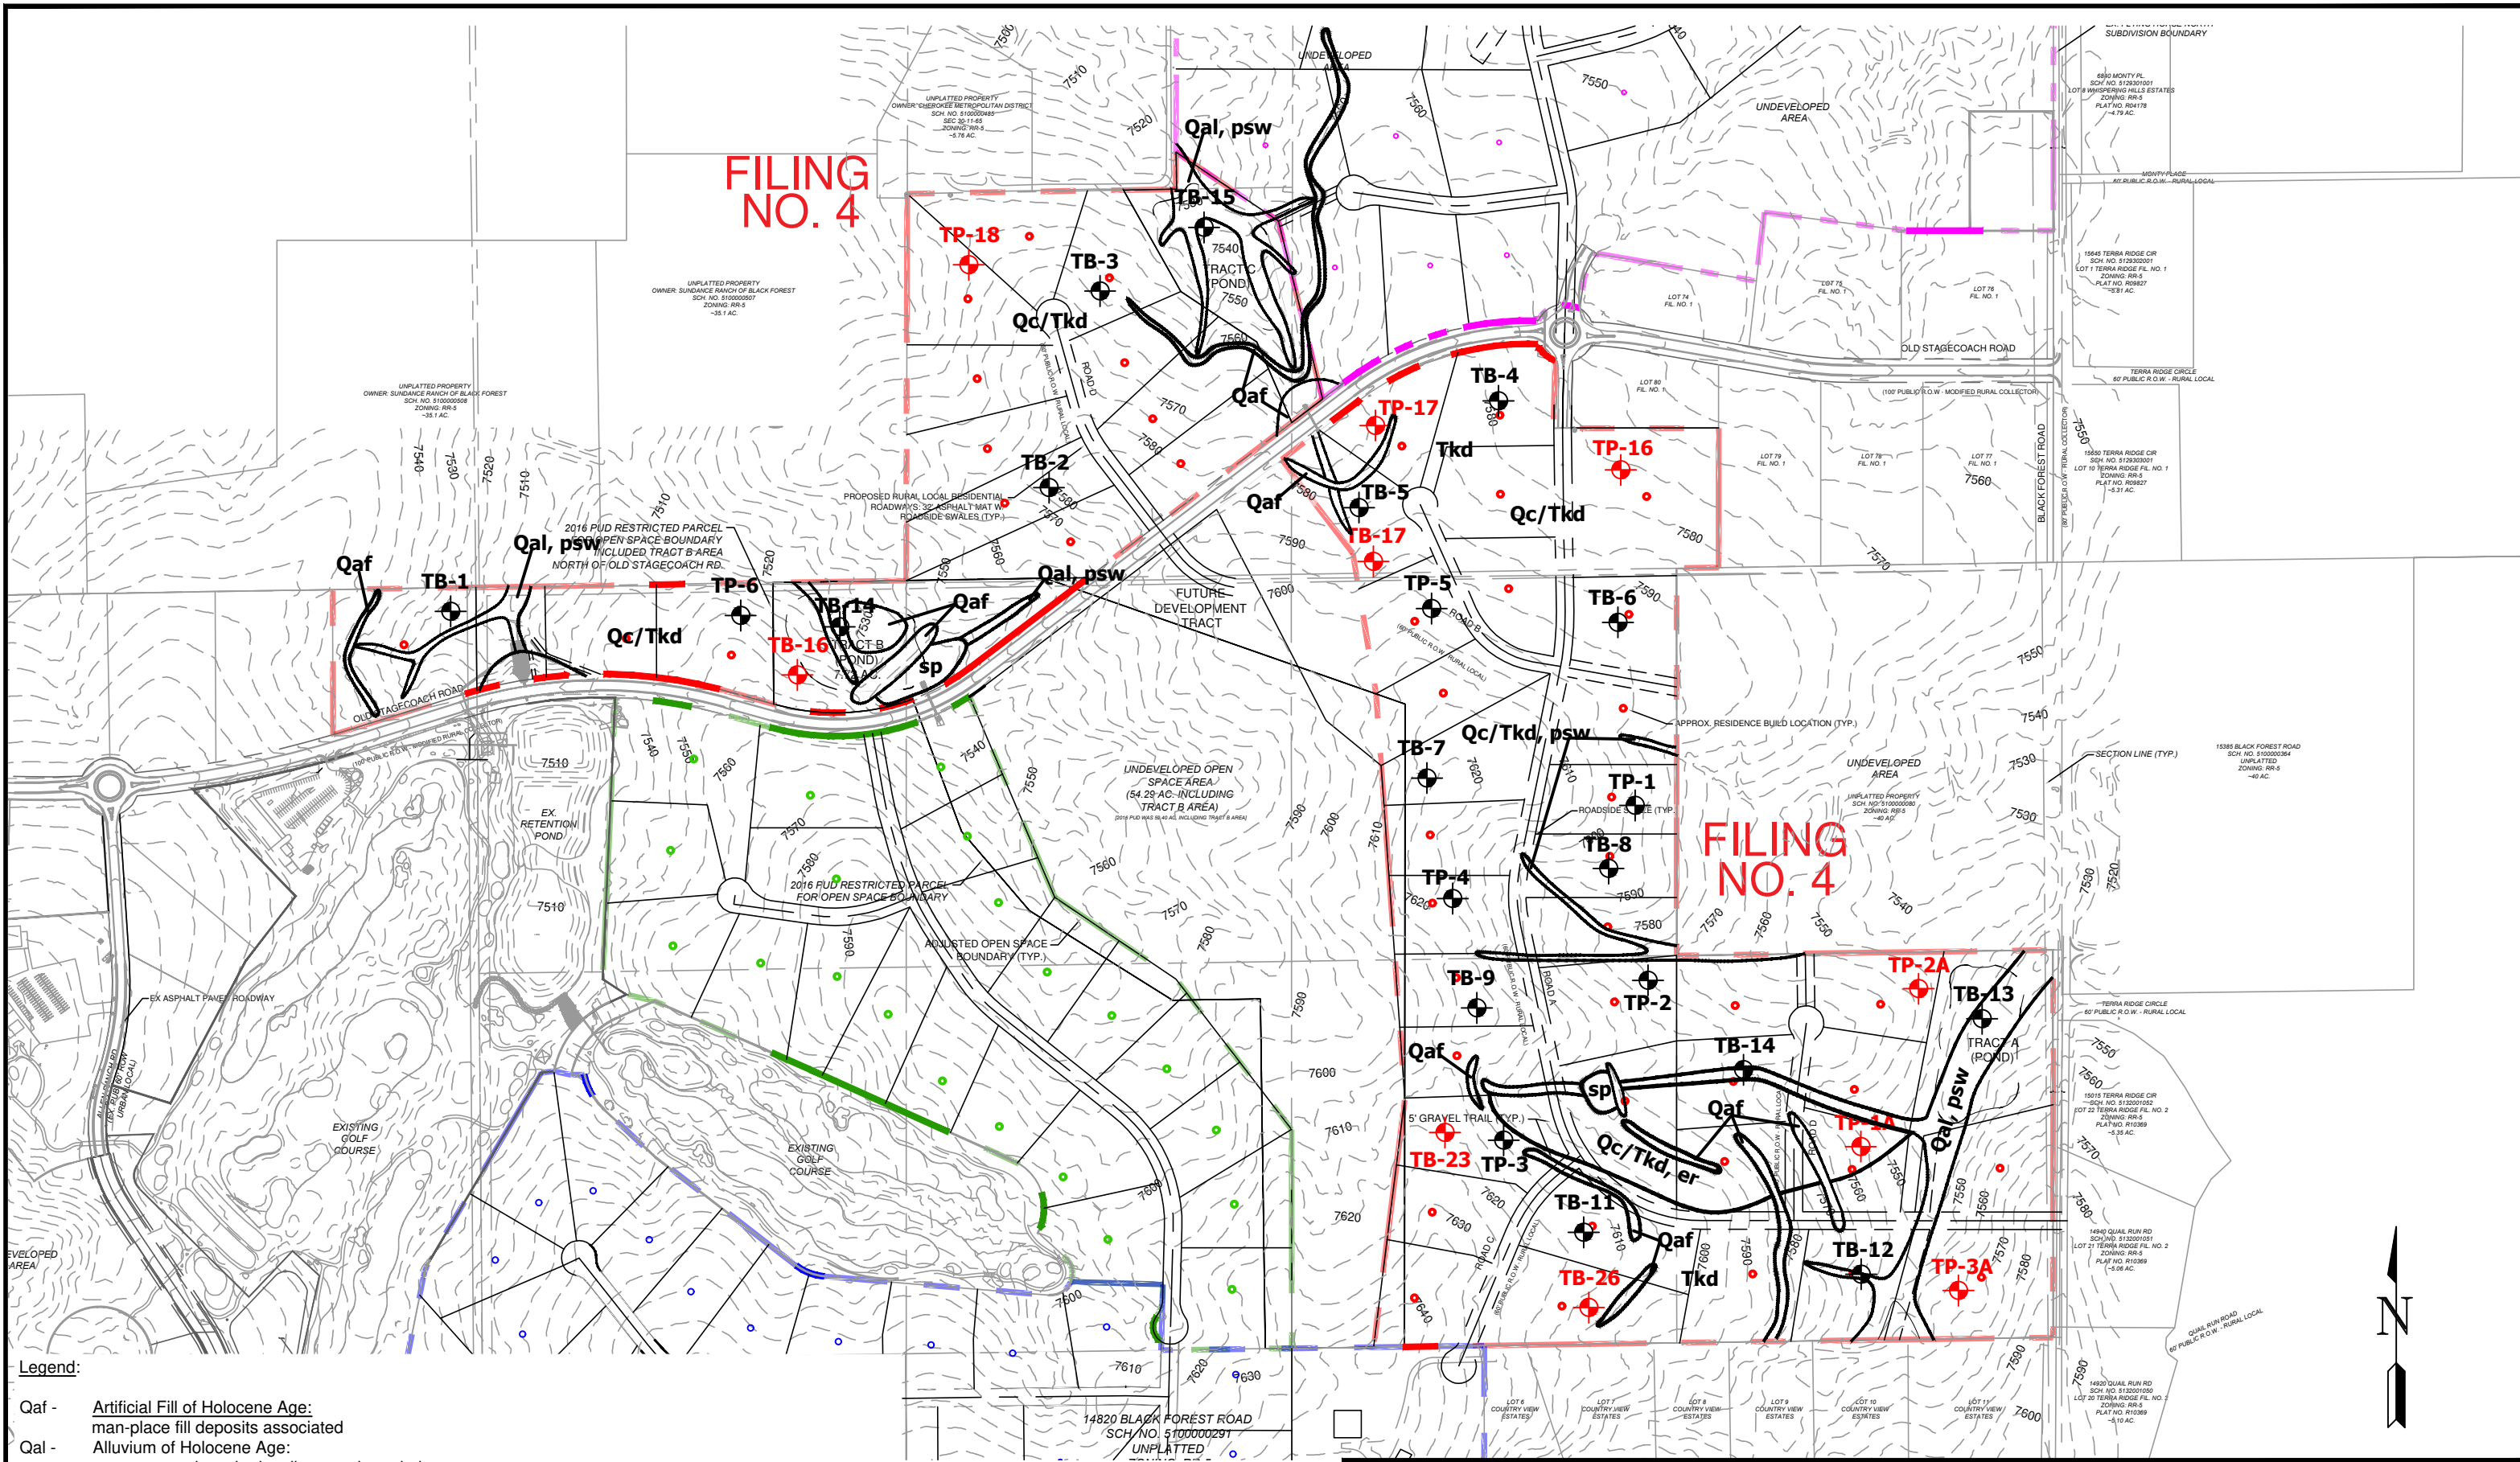
JOB NO.
241144
FIG. 6

Detailed mapping has been performed on this site to produce an Engineering Geology Map Figure 6. This map shows the location of various geologic conditions of which the developers should be cognizant during the planning, design and construction stages of the project. These hazards and the recommended mitigation techniques are as follows:

The seasonally shallow groundwater and potentially seasonal shallow groundwater areas located on the site are shown on the Geology/Engineering Geology Map, Figure 7. Portions of these areas mapped with these hazards have been identified in the National Wetland Inventory as Freshwater Emergent Wetland habitats classified as PEM1C (Palustrine – P, Emergent – EM, Persistent – 1, Seasonally Flooded – C), and Freshwater Pond habitat classified as PUSCh (Palustrine – P, Emergent – US, Seasonally Flooded – C, Diked/Impounded – H), (Figure 8, Reference 12).

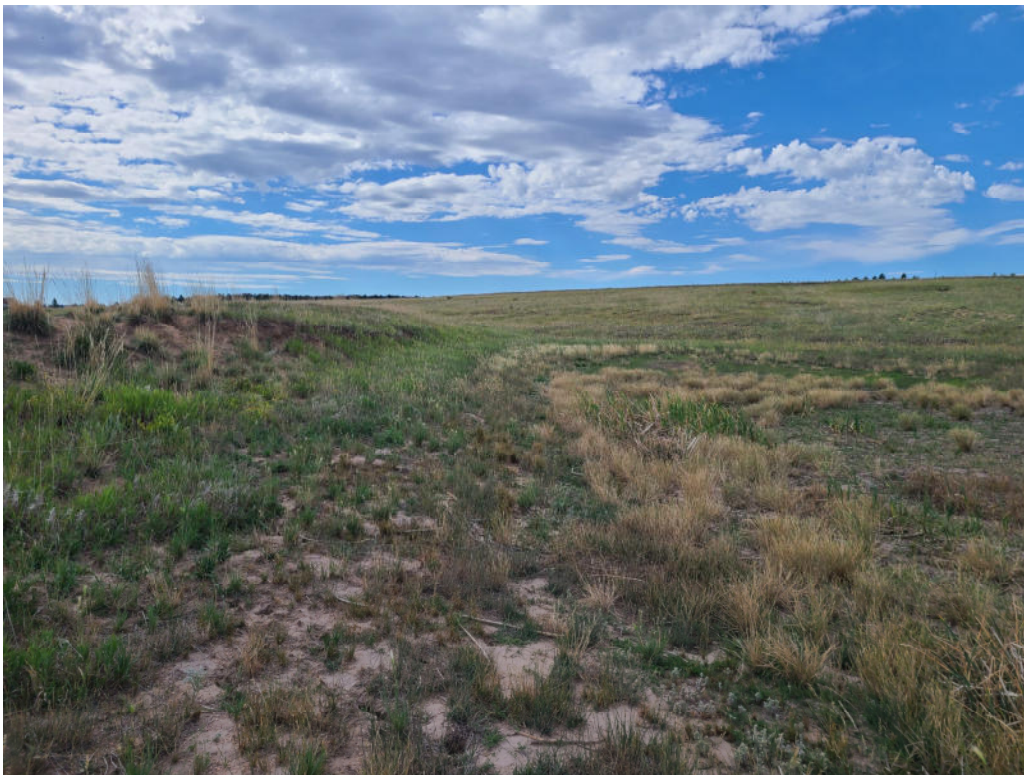
Looking southwest along existing earthen dam and pond in the southern portion of the site.
