**SOIL, GEOLOGY, GEOLOGIC HAZARD,  
AND WASTEWATER STUDY,  
JUDGE ORR ROAD RV PARK AND STORAGE  
14010 JUDGE ORR ROAD  
PARCEL NO. 42330-00-027  
EL PASO COUNTY, COLORADO**

December 12, 2016

Entech Job No. 160533  
AAprojects/2016/160533 countysoil/geo/ww

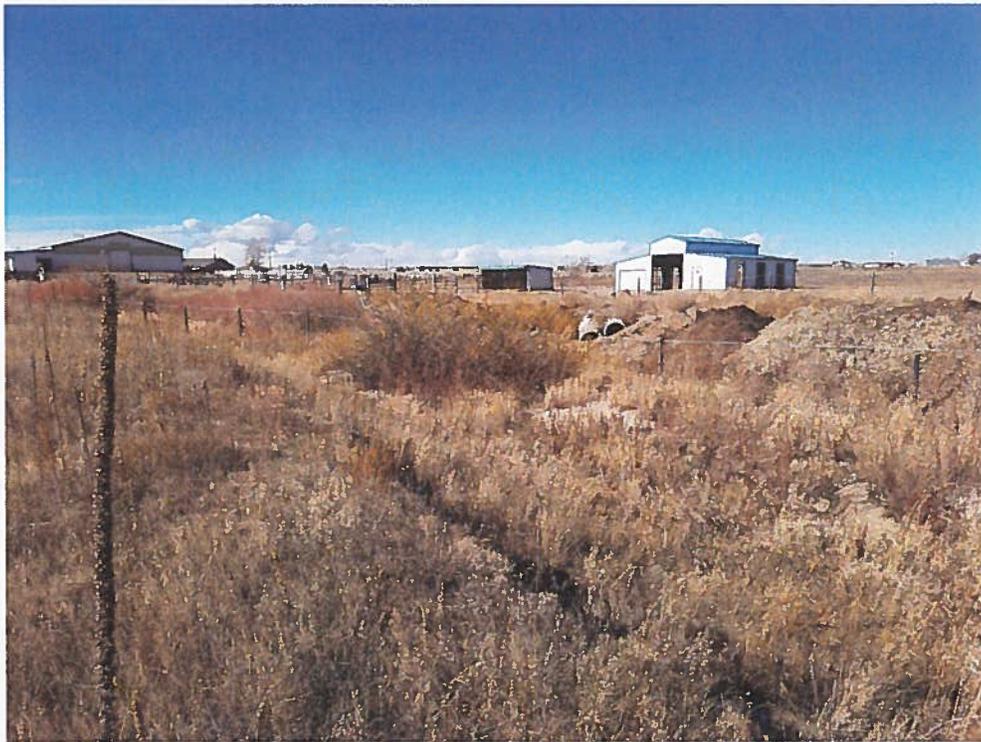
**Flood zone and drainage northeast corner of the property.**

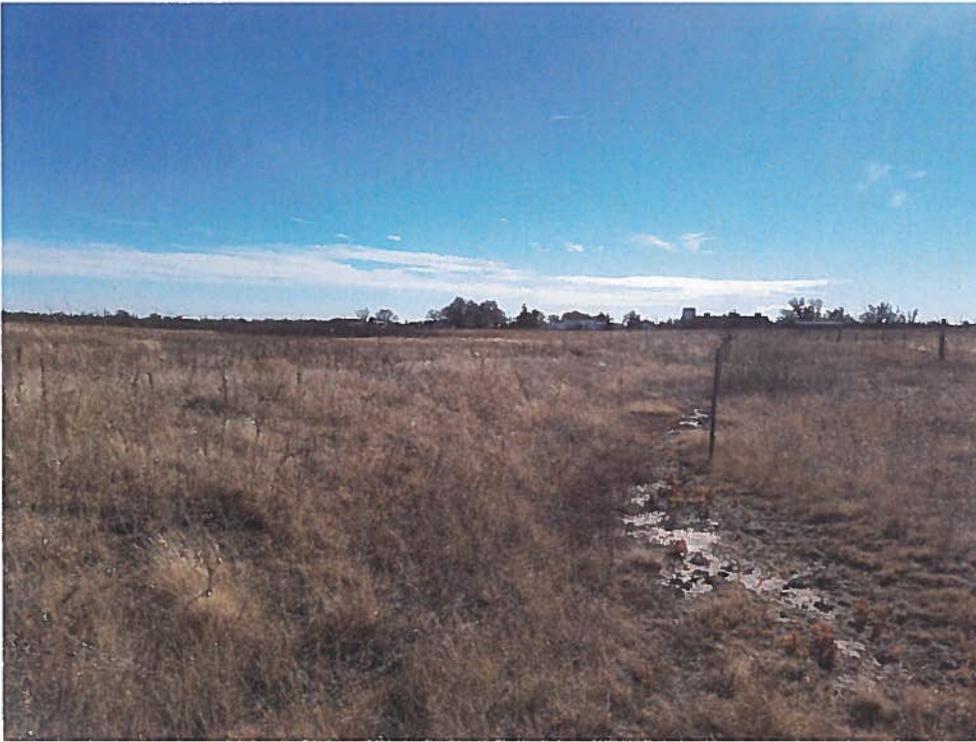
**Looking south along  
the berm and drainage  
from the northwest  
corner of the property.**

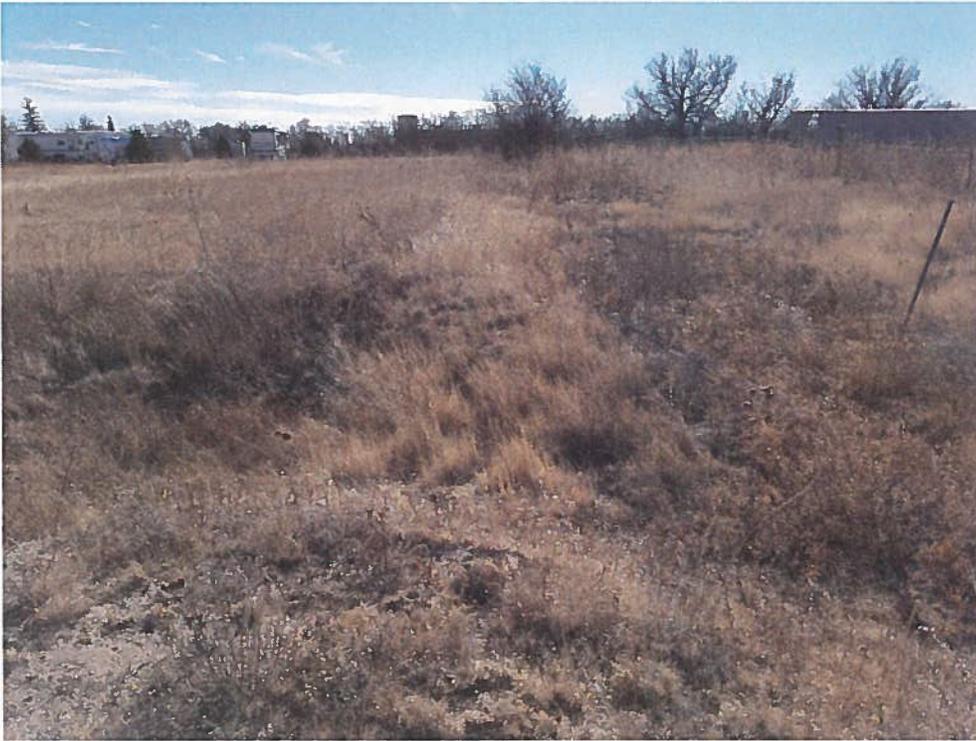
**Looking south along  
berm and drainage on  
the west side of the  
property.**

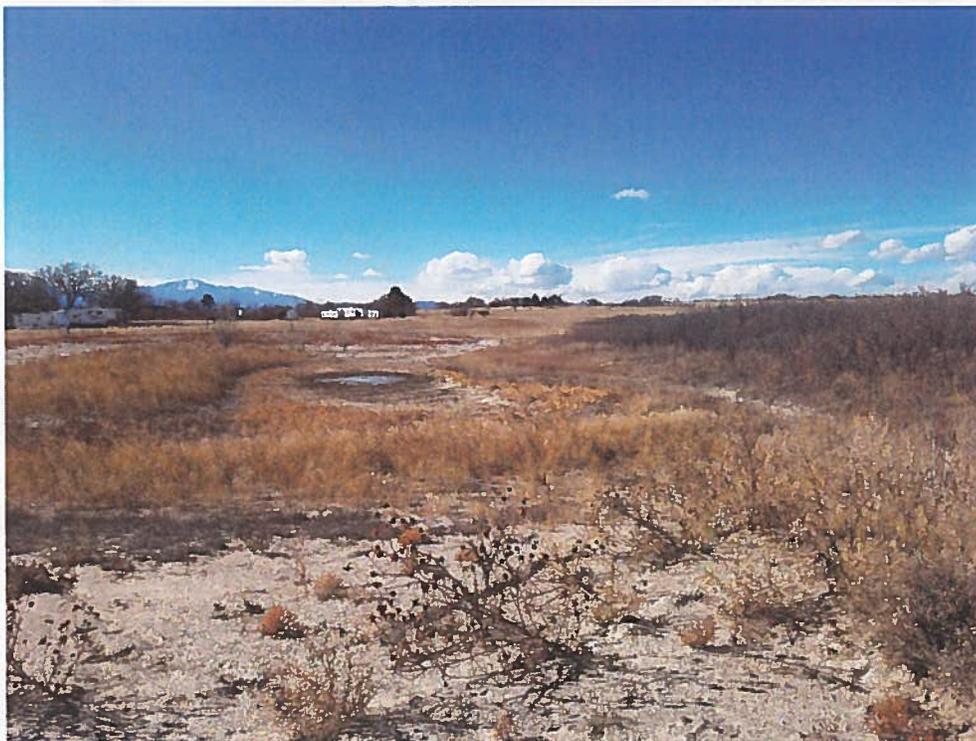
**Looking west from the  
dam towards the pond.**

Areas of Pondered Water: This the area where water is ponded behind earthen dam on-site. This area will likely be removed during site grading. Should construction be considered in these areas, regrading will be necessary in order to fill the area above the groundwater level. All soft or organic soils should be removed prior to filling. The same mitigation techniques for seasonally high groundwater areas are recommended for these ponded areas as well.
