**SOIL, GEOLOGY, GEOLOGIC HAZARD,
AND WASTEWATER STUDY,
JUDGE ORR ROAD RV PARK AND STORAGE
14010 JUDGE ORR ROAD
PARCEL NO. 42330-00-027
EL PASO COUNTY, COLORADO**

December 12, 2016

Entech Job No. 160533
AAprojects/2016/160533 countysoil/geo/ww

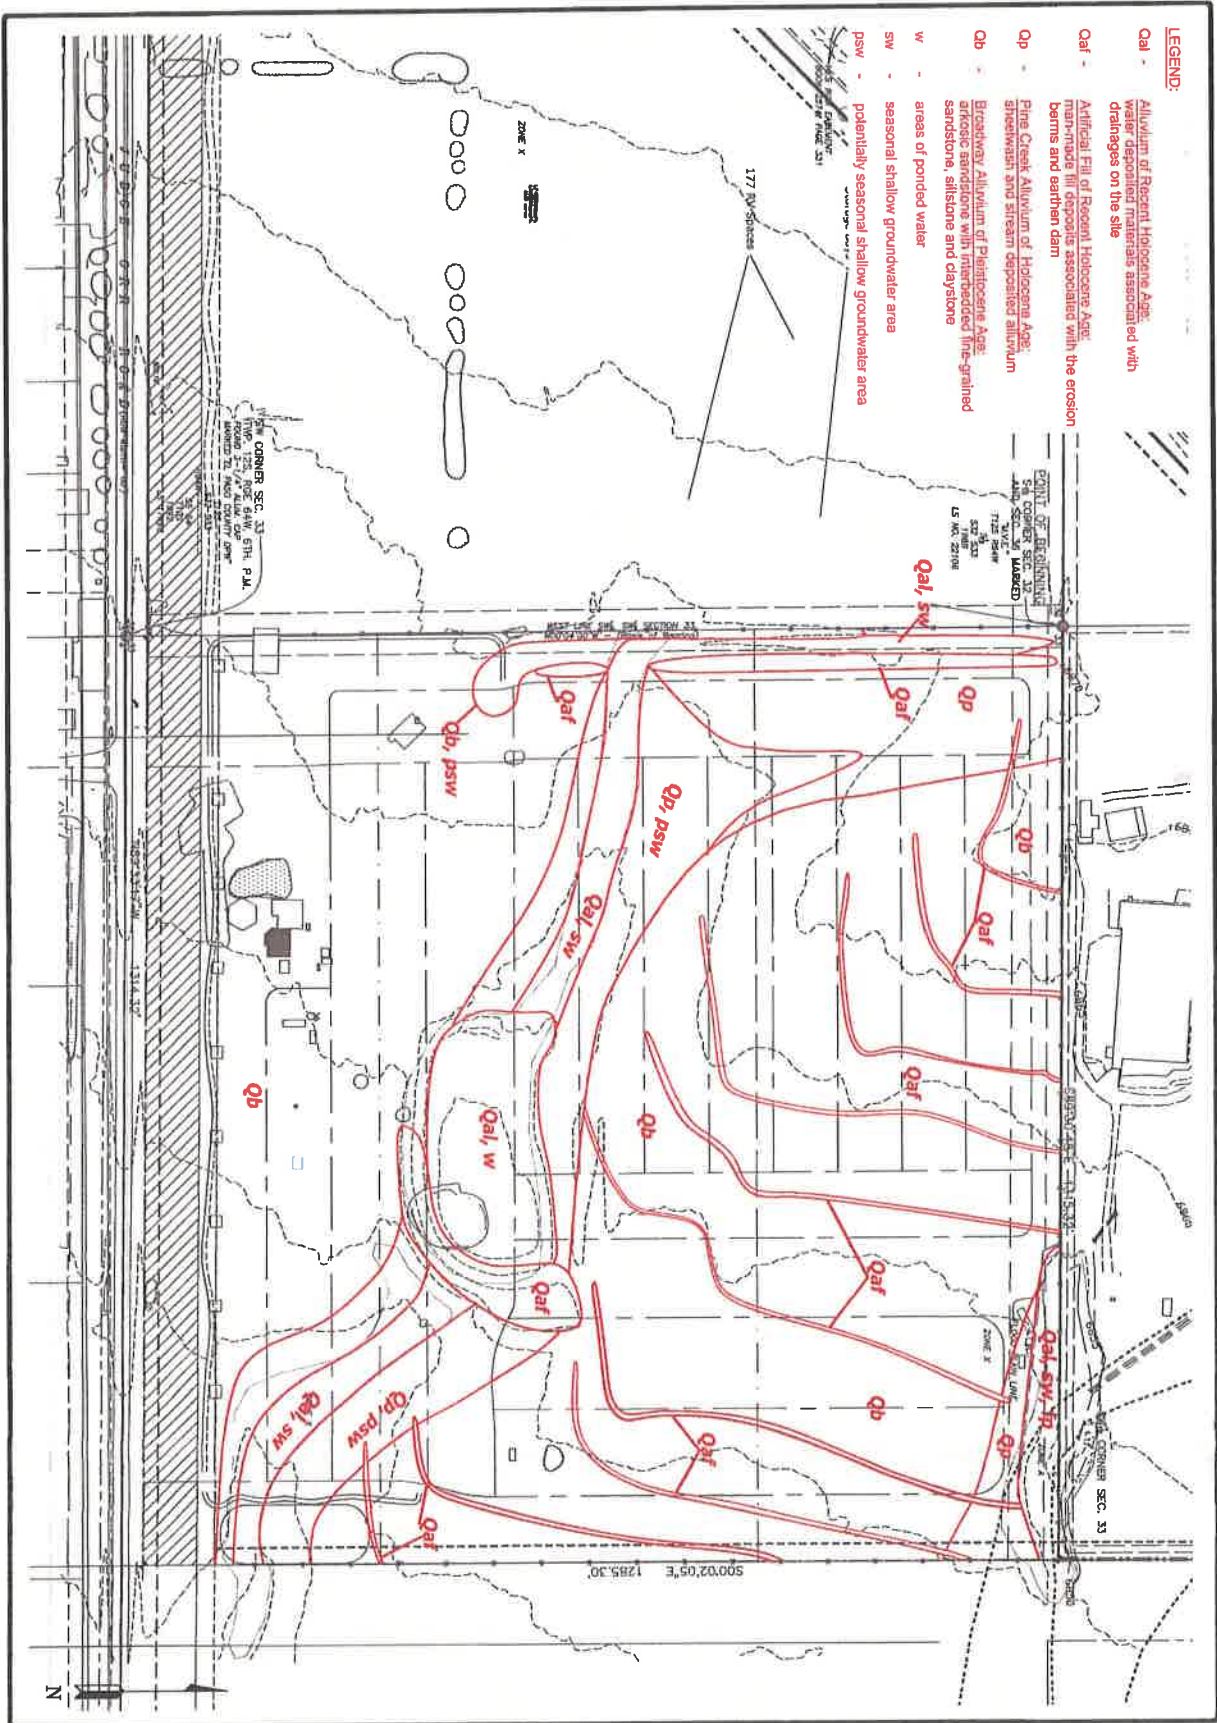
As mentioned previously, detailed mapping has been performed on this site to produce an Engineering Geology Map (Figure 6). This map shows the location of various geologic conditions of which the developers should be cognizant during the planning, design and construction stages of the project. These hazards and the recommended mitigation techniques are as follows:

Areas within the drainages on-site have been identified as areas of seasonally high groundwater areas, potentially seasonally high groundwater areas and floodplains. Additionally, areas of ponded water also exist on-site. Water was not flowing in the any of the drainages at the time of this investigation. The drainage located in the northeast corner of the property has been mapped as a floodplain zone according to the FEMA Map No. 08041CO575F Figure 7 (Reference 7). These areas are discussed as follows:

Mitigation: Due to the proposed use as RV Storage and camp sites the regrading will mitigate these areas. Foundations if installed in these areas are subject to severe frost heave potential should penetrate sufficient depth so as to discourage the formation of ice lenses beneath foundations. At this location and elevation, a foundation depth for frost protection of 30-inch is recommended. In areas where high subsurface moisture conditions are anticipated periodically, a subsurface perimeter drain will be necessary to help prevent the intrusion of water into areas located below grade. A typical perimeter drain detail is presented in Figure 8. Additionally, swales should be created to intercept surface runoff and carry it safely around and away from structures. It is anticipated that the site grading may mitigate the drainages on the property. The water table may be of sufficient depth to minimize the effects on buildings in some areas.

Mitigation: In areas where development is planned, overlot grading will mitigate the drainages. All organic material, soft or wet soils should be removed prior to any filling. The same mitigation recommendations for potentially high groundwater areas as discussed previously should be followed in these areas of seasonally high groundwater. In some areas, it may be necessary to dewater the excavation. Any grading should be done in a manner that directs surface flow around construction to avoid areas of ponded water. Structures should not block drainages, but swales should be created to intercept surfacerunoff and carry it safely around and away from structures. Additional investigation will be necessary to determine the water depth and its affect on development. Other areas than those mapped could encounter groundwater that could affect shallow foundations on-site.

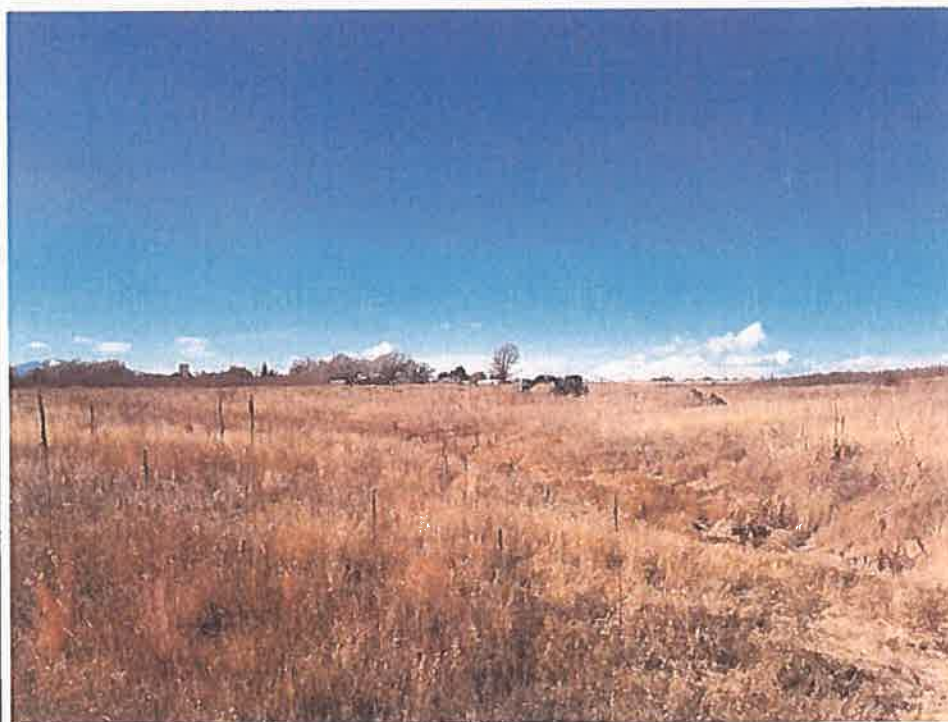
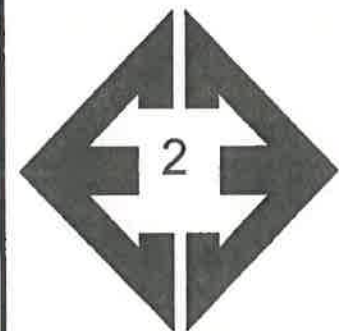
**Looking west towards
proposed OWTS area
along drainage.**

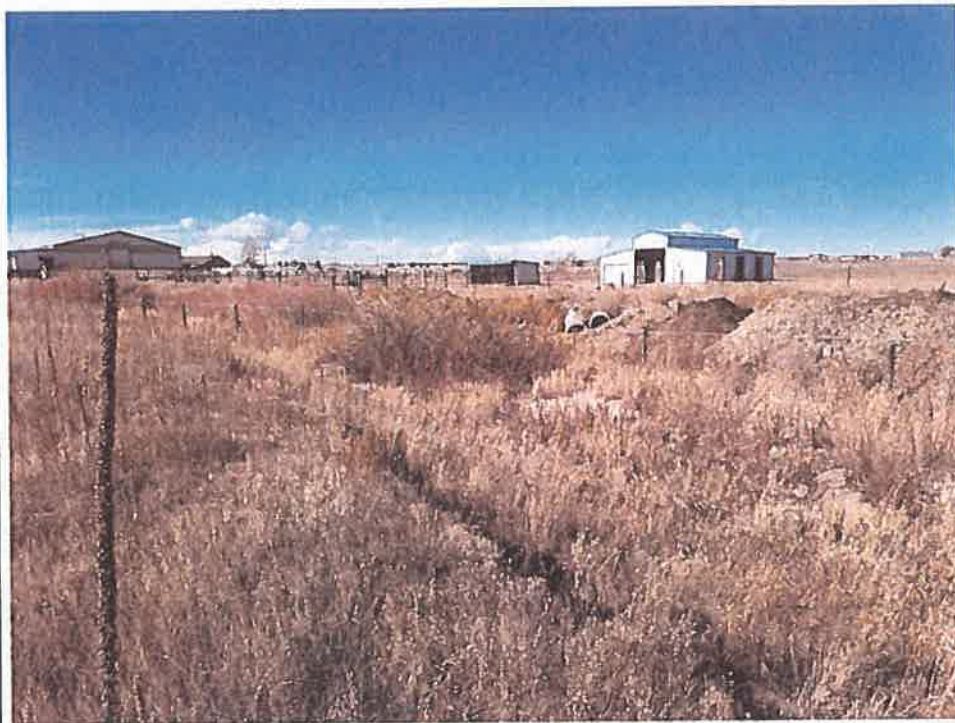
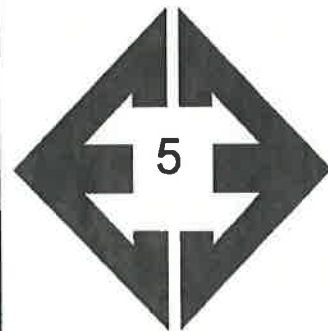
Floodplain: It is anticipated that the proposed improvements will not be within the floodplain zone at the northeast corner of the site. Development within the floodplain would require approval of the Drainage Plan prior to construction. Building areas within the floodplain will require filling to raise the building area above floodplain and seasonally high groundwater levels. Mitigation for Seasonally High Groundwater levels discussed in the following sections is recommended for construction in the floodplain zone. Finished floor levels must

Flood zone and drainage northeast corner of the property.

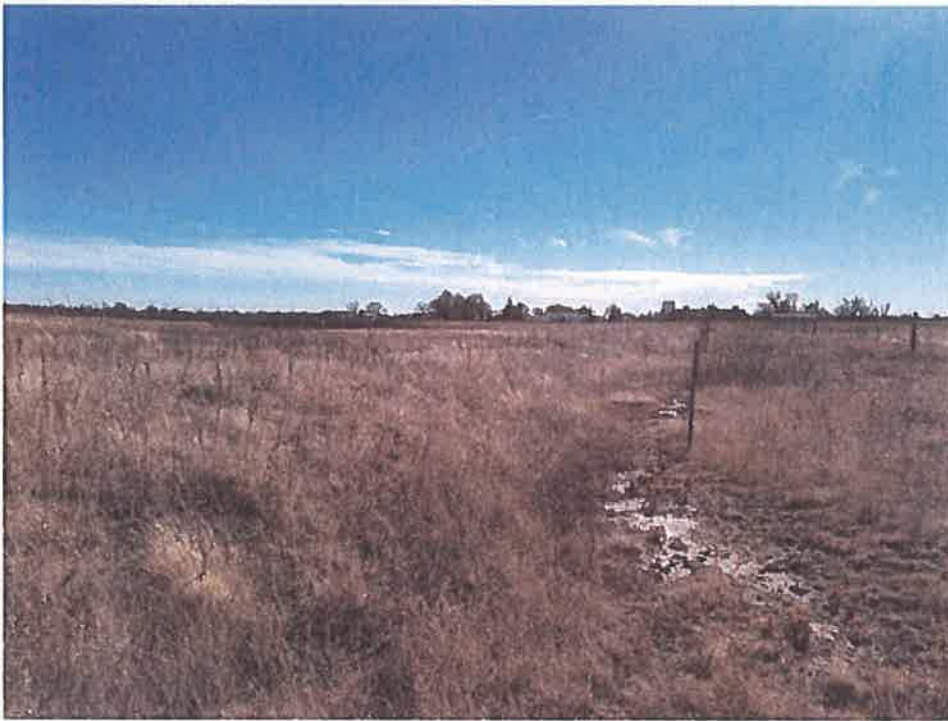
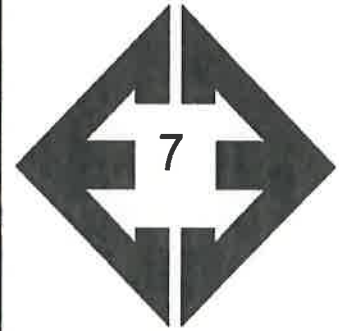
**Looking south along
the berm and drainage
from the northwest
corner of the property.**

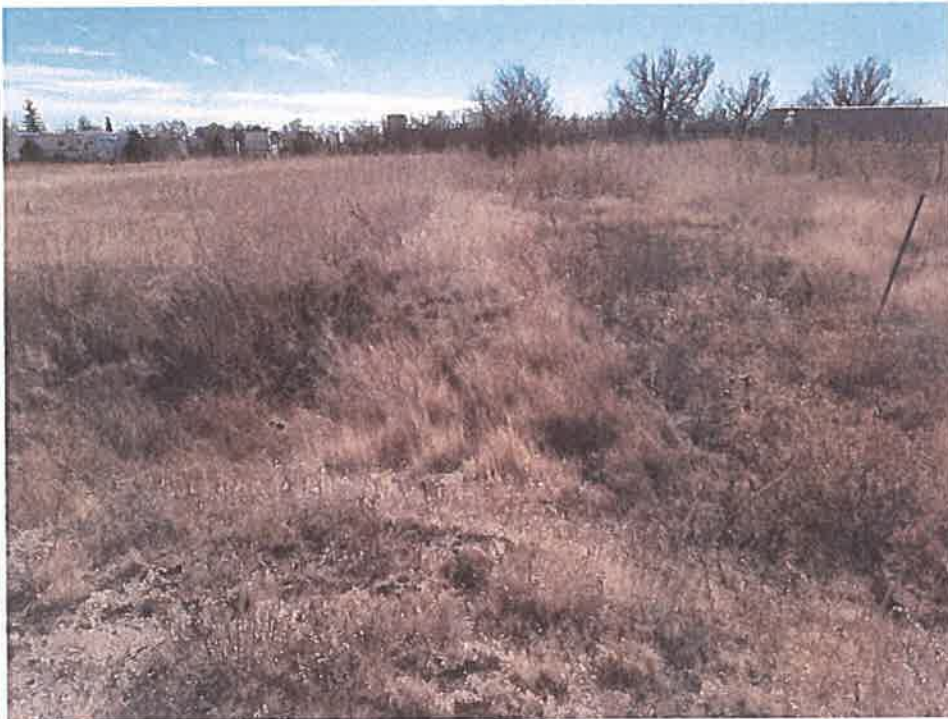
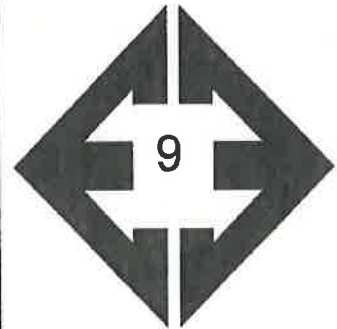
**Looking south along
berm and drainage on
the west side of the
property.**

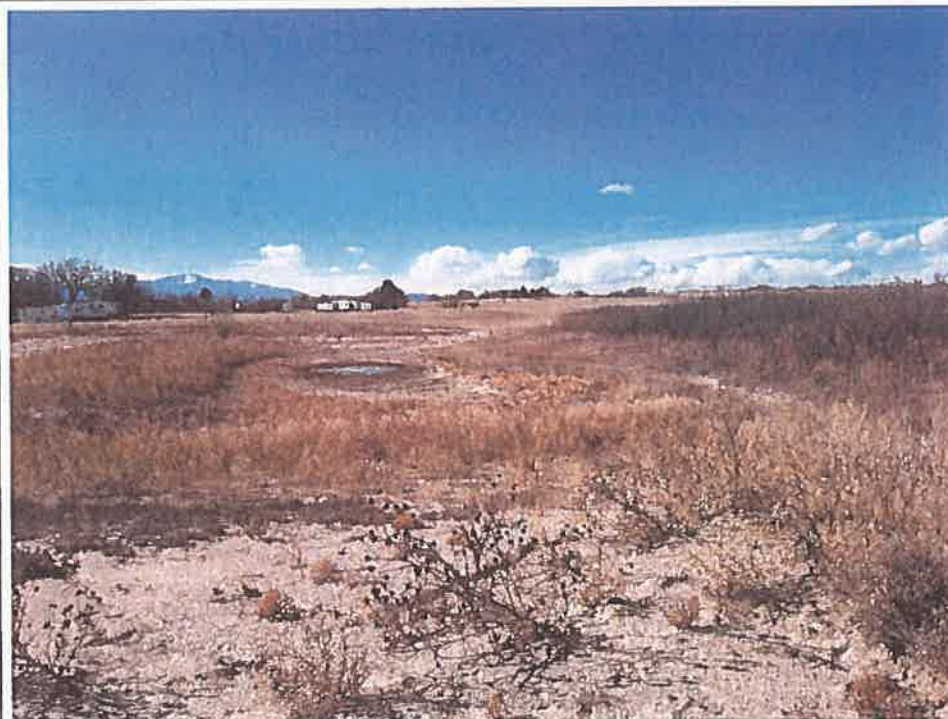
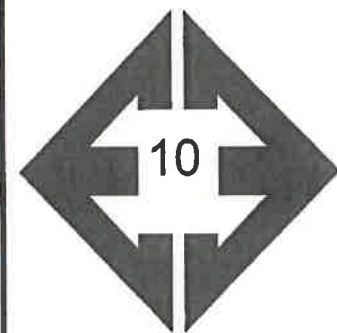
Areas of Pondered Water: This the area where water is ponded behind earthen dam on-site. This area will likely be removed during site grading. Should construction be considered in these areas, regrading will be necessary in order to fill the area above the groundwater level. All soft or organic soils should be removed prior to filling. The same mitigation techniques for seasonally high groundwater areas are recommended for these ponded areas as well.

**Looking west from the
dam towards the pond.**

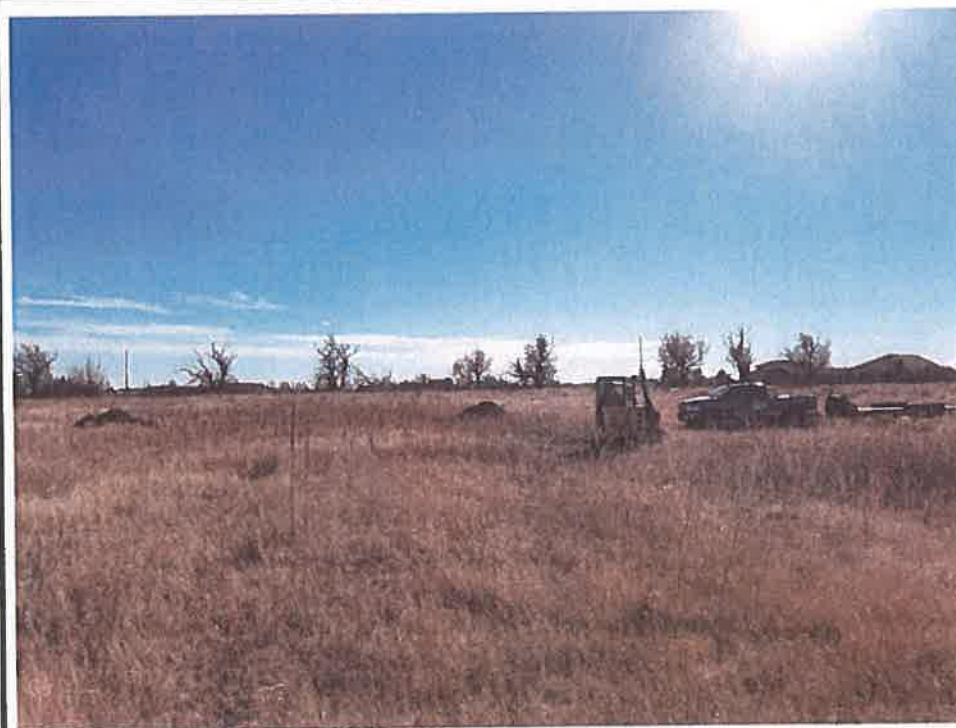
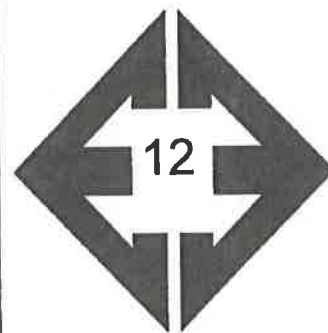
**Looking southeast
from the east side of
the dam towards the
proposed OWTS area.**
