**SOIL, GEOLOGY AND
GEOLOGIC HAZARD STUDY
BANNING LEWIS RANCH NORTH
EL PASO COUNTY, COLORADO**

Norwood Development
111 South Tejon Street, Suite 222
Colorado Springs, Colorado 80903

June 17, 2019

Entech Job No. 190723
AAProjects/2019/190723 soil ge

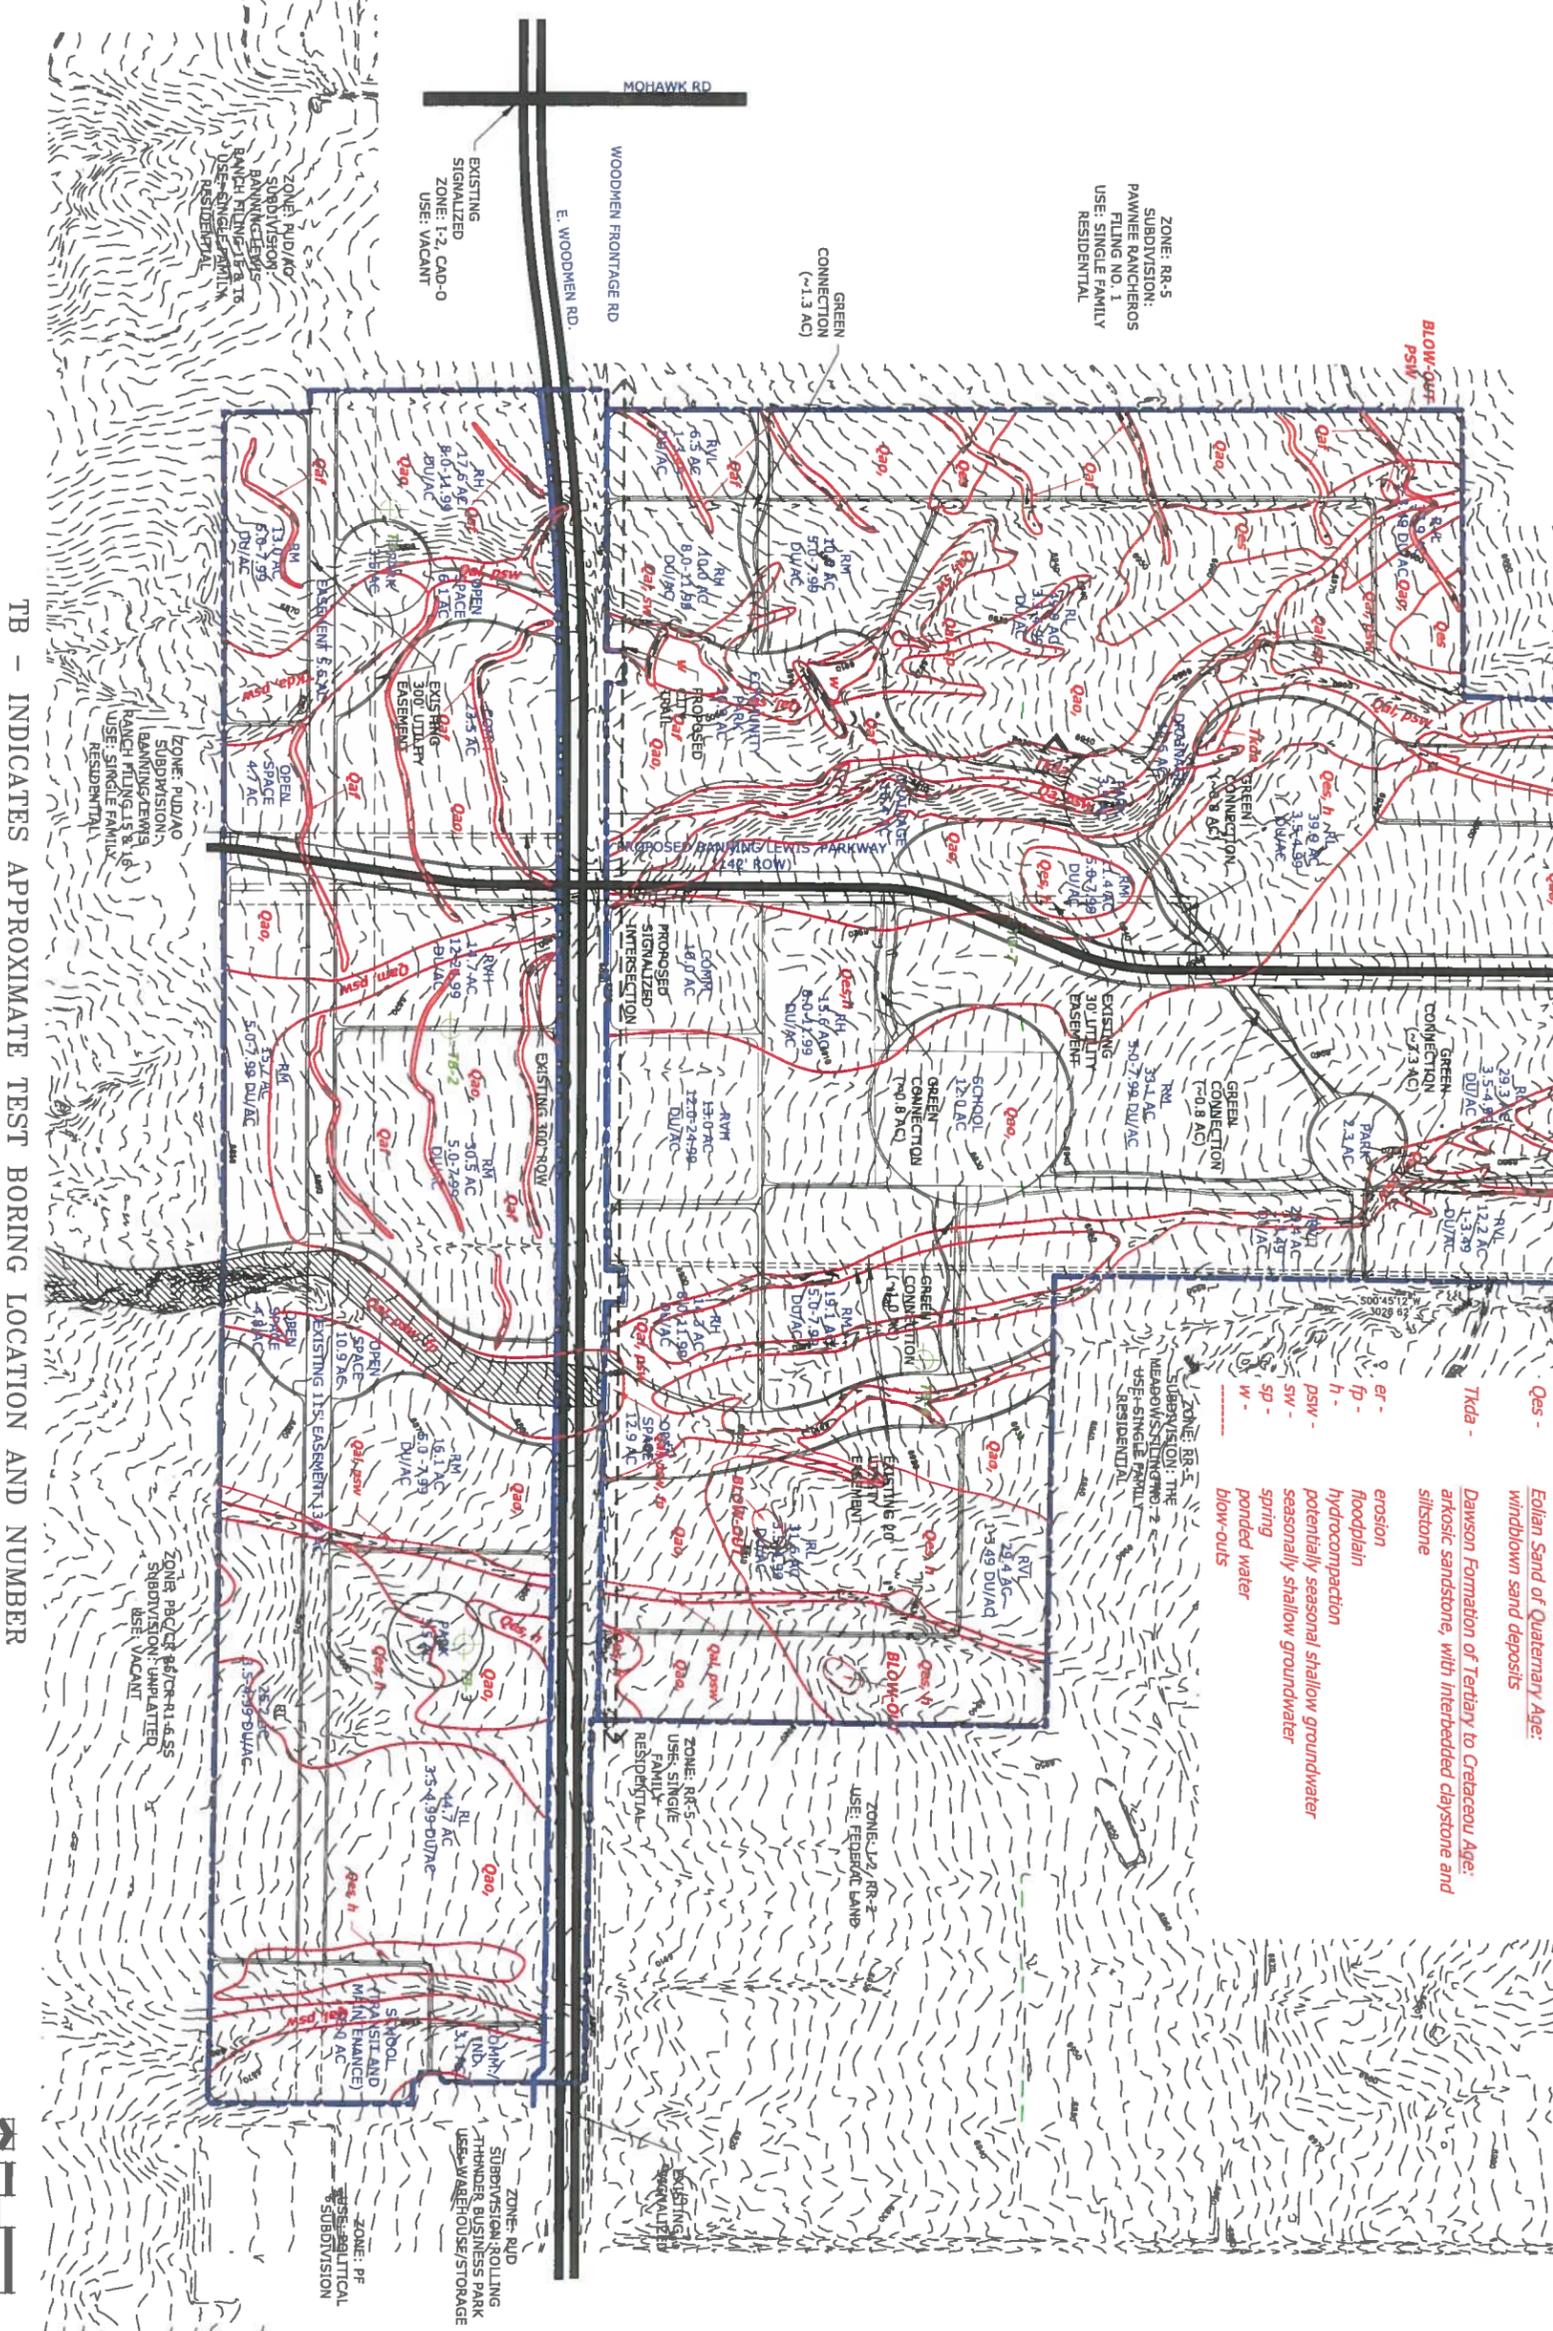
GEOLOGY/ENGINEERING GEOLOGY MAP
BANNING LEWIS RANCH NORTH
COLORADO SPRINGS, CO
FOR: NORWOOD DEVELOPMENT

As mentioned previously, detailed mapping has been performed on this site to produce an Engineering Geology Map (Figure 6). This map shows the location of various geologic conditions of which the developers and planners should be cognizant during the planning, design and construction stages of the project. The hazards identified on this site include hydrocompaction, loose soils, erosion, artificial fill, potentially expansive soils, seasonal and potentially seasonal shallow groundwater areas, springs, and areas of ponded water. The following hazards have been addressed as a part of this investigation:

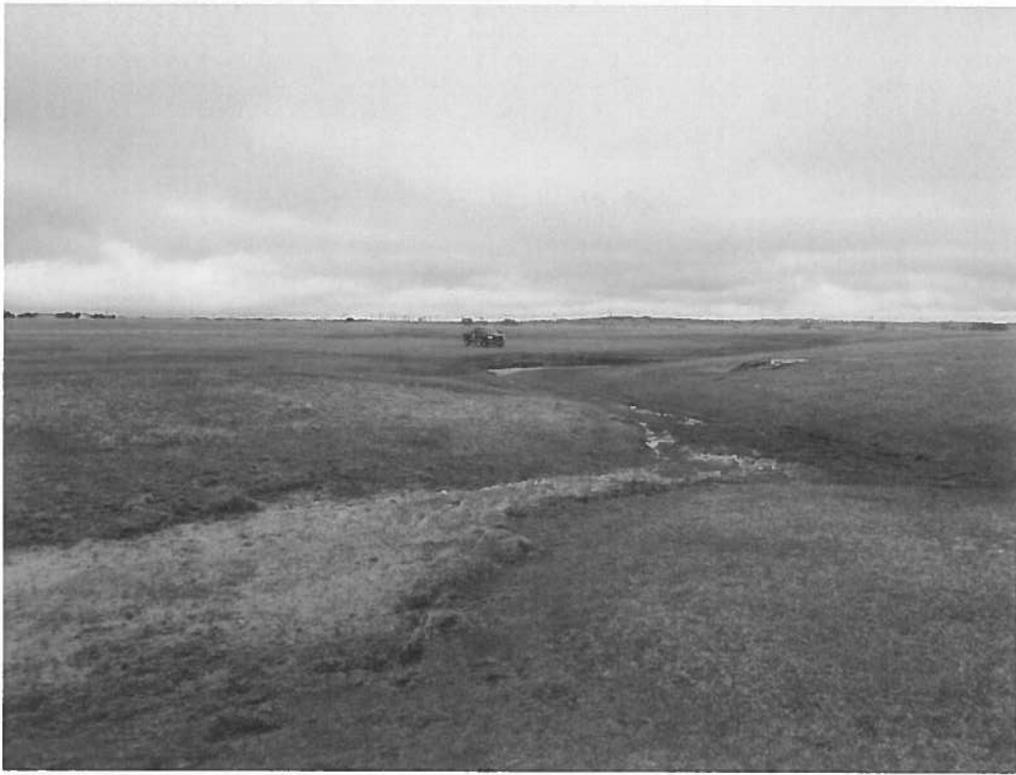
Looking at spring in the southeast from the northwest portion of the site.

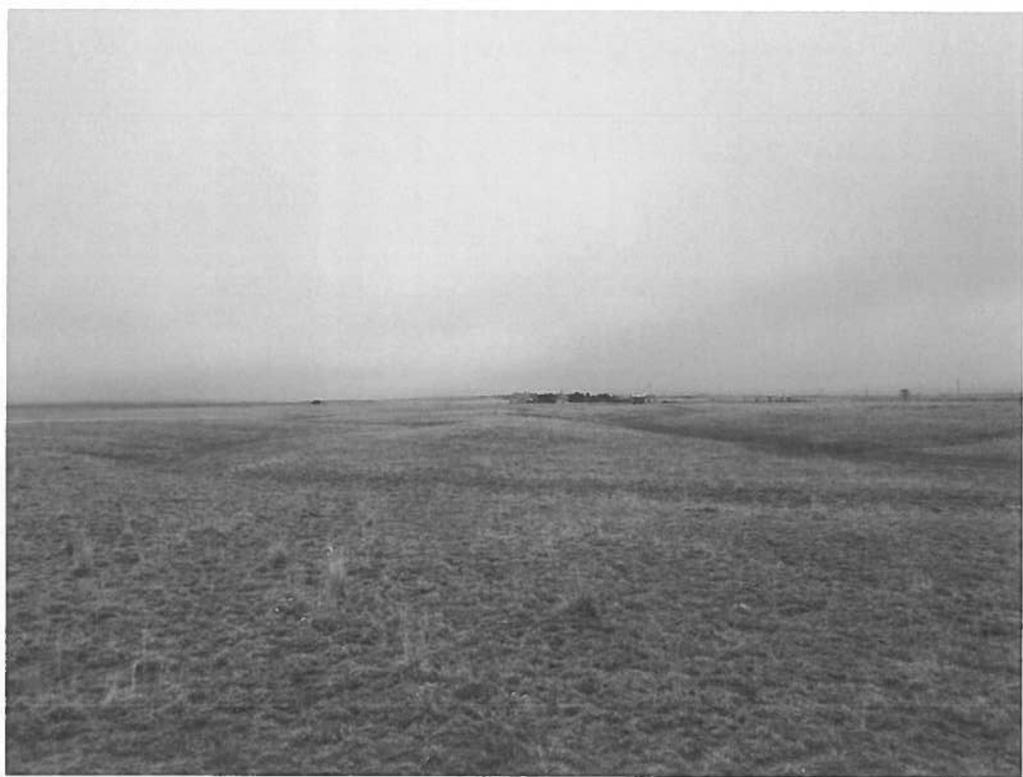
**Looking south along
drainage in north-
central portion of the
site.**

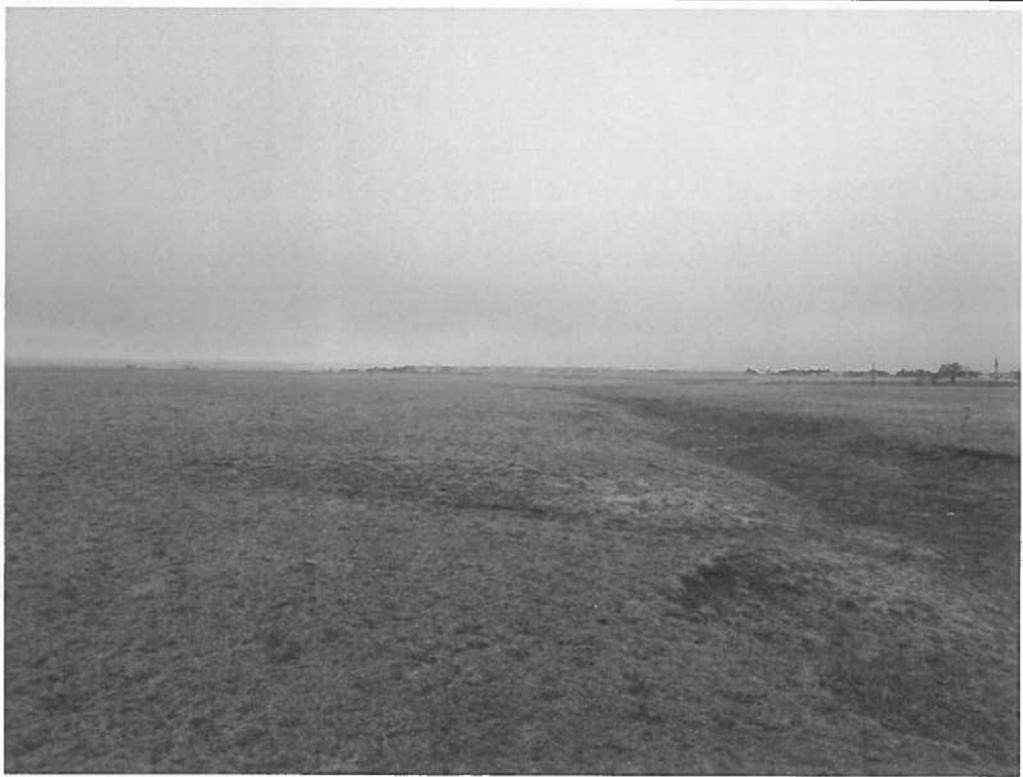
**Looking north along
drainage in the
northeastern portion of
the site.**

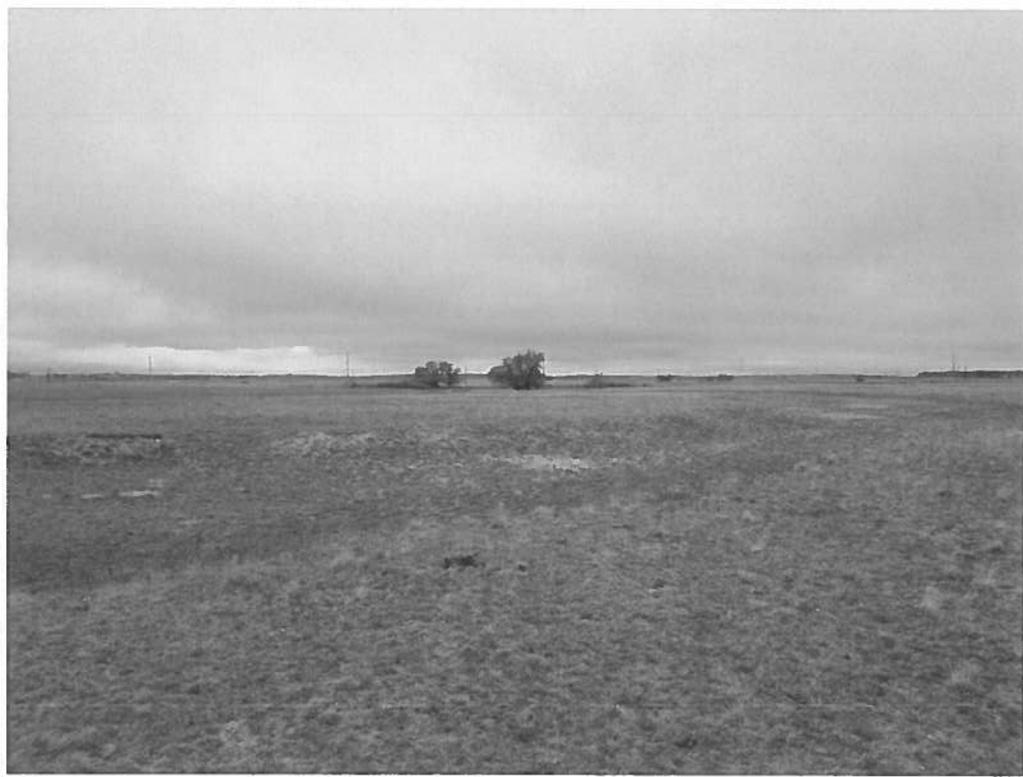
Looking south along drainage in the eastern portion of the site.

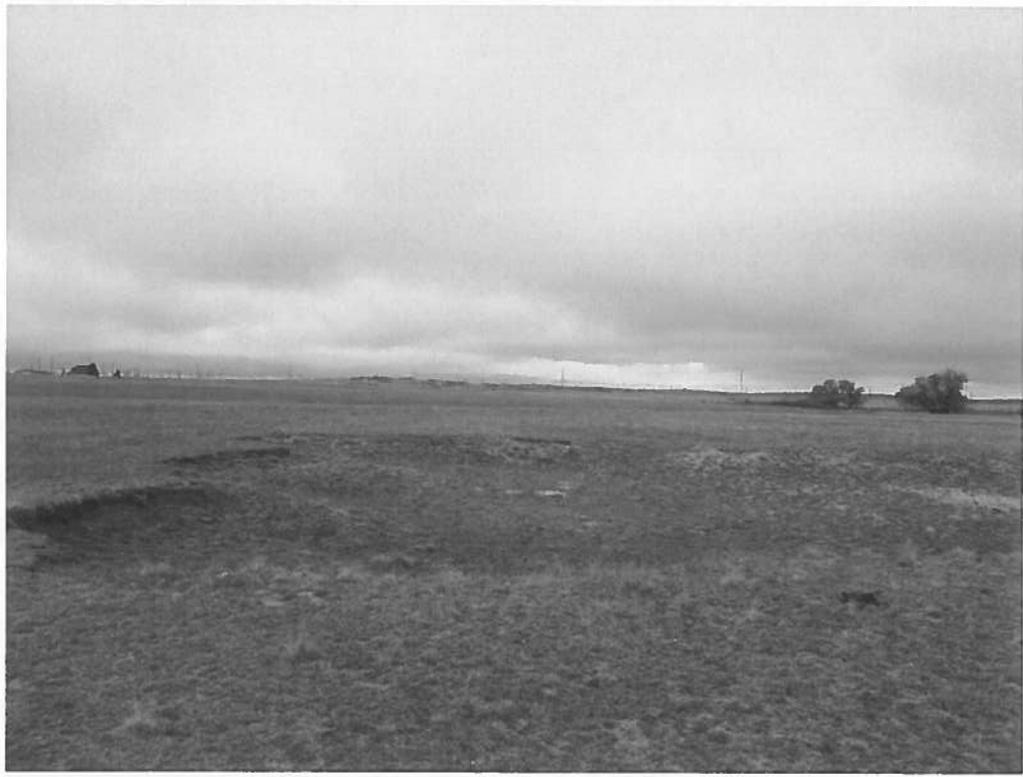
Looking southeast along drainage in the eastern portion of the site.
