GEOLOGIC HAZARD STUDY

**348 Spruce Rd
Site 145, Crystal Park
El Paso County, Colorado**

JOB NO. 196392

May 3, 2024

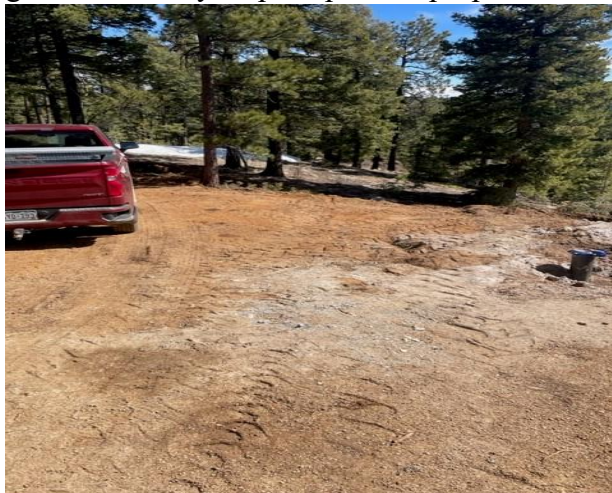
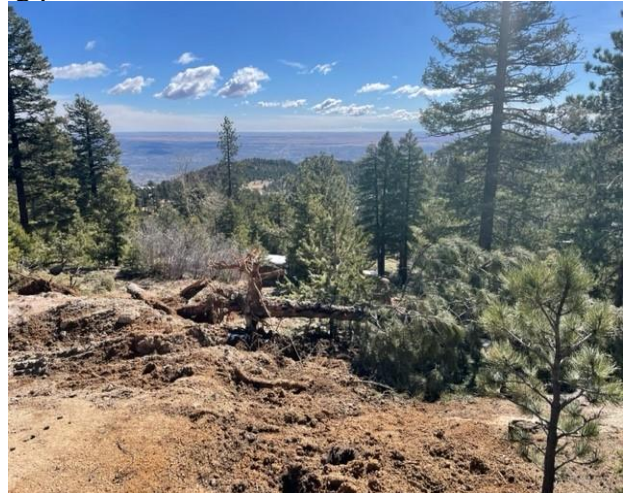
We performed a field reconnaissance on April 16, 2024. At the time of the field reconnaissance, the site consisted of vacant, undeveloped land that is near the top of the mountain, generally located about 3 miles from the gated entrance in the northeast portion of the Crystal Park subdivision. A gravel driveway slopes up to the proposed building pad.

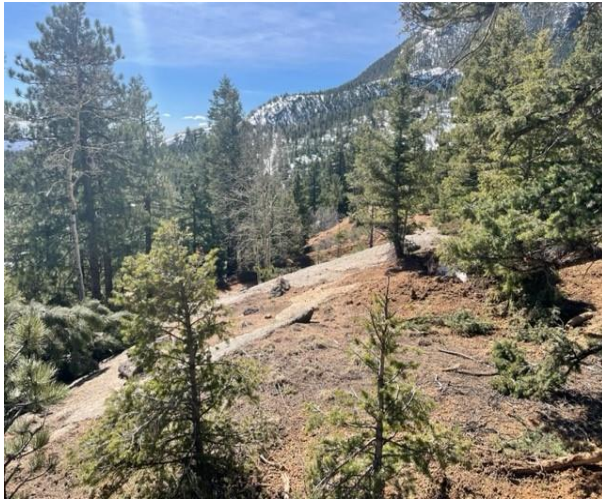
The ground surface within the proposed building and septic area had been cleared of vegetation. Surrounding the building and septic field pads, vegetation consisted of moderate- to high-growth coniferous trees, small rocks, boulders, native grasses and weeds. Topographically, the site resides atop a mountain which generally slopes down towards the east at approximately 30 percent. The site has generally good drainage in the form of surficial sheet flow directed to the east.

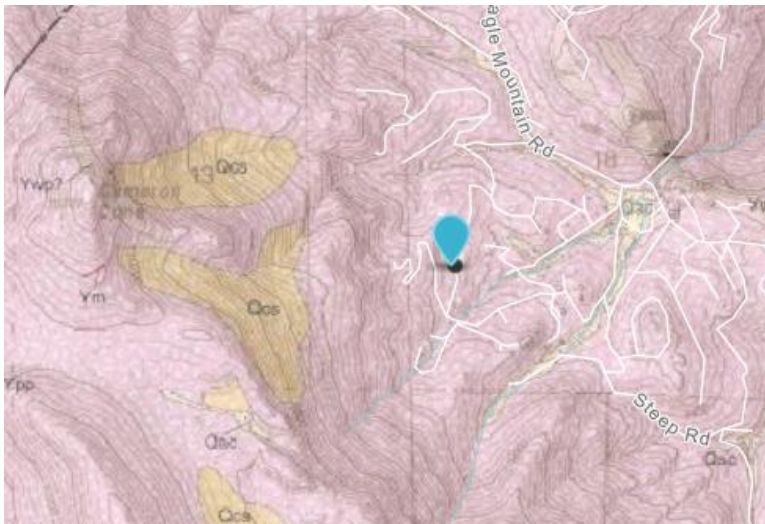
Based upon mapping presented by the Colorado Geological Survey (CGS) (¹Keller et al, 2003), the bedrock underlying the subject site is comprised of the Pikes Peak Granite (Middle Proterozoic) geologic map unit Ypp, as indicated by the salmon color below. The blue pin indicates the approximate site location.
