**SOIL, GEOLOGY, GEOLOGIC HAZARD,
AND WASTEWATER STUDY
PONY TRACKS SUBDIVISION FILING NO. 2
2030 OLD NORTH GATE ROAD
EL PASO COUNTY, COLORADO**

May 24, 2019

Entech Job No. 190448
AAprojects/2019/190448 countysoil/geo/ww.

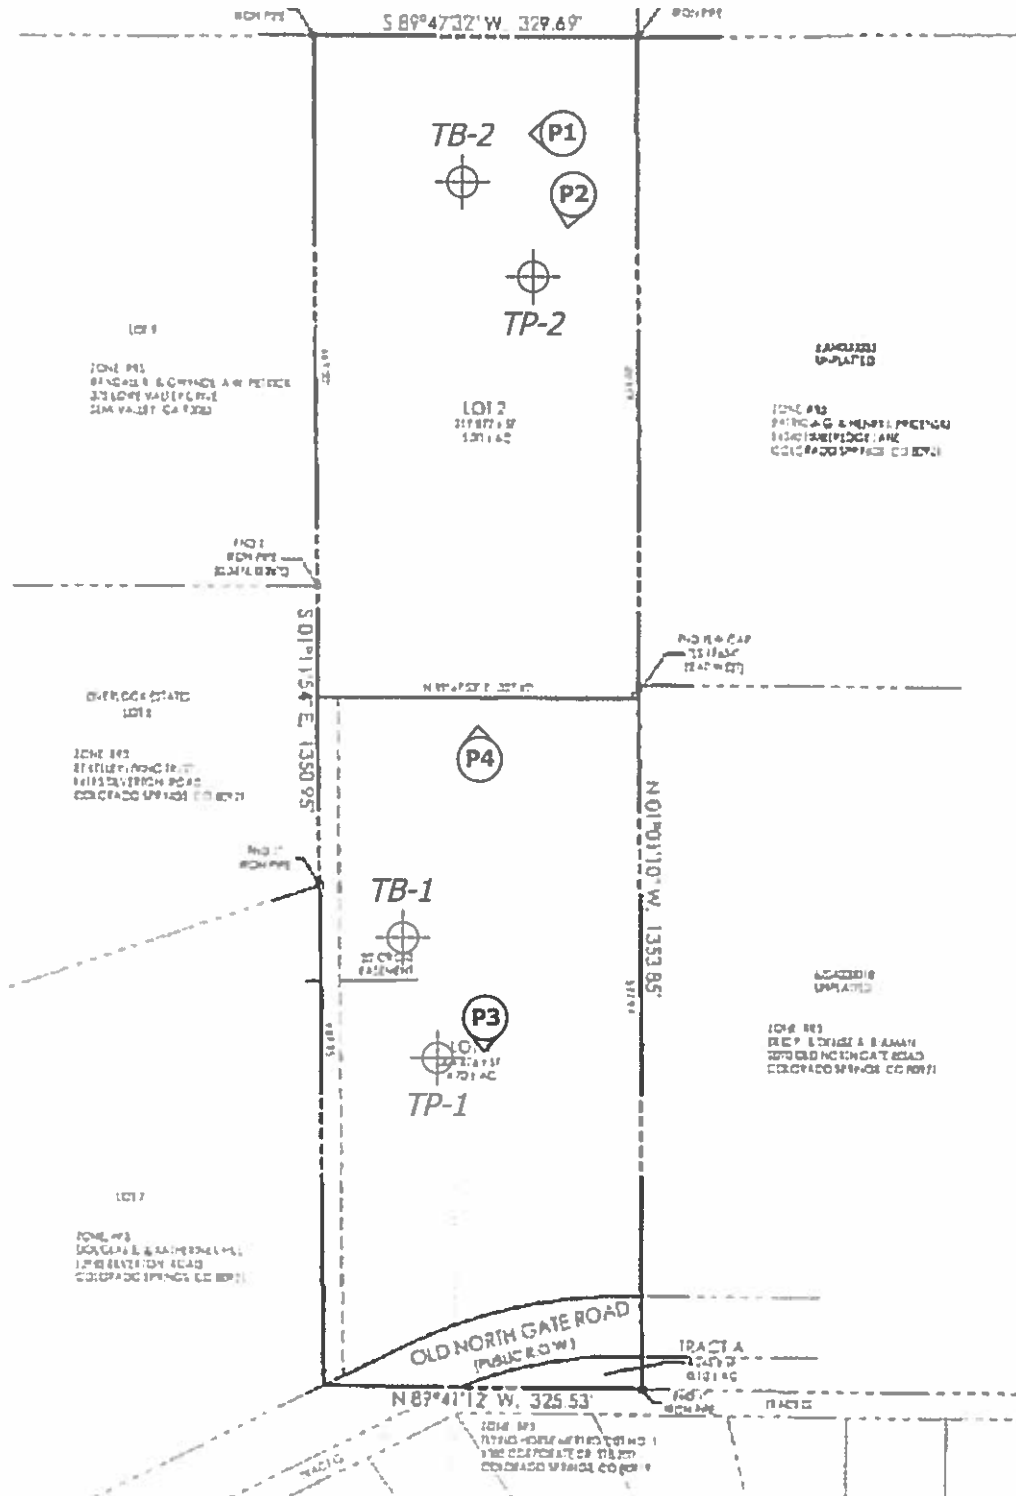
FIG NO.:
3

Two (2) Test Borings were drilled and two (2) Test Pits were excavated on the site to determine general soil information for development recommendations. The locations of the Test Borings and Test Pits are indicated on the Site Plan, Figure 3. The Test Pit Logs are presented in Appendix B. Results of this testing will be discussed later in this report.

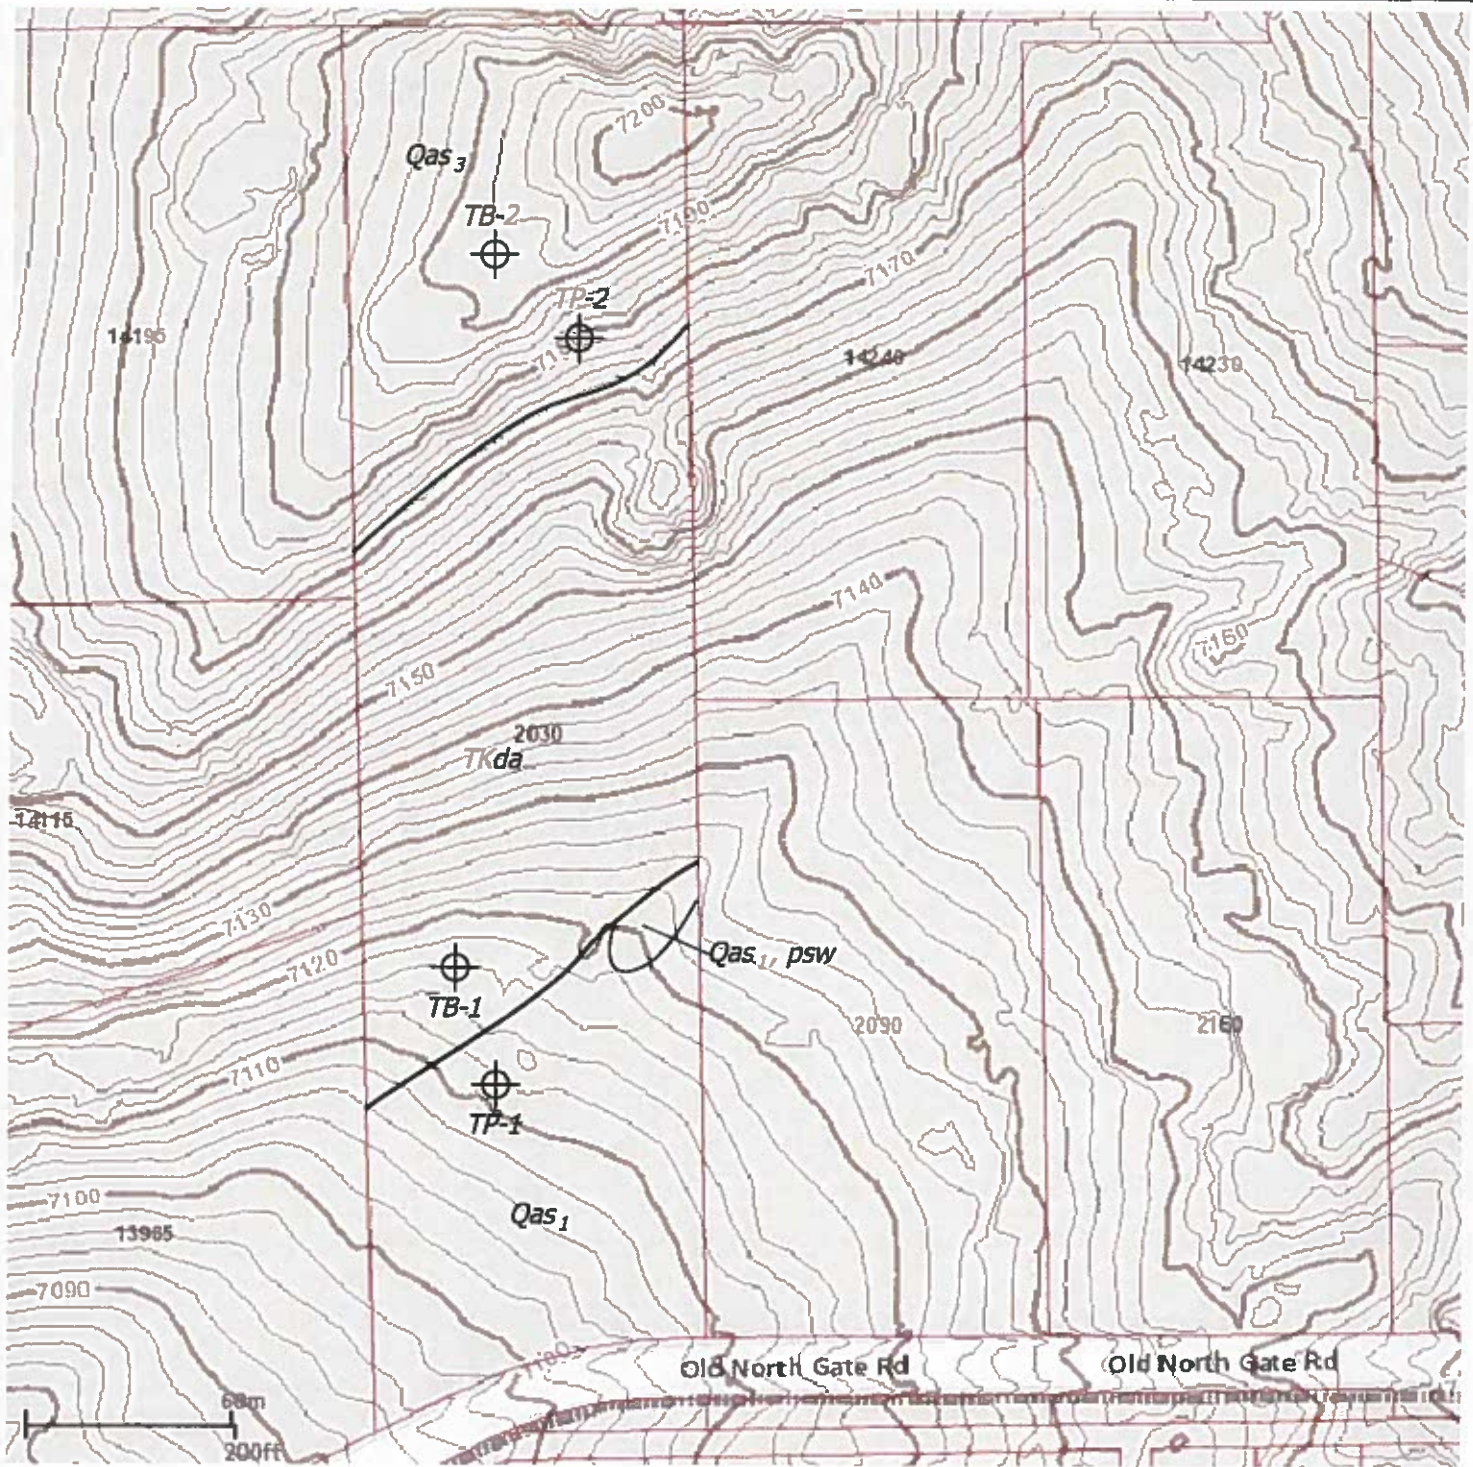
FIG NO.:
6

As mentioned previously, detailed mapping has been performed on this site to produce a Geology/Engineering Geology Map (Figure 6). This map shows the location of various geologic conditions of which the developers should be cognizant during the planning, design and construction stages of the project. These hazards and the recommended mitigation techniques are as follows:

The site is not mapped within any floodplains according to the FEMA Map No. 08041CO295G, dated December 7, 2018 (Figure 7, Reference 7). An area of potentially seasonal shallow groundwater associated with a low area was observed in the northeastern portion of Lot 1 on the site. In these areas, we would anticipate the potential for periodically high subsurface

An area of potentially seasonal shallow groundwater associated with a low area on Lot 1 was encountered on site. Water was not observed on the site. Due to the size of the lots and the proposed development, this area can be avoided by construction. Structures should not block drainages. Septic fields should not be located in these areas due to the potential for periodic high groundwater conditions.

Mitigation: Foundations must have a minimum 30-inch depth for frost protection. In areas where high subsurface moisture conditions are anticipated periodically, subsurface perimeter drains are recommended to help prevent the intrusion of water into areas below grade. Typical drain details are presented in Figure 8. Any grading in these areas should be done to direct surface flow around construction to avoid areas of ponded water. All organic material would be completely removed prior to any fill placement. Specific drainage studies are beyond the scope of this report.

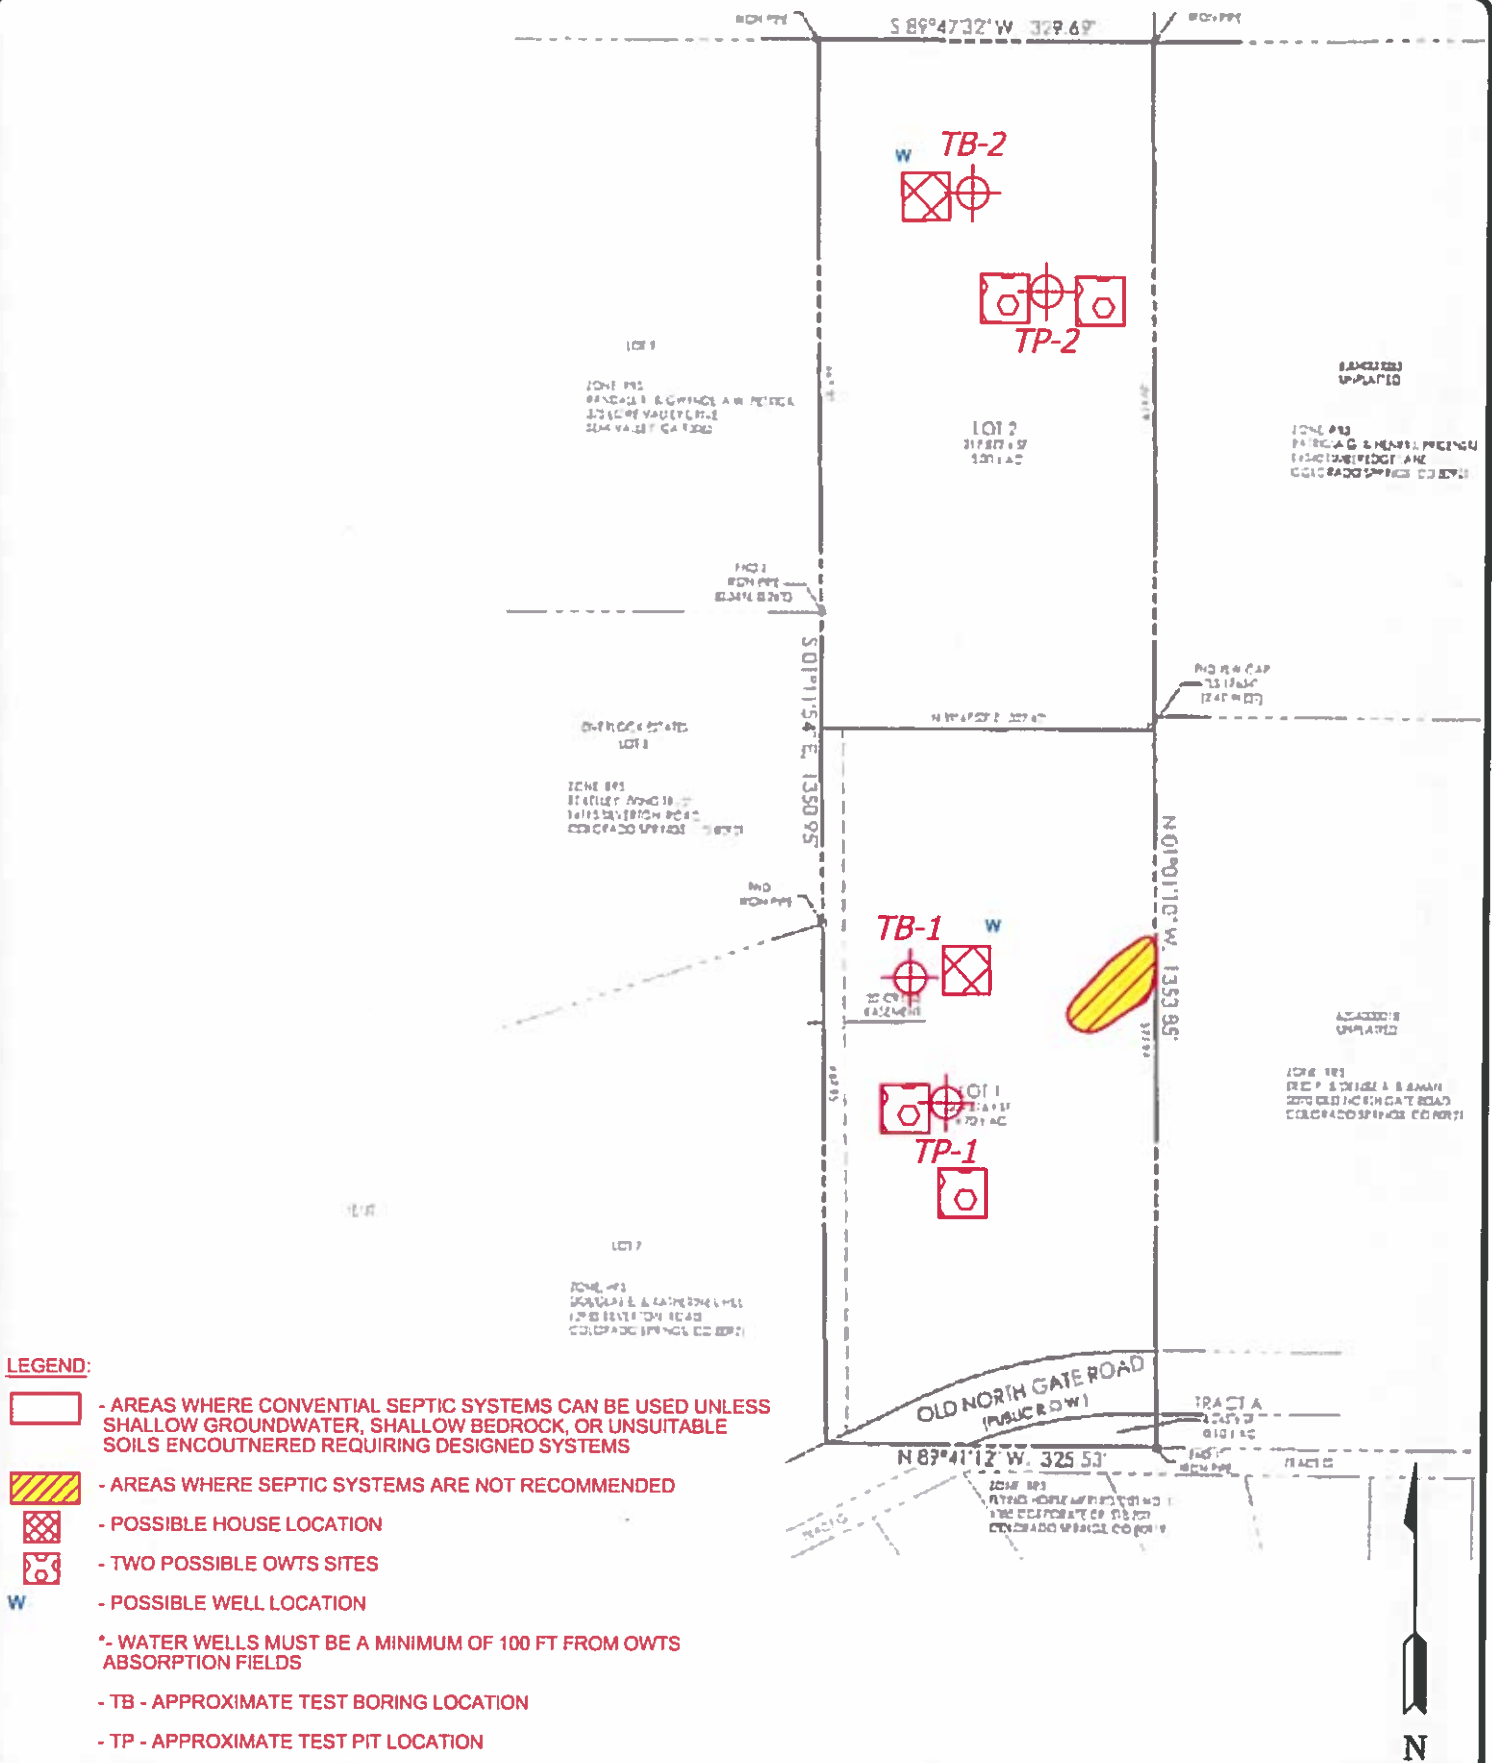
FIG NO.:
9

The site was evaluated for individual on-site wastewater treatment systems in accordance with El Paso Land Development Code. Two (2) test pits were excavated on the site. The approximate locations of the test pits are indicated on Figure 3, on the Geology/Engineering Geology Map, Figure 6, and on the Septic Suitability Map, Figure 9. A table showing the results of the test pits is presented in Table 2.

confining layer. Should groundwater or bedrock be encountered within 6 feet of the surface, designed systems will be required.
