**SOIL, GEOLOGY, GEOLOGIC HAZARD,
AND WASTEWATER STUDY
MOUNTAINS TO VIEW ESTATES
11150 NORTH ELLICOTT HIGHWAY
EL PASO COUNTY, COLORADO**

Avalar Real Estate
7495 McLaughlin Road, Suite 101
Falcon, Colorado 80831

April 16, 2018

Entech Job No. 180343

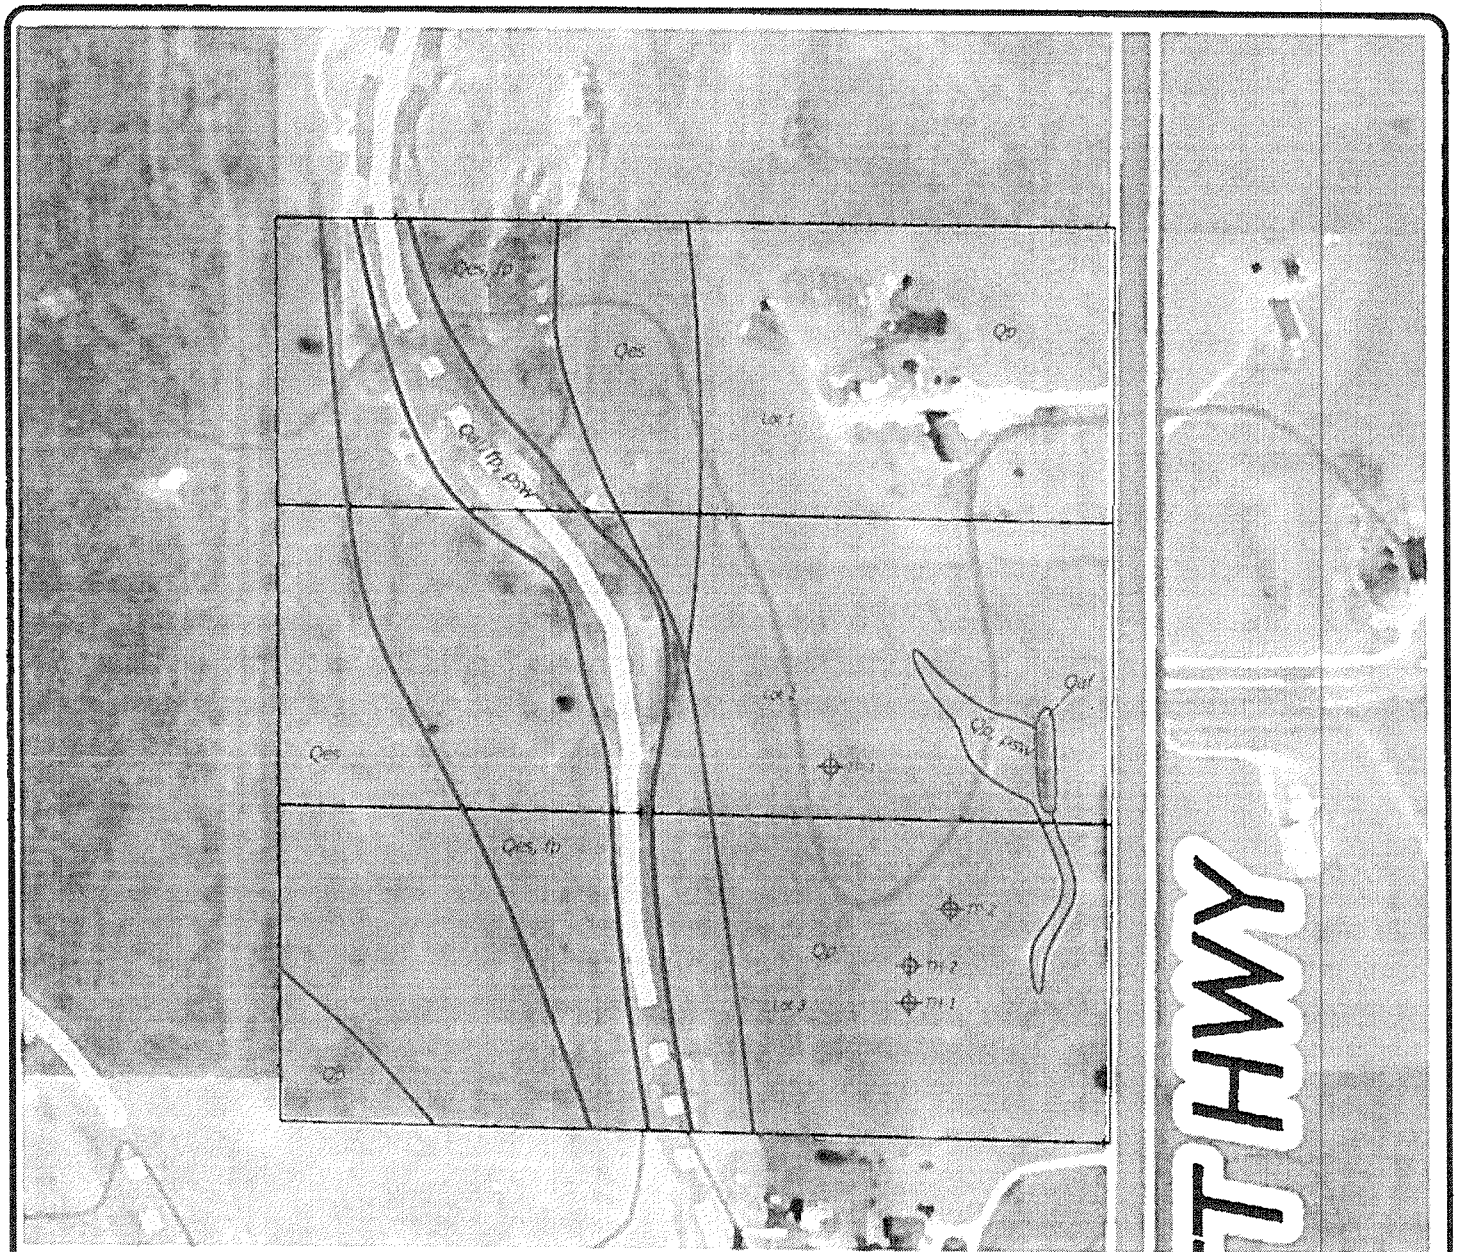
FIG NO.:
6

As mentioned previously, detailed mapping has been performed on this site to produce an Engineering Geology Map Figure 6. This map shows the location of various geologic conditions of which the developers should be cognizant during the planning, design and construction stages of the project. These hazards and the recommended mitigation techniques are as follows:

Areas in which hydrocompaction have been identified are acceptable as building sites. In areas identified for this hazard classification, however, we anticipate a potential for settlement movements upon saturation of these surficial soils. The low density, uniform grain sized, windblown sand deposits are particularly susceptible to this type of phenomenon. Additionally, loose or collapsible soils may be encountered on this site.

Some of the sandy soils encountered on site exhibit low density and may be subject to settlement under a load. The potential for loose or collapsible soils exists anywhere in areas mapped as Eolian Sand (Qes) and may also exist in areas mapped as Piney Creek Alluvium (Qp).

In these areas, we would anticipate the potential for periodically high subsurface moisture conditions, frost heave potential and highly organic soils. The majority of these areas lie within defined drainages which can likely be avoided by the proposed development.

Mitigation: The earthen dam will be avoided by the development, and the small erosion berms can easily be removed or penetrated by foundations. Should any uncontrolled fill be encountered beneath foundations, removal and recompaction at 95% of its maximum Modified Proctor Dry Density, ASTM D-1557 will be required.

Mitigation: The potential for settlement movement is directly related to saturation of the soils below the foundation areas. Therefore, good surface and subsurface drainage is extremely critical in these areas in order to minimize the potential for saturation of these soils. The ground surface around all permanent structures should be positively sloped away from the structure to all points, and water must not be allowed to stand or pond anywhere on the site. We recommend that the ground surface within 10 feet of the structures be sloped away with a minimum gradient of five percent. If this is not possible on the upslope side of the structures, then a well-defined swale should be created to intercept the surface water and carry it quickly and safely around and away from the structures. Roof drains should be made to discharge well away from the structures and into areas of positive drainage. Where several structures are involved, the overall drainage design should be such that water directed away from one structure is not directed against an adjacent building. Planting and watering in the immediate vicinity of the structures, as well as general lawn irrigation, should be minimized.

Mitigation: Should loose collapsible soils be encountered beneath foundations, removal and recompaction of the upper 2 feet with thorough moisture conditioning at 95% of its maximum Modified Proctor Dry Density, ASTM D-1557 will be necessary. Specific recommendations should be made after additional investigation of each building site.

Mitigation: Foundations must have a minimum 30-inch depth for frost protection. In areas where high subsurface moisture conditions are anticipated periodically, subsurface perimeter drains are recommended to help prevent the intrusion of water into areas below grade. Typical drain details are presented in Figure 8. Any grading in these areas should be done to direct surface flow around construction to avoid areas of ponded water. Structures should not block drainages. All organic material should be completely removed prior to any fill placement.

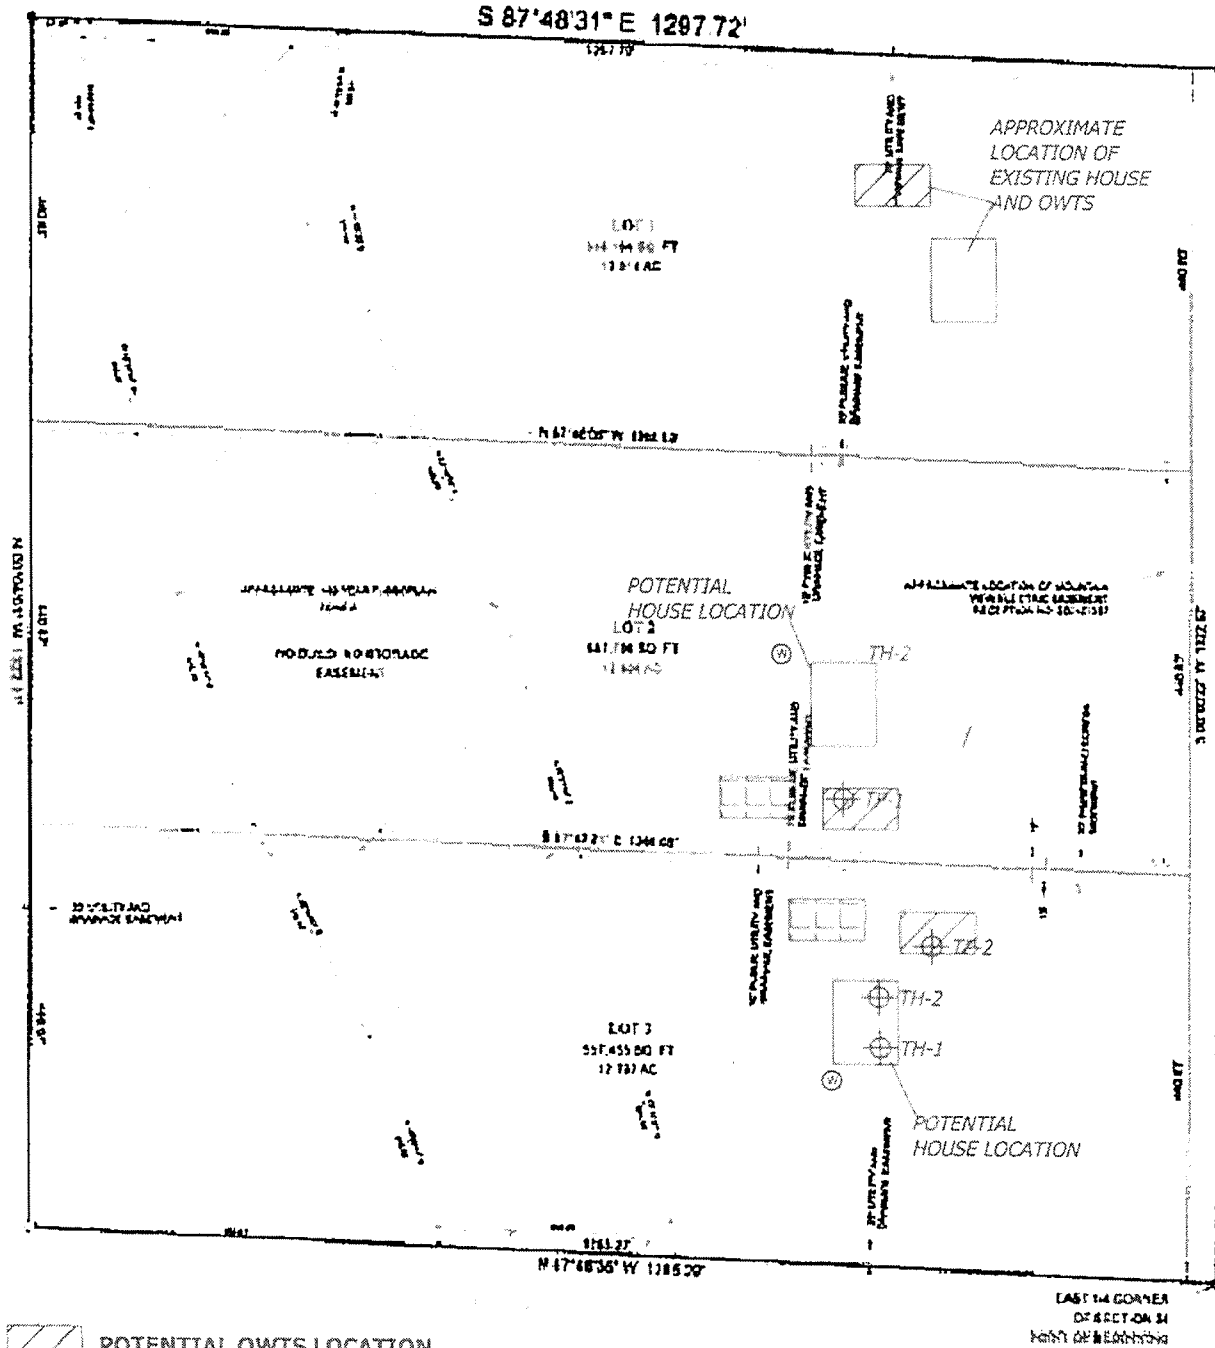
FIG NO.:
9

The site was evaluated for On-site Wastewater Treatment Systems (OWTS) for the proposed lots in accordance with El Paso Land Development Code. Two (2) tactile test pits were performed on the site. Tactile test pits were located in anticipated locations of proposed on-site wastewater treatment system (OWTS) for the development. The approximate locations of the test pits are indicated on Figure 3 and 6, and on the Septic Suitability Map, Figure 9. The locations were chosen to determine a general understanding of the soil and bedrock conditions across the site. The results of the tactile test pits are presented in Table 1. An existing mobile home and septic system are located on Lot 1 and will remain. Septic records for Lot 1 are presented in Appendix F. An infiltrator system installed in 2002 is presently located on the site.

Soils encountered in the tactile test pits consisted of sandy loam to loamy sand. The limiting layers encountered in the test pits are the sandy loam, which corresponds to an LTAR value of 0.50 gallons per day per square foot. The conditions encountered in test pits are suitable for a conventional OWTS. Signs of seasonal shallow groundwater or bedrock were not observed in the test pits, which were excavated to 8 feet.

In summary, it is our opinion the site is suitable for individual on-site wastewater treatment systems and that contamination of surface and subsurface water resources should not occur provided the OWTS sites are evaluated and installed according to El Paso County Guidelines and properly maintained. A Septic Suitability Map is presented in Figure 9. Absorption fields must be located a minimum of 100 feet from any well, including those on adjacent properties. Absorption fields must also be located a minimum of 50 feet from any ponded areas and 25 feet from dry gulches. It should be noted that additional testing will be required for the individual lots prior to construction on each lot.
