**SOIL, GEOLOGY, GEOLOGIC HAZARD,  
AND WASTEWATER STUDY  
MOUNTAINS TO VIEW ESTATES  
11150 NORTH ELLICOTT HIGHWAY  
EL PASO COUNTY, COLORADO**

**Avalar Real Estate**  
7495 McLaughlin Road, Suite 101  
Falcon, Colorado 80831

April 16, 2018

Entech Job No. 180343  
A\Projects\2018\180343 countysoil/geo/wastewater

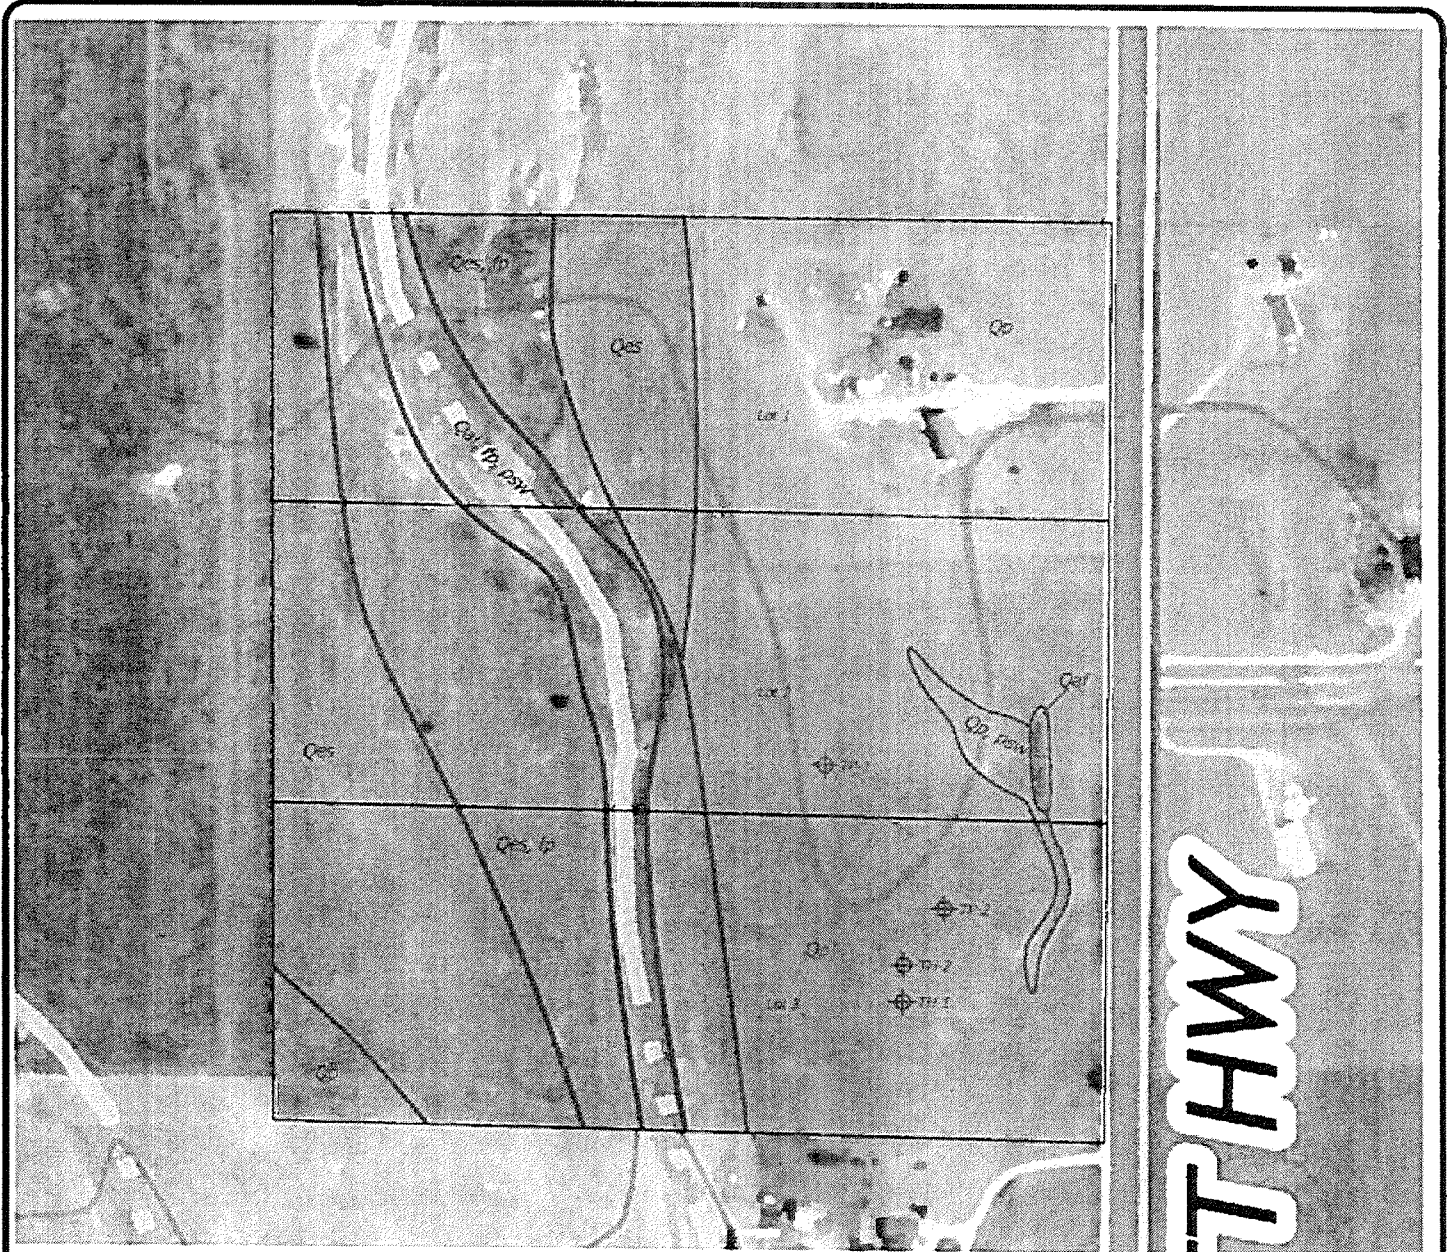
FIG NO.:  
**6**

As mentioned previously, detailed mapping has been performed on this site to produce an Engineering Geology Map Figure 6. This map shows the location of various geologic conditions of which the developers should be cognizant during the planning, design and construction stages of the project. These hazards and the recommended mitigation techniques are as follows:

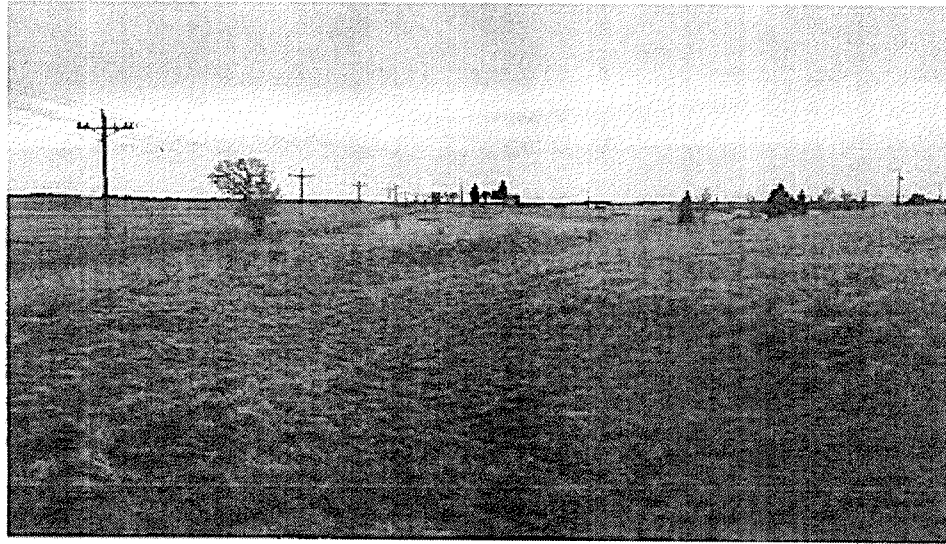
Looking south from the eastern portion of the site.

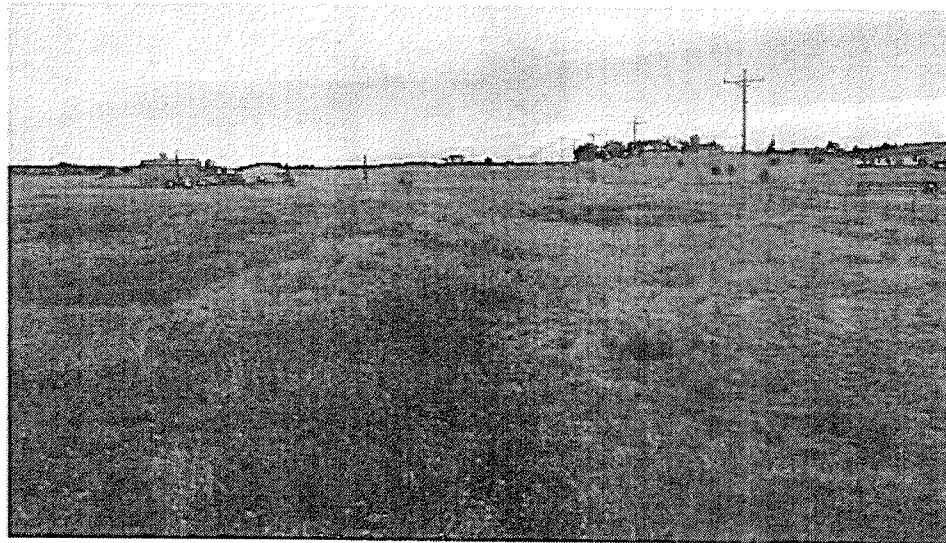
Looking north from the eastern portion of the site.

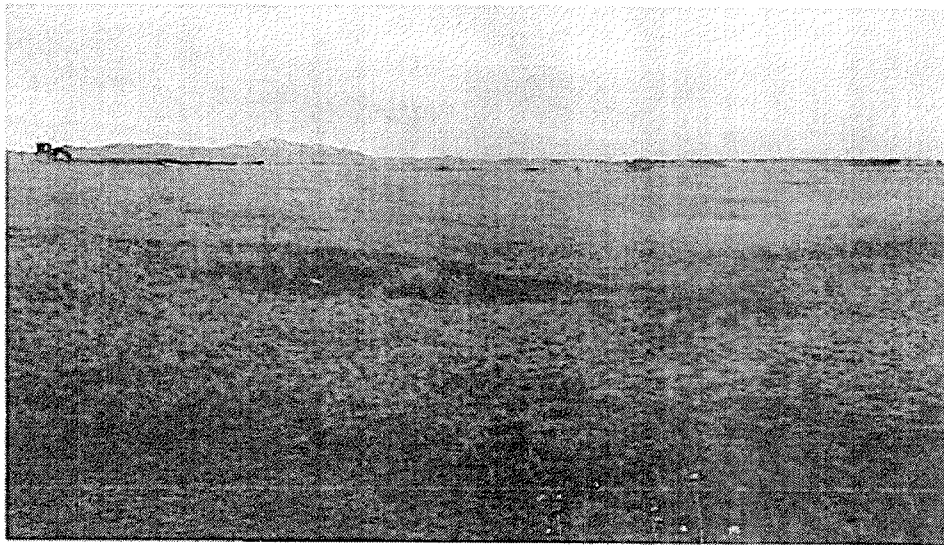
Looking west from the eastern portion of the site.

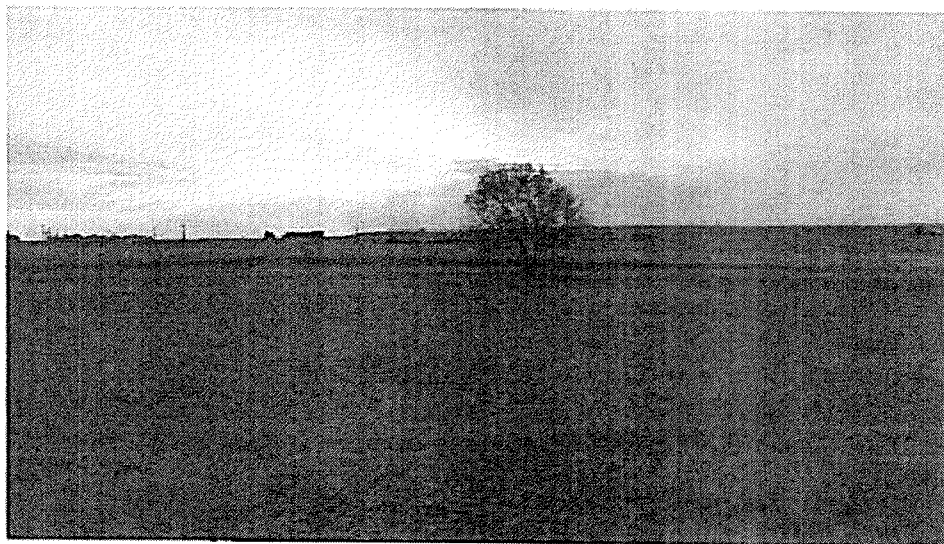
Looking east from the northwestern portion of the site.

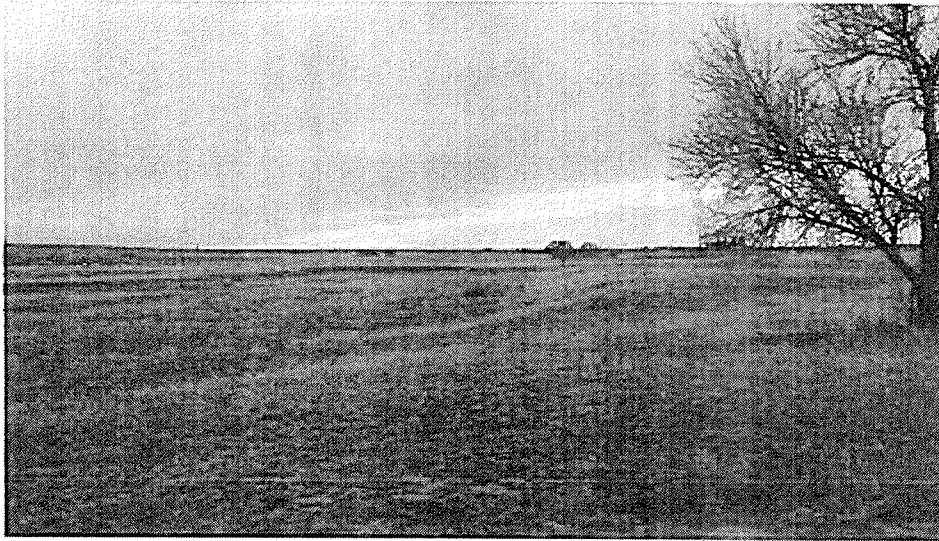
Looking southeast  
from the northwestern  
portion of the site.

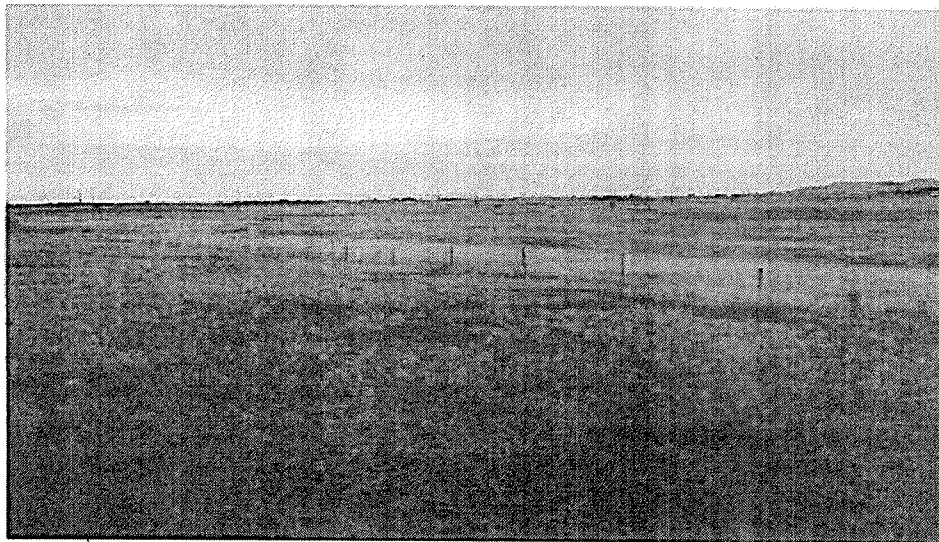
Looking southeast  
from the central  
portion of the site.
