Job No. 176395

September 25, 2020

Re: Wastewater Study
15330 Chaparral Loop East
El Paso County, Colorado

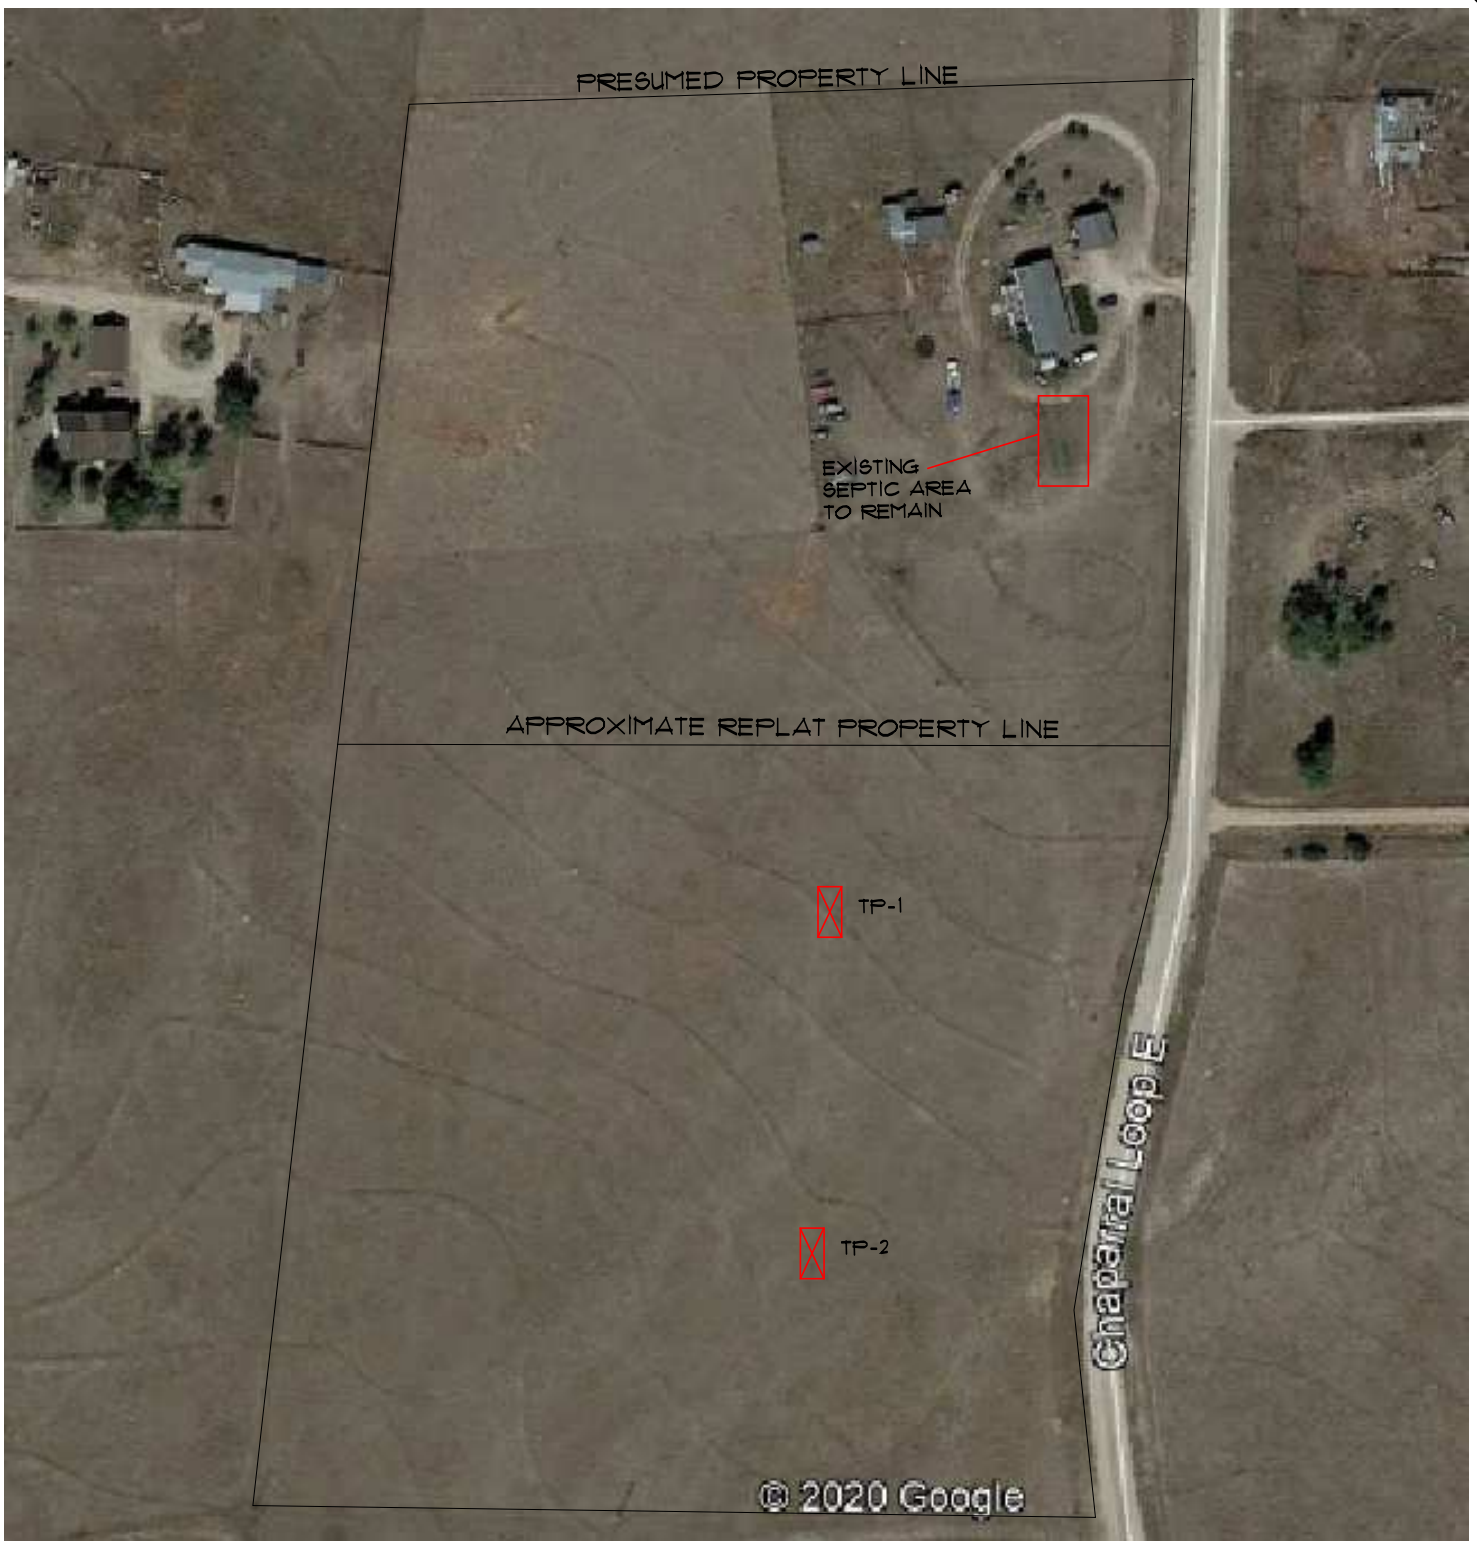
FIG No. 1

Personnel of RMG performed a reconnaissance visit on August 21, 2020. The purpose of the reconnaissance visit was to evaluate the site surface characteristics including landscape position, topography, vegetation, natural and cultural features, and current and historic land uses. Two 8-foot deep test pits were performed on 15330 Chaparral Loop East, during our reconnaissance visit. A Test Pit Location Plan is presented in Figure 1.

Personnel of RMG performed a soil evaluation to include two 8-foot deep test pits 15330 Chaparral Loop East, on August 21, 2020 (Test Pit TP-1 and TP-2), utilizing the visual and tactile method for the evaluation of the site soils. The test pits were excavated in areas that appeared most likely to be used for residential construction. The Test Pit Logs are presented in Figure 4. A Septic Suitability map is presented in Figure 5.

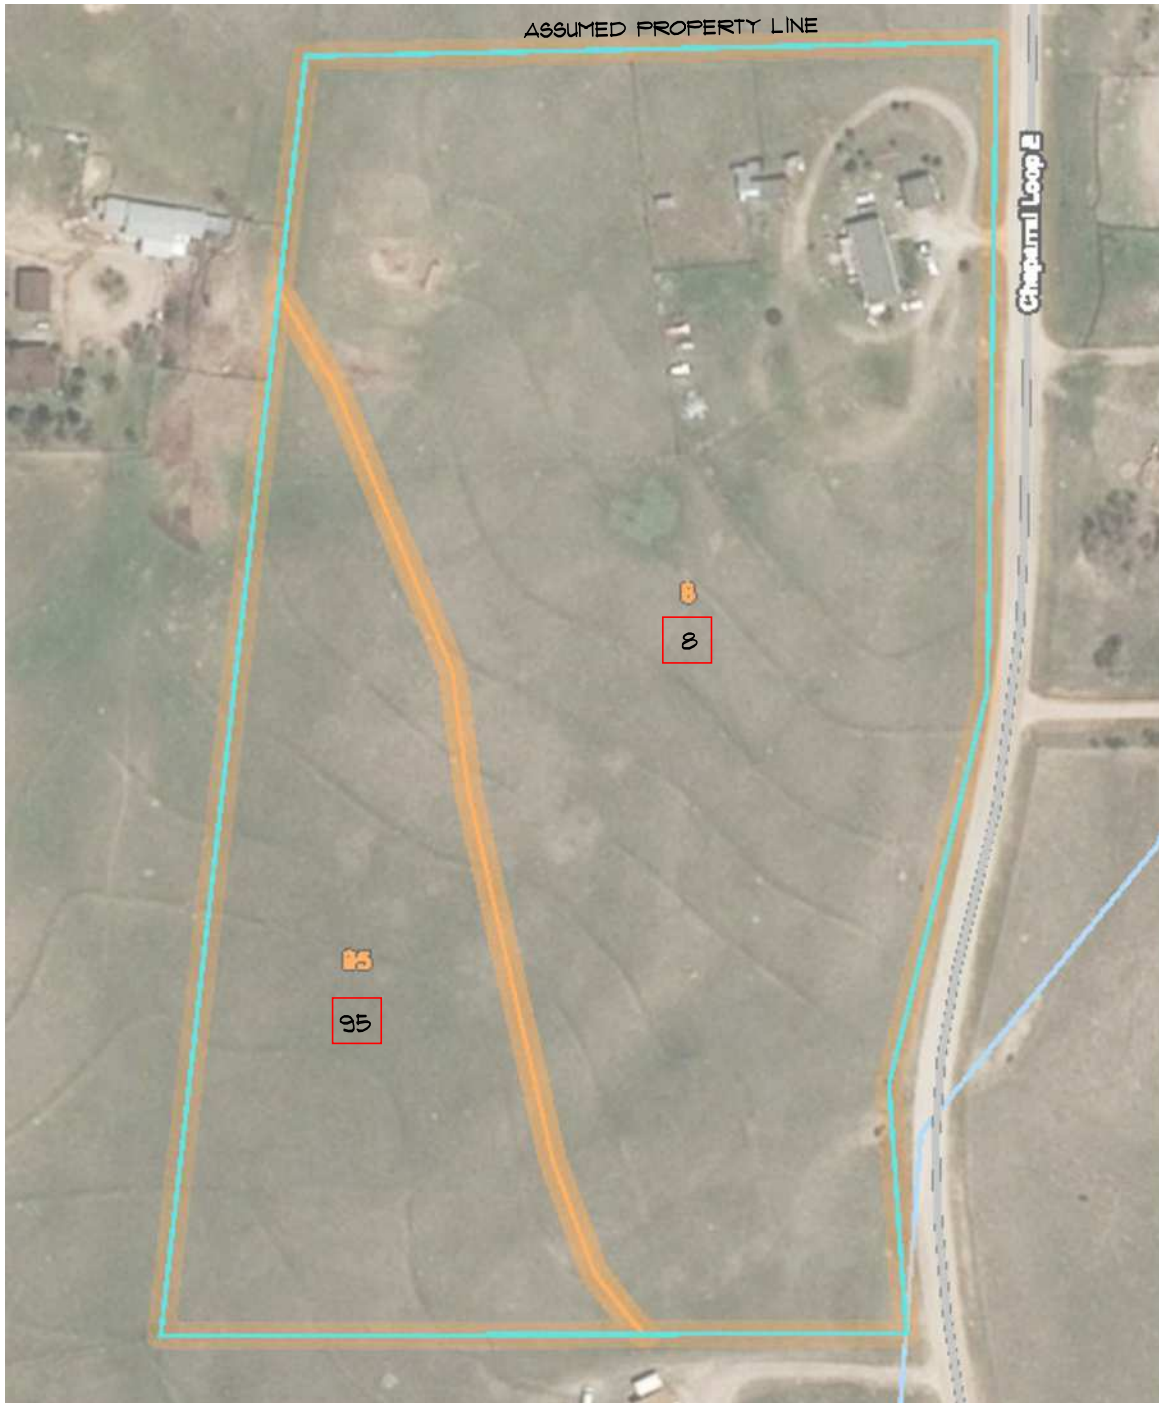
FIG No. 2

The soil conditions as indicated by the NRCS data are anticipated to consist of Blakeland loamy sand with 1 to 9 percent slopes. The Blakeland loamy sand was mapped by the USDA to encompass the majority of the eastern portion of property. Properties of the loamy sand include somewhat excessively drained soils, depth of the water table is anticipated to be greater than 6.5 feet, runoff is anticipated to be low, frequency of flooding and/or ponding is none, and landforms include hills and flats. Truckton, loamy sand was mapped to encompass the majority of the western portion of the property. This soil condition is located outside of the proposed OWTS locations and has been eliminated from this study. A USDA Soil Survey Map and USDA Full Map Unit Descriptions are attached in Figures 2 and 3.

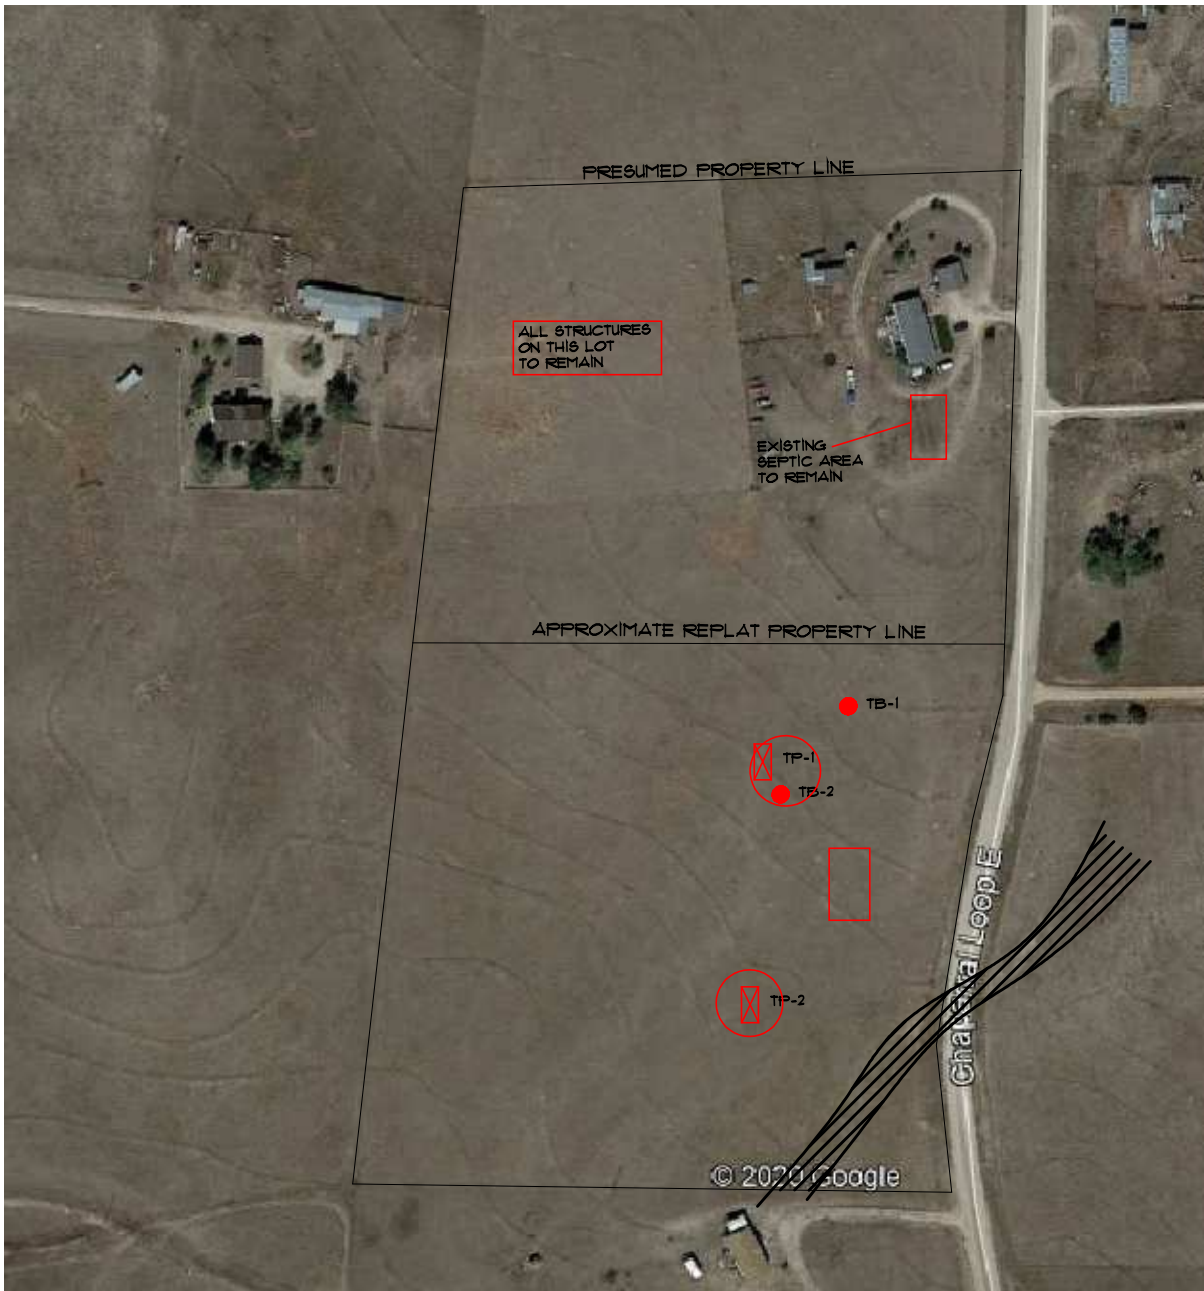
FIG No. 5

- Treatment areas are to be located a minimum 100 feet from any well (existing or proposed), including those located on adjacent properties per Table 7-2 per the EPCHDE;
- Treatment areas must also be located a minimum 50 feet from any spring, lake, water course, irrigation ditch, stream or wetland, and 25 feet from dry gulches.
- Other setbacks include the treatment area to be located a minimum 10 feet from property lines, dry gulches, cut banks and fill areas (from the crest).
- The new parcel shall be laid out to ensure that the proposed OWTS does not fall within any restricted areas, (e.g. utility easements, right of ways). Based on the test pit observations, the parcel has a minimum of two locations for the OWTS.

In summary, it is our opinion the site is suitable for individual on-site wastewater treatment systems within the cited limitations. There are no foreseeable or stated construction related issues or land use changes proposed at this time. The new southern lot is suitable for an individual OWTS.

An OWTS is proposed for 15330 Chaparral Loop East and should conform to the recommendations of a future OWTS site evaluation, performed in accordance with the applicable health department codes prior to construction. This report may require additional test pits in the vicinity of the proposed treatment field. A minimum separation of 4 feet shall be maintained from groundwater and bedrock to the infiltrative surface.

An OWTS site evaluation will need to be performed in accordance with the applicable health department codes prior to construction.
