December 28, 2021

**ENTECH**  
ENGINEERING, INC.

Re: Soil, Geology, and Geologic Hazard Study  
6665 Walker Road  
Parcel No. 51000-00-421  
El Paso County, Colorado

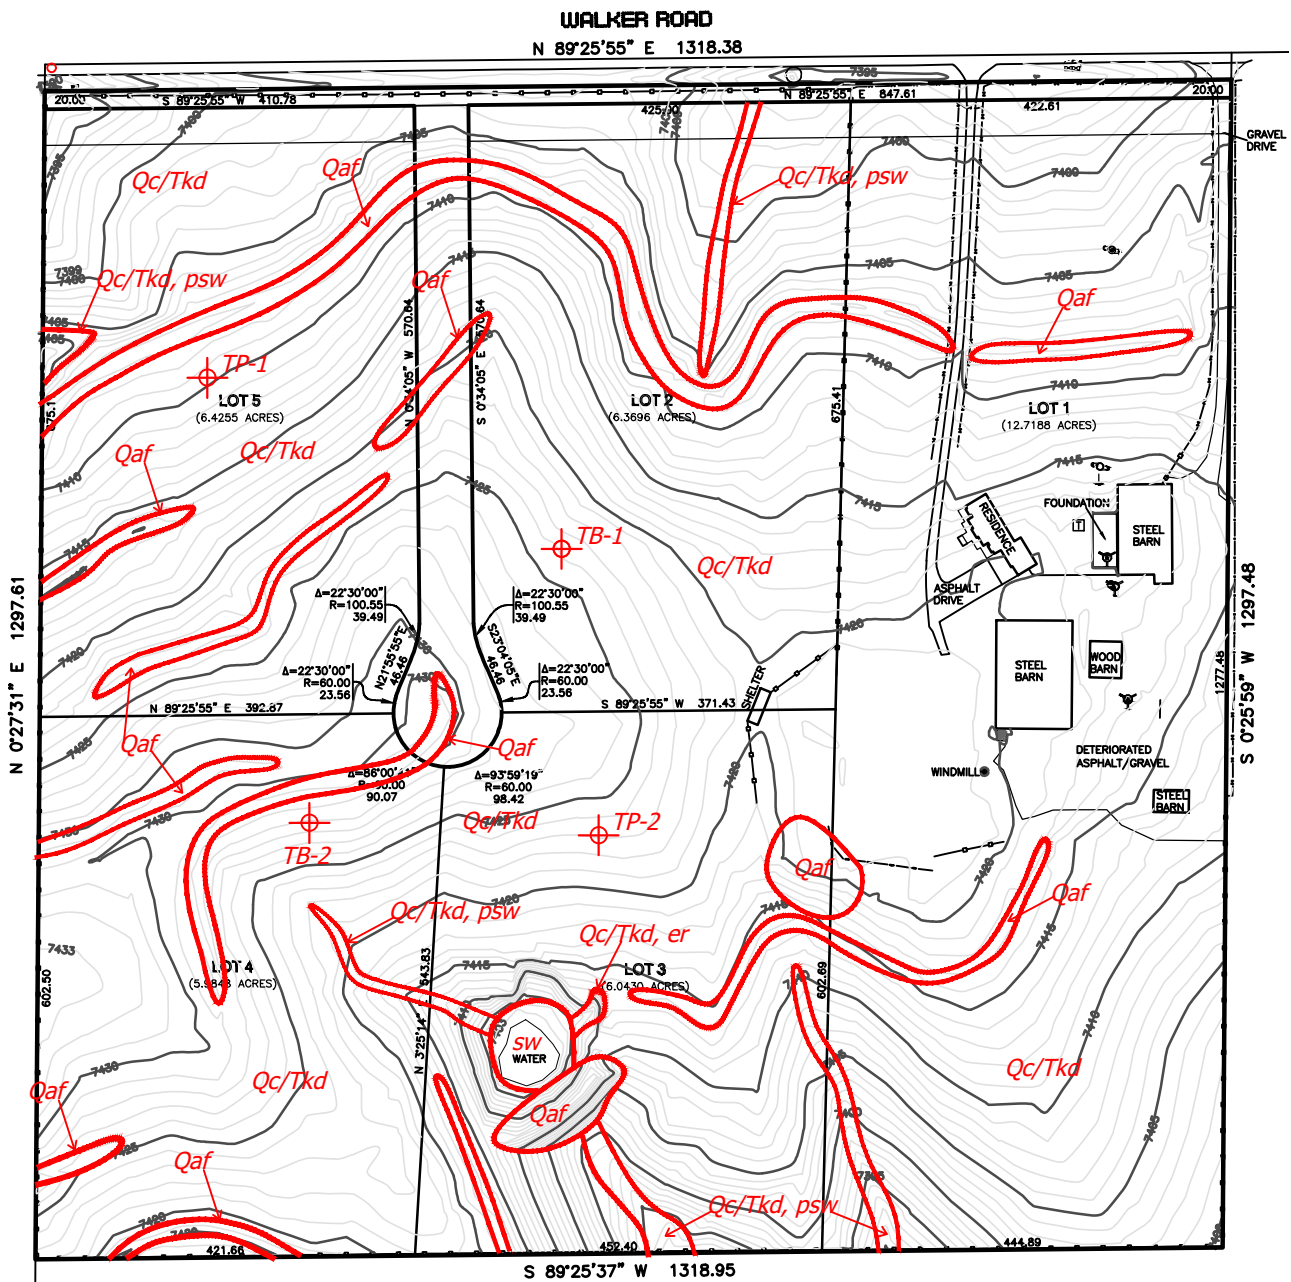
FIG NO.:  
**6**

These are man-made fill deposits associated with erosion berms and earthen dams on site. There is also a manure pile that is indicated on the Geology/Engineering Geology Map, Figure 6.

The minor drainages have been mapped as potentially seasonal shallow groundwater areas. Additionally, the uphill sides of the erosion berms have the potential for seasonally shallow groundwater. In these areas, we would anticipate the potential for periodically high subsurface moisture conditions, frost heave potential. Construction in any portions of these areas, if required, or immediately adjacent to these areas should follow these precautions.

Mitigation: The earthen dam embankment will be avoided by the development. Small erosion berms can be removed or penetrated by foundations. Should any uncontrolled fill be encountered beneath foundations, removal and recompaction at 95% of its maximum Modified Proctor Dry Density, ASTM D-1557 will be required.

Mitigation: Foundations must have a minimum 30-inch depth for frost protection. In areas where high subsurface moisture conditions are anticipated periodically, subsurface perimeter drains are recommended to help prevent the intrusion of water into areas below grade. Typical drain details are presented in Figure 8. Any grading in these areas should be done to direct surface flow around construction to avoid areas of ponded water. All organic material would be completely removed prior to any fill placement. **Specific drainage studies are beyond the scope of this report.**

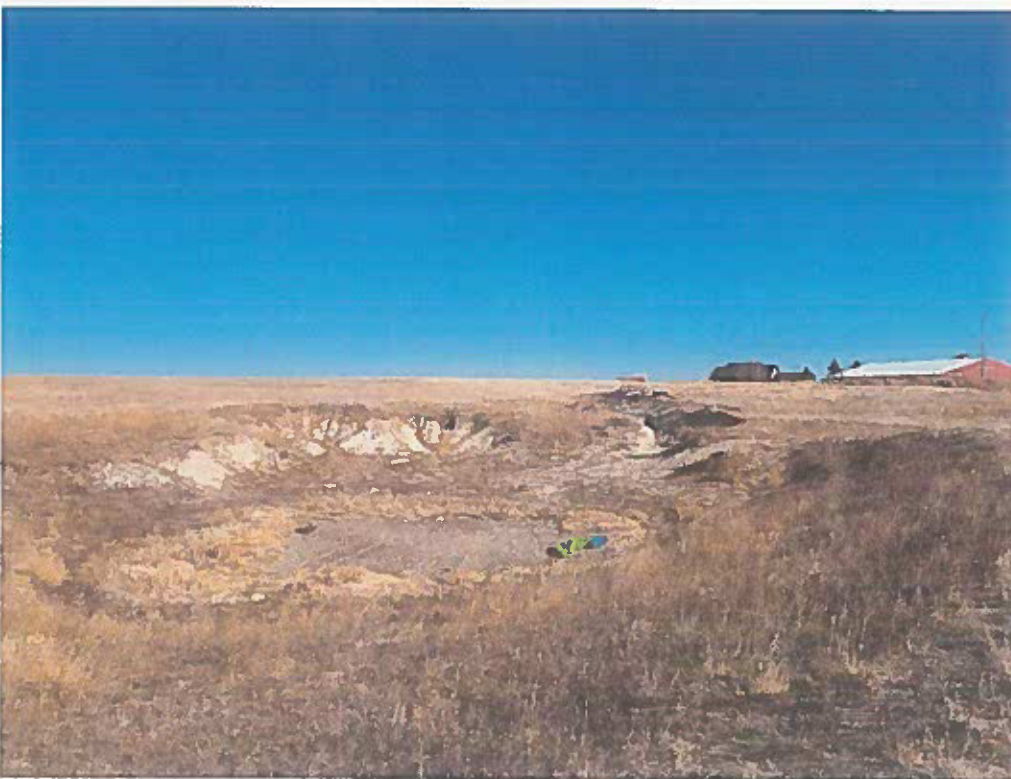
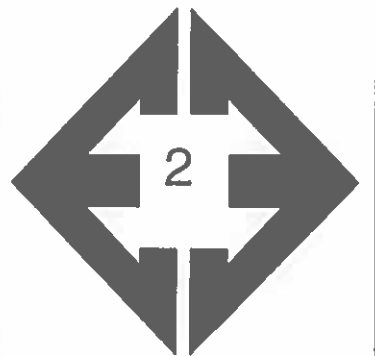
This is an area where water seasonally ponds behind a dam in the southern portion of the site. It is anticipated that these areas will be avoided by structures. There is sufficient area on Lot 3 to allow room for a structure and access. Construction is not recommended in the seasonally wet area.

**Looking north at dry  
pond in south-central  
portion of the site.**

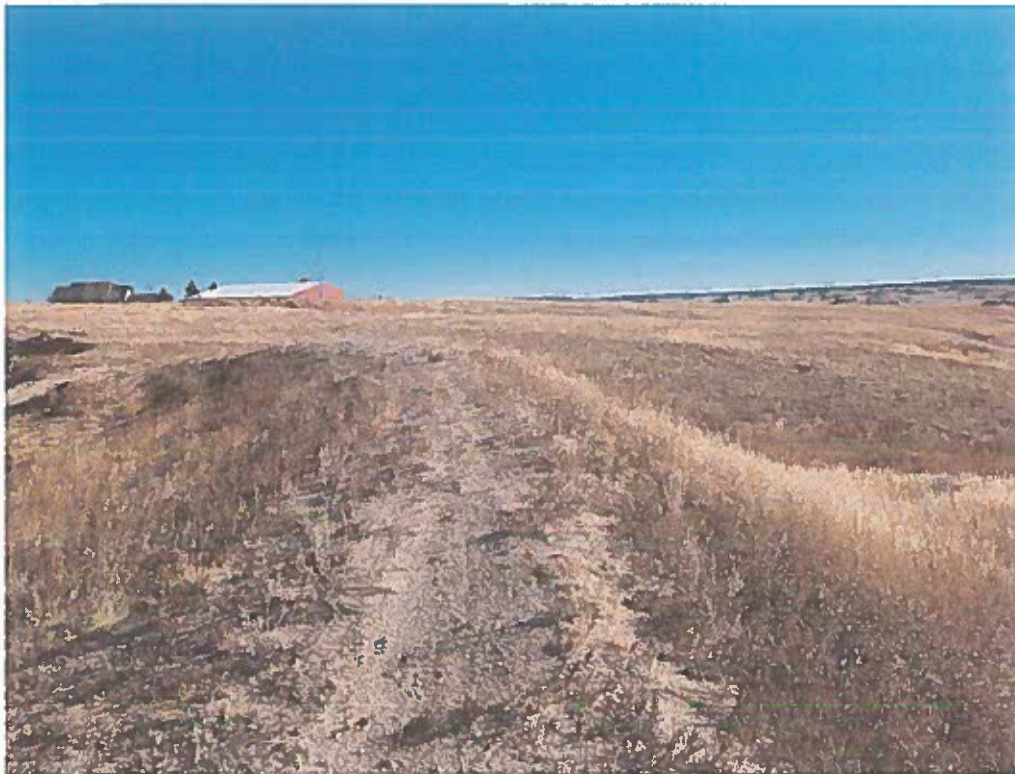
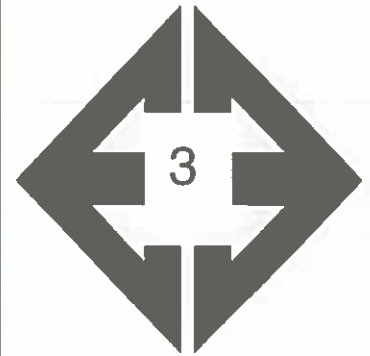
**Looking along crest of  
earthen dam in the  
southern portion of the  
site.**

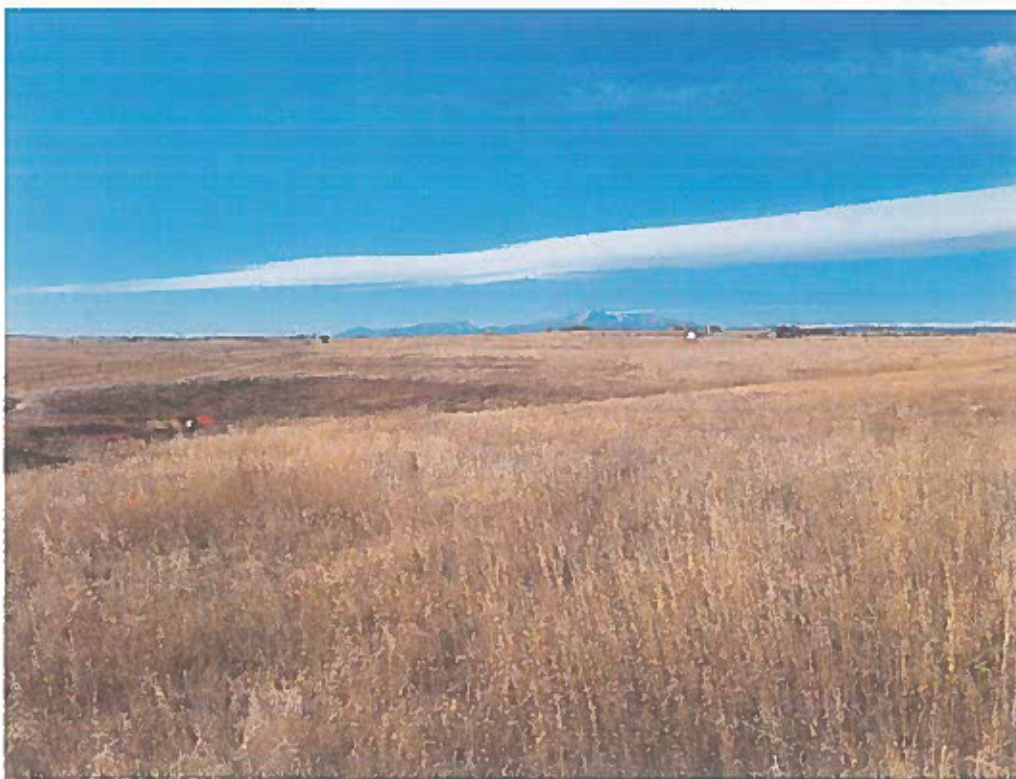
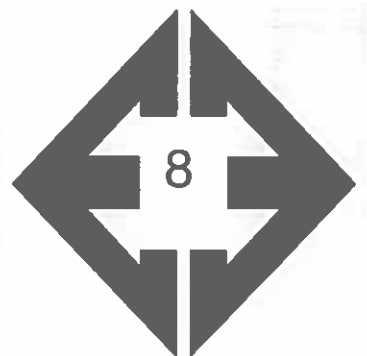
**Looking west from  
east side pond in the  
southern portion of the  
site.**
