**SOIL, GEOLOGY, GEOLOGIC HAZARD,
AND WASTEWATER STUDY,
ROLLIN RIDGE ESTATES
HODGEN ROAD AND HIGHWAY 83 – SOUTHWEST CORNER
EL PASO COUNTY, COLORADO**

November 24, 2017

Entech Job No. 170837
A\projects\2017\170837 countysoil\geo\ww

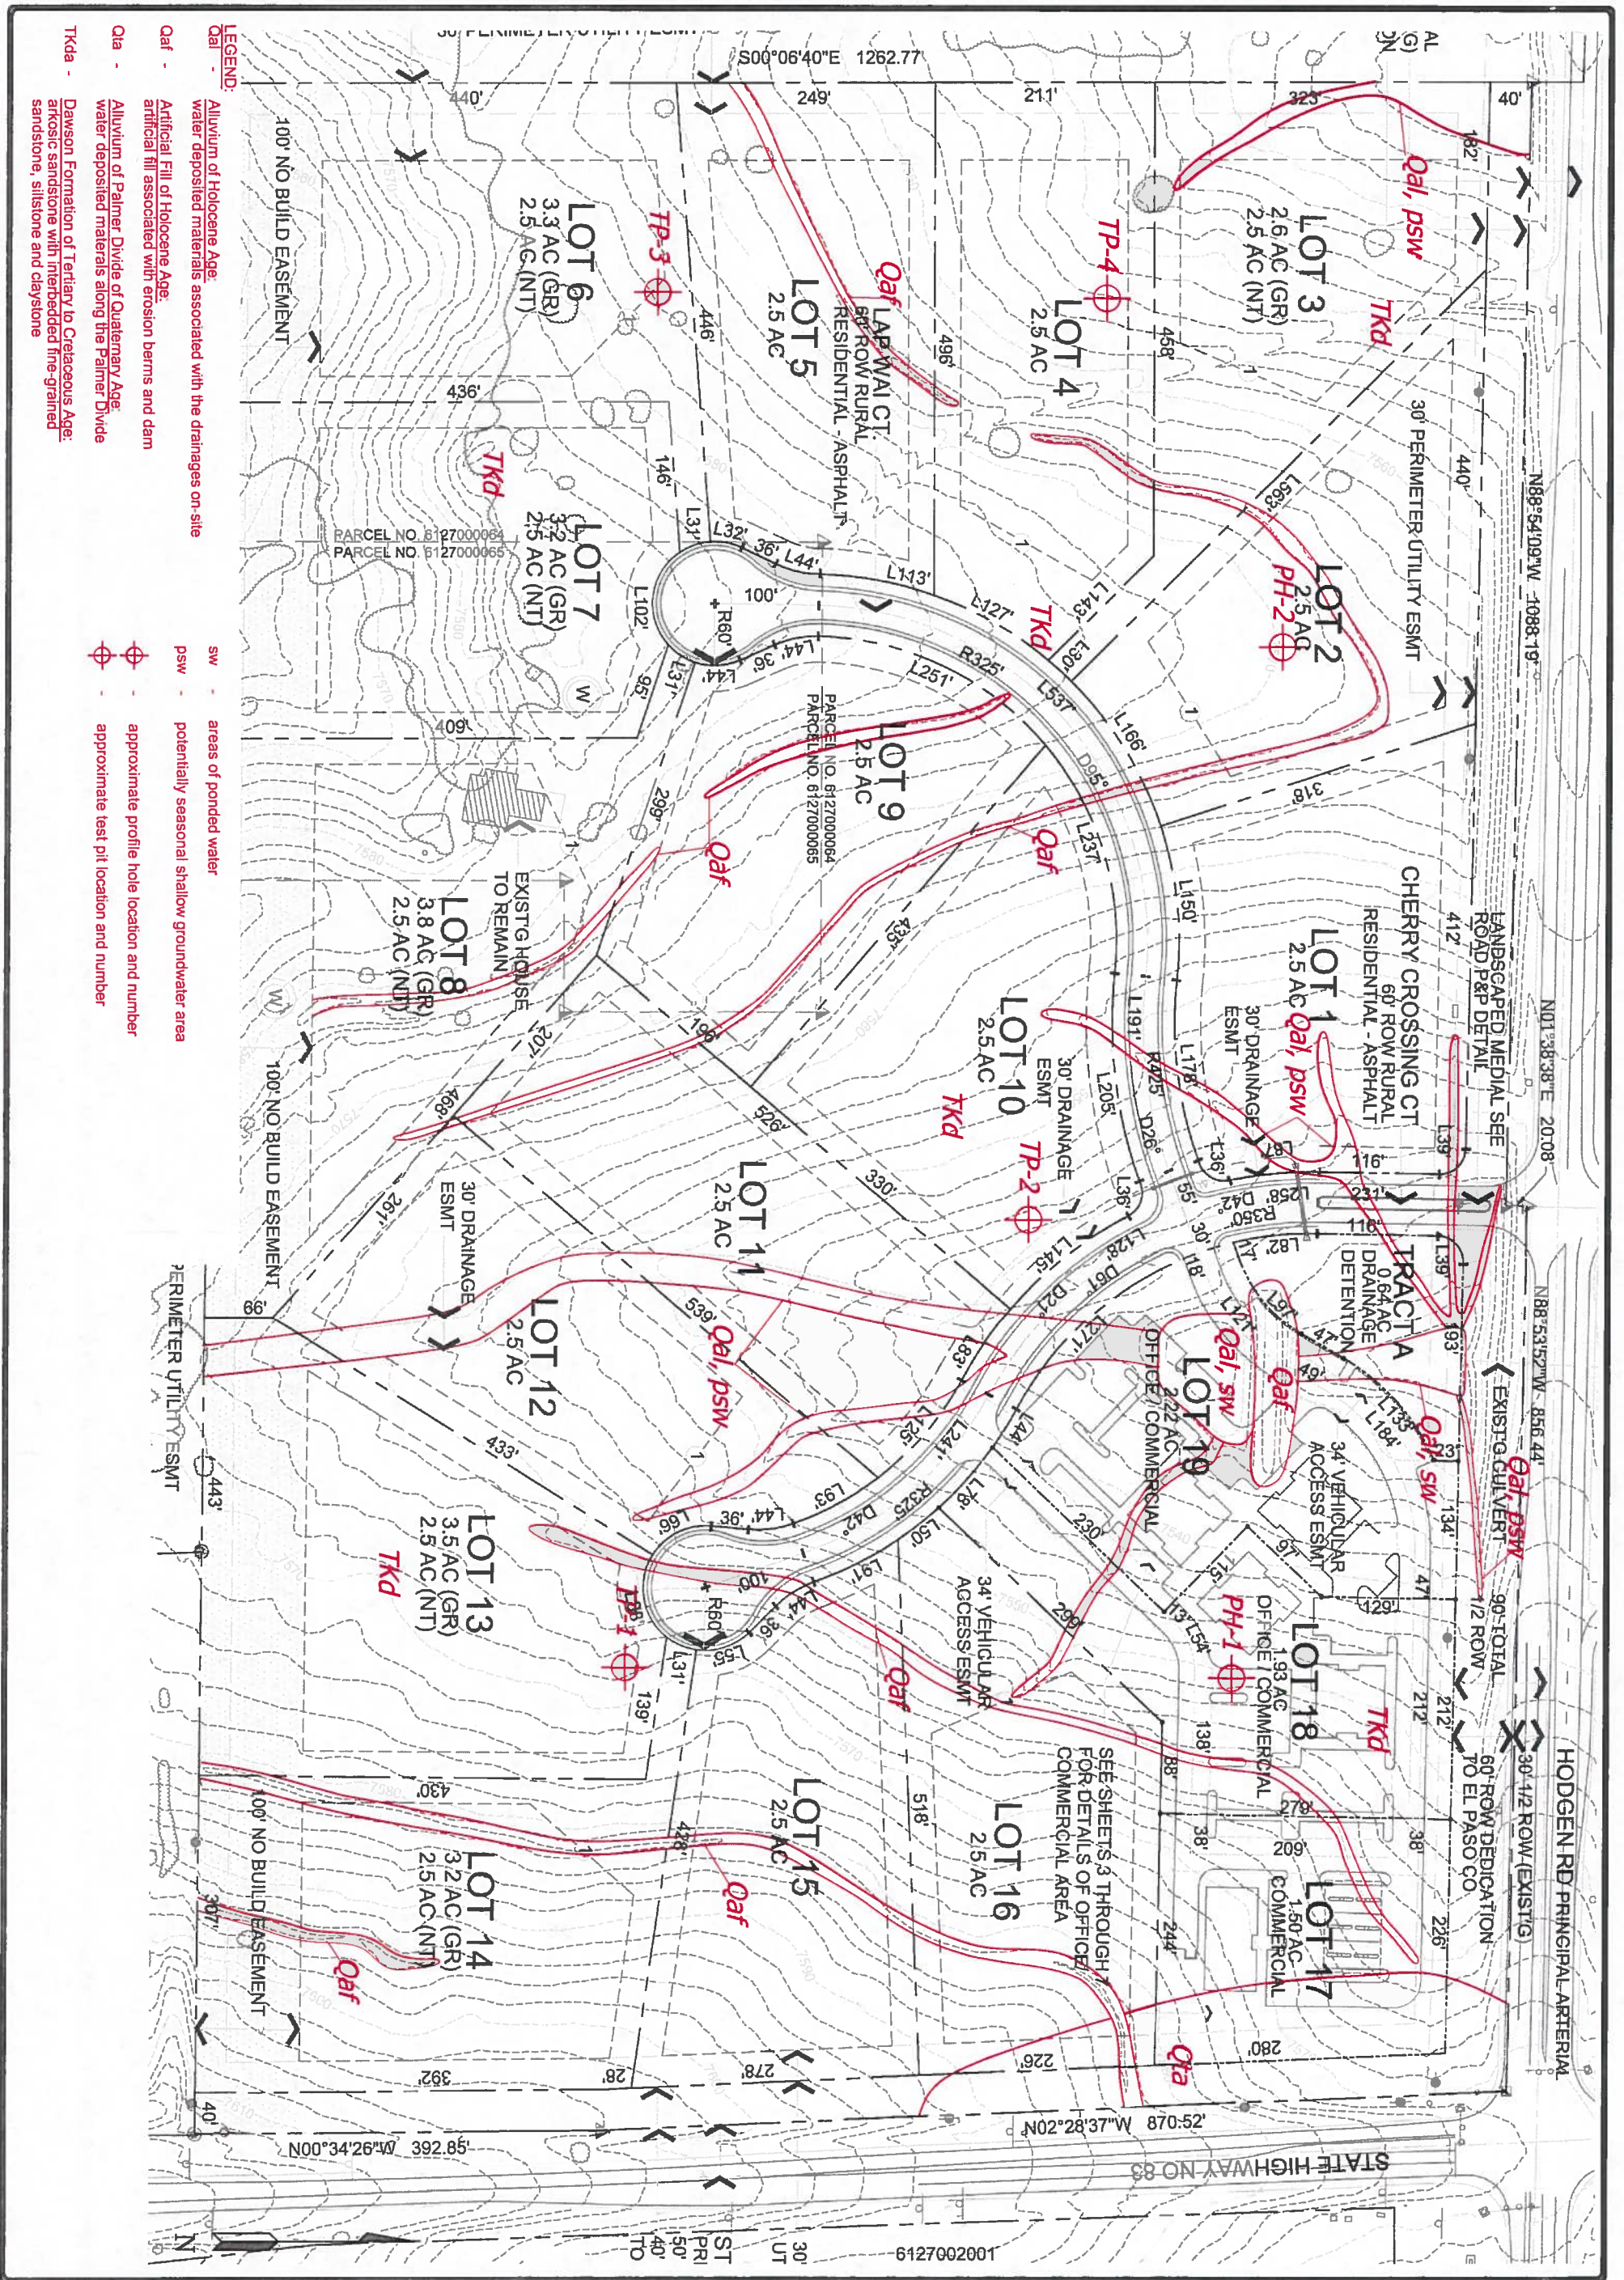
DATE	10/28/17
SCALE	AS SHOWN
DRAWN BY	AS SHOWN
CHECKED	170837
PROJECT NO.	6

As mentioned previously, detailed mapping has been performed on this site to produce an Geology/Engineering Geology Map (Figure 6). This map shows the location of various geologic conditions of which the developers should be cognizant during the planning, design and construction stages of the project. These hazards and the recommended mitigation techniques are as follows:

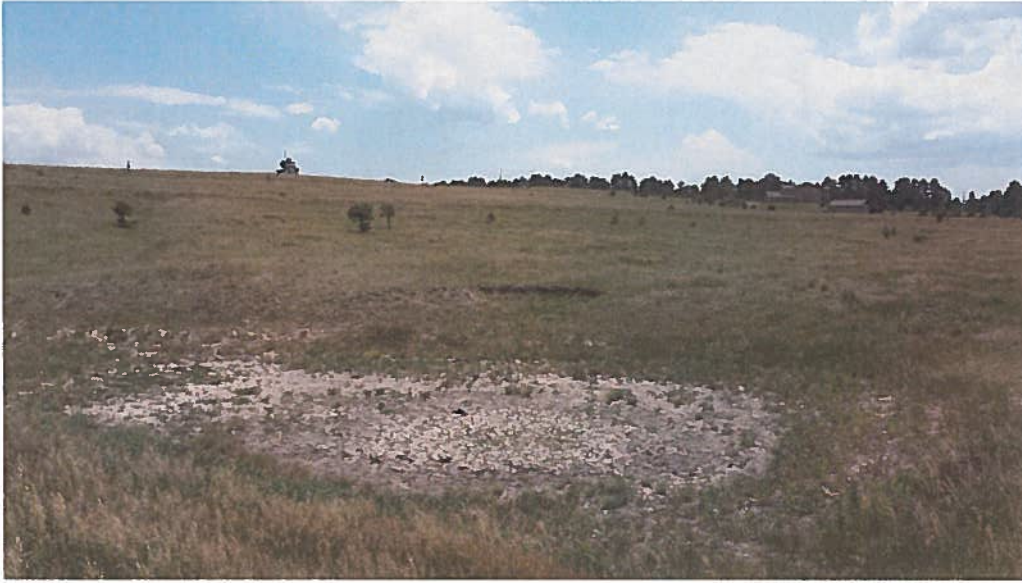
**Looking southeast
from the pond in the
northeastern portion of
the site.**

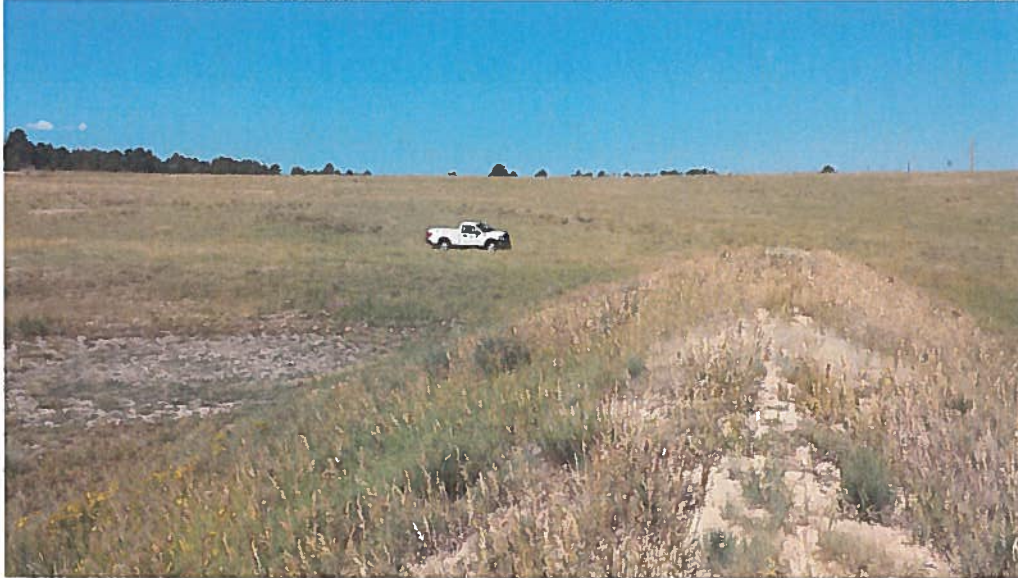
**Looking west along
the dam located in the
northeastern portion of
the site.**

Mitigation: The earthen dam will be avoided by the development, and the small erosion berms can easily be removed or penetrated by foundations. Should any uncontrolled fill be encountered beneath foundations, removal and recompaction at 95% of its maximum Modified Proctor Dry Density, ASTM D-1557 will be required.
