**SOIL, GEOLOGY, GEOLOGIC HAZARD STUDY  
THE RESERVE AT CORRAL BLUFFS  
EL PASO COUNTY, COLORADO**

**Corral Ranches Development Company**  
1830 Coyote Point Drive  
Colorado Springs, Colorado 80904

December 11, 2019

Entech Job No. 192142 (previously 83691)  
AAPProjects/2019/192142 county soil geo

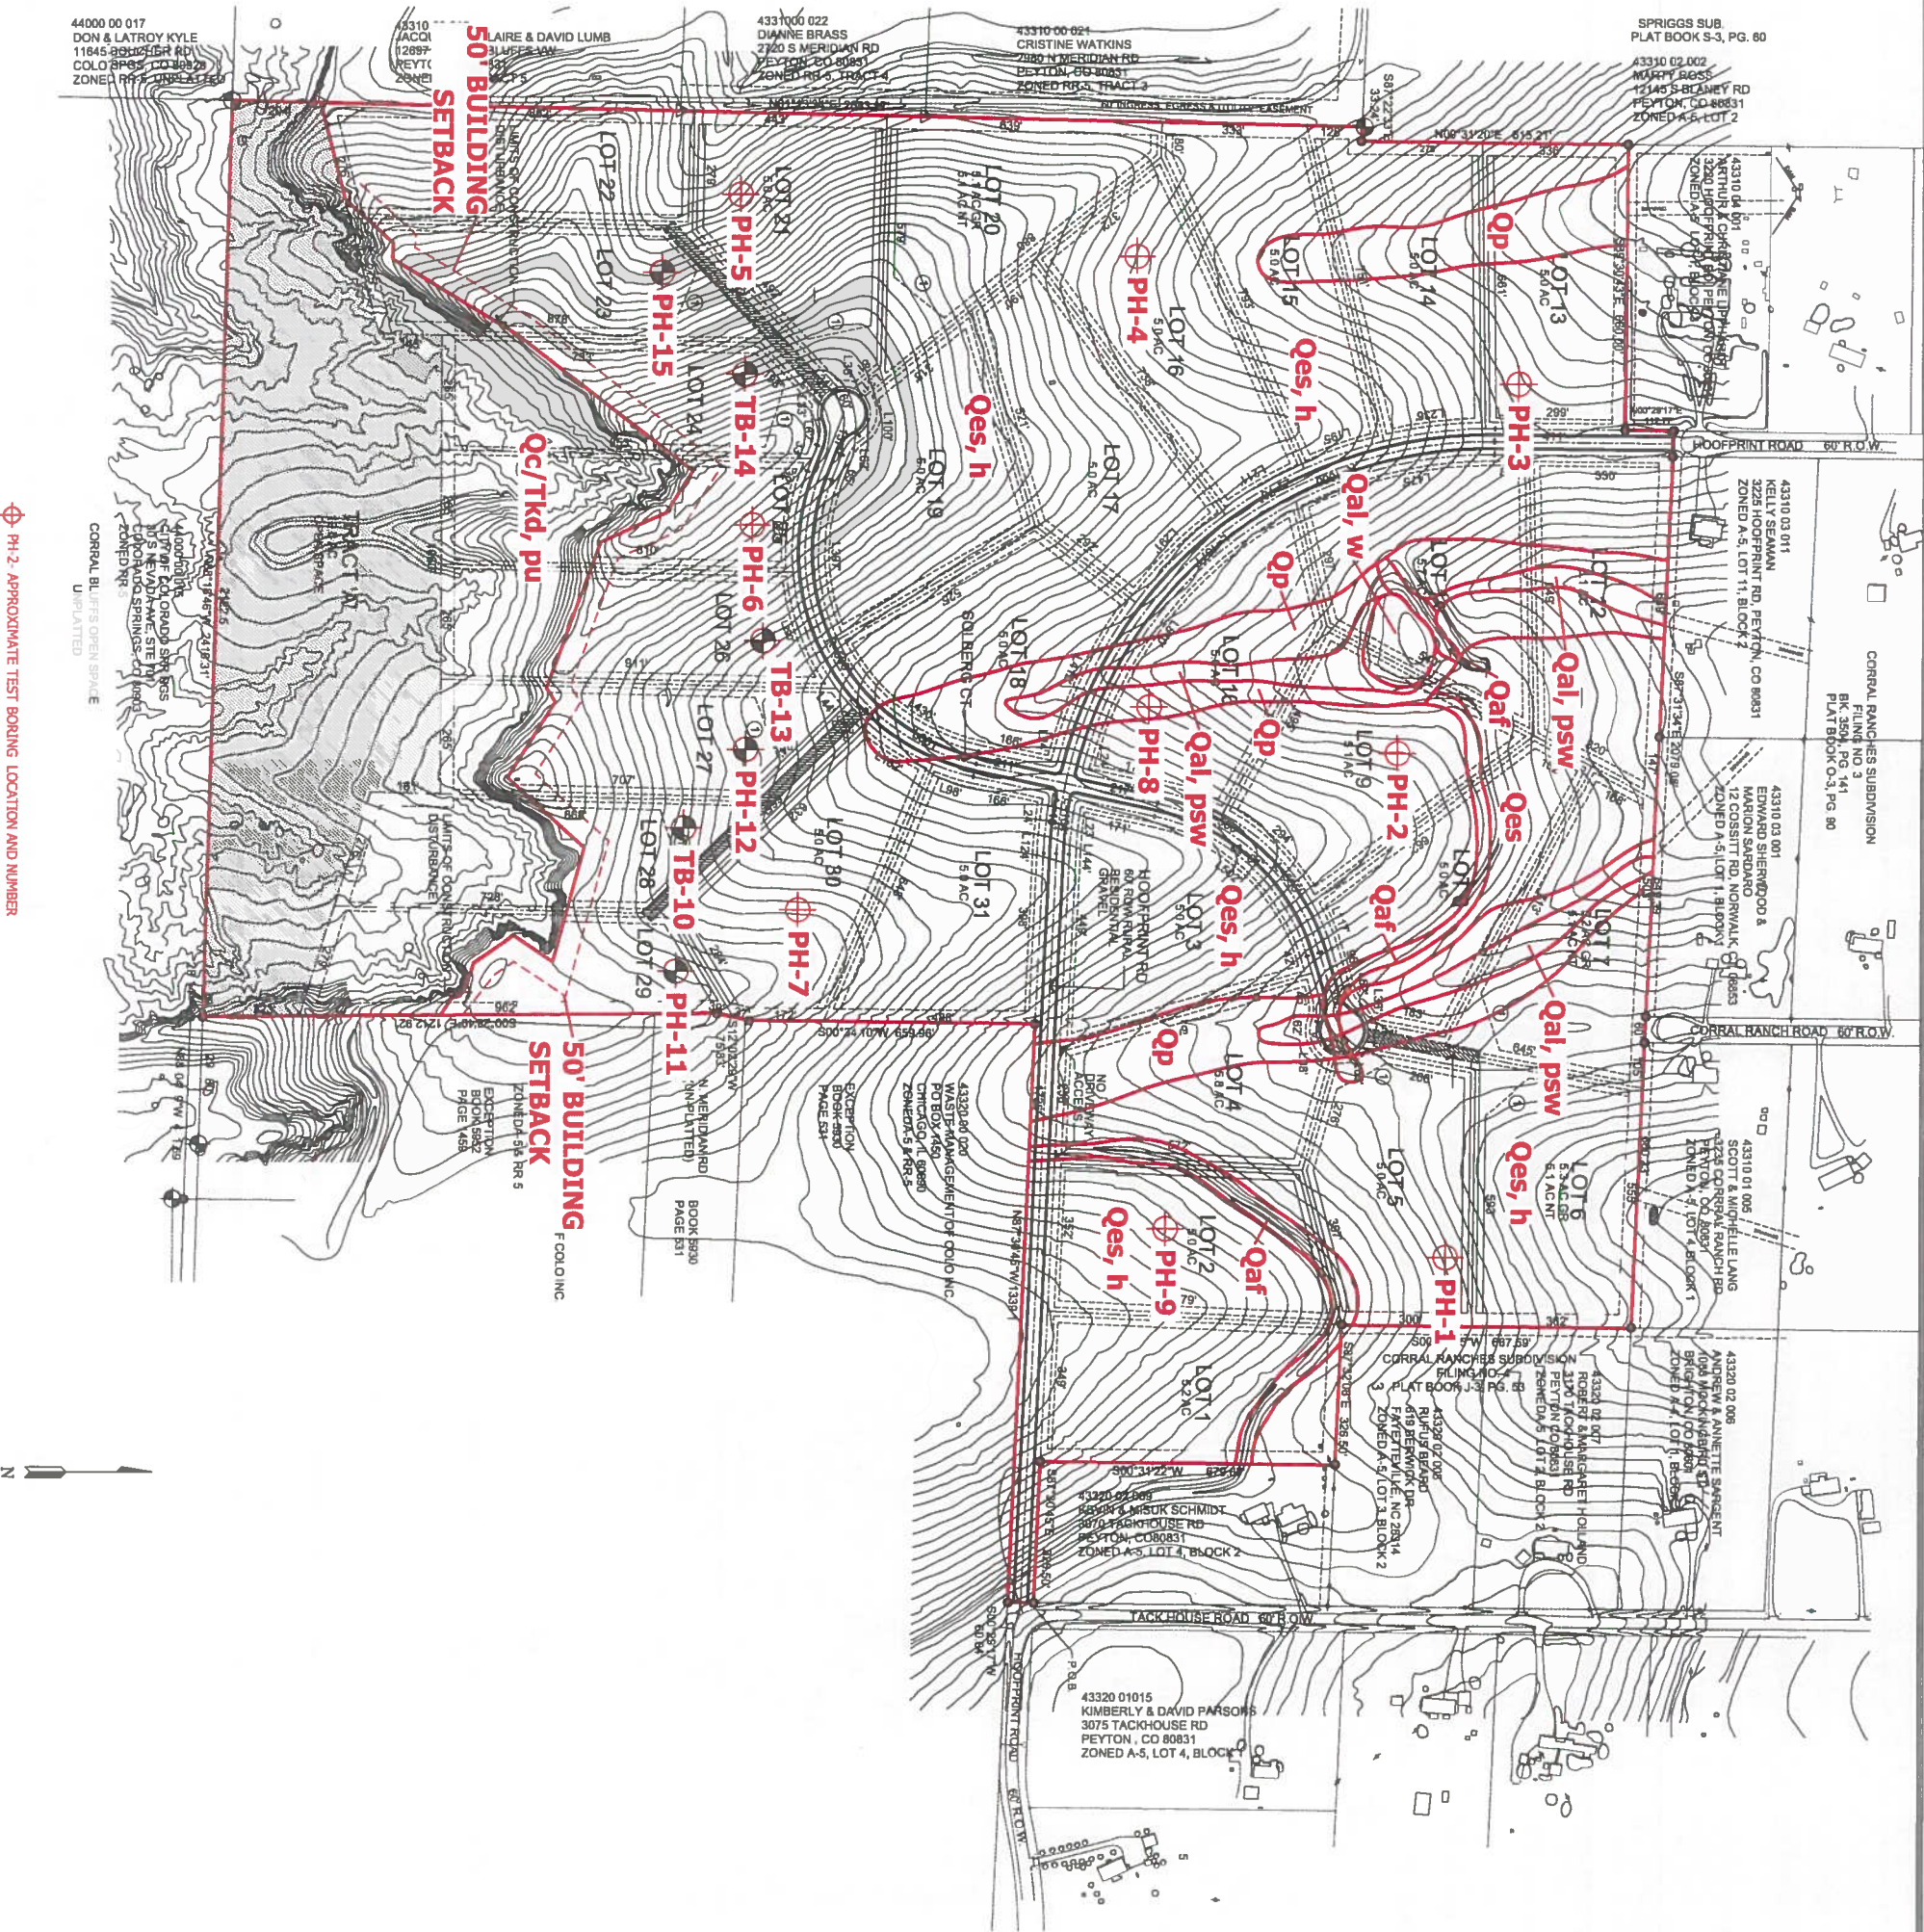
GEOLOGY/ENGINEERING GEOLOGY MAP  
THE RESERVE AT CORRAL BLUFFS  
EL PASO COUNTY, CO  
FOR: CORRAL RANCH DEVELOPMENT

Mapping has been performed on this site to produce an Engineering Geology Map (Figure 8). This map shows the location of various geologic conditions of which the developers should be cognizant during the planning, design and construction stages of the project. These hazards and the recommended mitigation techniques are as follows:

Mitigation: Building should be avoided in these areas. A building setback of 50 feet from the crest of these slopes is recommended. The building setback line is indicated on Figure 8. Proper control of drainage at both the surface and in the subsurface is extremely important. Areas of ponded water at the surface should be avoided above these slopes. Utility trenches, basement excavations and other subsurface features

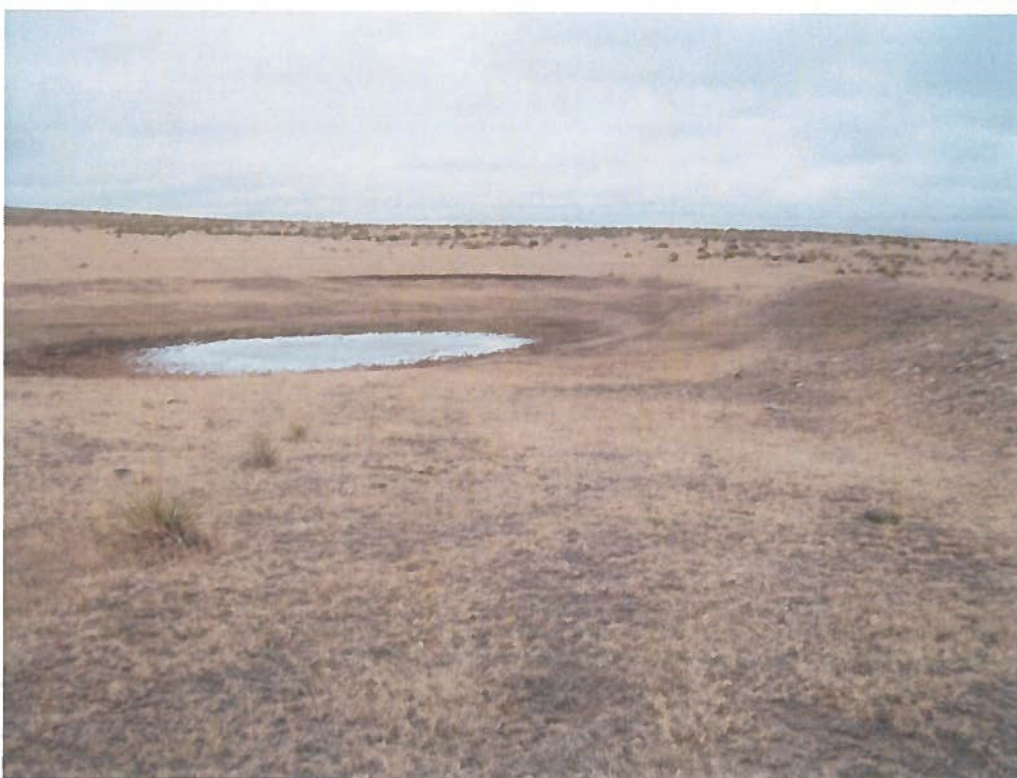
Fill associated with erosion berms and an earthen dam was observed on site. Additionally, other areas of artificial fill may be encountered in areas other than those mapped. These berms and dam are considered uncontrolled for construction purposes.

**Looking at dam and  
pond in central portion  
of the site.**

Mitigation: These areas are limited and it is anticipated they could be avoided by construction. Smaller erosion berms can be regraded or penetrated by foundations. Any uncontrolled fill encountered beneath foundation will require removal and recompaction at a minimum of 95 percent of its maximum Modified Proctor Dry Density, ASTM D-1557.

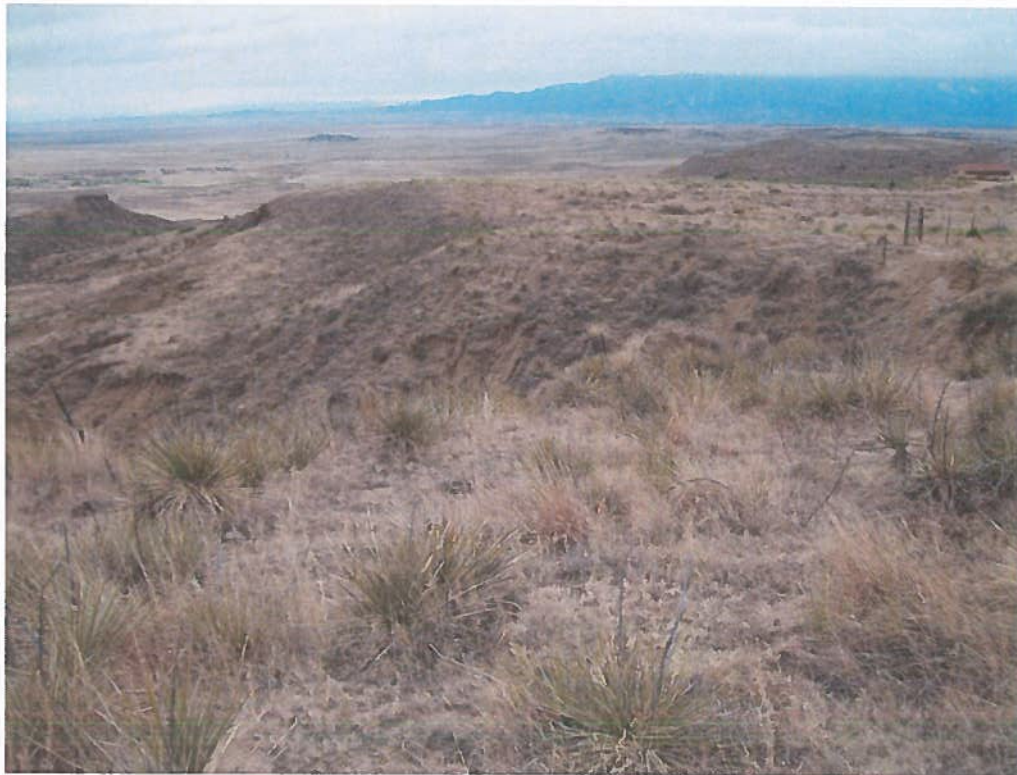
The majority of the slopes on-site are gently to moderately sloping and do not exhibit any past or potential unstable slopes or landslides. The steeply sloping areas in the southern portions of the site have been identified as potentially unstable slopes. These areas are designated as open space and non-build zones. The recommendations for these areas are as follows:

Considerable care must be exercised in these areas not to create a condition which would tend to activate instability.

**Looking south at  
potentially unstable  
slopes in south central  
portion of the site.**

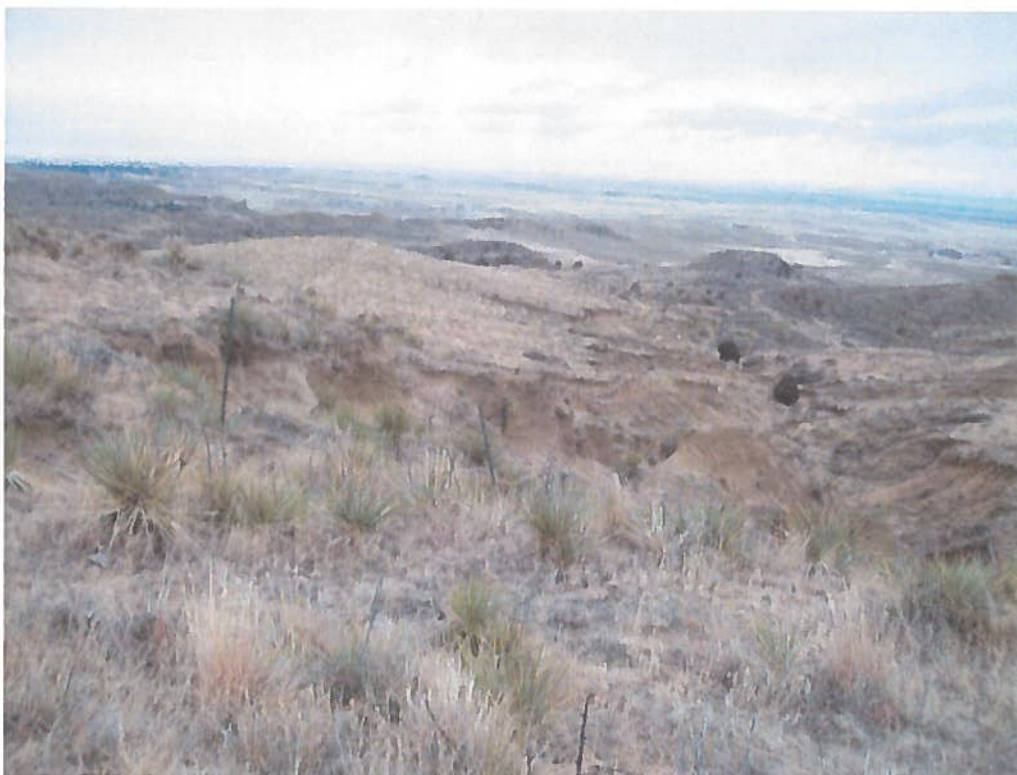
**Looking southeast at  
potentially unstable  
slopes in south central  
portion of the site.**
