September 20, 2019

Re: Soil, Geology and Geologic Hazard Evaluation  
Meridian Ranch – Rolling Hills Ranch, Filings 1 through 4  
SE of Sunrise Ridge Drive and Rex Road  
El Paso County, Colorado

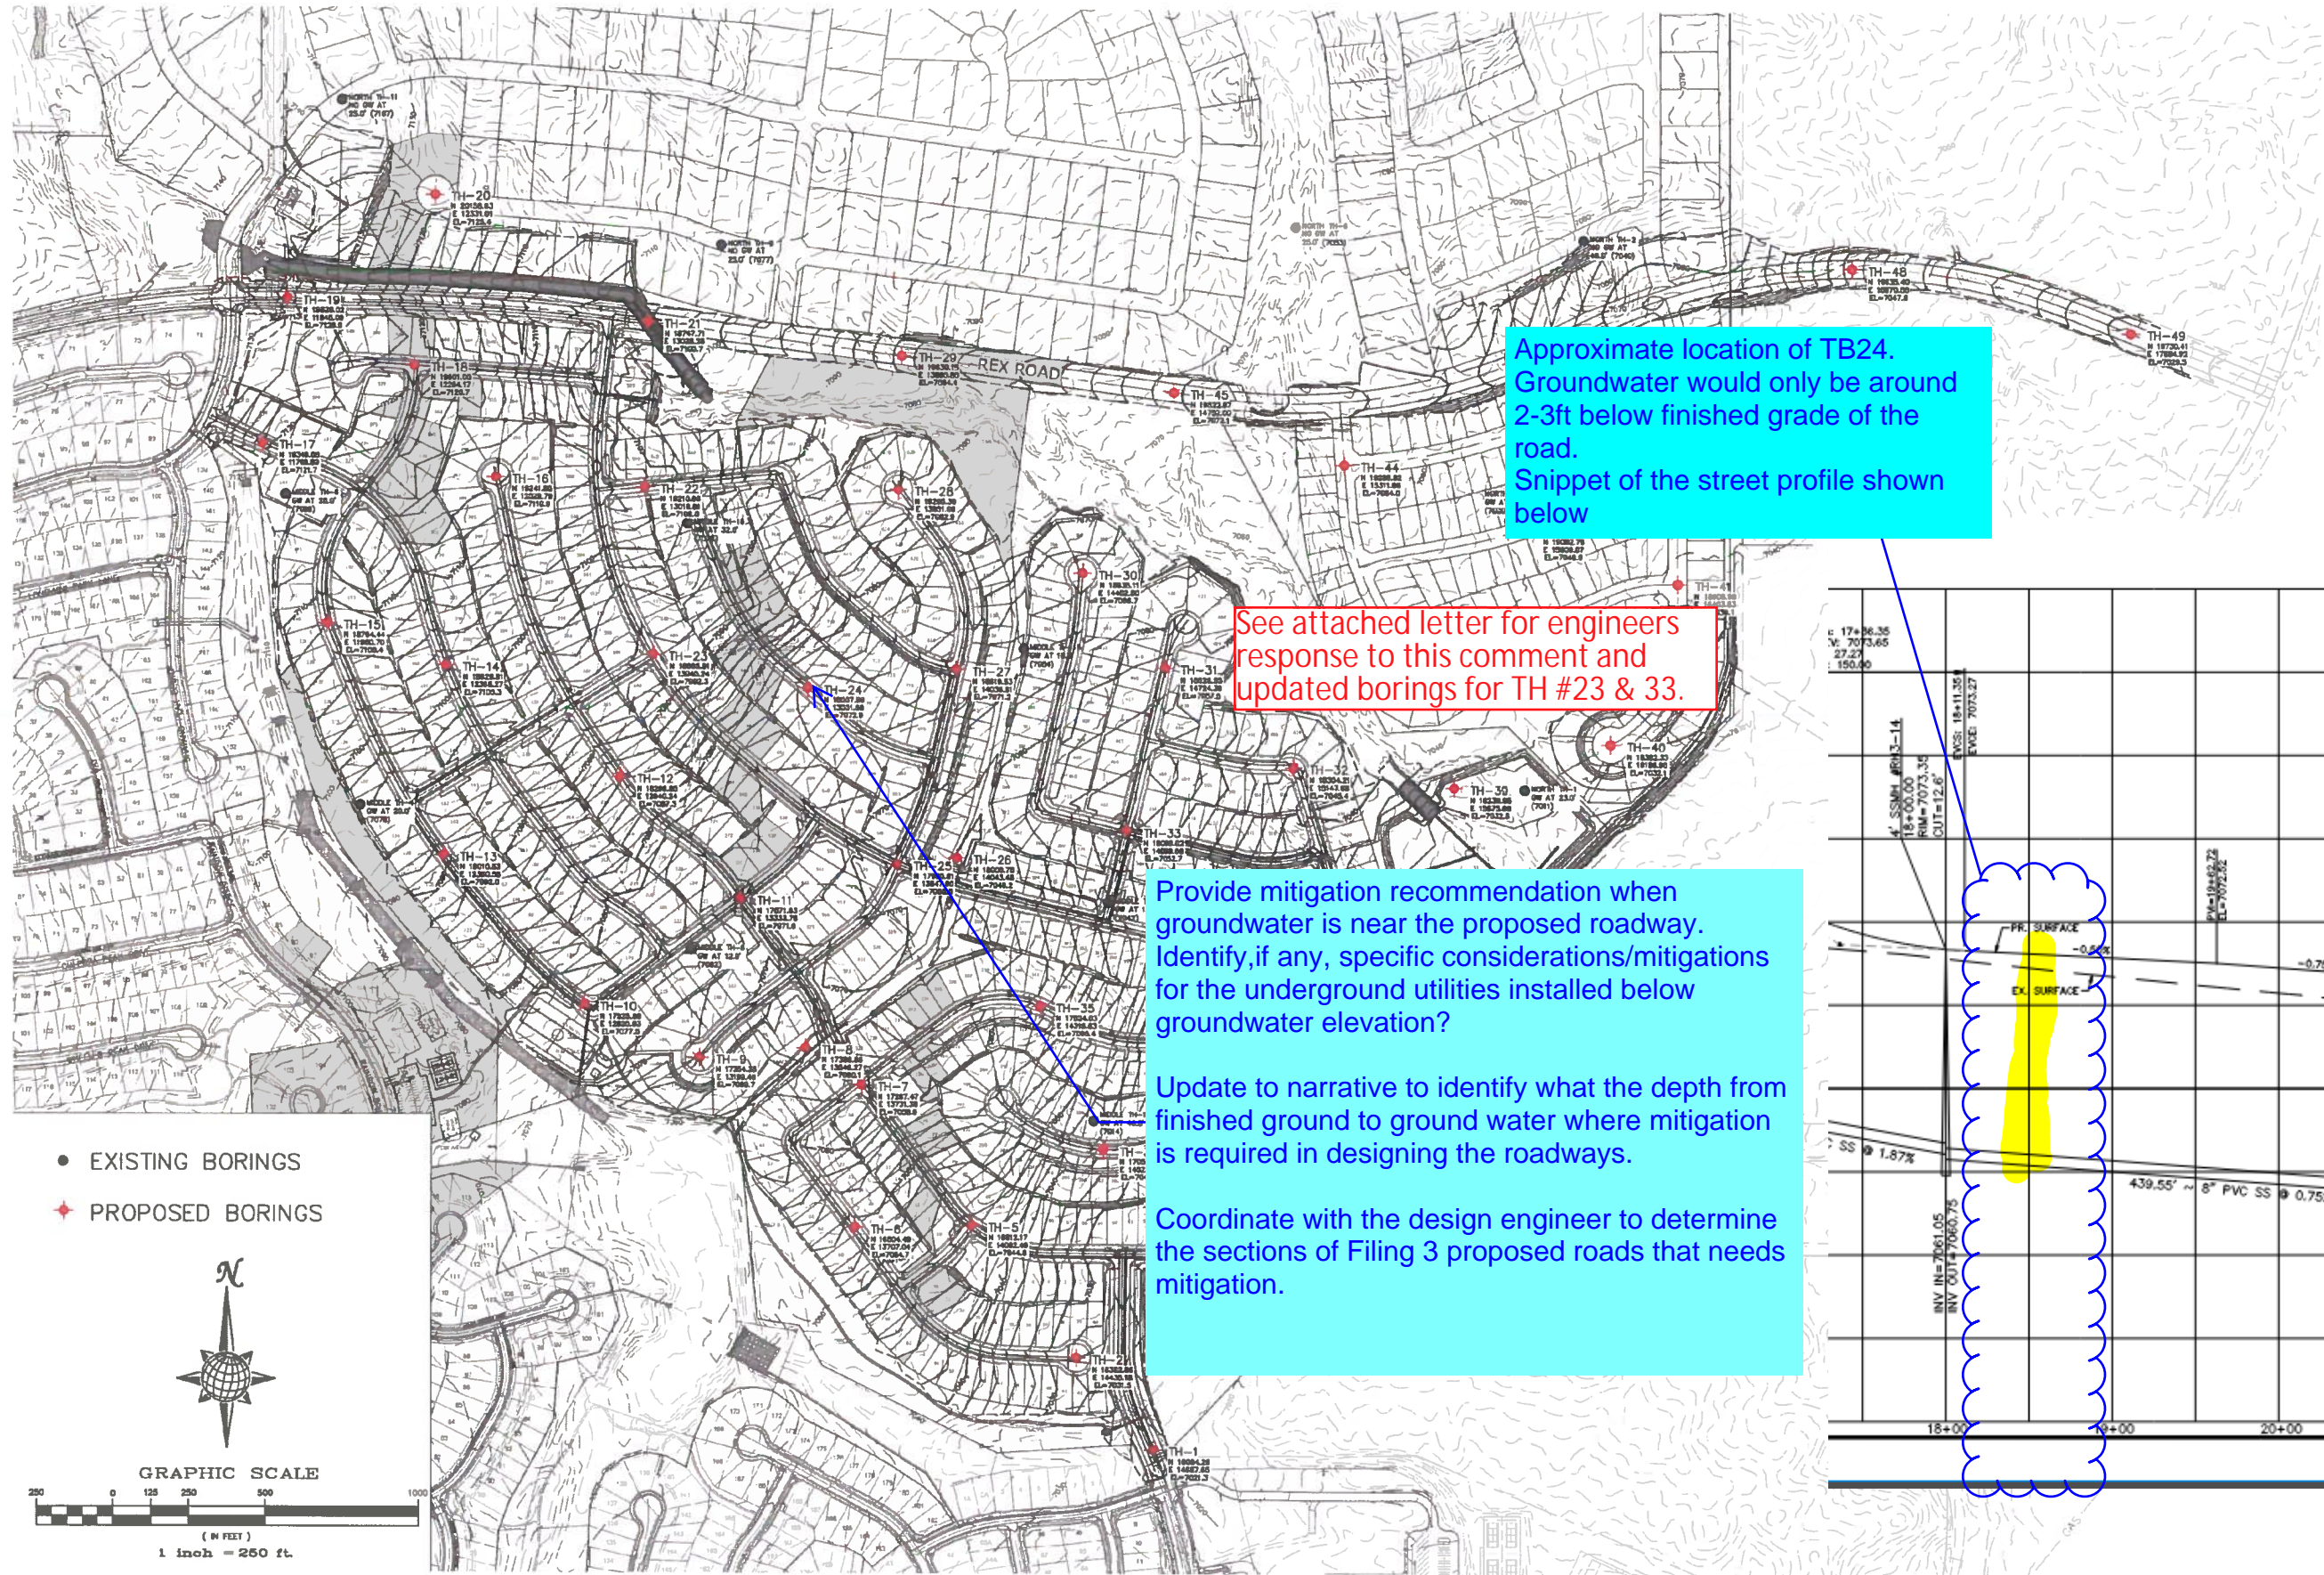
Approximate location of TB24. Groundwater would only be around 2-3ft below finished grade of the road. Snippet of the street profile shown below

Provide mitigation recommendation when groundwater is near the proposed roadway. Identify, if any, specific considerations/mitigations for the underground utilities installed below groundwater elevation?

Update to narrative to identify what the depth from finished ground to ground water where mitigation is required in designing the roadways.

See attached letter for engineers response to this comment and updated borings for TH #23 & 33.

Coordinate with the design engineer to determine the sections of Filing 3 proposed roads that needs mitigation.
