**GEOLOGIC HAZARD / LAND USE STUDY
AND PRELIMINARY
SUBSURFACE SOIL INVESTIGATION
STERLING RANCH
EL PASO COUNTY, COLORADO**

Morley-Bentley Investments, LLC
15 N. Nevada Avenue
Colorado Springs, Colorado 80903

October 31, 2006

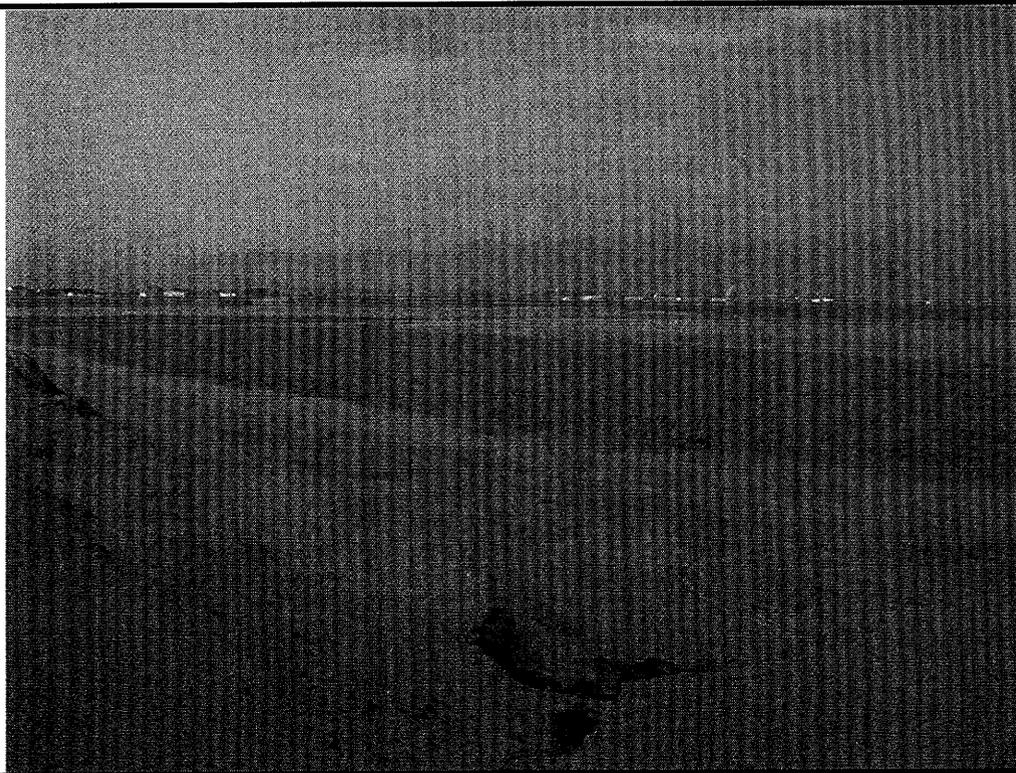
**Looking south at quarry
in central portion of the
site.**

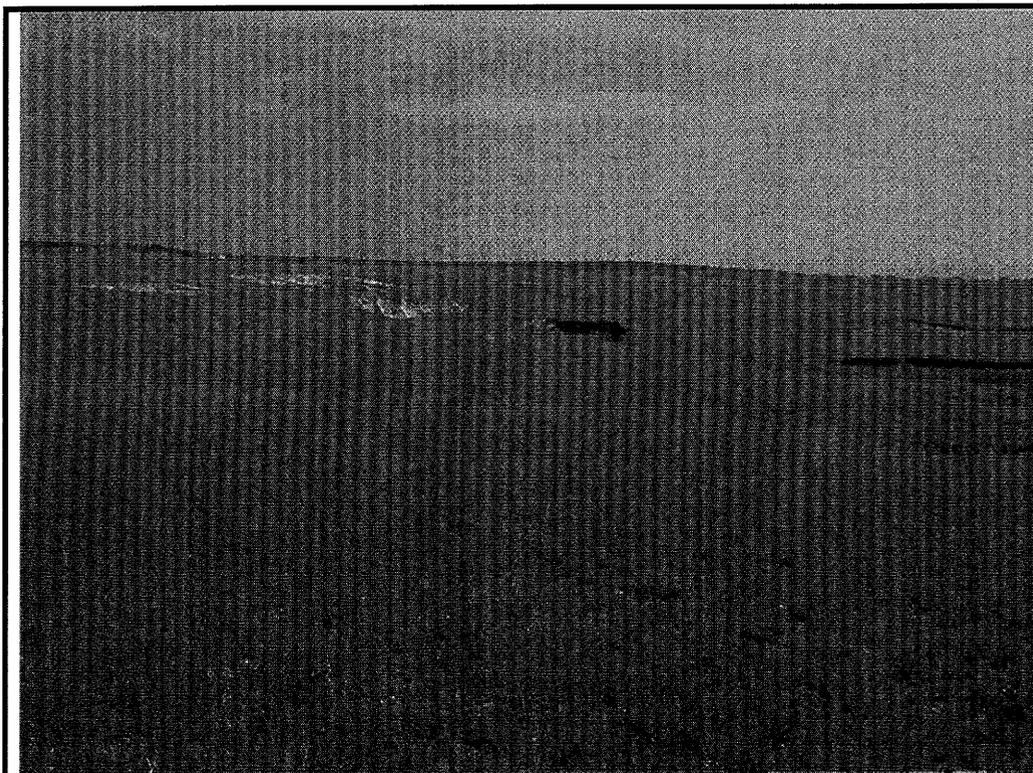
**Looking east at
drainages in west central
portion of the site.**
