**SOILS AND GEOLOGY STUDY
RETREAT AT TIMBERRIDGE FILING NO. 4
PARCEL NO. 52220-00-023
EL PASO COUNTY, COLORADO**

Prepared for:
**TimberRidge Development Group, LLC
2138 Flying Horse Club Drive
Colorado Springs, CO 80921**

December 21, 2023
Revised June 17, 2024
Revised August 6, 2024
Revised August 30, 2024

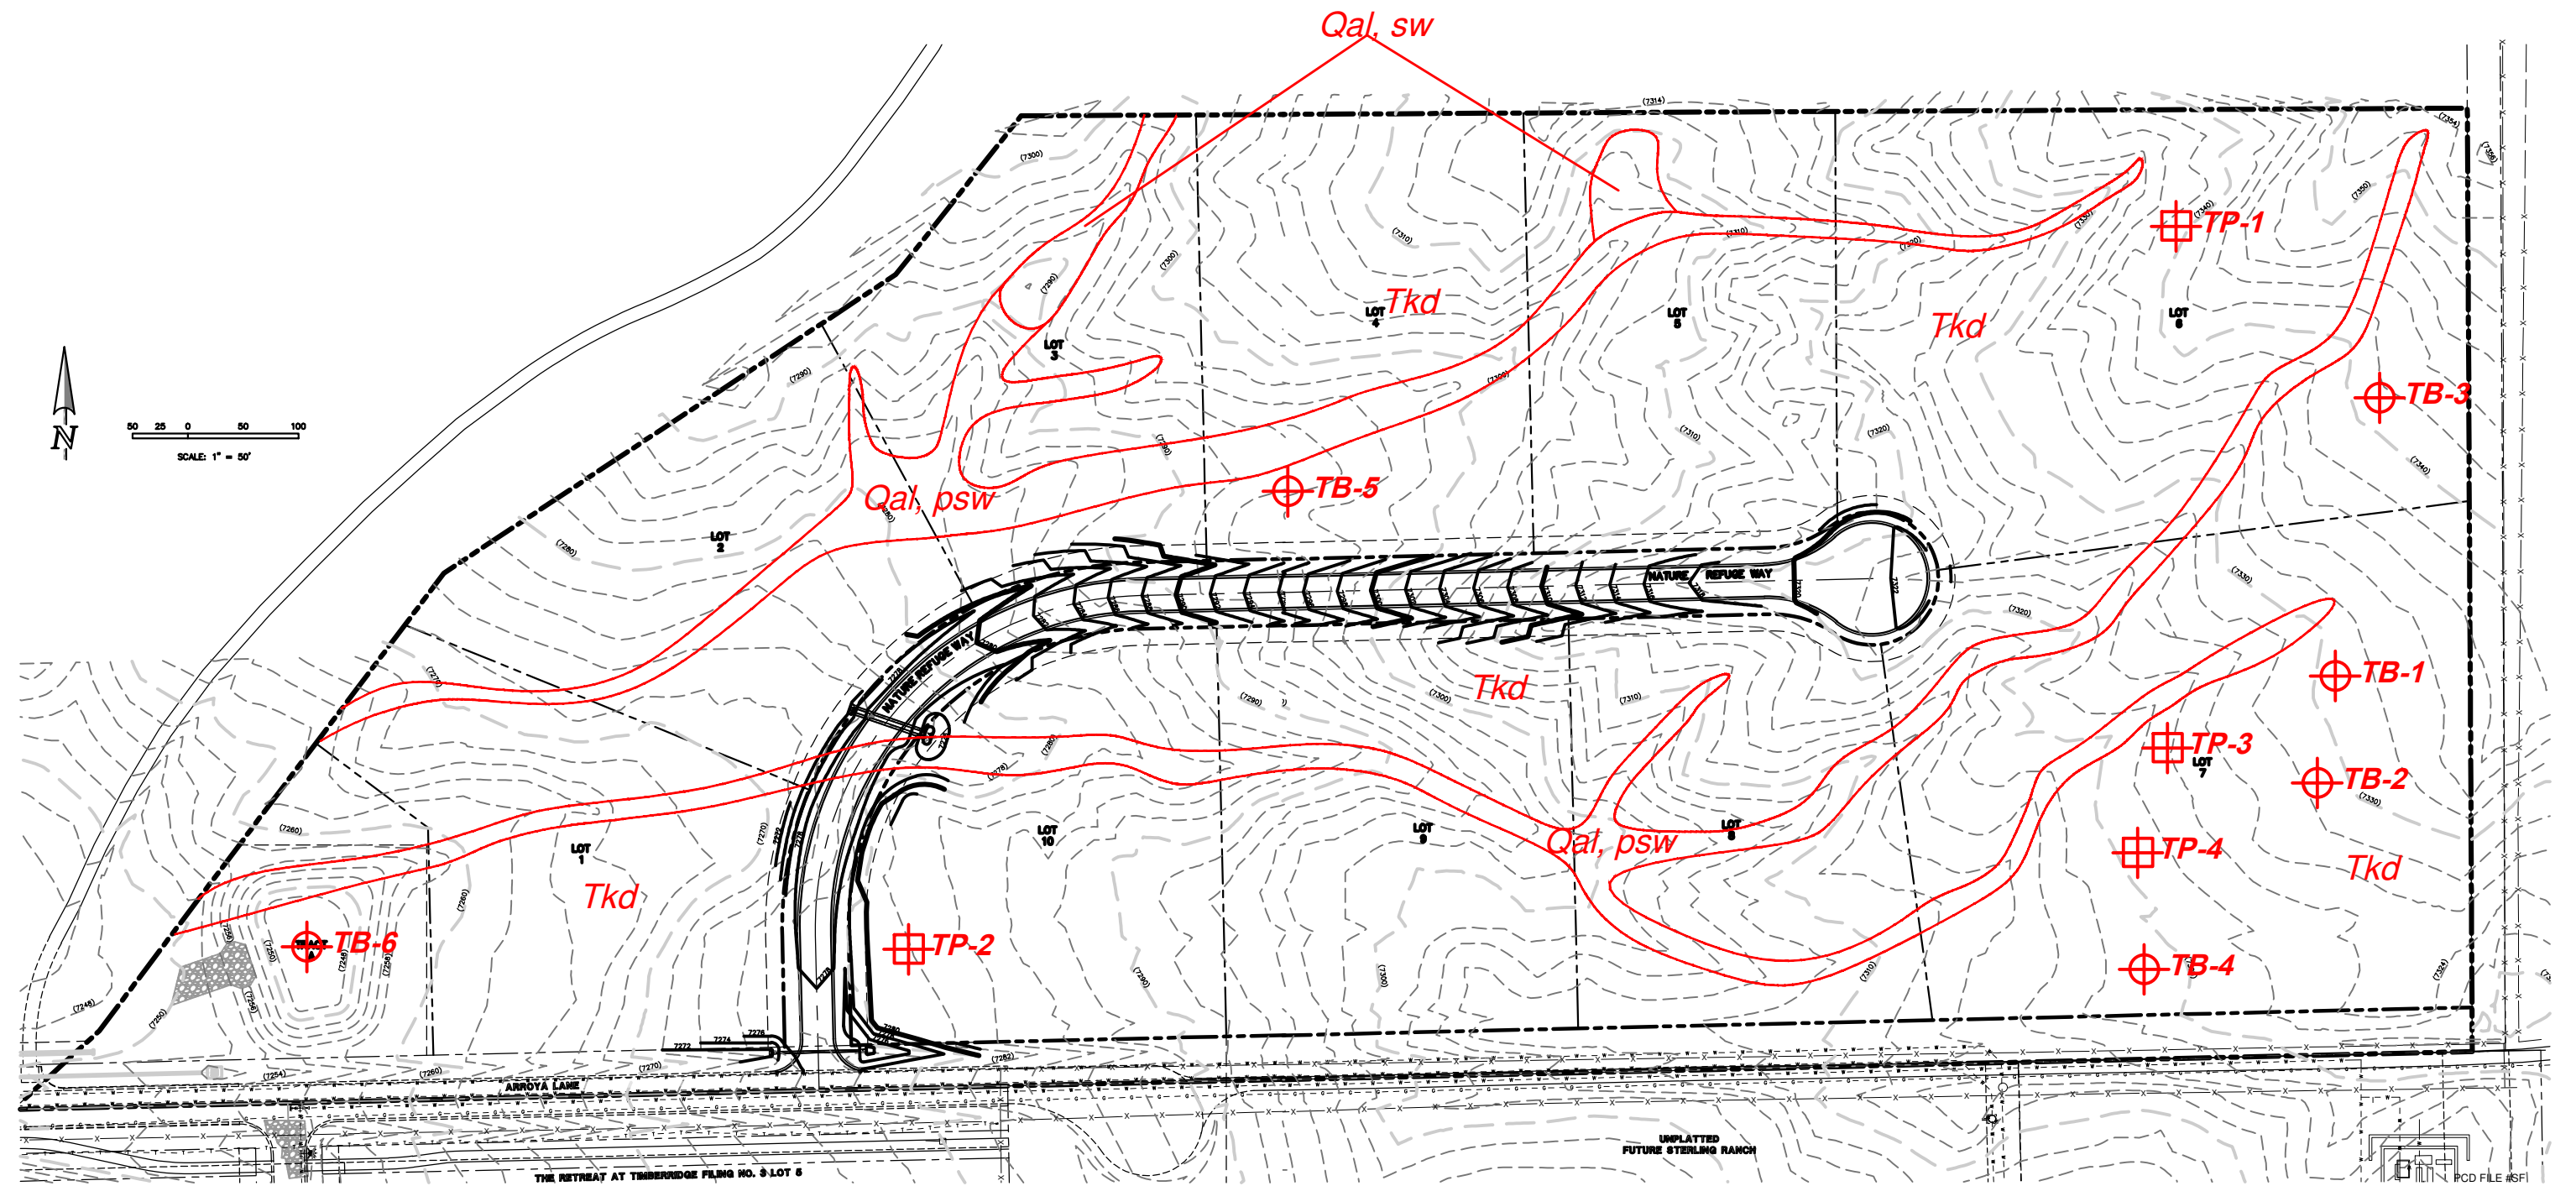
FIG. 6

The northern side of the proposed embankment for the Extended Detention Basin (EDB) is located in a potential seasonal shallow groundwater area as indicated on the Geology/Engineering Geology Map, Figure 6. An additional test boring (TB-6) was drilled in the EDB to a depth of 20 feet. Groundwater was not encountered in the boring during or subsequent to drilling. Areas receiving fill may require stabilization with rock or geogrid if shallow groundwater conditions are encountered. A private storm sewer that discharges to the EDB is proposed along a section of Nature Refuge Way and through the drainage easement on Lot 1. Additional investigation of the pond is recommended as plans are finalized and prior to construction.

The northern side of the proposed embankment for the EDB is located in a potential seasonal shallow groundwater area as indicated on the Geology/Engineering Geology Map, Figure 6. Based on the soils types and the gradual existing slopes near the EDB location lining of the EDB is not necessary. Any areas to receive fill should have all topsoil, organic material or debris removed. Prior to fill placement Entech should observe the subgrade. Fill must be properly benched and compacted to minimize potentially unstable conditions in slope areas. Fill slopes should be 3:1 or flatter. The subgrade should be scarified and moisture conditioned to within 2% of optimum moisture content and compacted to a minimum of 95% of its maximum Modified Proctor Dry Density, ASTM D-1557, prior to placing new fill. Areas receiving fill may require stabilization with rock or fabric if shallow groundwater conditions are encountered.

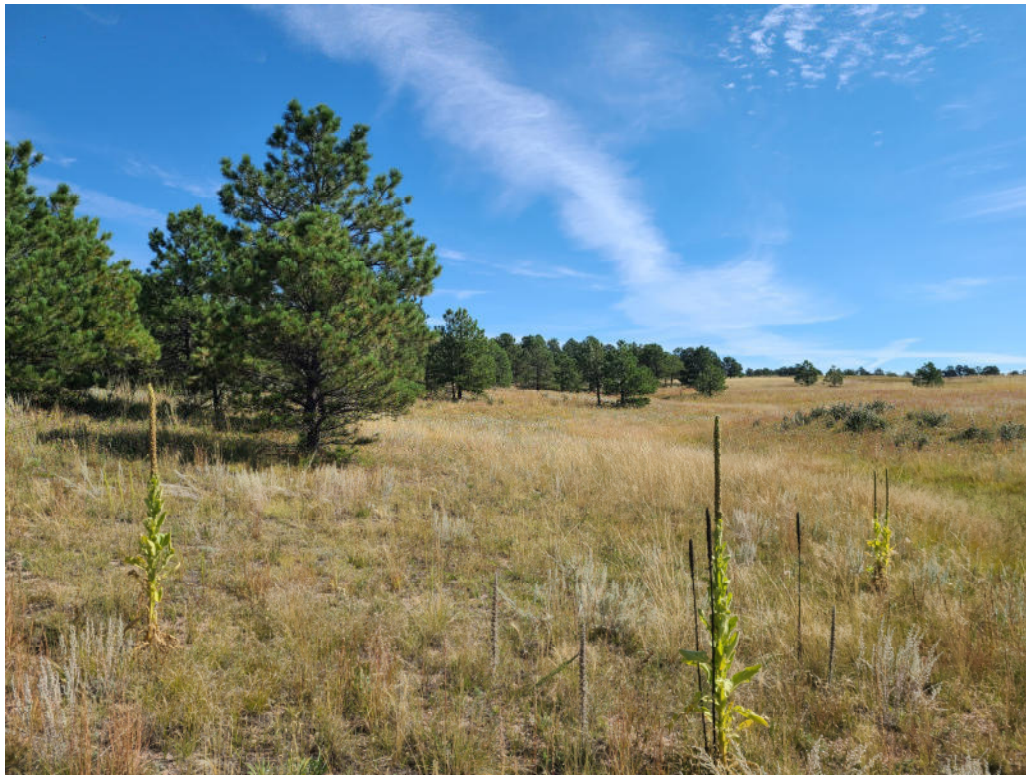
**Looking east towards
erosion feature eastern
side of site.**
