ENTECH
ENGINEERING, INC.

**SOILS AND GEOLOGY STUDY
RETREAT AT TIMBERRIDGE FILING NO. 4
PARCEL NO. 52220-00-023
EL PASO COUNTY, COLORADO**

December 21, 2023
Revised June 17, 2024
Revised August 6, 2024

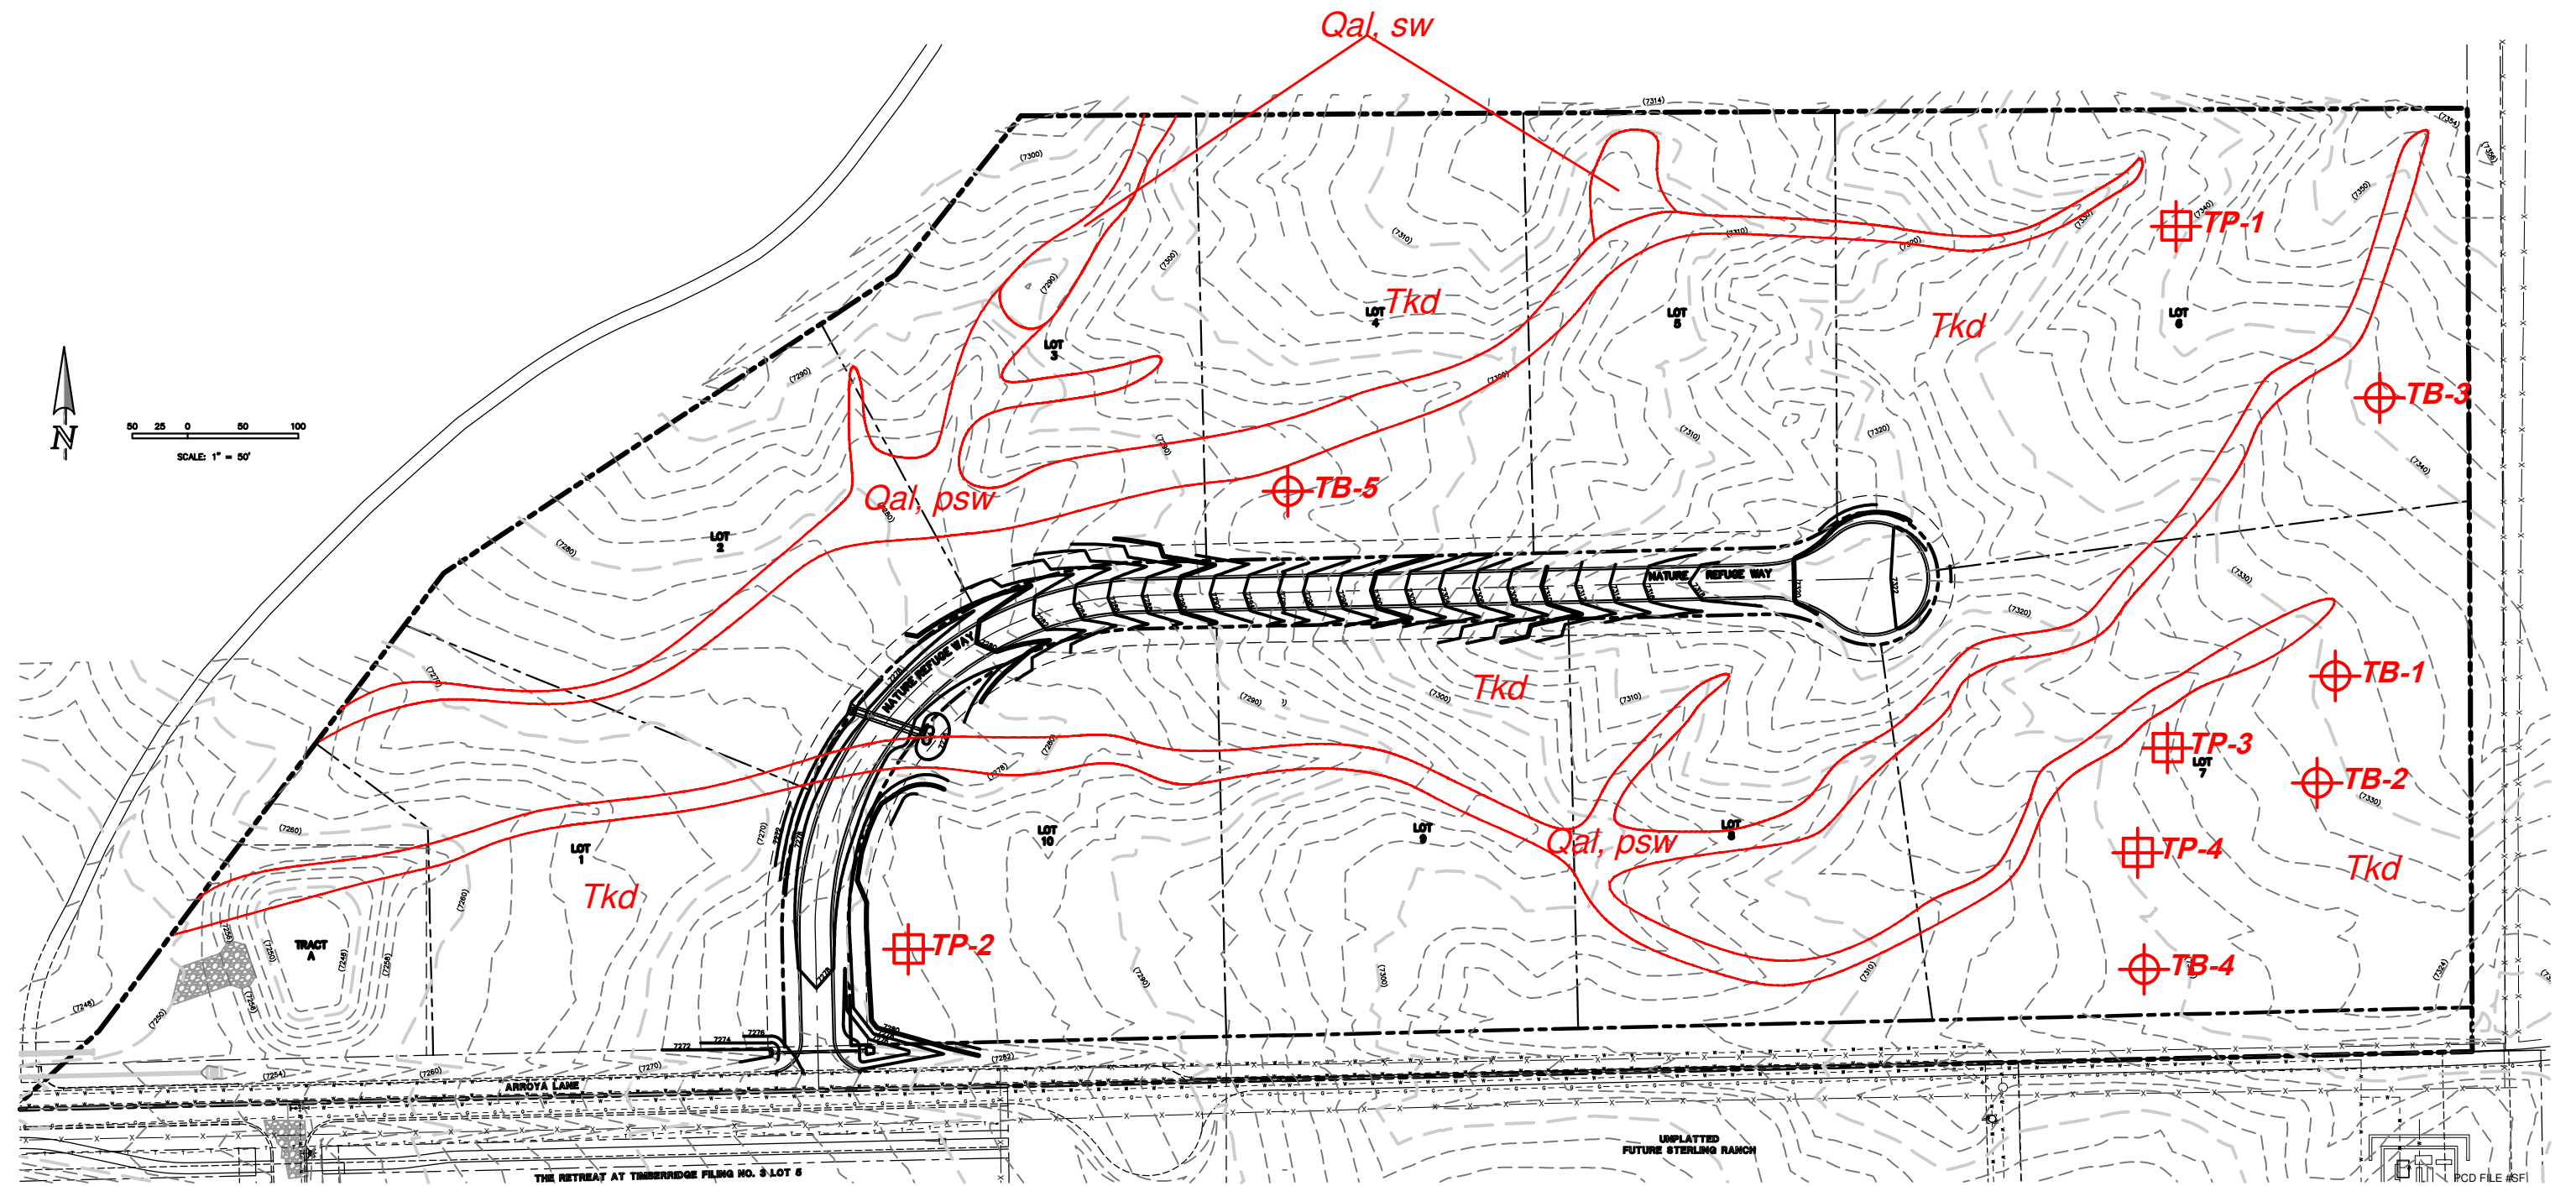
FIG. 6

The northern side of the proposed embankment for the Extended Detention Basin (EDB) is located in a potential seasonal shallow groundwater area as indicated on the Geology/Engineering Geology Map, Figure 6. Areas receiving fill may require stabilization with rock or geogrid if shallow groundwater conditions are encountered. A private storm sewer that discharges to the EDB is proposed along a section of Nature Refuge Way and through the drainage easement on Lot 1. **Additional investigation of the pond is recommended as plans are finalized and prior to construction.**

Areas of potential seasonally and seasonally shallow groundwater were observed on site. The seasonally shallow groundwater areas are located in the northern portions of Lots 3 and 5. The potentially shallow groundwater areas have been identified across the site, in these areas we would anticipated the potential for higher groundwater levels. Drains may be necessary for structures adjacent to these areas to help prevent the intrusion of water into areas below grade. Typical drain details are presented in Figures 9 to 11. The site does not lie within any floodplain zones according to the FEMA Map No. 08041CO535G, dated December 7, 2108 (Figure 8, Reference 8). Exact locations of floodplain and specific drainage studies are beyond the scope of this report.

The northern side of the proposed embankment for the EDB is located in a potential seasonal shallow groundwater area as indicated on the Geology/Engineering Geology Map, Figure 6. Based on the soils types and the gradual existing slopes near the EDB location lining of the EDB is not necessary. Any areas to receive fill should have all topsoil, organic material or debris removed. Prior to fill placement Entech should observe the subgrade. Fill must be properly benched and compacted to minimize potentially unstable conditions in slope areas. Fill slopes should be 3:1 or flatter. The subgrade should be scarified and moisture conditioned to within 2% of optimum moisture content and compacted to a minimum of 95% of its maximum Modified Proctor Dry Density, ASTM D-1557, prior to placing new fill. Areas receiving fill may require stabilization with rock or fabric if shallow groundwater conditions are encountered.

Mitigation: Foundations must have a minimum 30-inch depth for frost protection. In areas where high subsurface moisture conditions are anticipated periodically, subsurface perimeter drains are recommended to help prevent the intrusion of water into areas below grade. Seasonally shallow groundwater areas are located in the northern portions of Lots 3 and 5. The potentially shallow groundwater areas have been identified across the site (building in these areas is not anticipated). In these areas we would anticipated the potential for higher groundwater levels. Fill added to these areas further raise foundations above groundwater levels if earthwork is proposed. Foundations should be kept as high as possible. Areas may experience higher groundwater levels during period of higher precipitation where water can flow through permeable sands on top of less permeable bedrock materials. Subsurface perimeter drains may be necessary to prevent the intrusion of water into areas below grade. Typical drain details are presented in Figure 8. **Where shallow groundwater is encountered, underslab drains or interceptor drains may be necessary.** Typical drain details are presented in Figures 9 and 11. It is anticipated that the shallow water areas will be avoided or mitigated with site grading and the installation of sewer underdrains. Specific recommendations should be made after additional investigation and site grading has been completed.

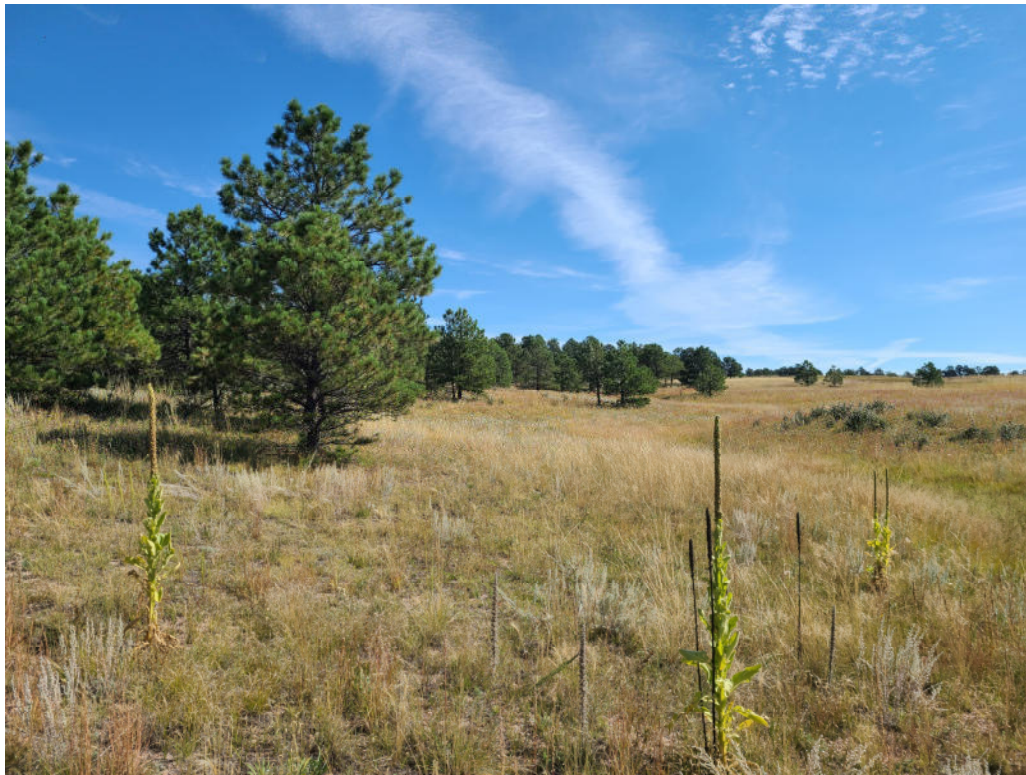
**Looking east towards
erosion feature eastern
side of site.**
