ENTECH
ENGINEERING, INC.

**WASTEWATER STUDY
RETREAT AT TIMBERRIDGE FILING NO. 4
PARCEL NO. 52220-00-023
EL PASO COUNTY, COLORADO**

December 21, 2023

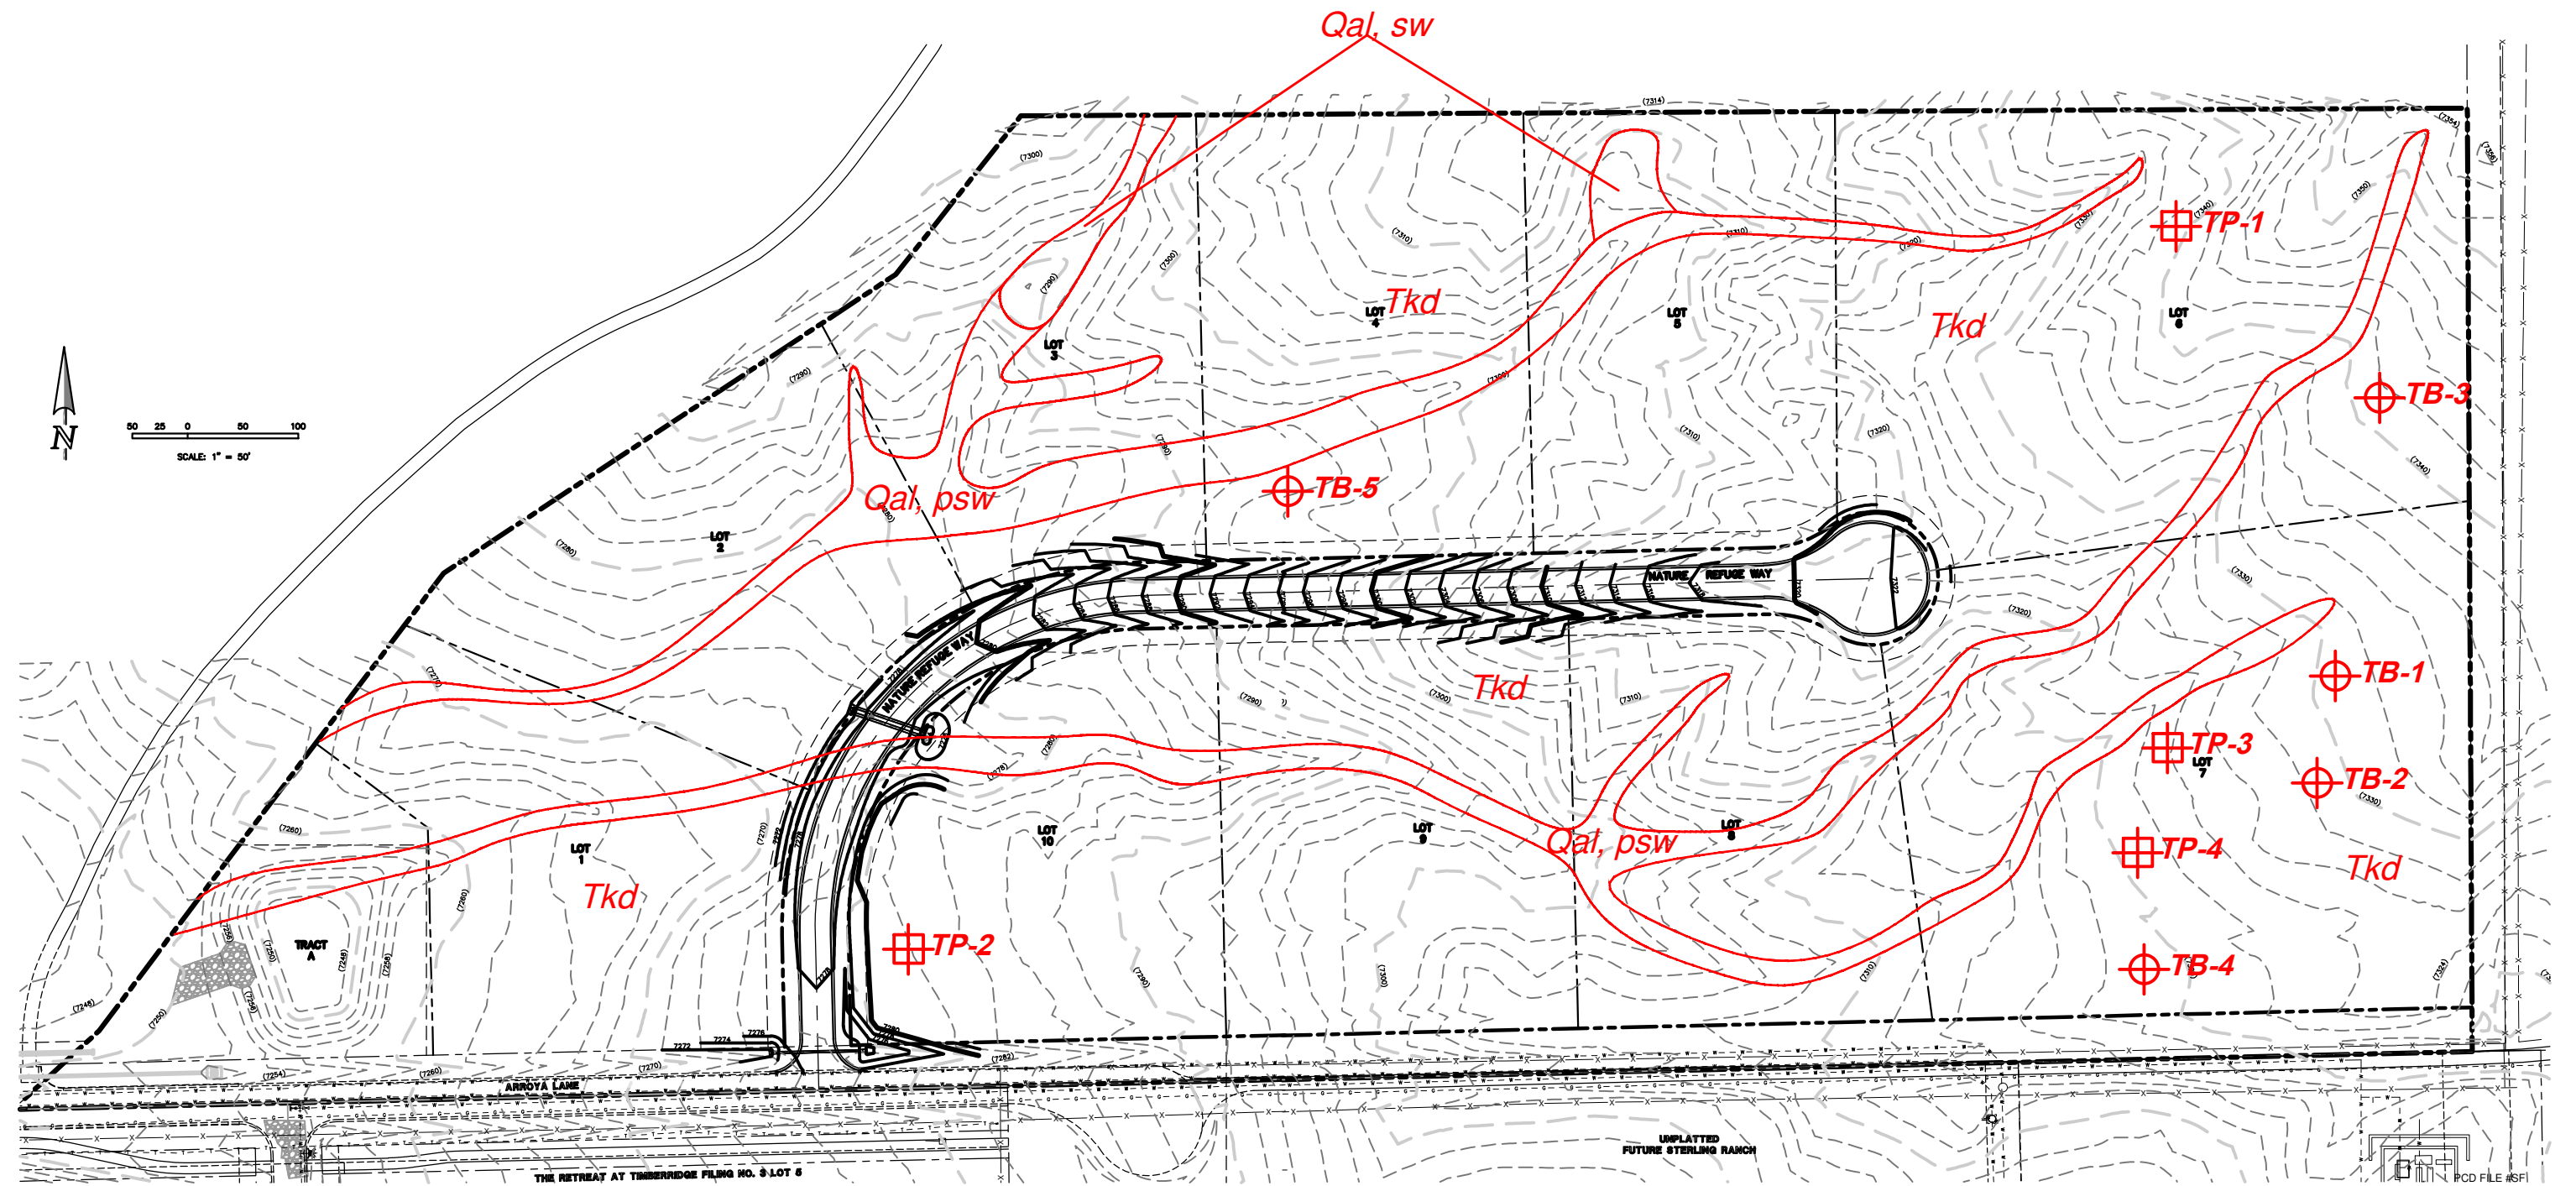
FIG. 6

Drainage areas mapped with potential seasonally and seasonally shallow groundwater are located on the proposed lots. In these areas a 25-foot setback for the soil treatment area will be required. This will limit the potential buildable areas on the lots depending on the final size of the anticipated OWTS. Signs of seasonally occurring groundwater were observed in the Test Pit No. 2 at 5 feet. Weathered bedrock was encountered at approximately 1 to 3.5 feet in the test pits.

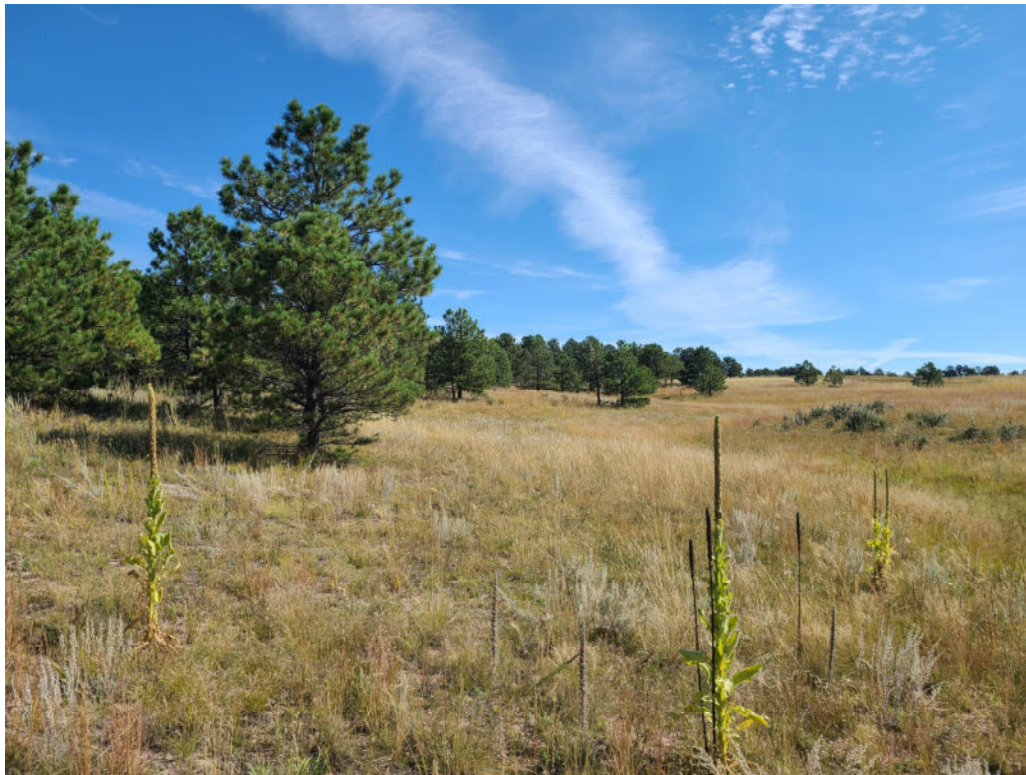
Looking east towards erosion feature eastern side of site.
