**SOILS AND GEOLOGY STUDY
RETREAT AT TIMBERRIDGE FILING NO. 4
PARCEL NO. 52220-00-023
EL PASO COUNTY, COLORADO**

Prepared for:
**TimberRidge Development Group, LLC
2138 Flying Horse Club Drive
Colorado Springs, CO 80921**

December 21, 2023
Revised June 17, 2024

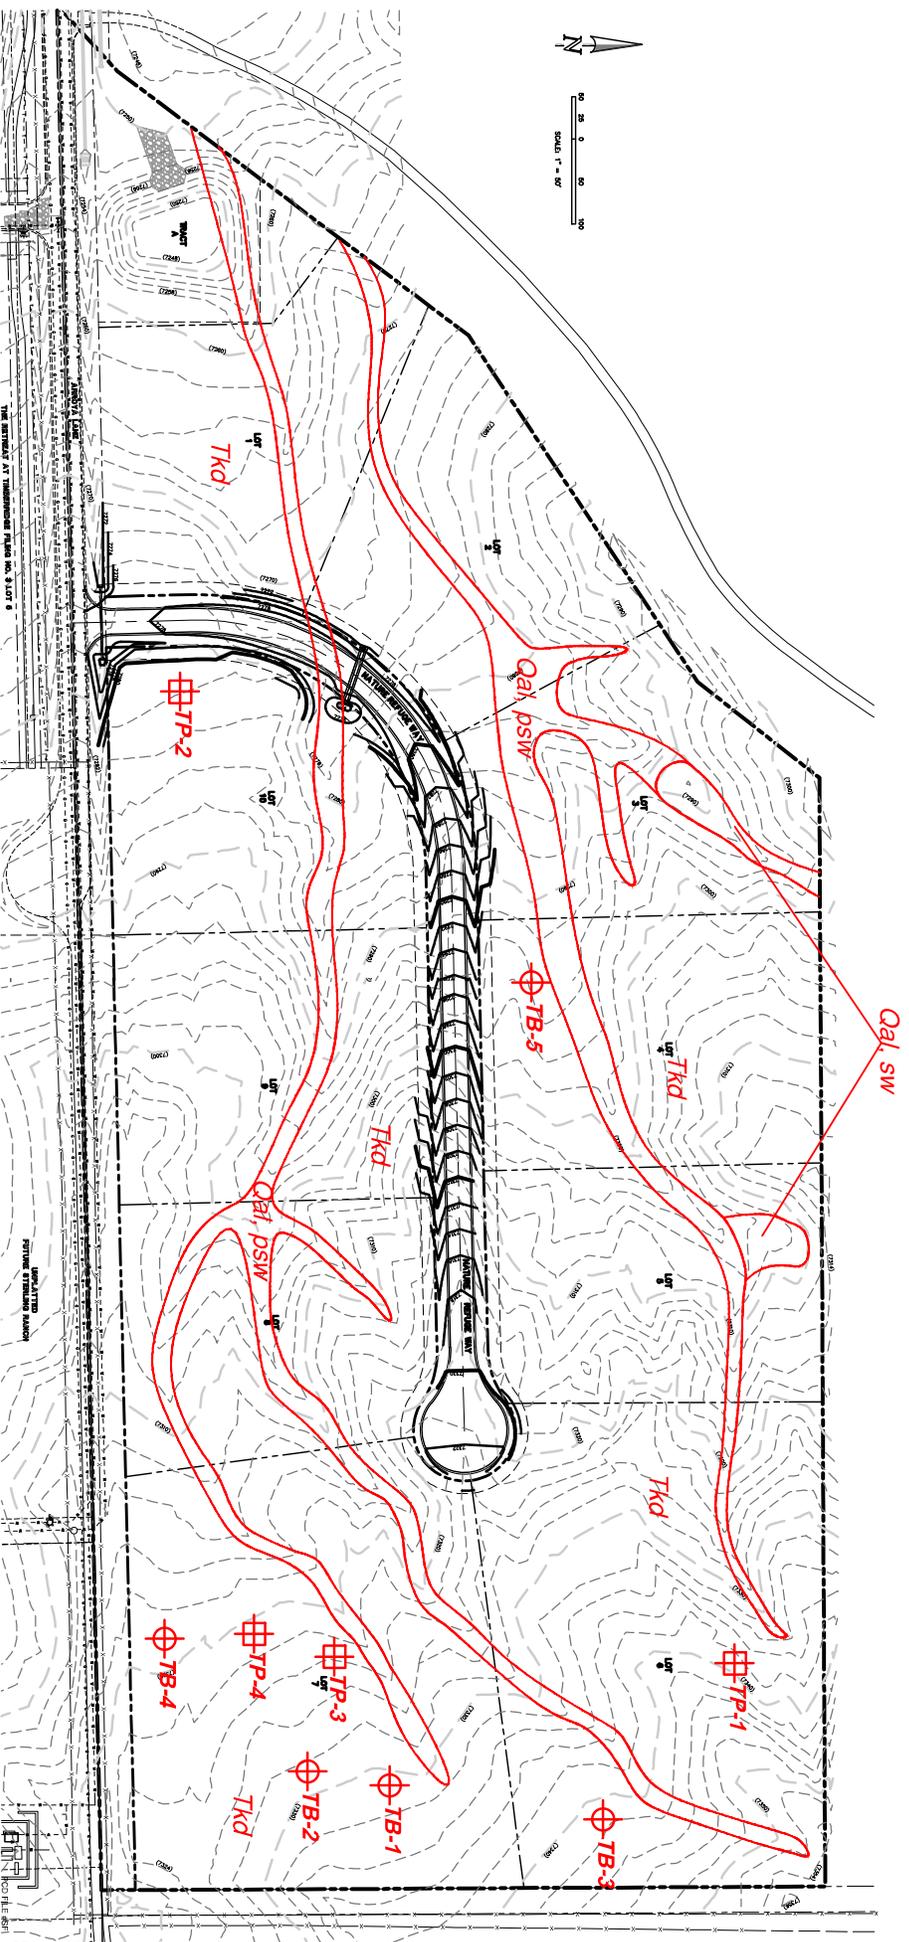
GEOLOGY / ENGINEERING MAP
 RETREAT AT TIMBERRIDGE FIL. NO. 4
 EL PASO COUNTY, CO
 TIMBERRIDGE DEVELOPMENT GROUP, LLC

The northern side of the proposed embankment for the Extended Detention Basin (EDB) is located in a potential seasonal shallow groundwater area as indicated on the Geology/Engineering Geology Map, Figure 6. Areas receiving fill may require stabilization with rock or geogrid if shallow groundwater conditions are encountered. A private storm sewer that discharges to the EDB is proposed along a section of Nature Refuge Way and through the drainage easement on Lot 1. A vane grate inlet that is connected to the storm sewer is proposed in the potential seasonal shallow groundwater area on the northeastern side of the proposed embankment.

The northern side of the proposed embankment for the EDB is located in a potential seasonal shallow groundwater area as indicated on the Geology/Engineering Geology Map, Figure 6. Based on the soils types and the gradual existing slopes near the EDB location lining of the EDB is not necessary. Any areas to receive fill should have all topsoil, organic material or debris removed. Prior to fill placement Entech should observe the subgrade. Fill must be properly benched and compacted to minimize potentially unstable conditions in slope areas. Fill slopes should be 3:1 or flatter. The subgrade should be scarified and moisture conditioned to within 2% of optimum moisture content and compacted to a minimum of 95% of its maximum Modified Proctor Dry Density, ASTM D-1557, prior to placing new fill. Areas receiving fill may require stabilization with rock or fabric if shallow groundwater conditions are encountered.

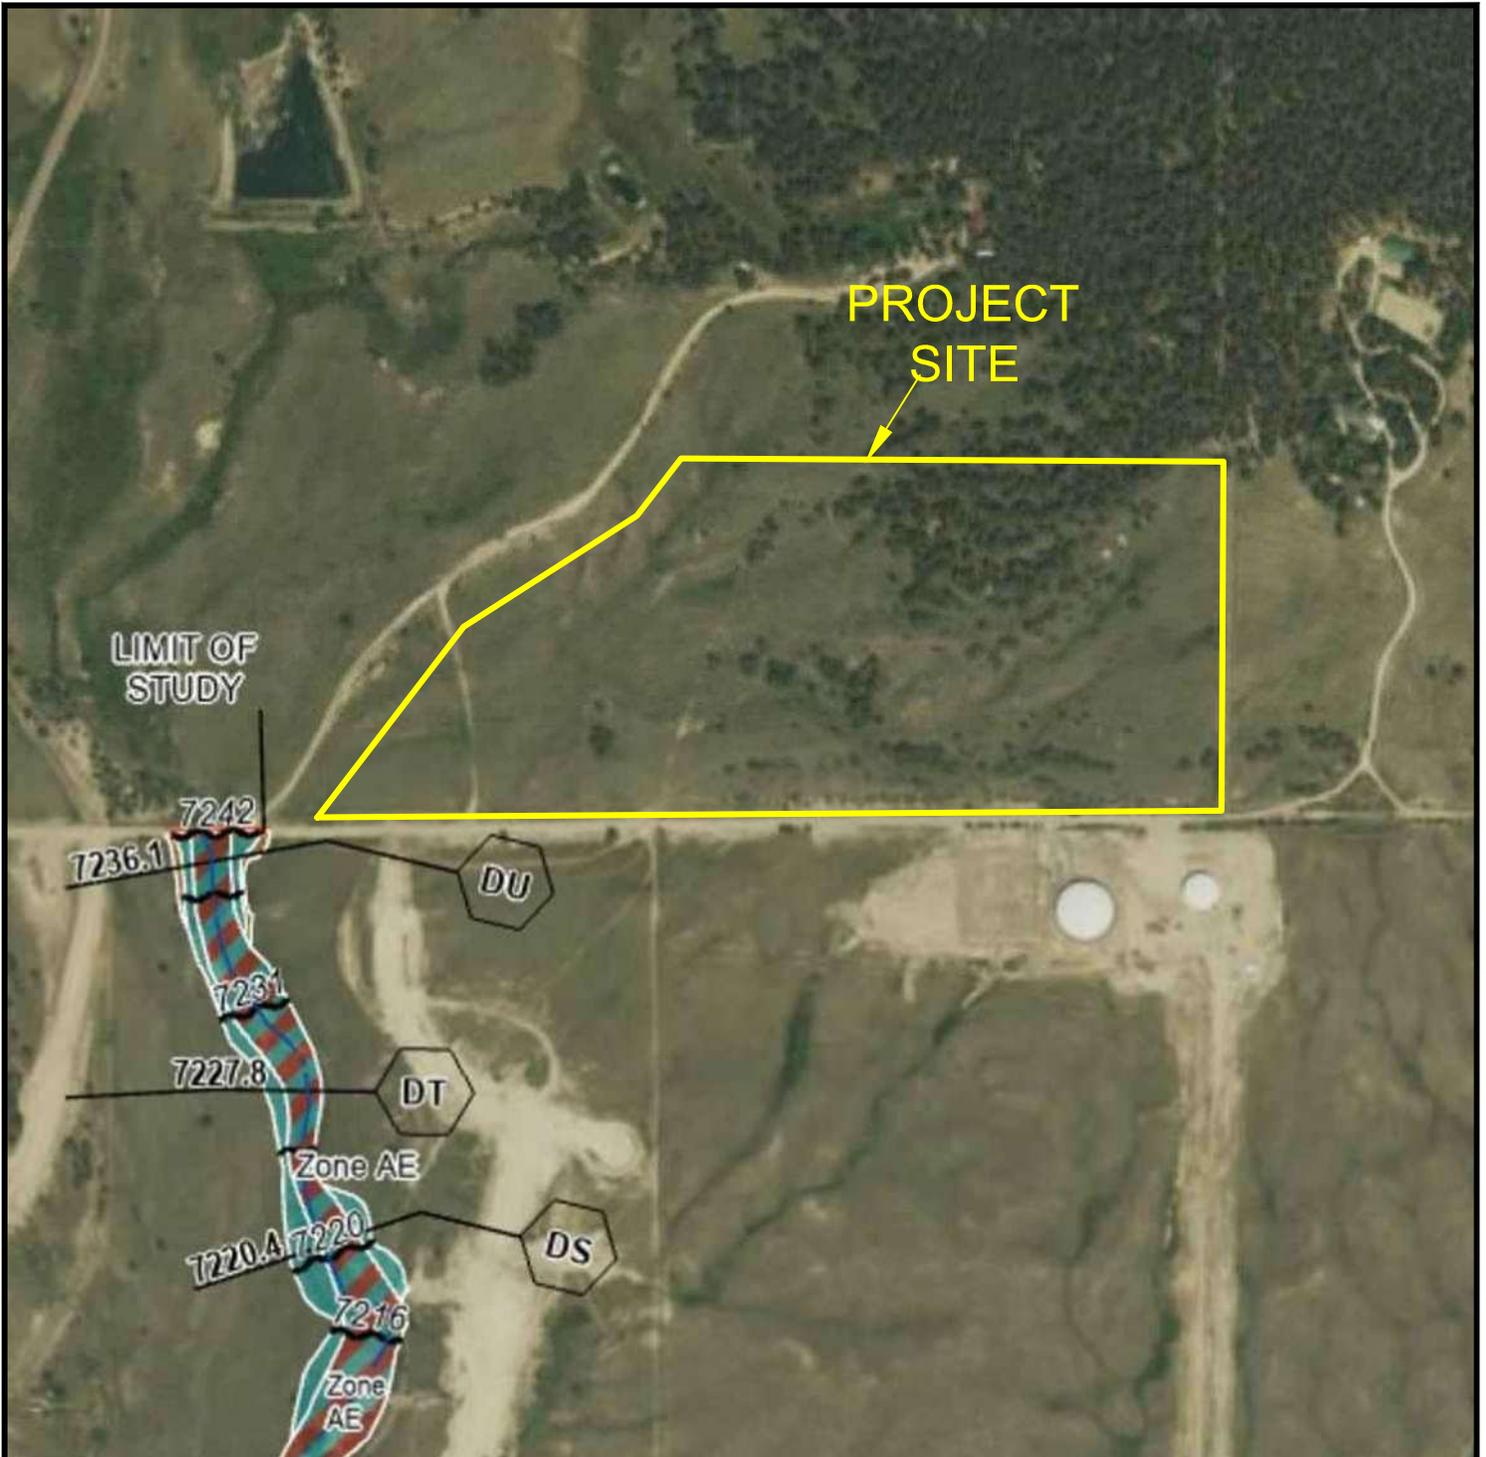
FEMA FLOODPLAIN MAP

Areas within the minor drainages on-site have been identified as areas of seasonally high groundwater areas. Water was not flowing in the any of the drainages at the time of this investigation. The site is not mapped within floodplain zones according to the FEMA Map No. 08041CO535G, (Reference 8, Figure 8). These areas are discussed as follows:

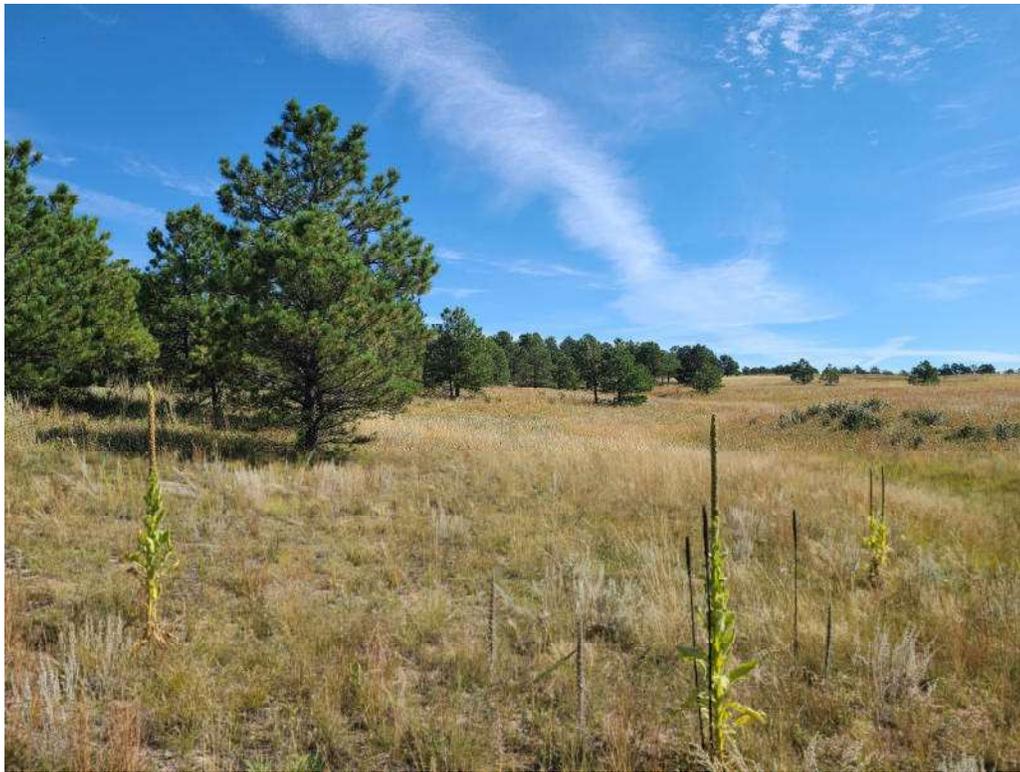
**Looking east towards
erosion feature eastern
side of site.**
