**SOILS AND GEOLOGY STUDY
RETREAT AT TIMBERRIDGE FILING NO. 4
PARCEL NO. 52220-00-023
EL PASO COUNTY, COLORADO**

Prepared for:
**TimberRidge Development Group, LLC
2138 Flying Horse Club Drive
Colorado Springs, CO 80921**

December 21, 2023
Revised June 17, 2024

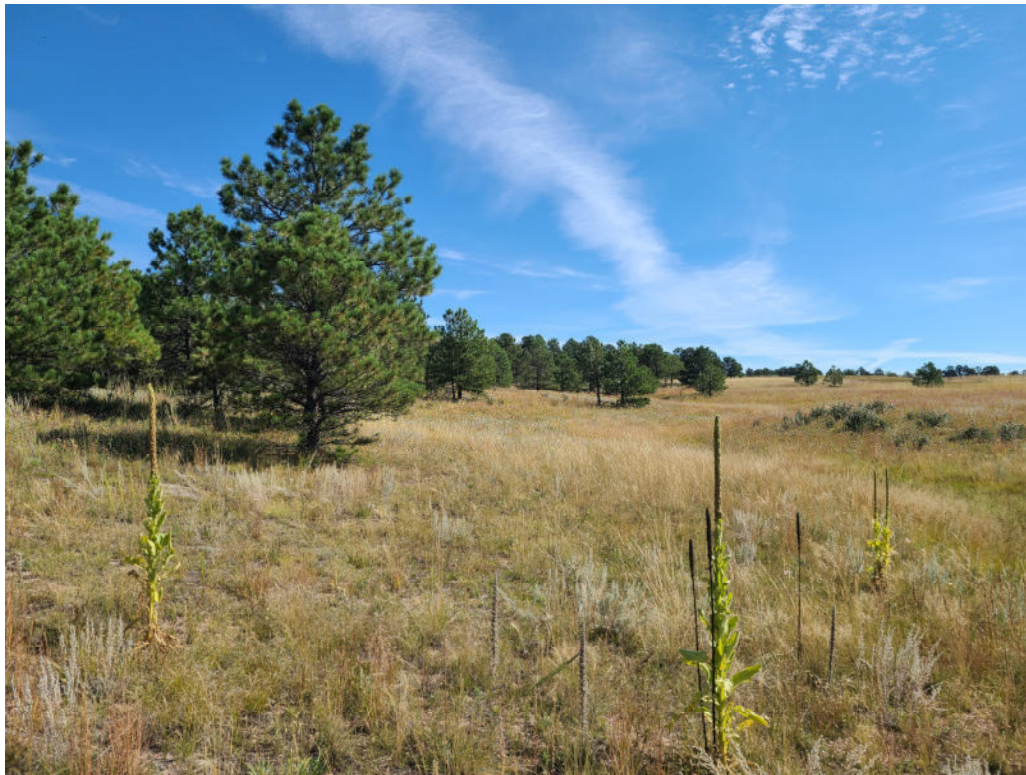
**Looking east towards
erosion feature eastern
side of site.**
