**SOIL, GEOLOGY, GEOLOGIC HAZARD,  
AND WASTEWATER STUDY,  
SETTLERS VIEW SUBDIVISION  
STEPPLER ROAD AND HODGEN ROAD  
EL PASO COUNTY, COLORADO**

**Jerome Hannigan and Associates, INC.**  
19360 Spring Valley Road  
Monument, Colorado 80132

February 2, 2017

Entech Job No. 162442  
AAprojects/2016/162442countysoil/geo/ww

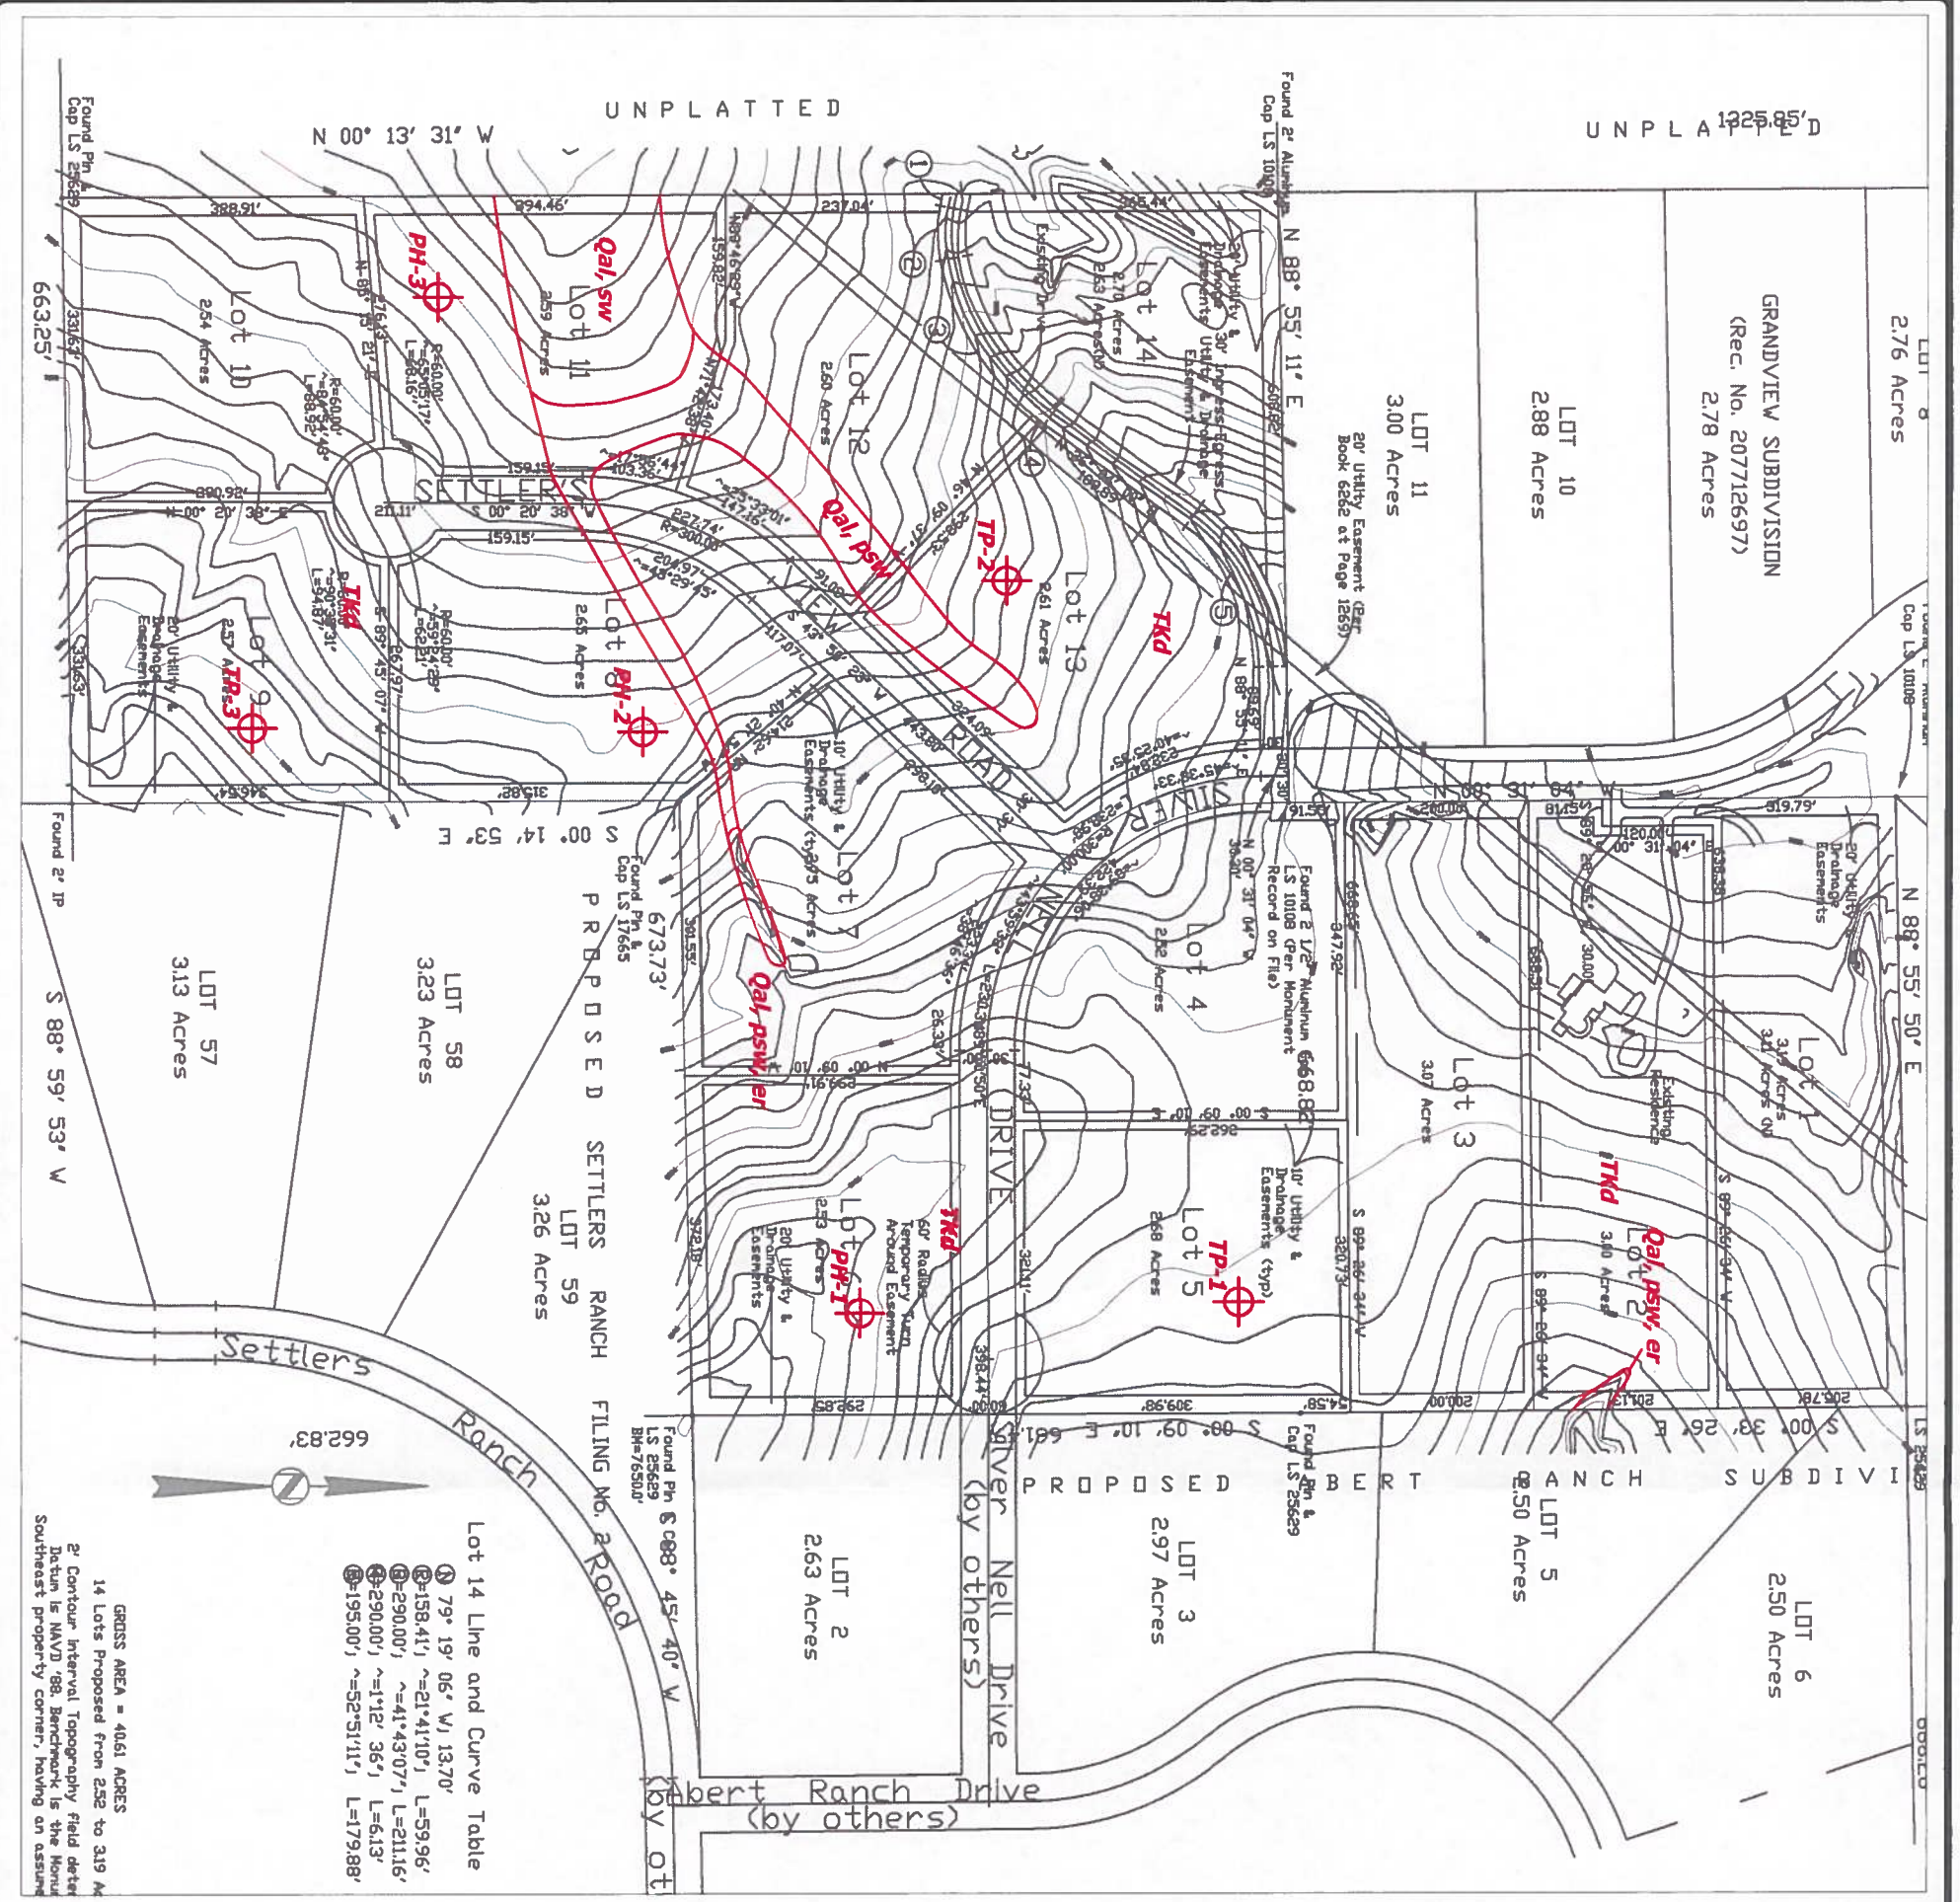
DRAWN	
CHECKED	
DATE	2/2/17
SCALE	AS SHOWN
DWG NO.	102442
REVISION	6

As mentioned previously, detailed mapping has been performed on this site to produce an Engineering Geology Map (Figure 6). This map shows the location of various geologic conditions of which the developers should be cognizant during the planning, design and construction stages of the project. These hazards and the recommended mitigation techniques are as follows:

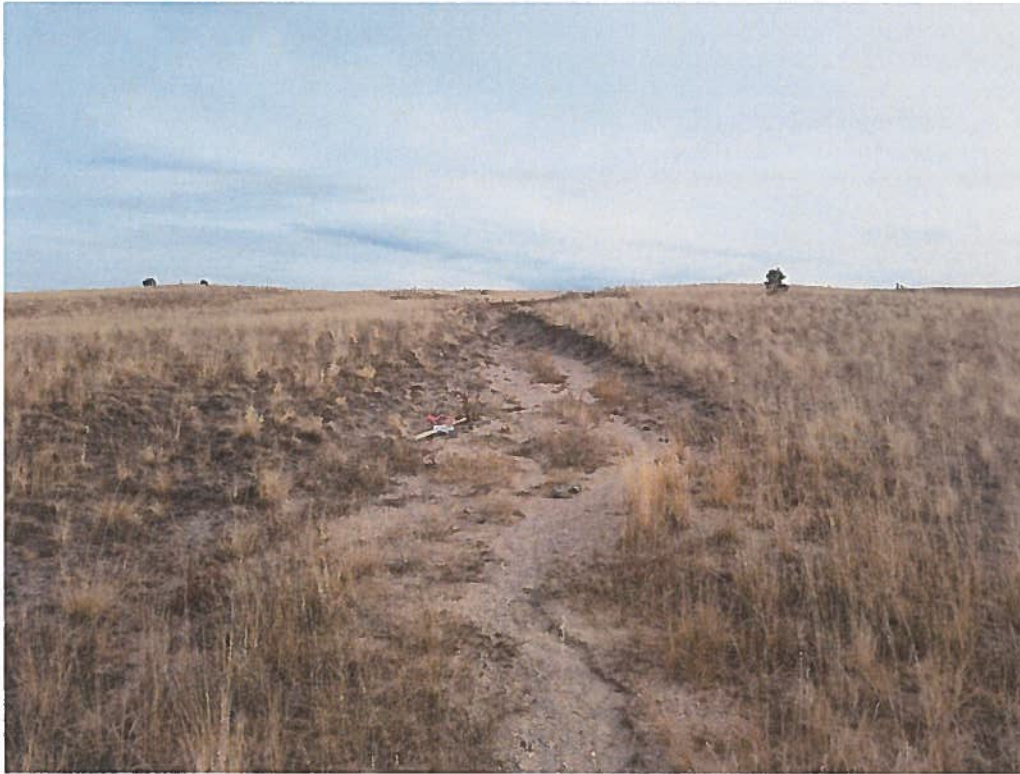
**Looking east at erosion feature southeastern portion of the site.**

Mitigation: Due to the nature of the soils on this site, virtually all the soils are subject to erosion by wind and water. Other minor areas of erosion were observed on site other than those mapped, particularly where some rill erosion has occurred. Areas of erosion can occur across the entire site, particularly if the soils are disturbed during construction. Vegetation reduces the potential for erosion. The areas identified where erosion is actually taking place may require check dams, regrading and revegetation using channel lining mats to anchor vegetation. Further recommendations for erosion control are discussed under Section 9.0 "Erosion Control" of this report. Recommendations pertaining to revegetation may require input from a qualified landscape architect and/or the Natural Resource Conservation Service (previously Soil Conservation Service).
