**SOIL, GEOLOGY, AND GEOLOGIC HAZARD STUDY
HOMESTEAD AT STERLING RANCH FILING NO. 2
EL PASO COUNTY, COLORADO**

June 20, 2019

Entech Job No. 190935 Homestead
F:/AAPProjects/2019/190935Homestead F2 Geohaz

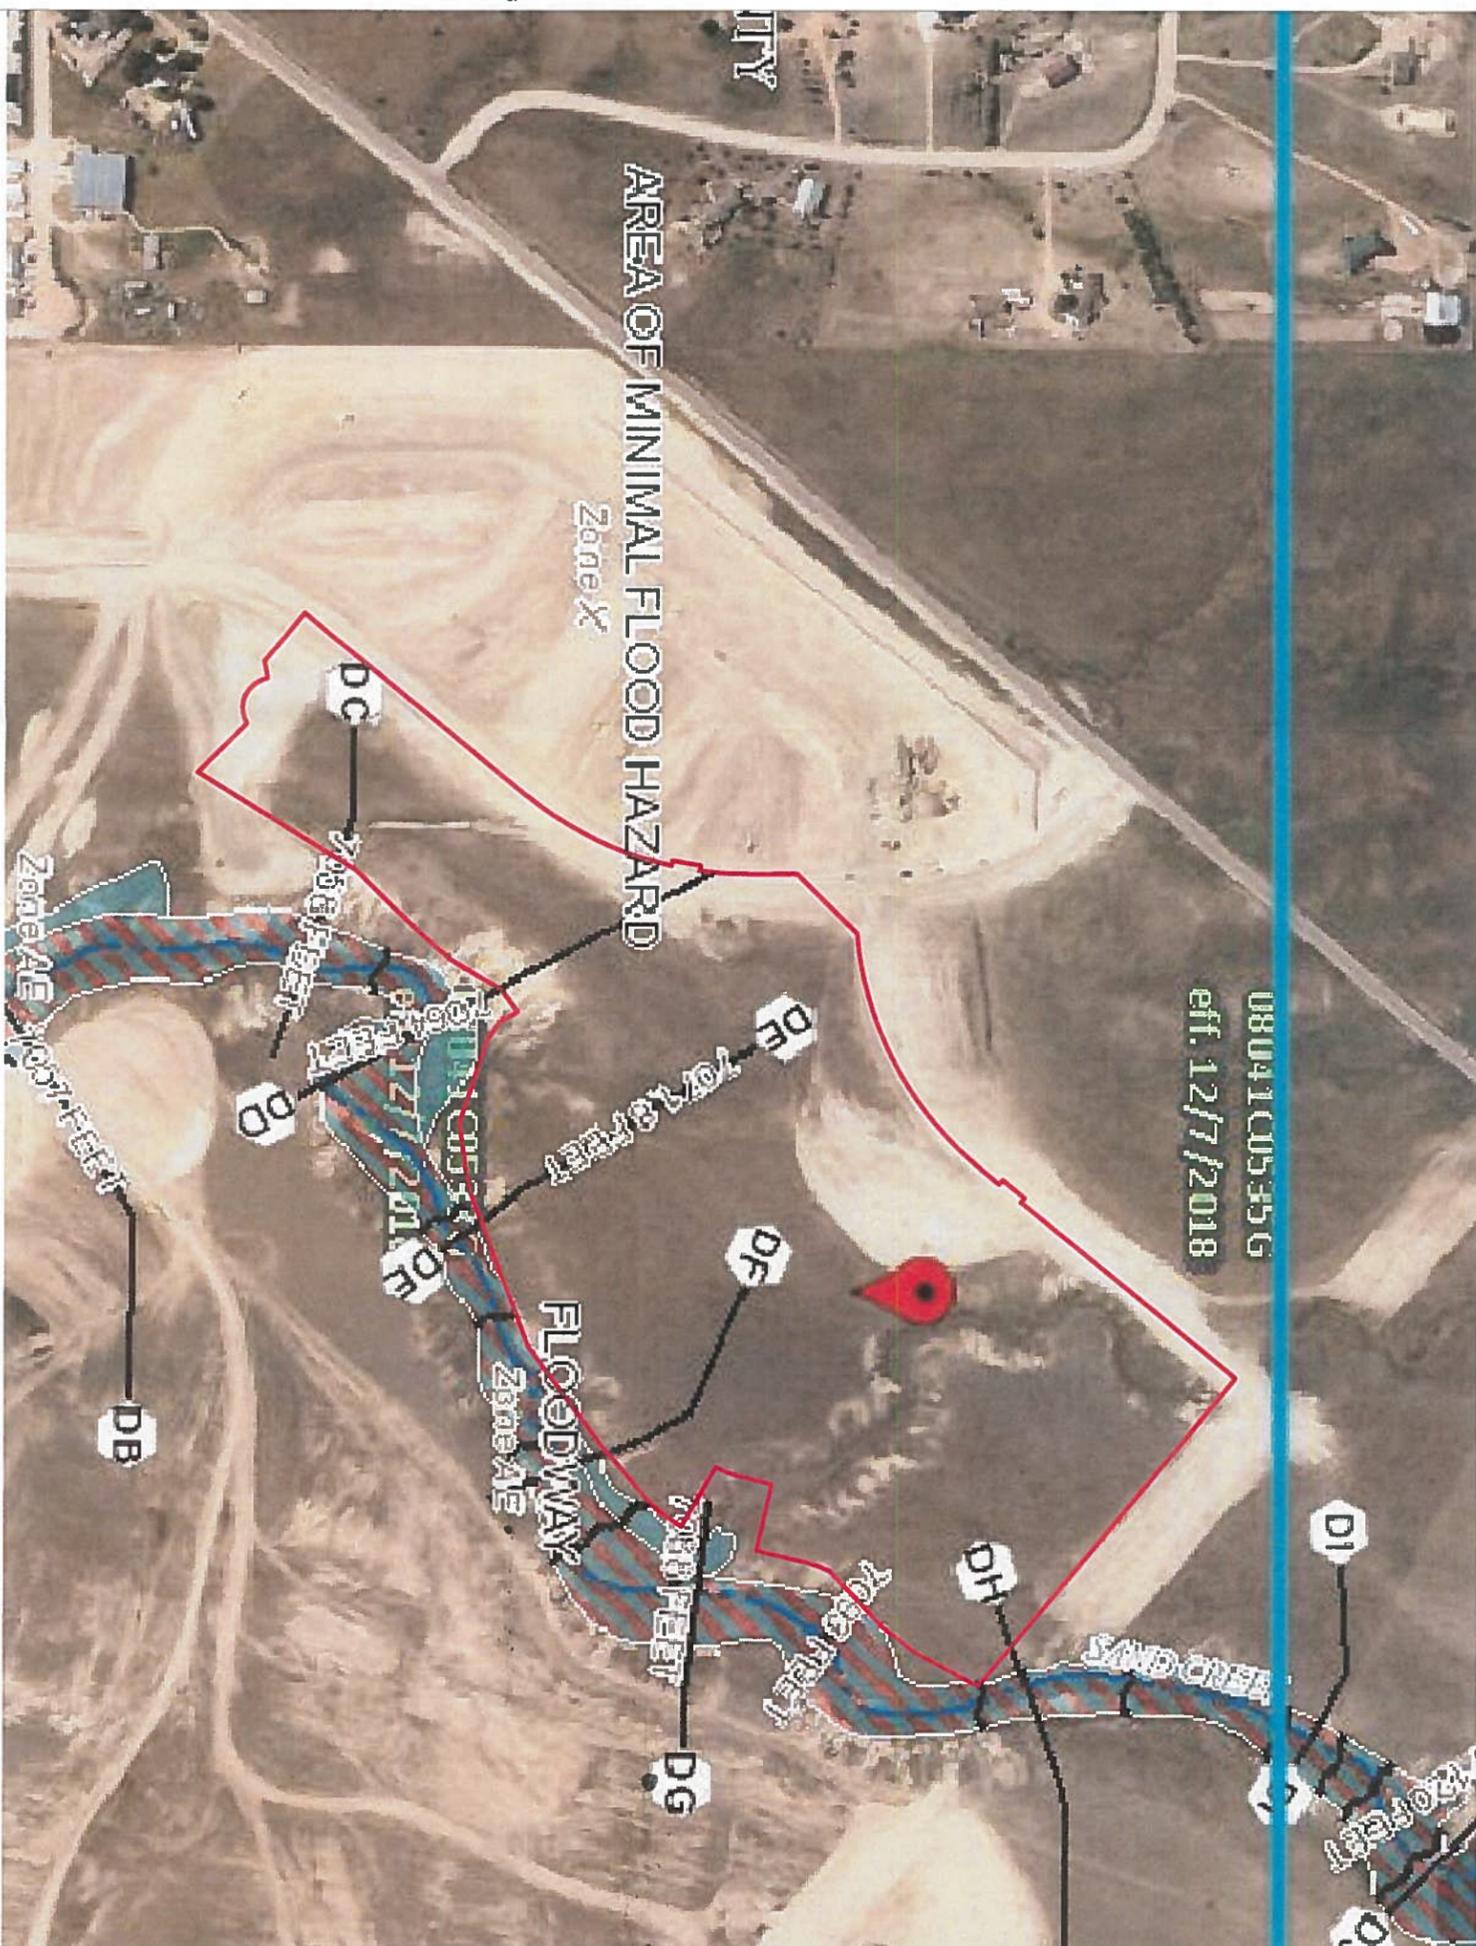
Floodplain Map
 Homestead at Sterling Ranch F2
 El Paso County, CO.
 For: Morley-Bentley Investments, LLC

The floodplain areas of the Sand Creek drainage exist along the eastern boundary of the site. According to the Overall Site Plan, Figure 3, this area is to be preserved as open space. Should development be considered in the floodplain, channelization and drainage improvements would be necessary as well as raising building site grades above the floodplain level. According to the development plan, the lots are proposed outside the floodplain zone. Finished floor elevations must be a minimum of one foot above the floodplain level. Drains may be necessary for foundations immediately adjacent to the floodplain to help prevent the intrusion of water into areas below grade. Specific floodplain location and drainage studies are beyond the scope of this report.

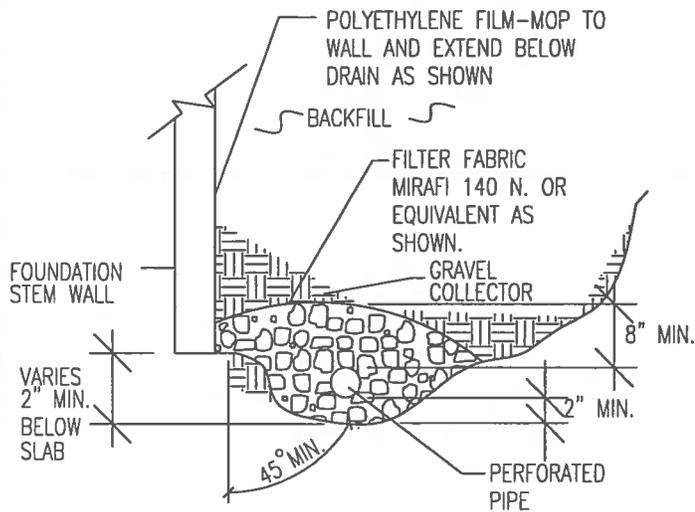
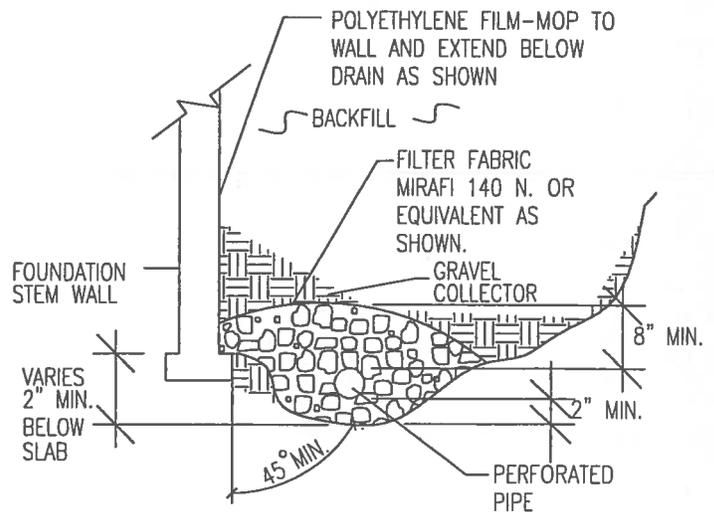
Areas of seasonal shallow groundwater have been mapped in the detention ponds on site. These areas will be avoided by structures, however, structures immediately adjacent to the detention ponds may experience higher water levels during periods of high moisture. Shallow groundwater areas may also affect utility installation. Geo-grids or shotrock may be necessary to stabilize excavation. In or adjacent to seasonal shallow groundwater areas, drains may be necessary to control seepage within the foundation zone. A typical perimeter drain detail is presented in Figure 9.

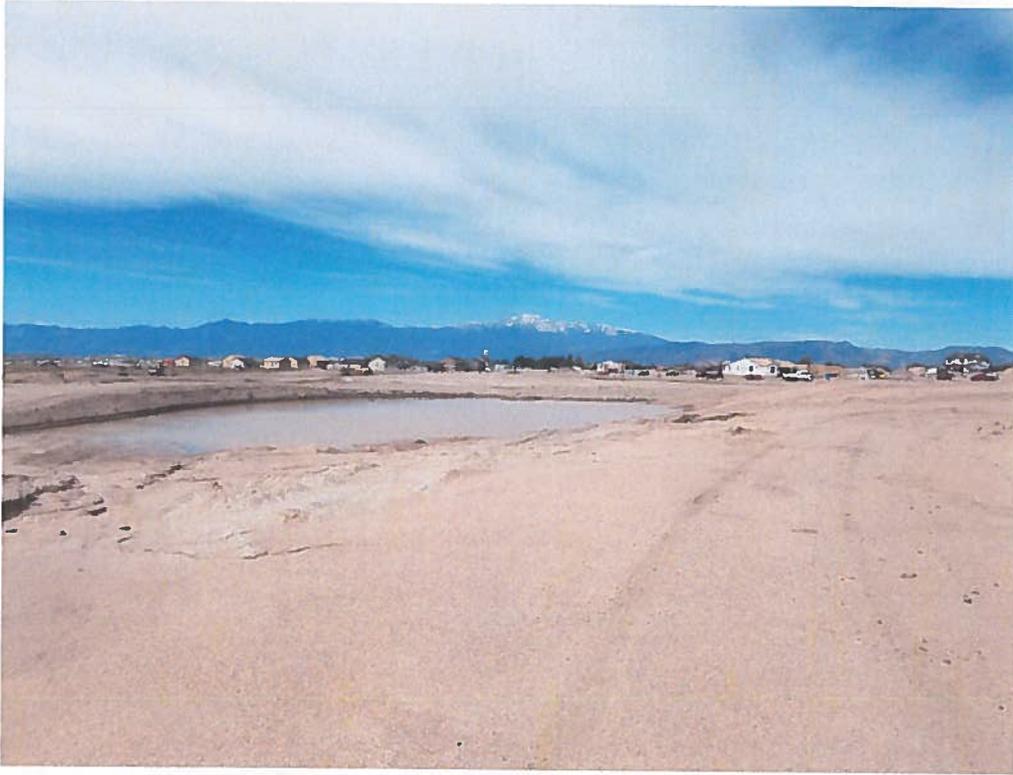
Looking west from the southeastern portion of the site.

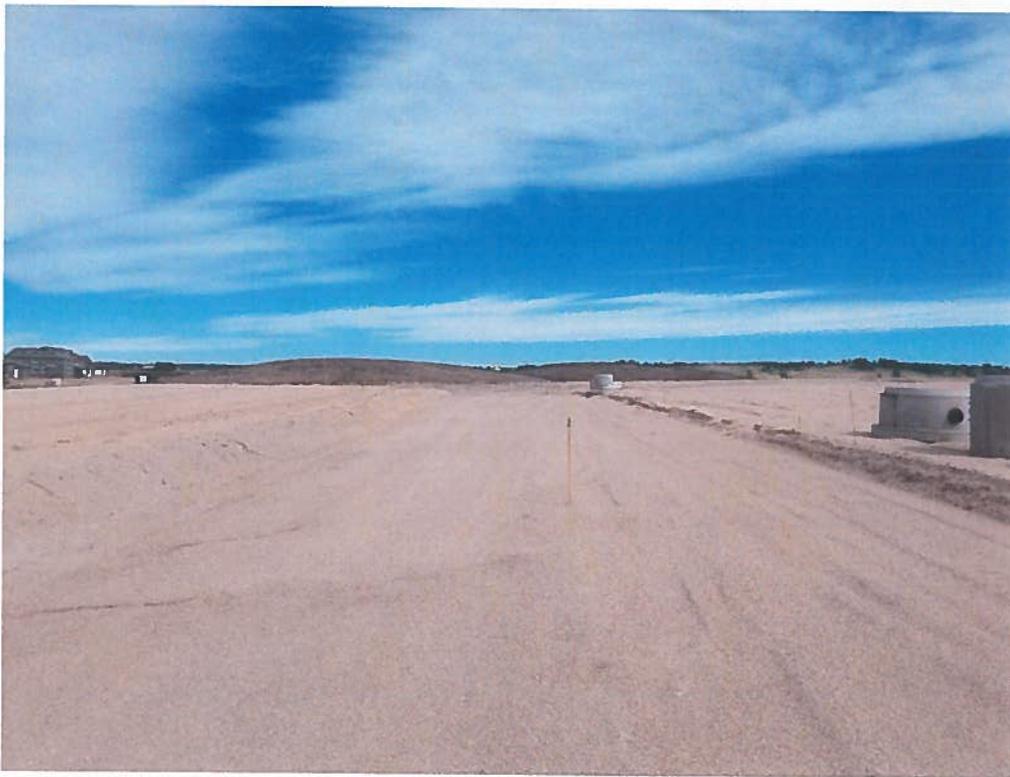
Looking north from the western portion of the site.

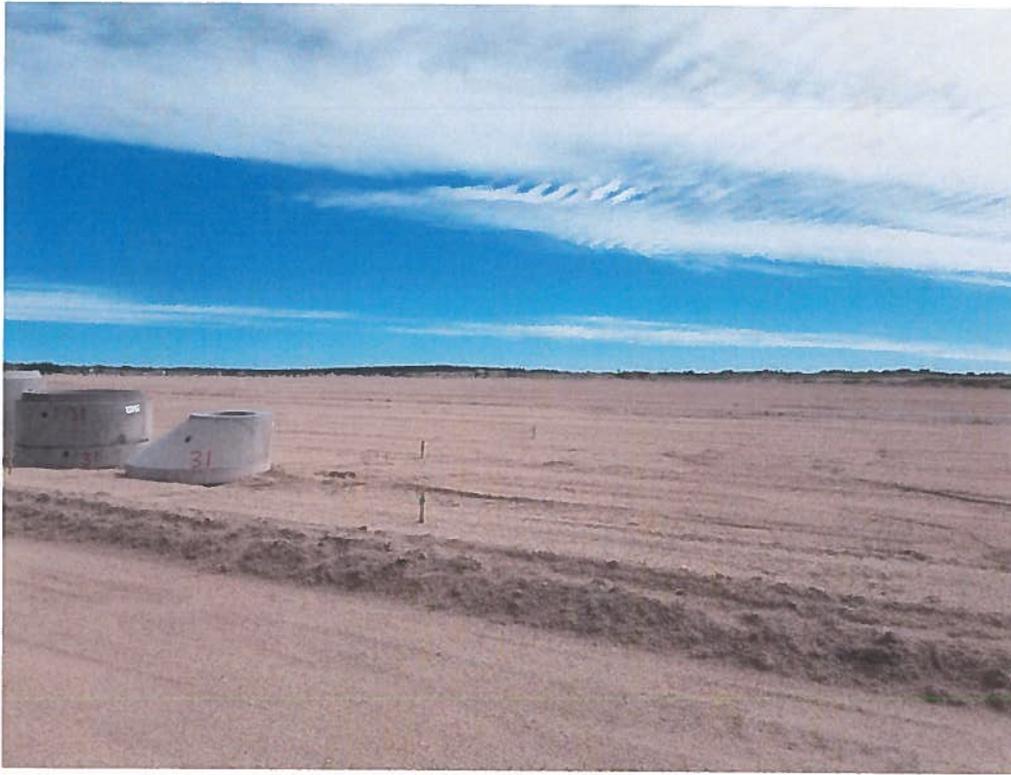
**Looking northeast
from the central
portion of the site.**

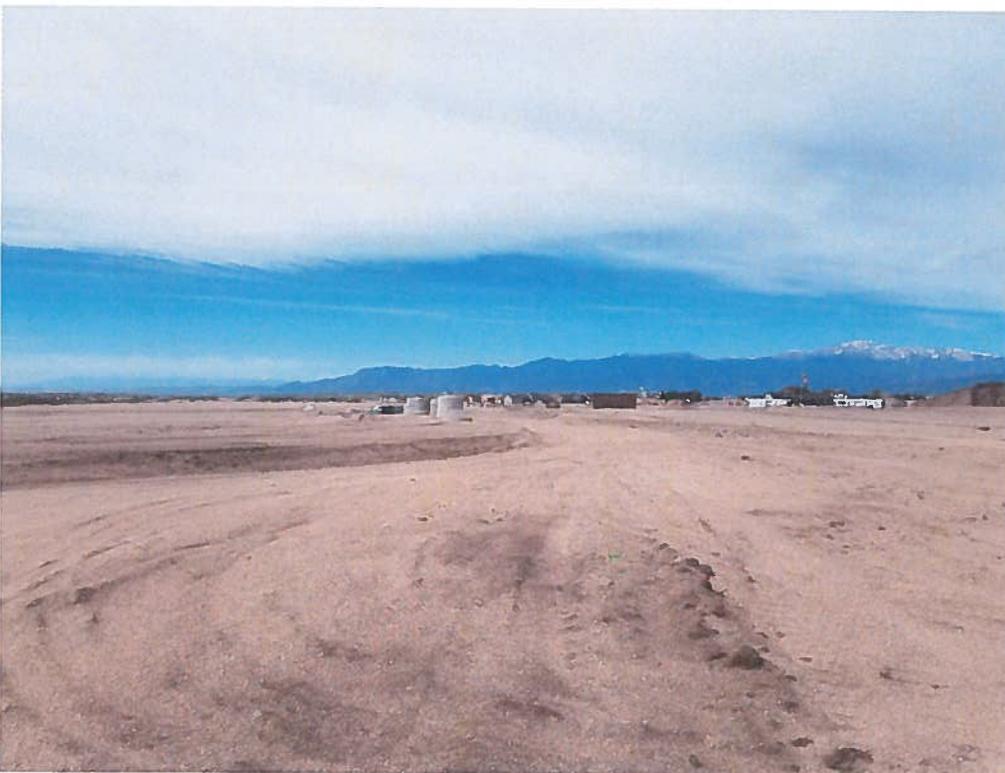
**Looking southwest
from the northern
portion of the site.**

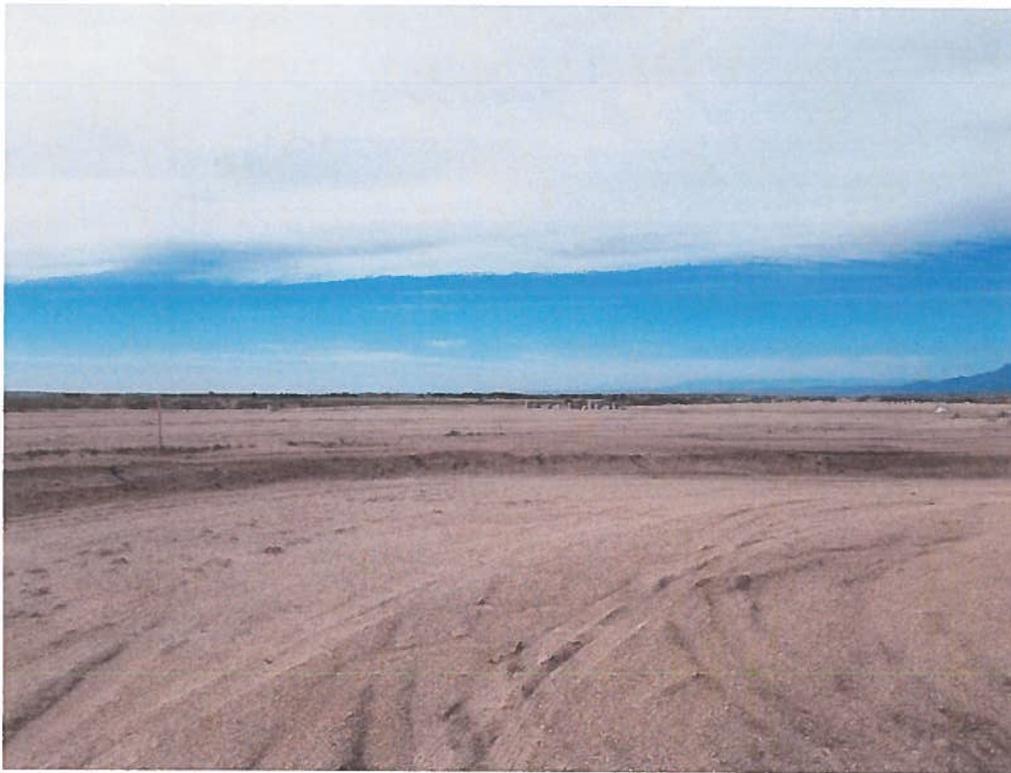
**Looking south from
the northern portion of
the site.**

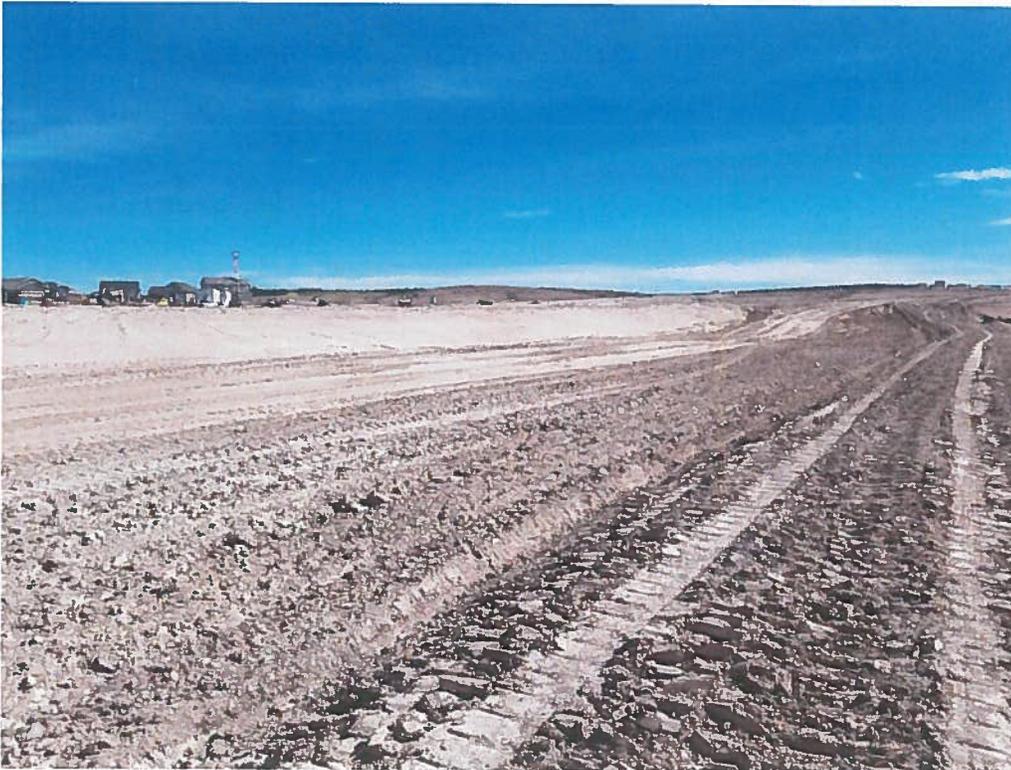
**Looking northeast
from the southern
portion of the site.**
