**PRELIMINARY SOIL, GEOLOGY, AND
GEOLOGIC HAZARD STUDY
GRANDVIEW RESERVE
PARCEL NO. 42000-00-396
EASTONVILLE ROAD
EL PASO COUNTY, COLORADO**

4 Site Investments, LLC
c/o Peter Martz
P.O. Box 50223
Colorado Springs, Colorado 80949

April 15, 2020

Entech Job No. 200693
AAprojects/2020/200693 countysoil/geo

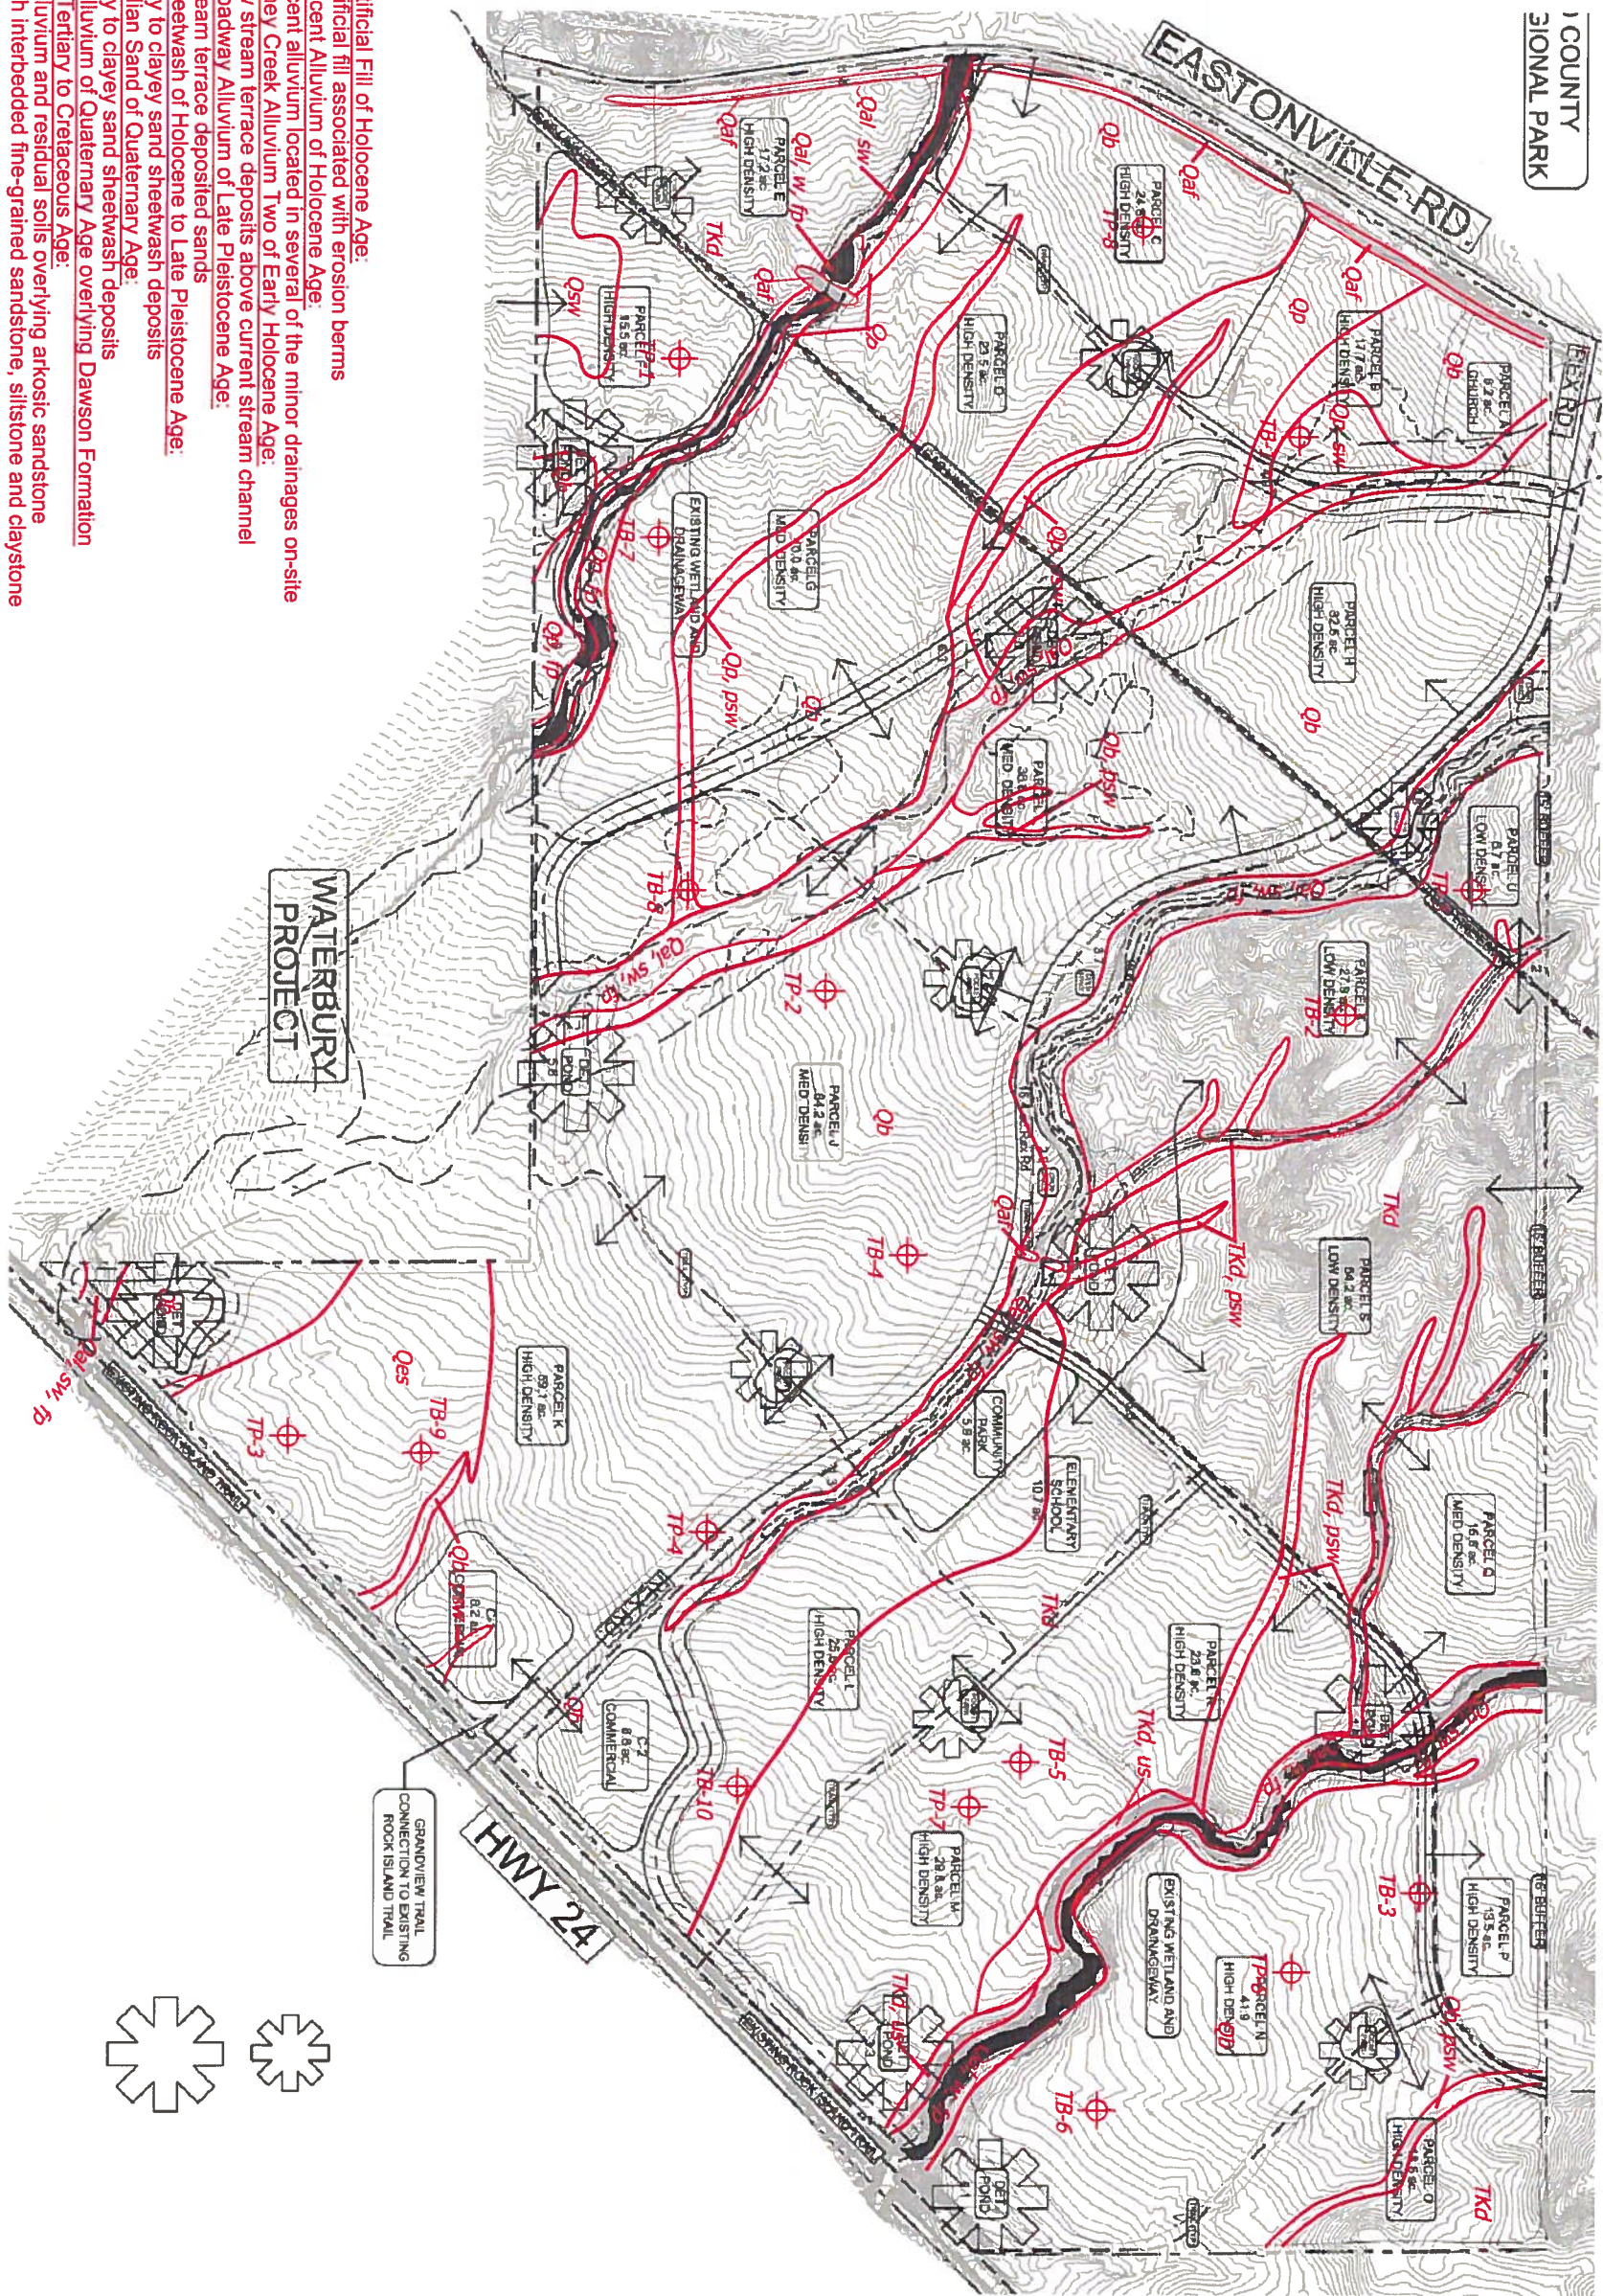
Detailed mapping has been performed on this site to produce an Geology/Engineering Geology Map (Figure 6). This map shows the location of various geologic conditions of which the developers should be cognizant during the planning, design and construction stages of the project. These hazards and the recommended mitigation techniques are as follows:

The majority of the slopes in the building areas on site are gently to moderately sloping and do not exhibit any past or potential unstable slopes or landslides. However, the steeply sloping areas along the drainage in the eastern portion of the site have been identified as unstable slopes. These areas are identified on the Geology/Engineering Geology Map, Figure 6. The recommendations for these areas are as follows:

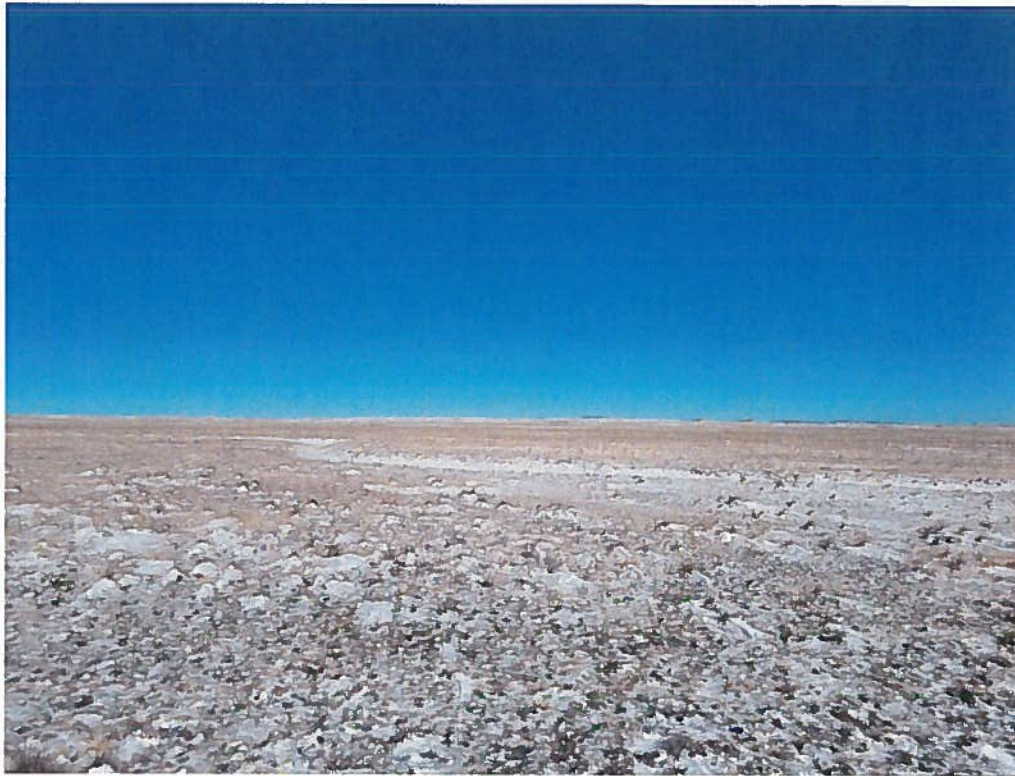
The area identified with this hazard is located in the northeastern portion of the site along a portion of a minor drainage where cut banks have created unstable slopes. Considerable care must be exercised in these areas not to create a condition which would tend to activate instability.

**Looking northwest
along drainage in
eastern portion of the
site.**

Mitigation: Building should be avoided in these areas. These areas are located in open space and will be avoided. Any structures or signs in these areas should be set back a minimum of 30 feet from the crest of these slopes. It appears there is sufficient room on the lots to avoid this hazard. Proper control of drainage at both the surface above the slope and the subsurface is extremely important. Areas of ponded water at the surface should be avoided. Utility trenches, basement excavations and other subsurface features should not be permitted to

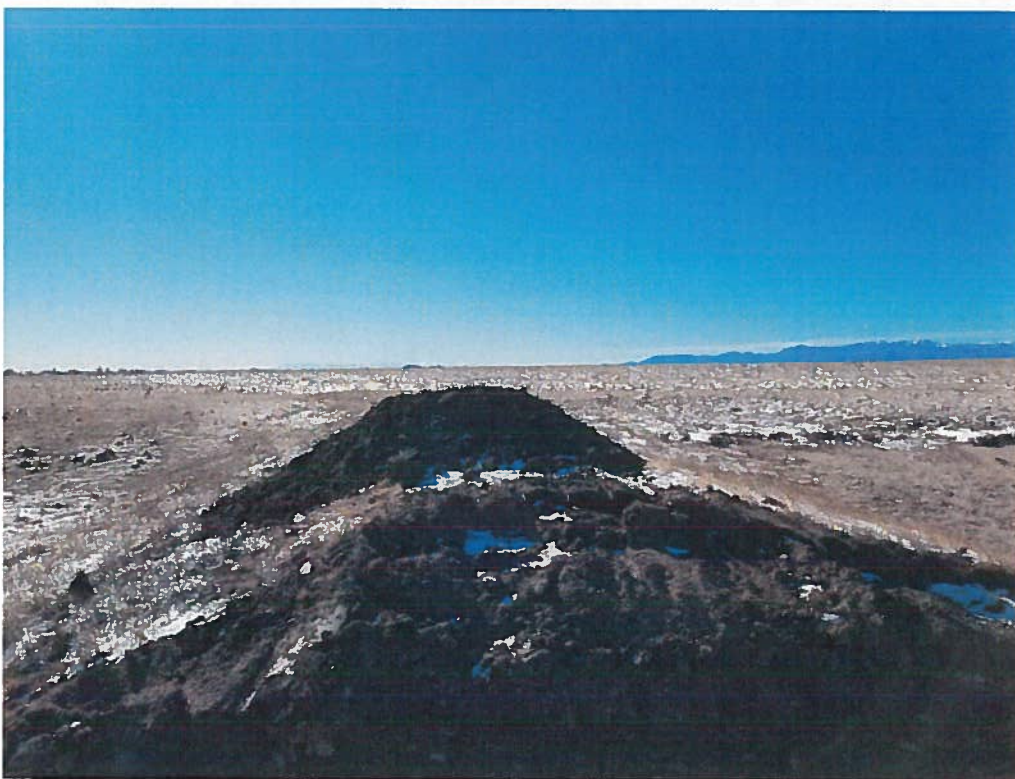
**Looking southwest
along man-made dam
in the central portion
of the site.**

Mitigation: Berms were observed along Eastonville Road that can be avoided or easily removed or penetrated by foundations. The earthen dams lie within areas designated as open space and will be avoided by development. Should any uncontrolled fill be encountered beneath foundations, removal and recompaction at 95 percent of its maximum Modified Proctor Dry Density, ASTM D-1557 will be required.
