**PRELIMINARY SOILS, GEOLOGY,
GEOLOGIC HAZARD
AND LAND USE STUDY
462 ACRE BAPTIST CHURCH PARCEL
780 EAST BAPTIST ROAD
EL PASO COUNTY, COLORADO**

June 3, 2005

Entech Job No. 51175
2MSW/rep/2005/51175ghs

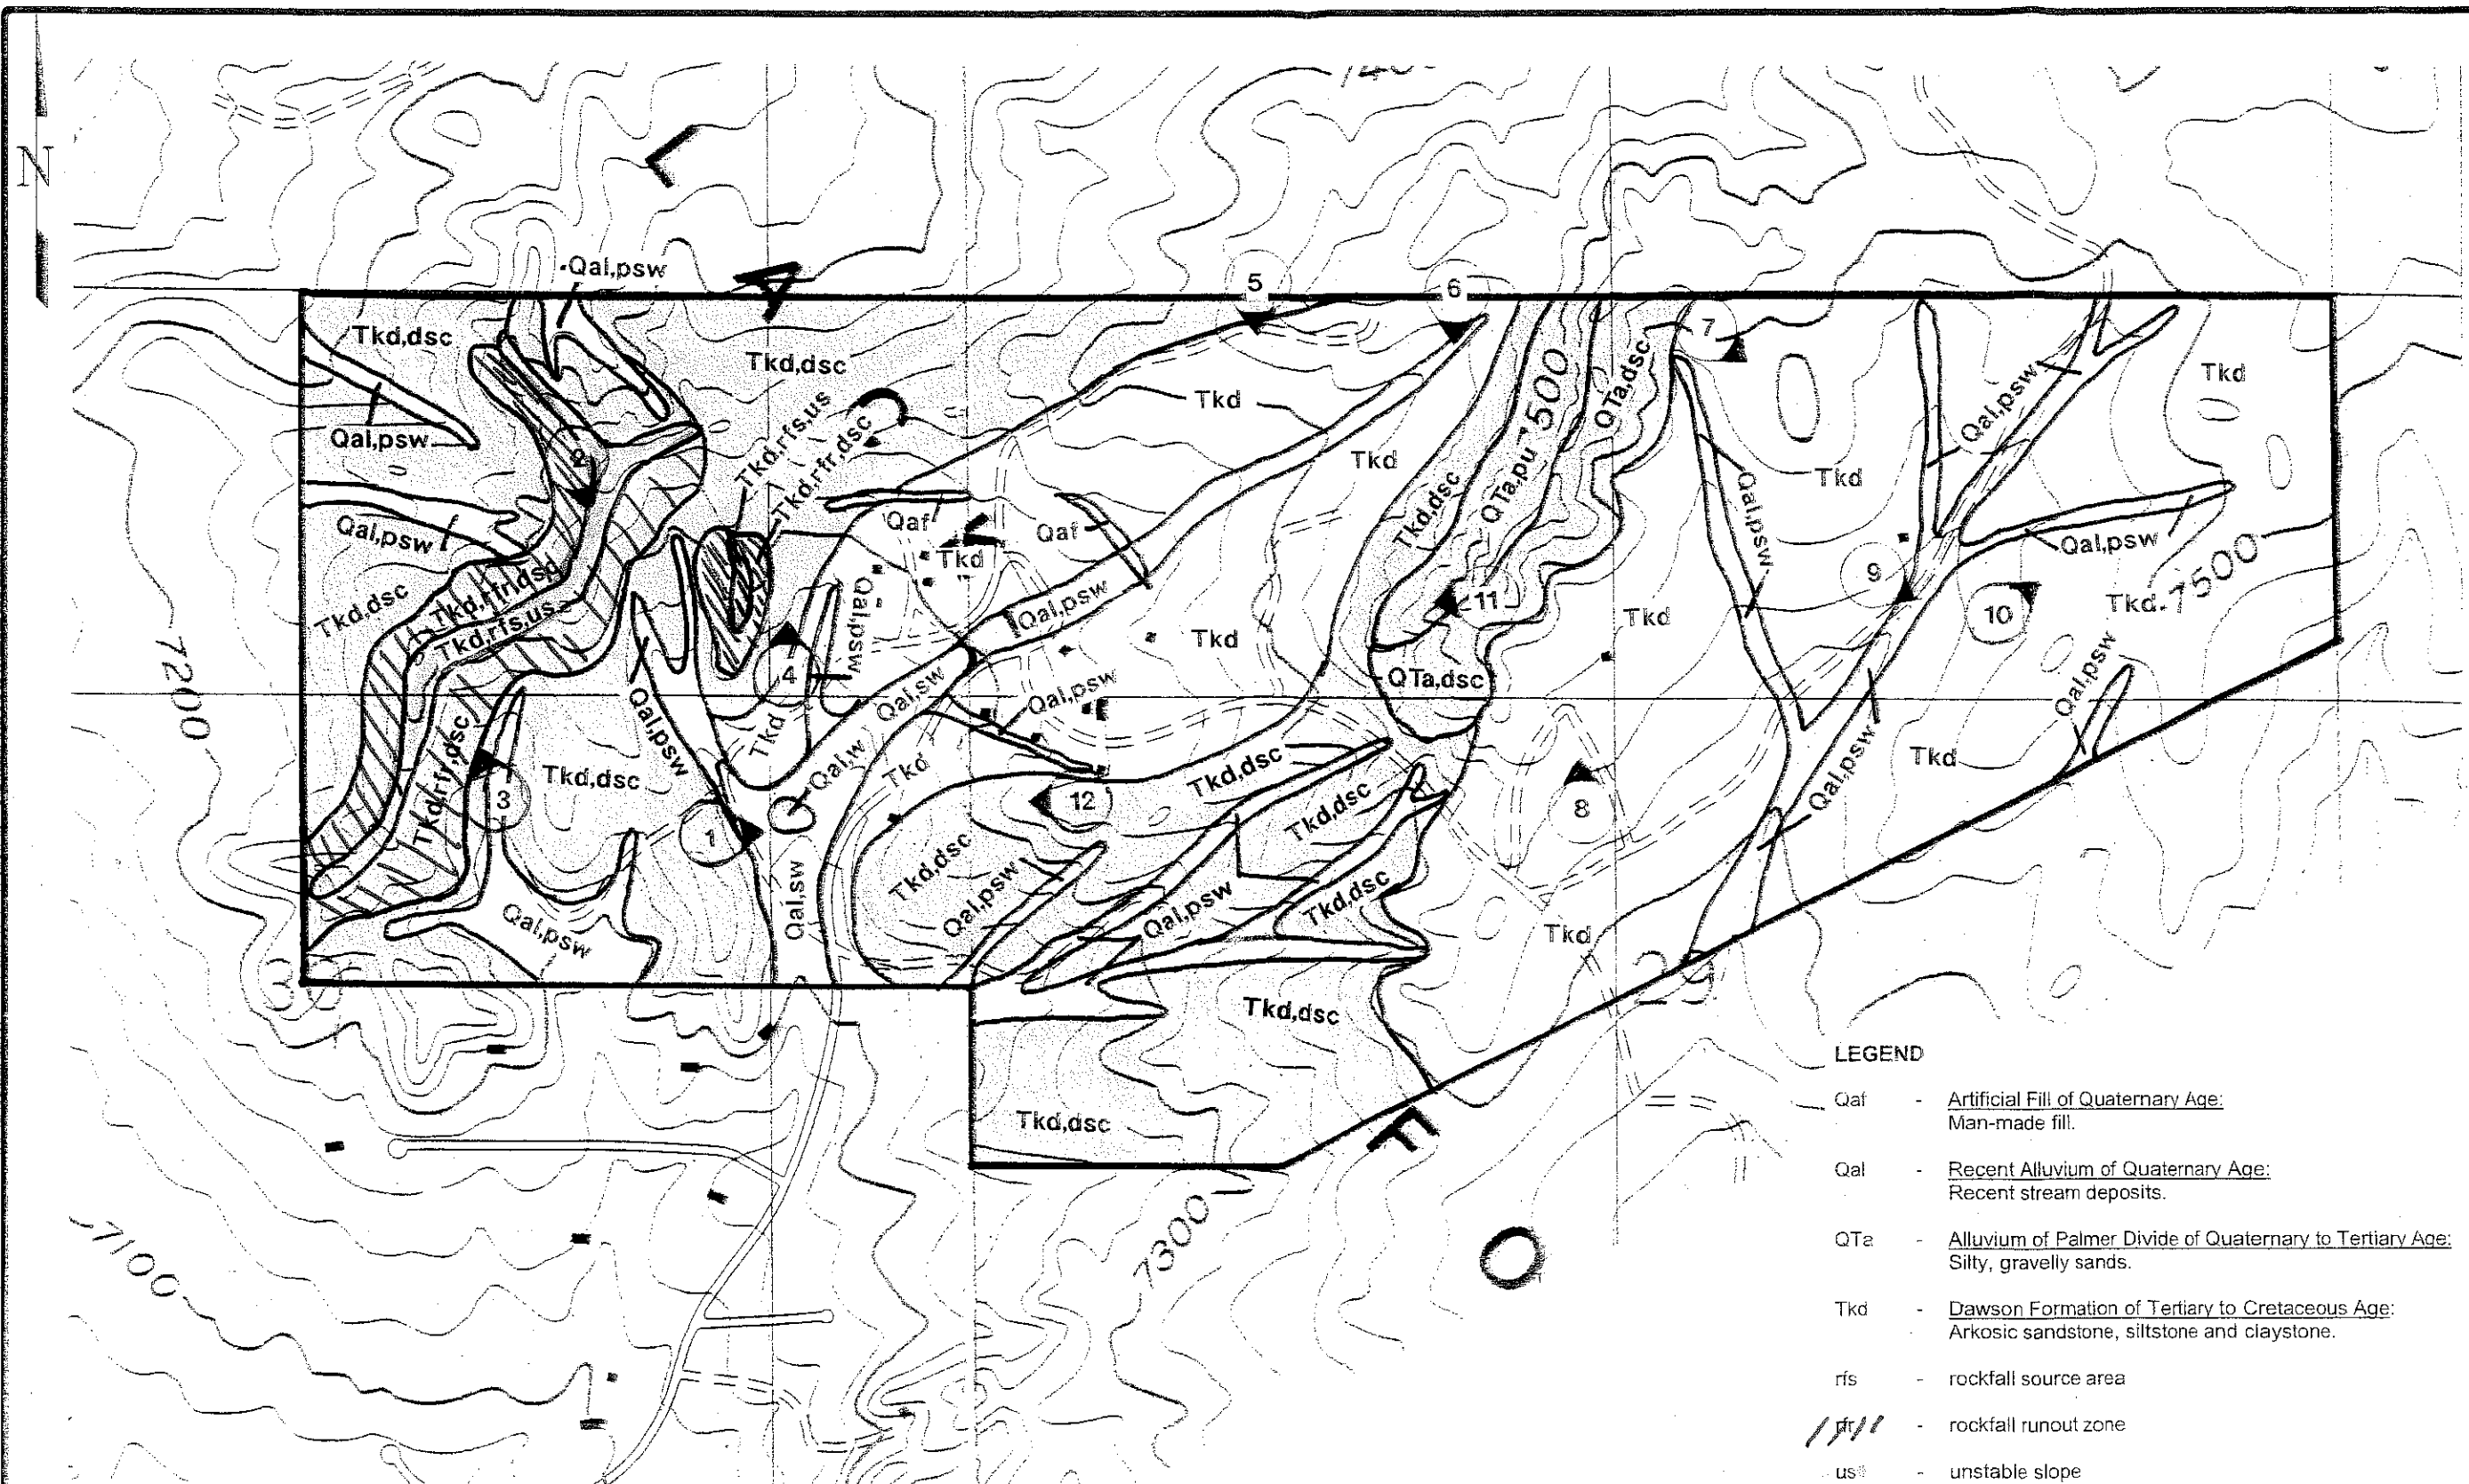
| JOB NO. 51175 | FIGURE No. 10 |

As mentioned previously, preliminary mapping has been performed on this site to produce an Engineering Geology Map (Figure 10). This map shows the location of various geologic conditions of which the developers and planners should be cognizant during the planning, design and construction stages of the project. Detailed mapping should be performed when a more detailed topographic map base is made available. The hazards identified on this site include areas of artificial fill, potentially expansive soils, unstable slopes, potentially unstable slopes, downslope creep, rock fall, ponded water, potentially seasonal shallow groundwater and seasonal shallow groundwater. The following hazards have been addressed as a part of this investigation.

Many of the slopes on the site have been identified as downslope creep, potentially unstable and unstable slopes on the Engineering Geology Map (Figure 10). Recommendations for these areas are discussed as follows:

Some of the steeper slopes on-site have been identified as unstable slopes. These are areas where exposed rocks and cliffs exist. Boulder and cobble-sized talus can be produced due to erosion and steep slopes in these areas. The rockfall hazard is discussed in the following section.

Areas were encountered on site where sandstone outcrops are exposed and produce boulder and cobble-sized talus. The areas of this rockfall hazard are divided into two separate zones based on the severity of the hazard. Areas lying topographically below the runout zone would be considered reasonably safe from rockfall. Preliminary mapping of rockfall zones are shown on the Engineering Geology Map, Figure 10. Detailed mapping of these areas should be performed when a more detailed topographic map base is made available. Recommendations for the rockfall areas are presented as follows:

rfs – rockfall source area: This zone delineates the major rockfall source areas or the sandstone bluffs and outcrops themselves. This area carries the highest risk of damaging rockfall, but also is an area which is not likely to be considered for development for many reasons. Some of the rock fragments located within this zone should be stabilized or knocked down to more stable areas, lessening the hazard in areas below this zone.

Mitigation: Building should be avoided on these slopes. Structures should be located a minimum of 30 feet from the crest or a toe of these slopes unless additional slope stability analysis is performed. Additionally, the recommendations for the potentially unstable slopes concerning drainage applies to these slopes as well.

Mitigation: Stabilization of the area can include removal of loose blocks of rock, often referred to as scaling. Other techniques include stabilization of loose blocks mechanically and may involve pinning the loose rocks to the face of the cliff to prevent dislodgment. This may be accomplished with Portland cement grout, gunite or a combination of mechanical rock bolts and some form of netting material such as chainlink fence or other similar materials. Some of these techniques, although effective in controlling rockfall, can be very unpleasing aesthetically.

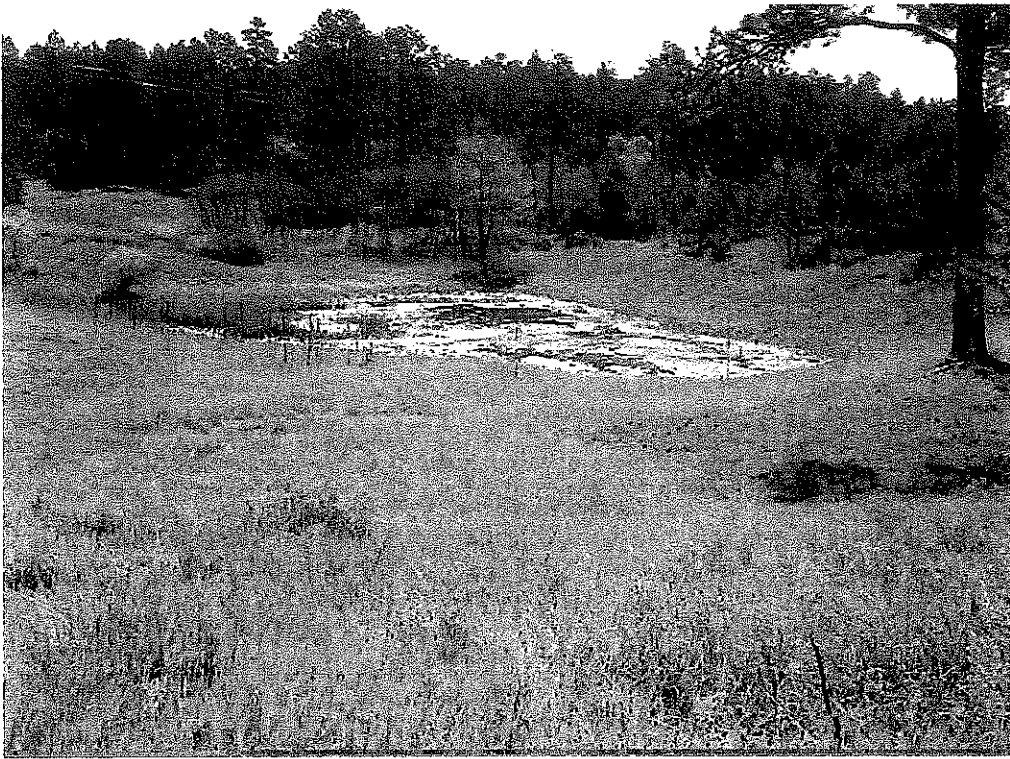
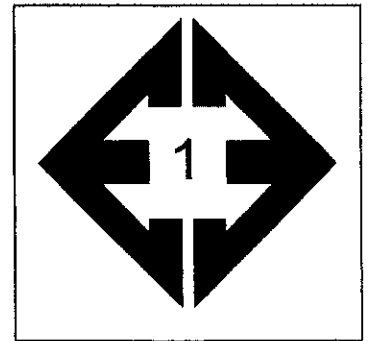
**Looking east at
ponded area.**

An area of ponded water observed on-site can be avoided by development. Should grading be desired in this area, all soft, wet or organic soils should be removed prior to filling.

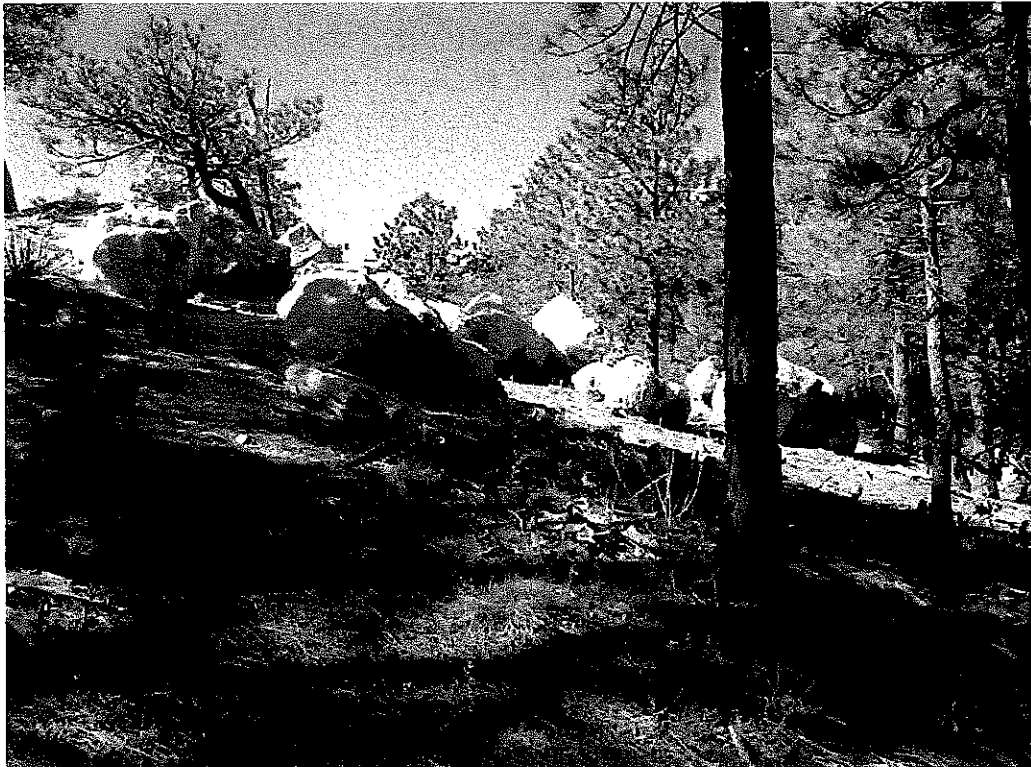
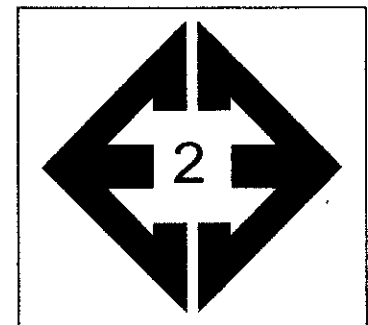
**Looking south at
rockfall areas in
northwest
portion of site.**

Areas of rockfall hazards exist on this site. Should development be considered in these areas, mitigation will be necessary. Exact locations of these hazards should be identified when a detail topographic map is made available. Mitigation in these areas may involve stabilization of loose rocks by scaling grouting or bolting. The use of designed walls or cavement structures is another alternative. Specific mitigation recommendations should be made on an individual basis after additional investigation.
