Job No. 188423

July 19, 2022

Re: Response to CGS Comments
515 Struthers Loop
Pair-A-Dise Subdivision, Filing No. 1
El Paso County, Colorado

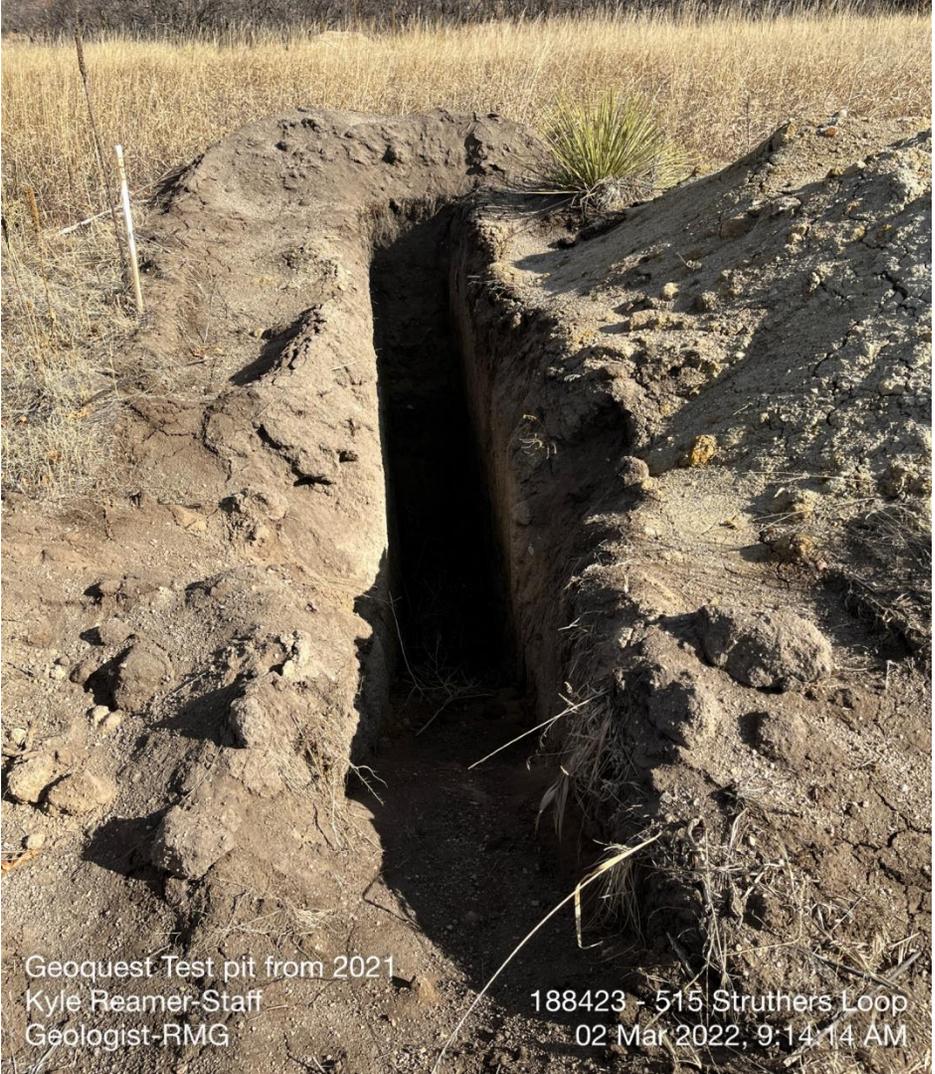
Remnants of 2021 Geoquest
test pit on lot 1
Kyle Reamer-Staff
Geologist-RMG

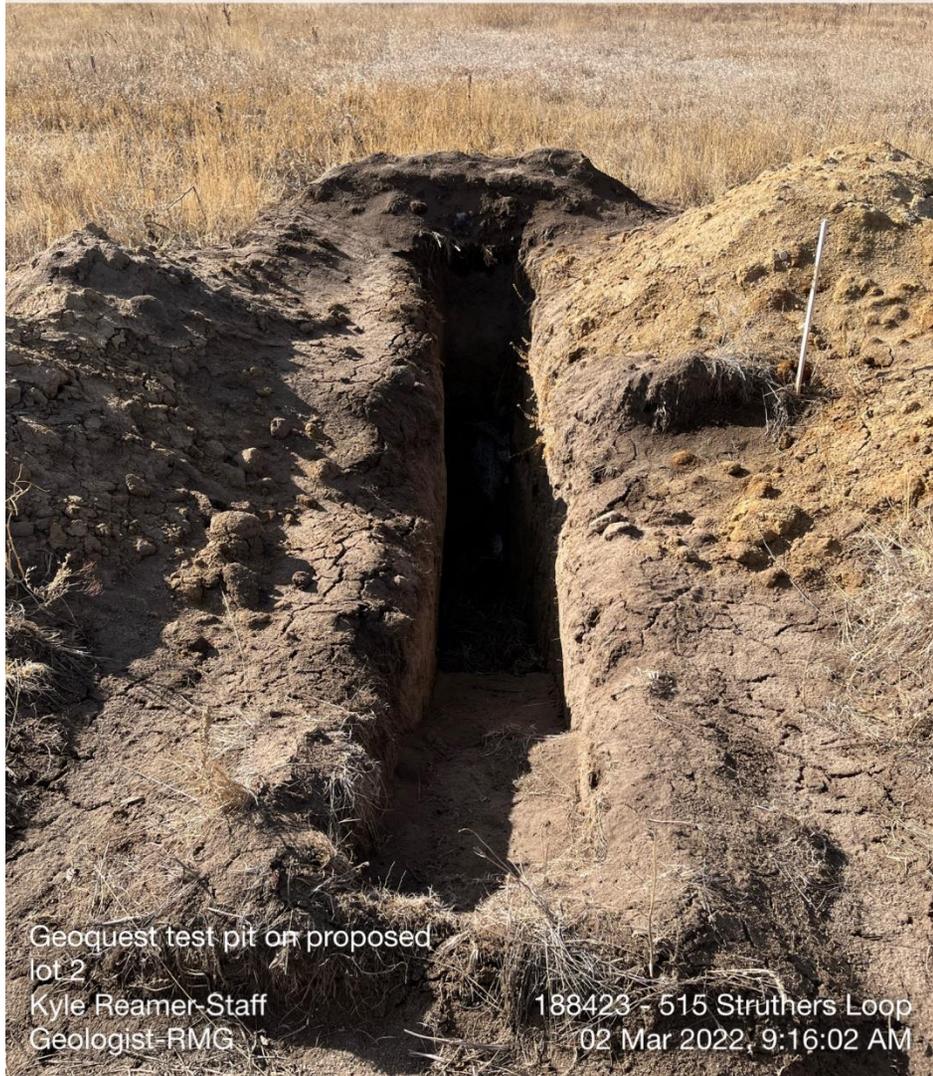
Geoquest test pit on proposed lot 2

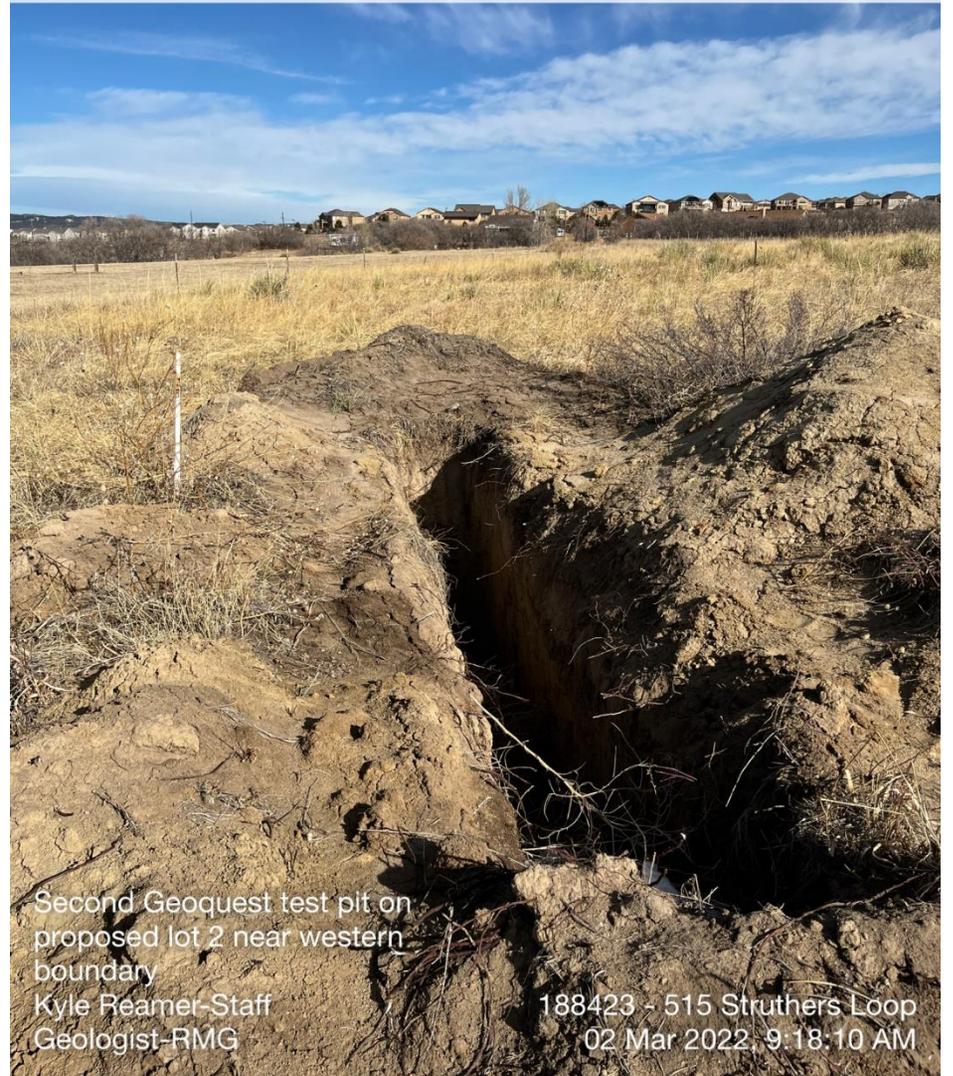
Second Geoquest test pit on proposed lot 2 near western boundary
