**PRELIMINARY SOIL, GEOLOGY, GEOLOGIC HAZARD,
AND WASTEWATER STUDY,
MCCUNE RANCH SUBDIVISION
PARCEL NO. 51000-00-493
17480 MERIDIAN ROAD NORTH
EL PASO COUNTY, COLORADO**

October 2, 2018

Entech Job No. 181459
AAprojects/2018/181459 countysoil/geo/ww

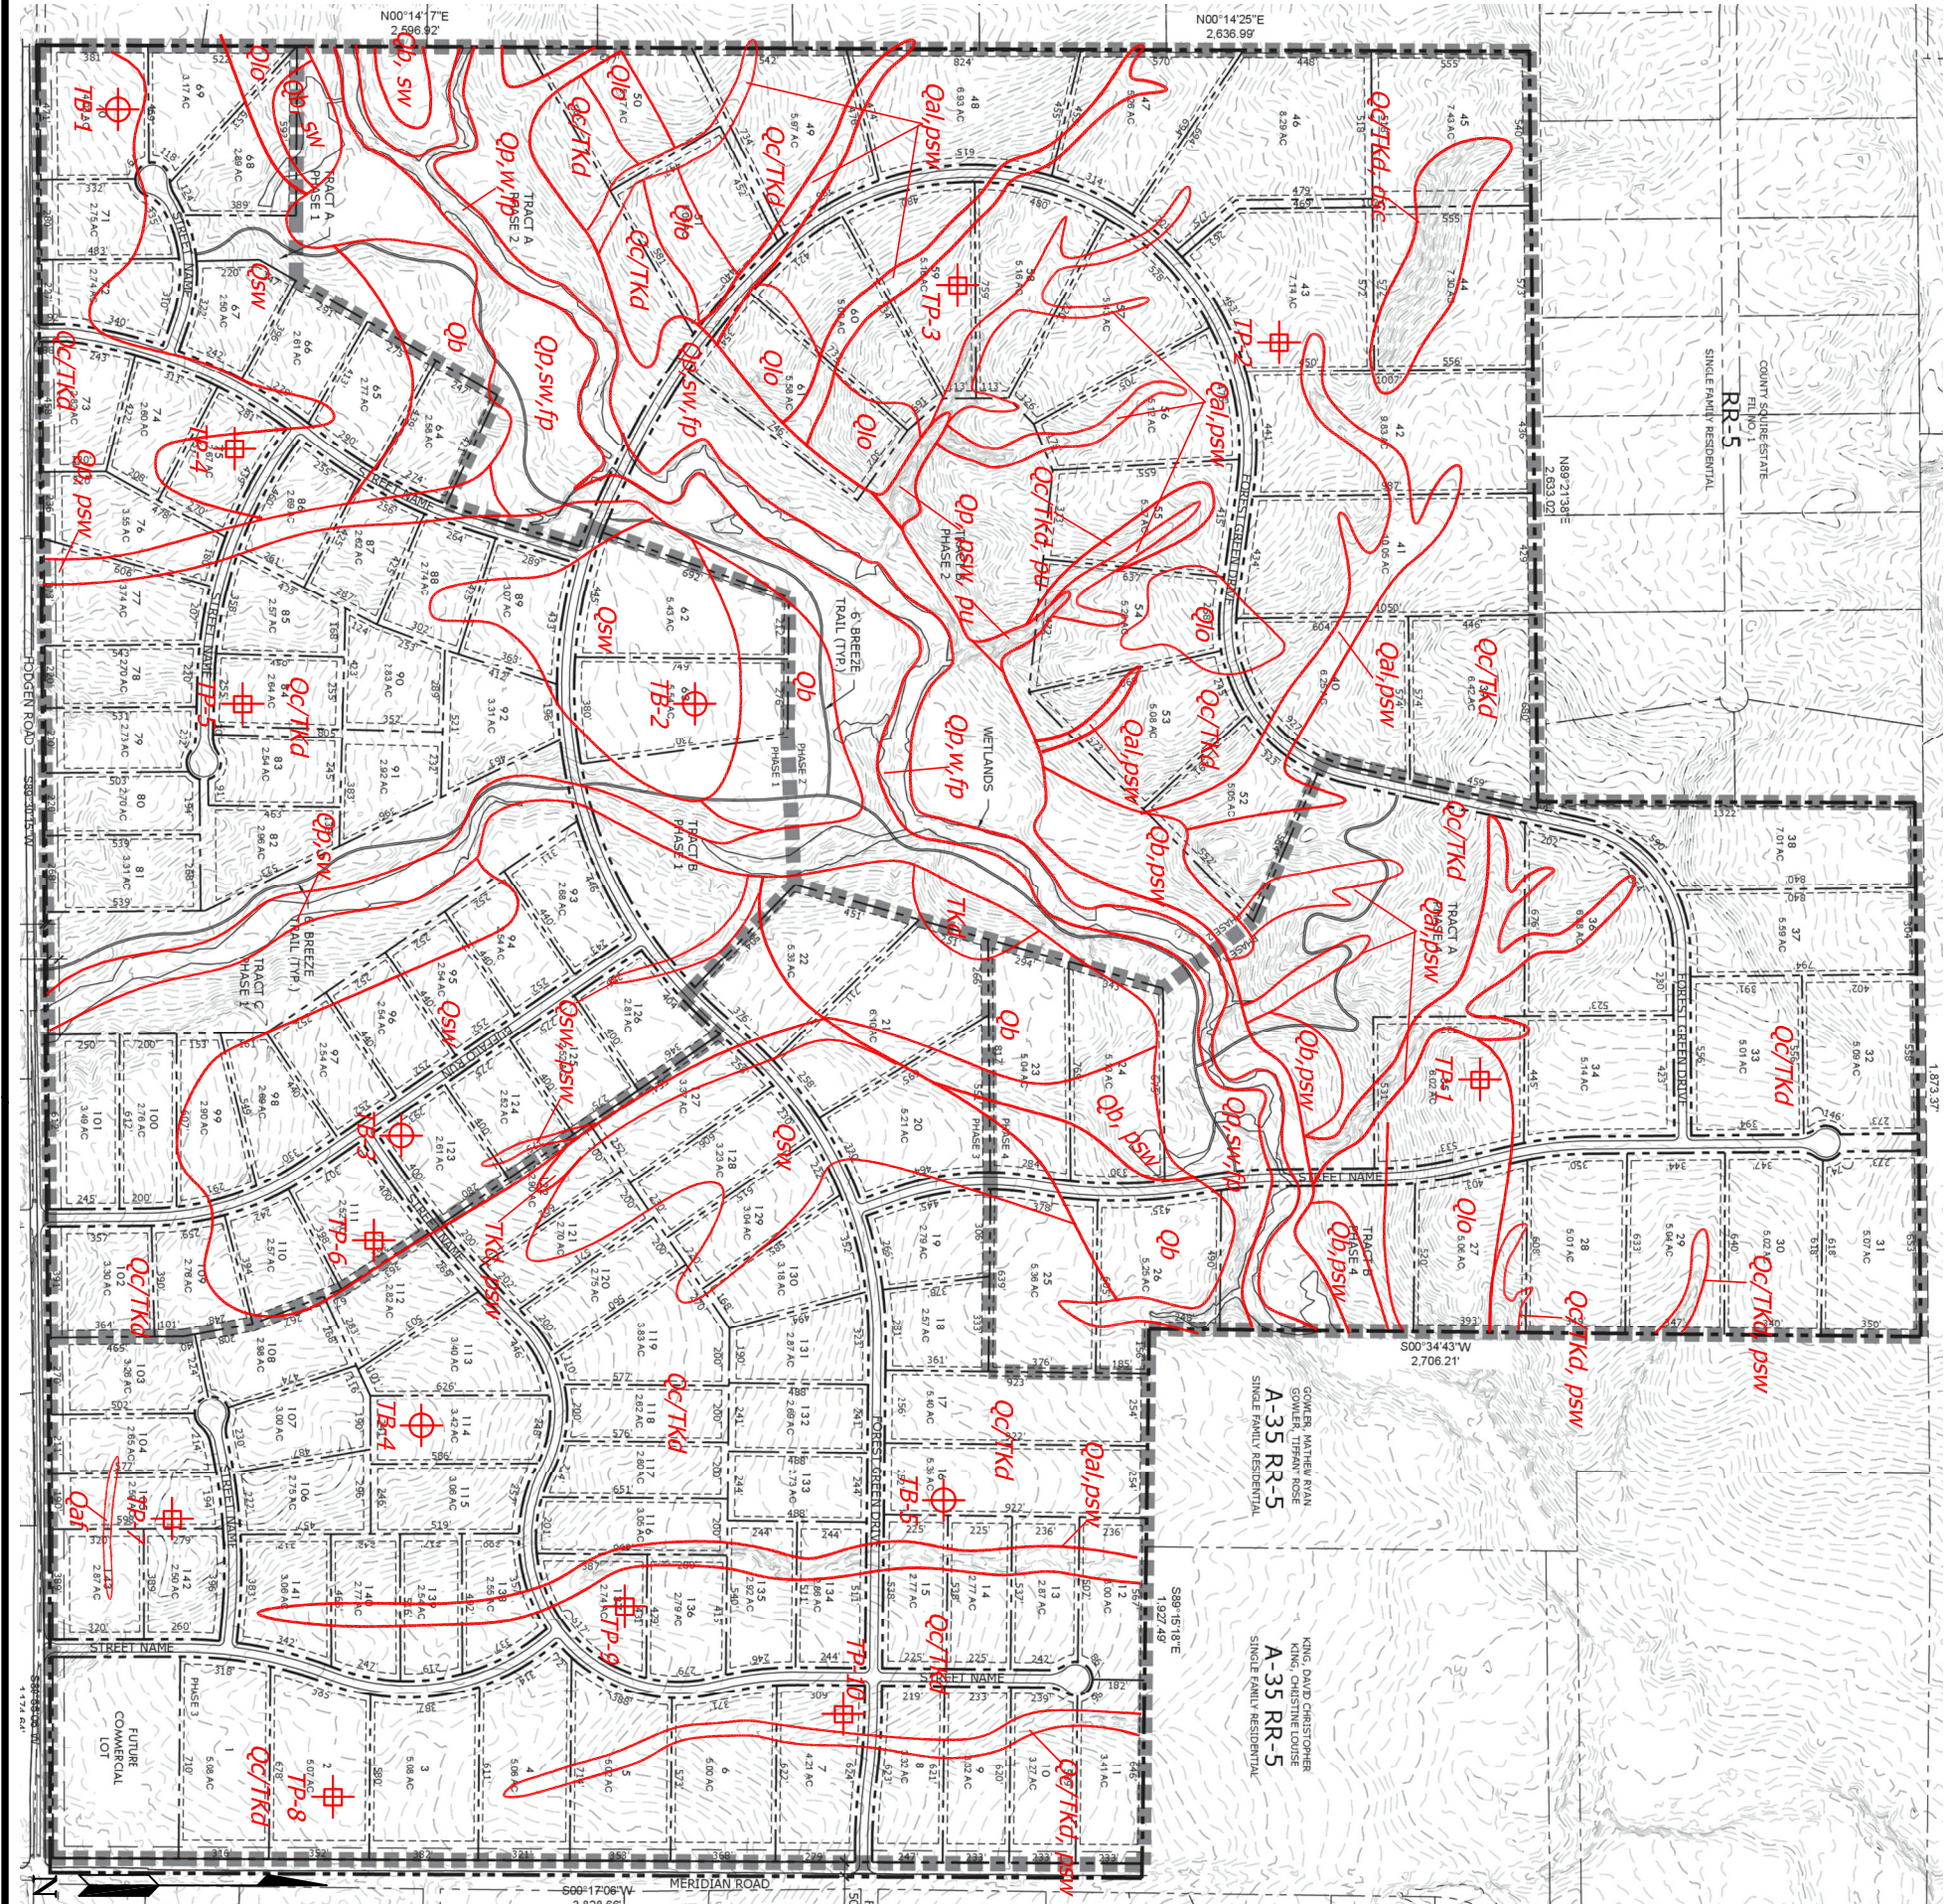
GEOLOGY/ENGINEERING GEOLOGY MAP
MCCUNE RANCH SUBDIVISION
17480 MERIDIAN ROAD NORTH
EL PASO COUNTY, CO.
FOR: PROTERRA PROPERTIES, LLC

As mentioned previously, detailed mapping has been performed on this site to produce an Geology/Engineering Geology Map (Figure 6). This map shows the location of various geologic conditions of which the developers should be cognizant during the planning, design and construction stages of the project. These hazards and the recommended mitigation techniques are as follows:

The majority of the slopes in the building areas on site are gently to moderately sloping and do not exhibit any past or potential unstable slopes or landslides. However, the steeply sloping areas along the drainage in the central portion of the site have been identified as potentially unstable slopes. Additionally, areas of downslope creep have been mapped on the site. These areas are identified on the Geology/Engineering Geology Map, Figure 6. The recommendations for these areas are as follows:

The area identified with this hazard is located along a portion of a minor drainage where cut banks have created potentially unstable slopes. Considerable care must be exercised in these areas not to create a condition which would tend to activate instability.

The areas identified with this hazard includes some of the steeper slopes on site, particularly in the northwest portion of the site. In these areas, we would anticipate lateral and vertical movement of the near surface soils in the downslope direction. These areas are acceptable as building sites with the following constraints on construction.

Mitigation: Building should be avoided in these areas. The lot most significantly affected by potentially unstable slopes is Lot 55. The structures on these lots should be set back a minimum of 30 feet from the crest of these slopes. It appears there is sufficient room on the lots to avoid this hazard. Proper control of drainage at both the surface above the slope and the subsurface is extremely important. Areas of ponded water at the surface should be avoided. Utility trenches, basement excavations and other subsurface features should not be permitted to become water traps which may promote saturation of the subsurface materials. Drainage should not be permitted over the potentially unstable slope but directed in a non-

erosive manner away from the slope. Irrigation above these slopes should be kept to a minimum to prevent saturation of the subsurface soils. The use of xeriscape landscaping utilizing native plantings is recommended to reduce the need for irrigation.

Mitigation: Building is possible in these areas if the following engineering and construction mitigation steps are taken: This type of movement will increase lateral pressures against foundation walls on the uphill side of structures. The design of foundations in these areas should account for this additional pressure. Additionally, the foundation should be designed to withstand pressures where steeper areas slope away from the foundation. Tie beams and buttresses are recommended to stiffen the foundation system.

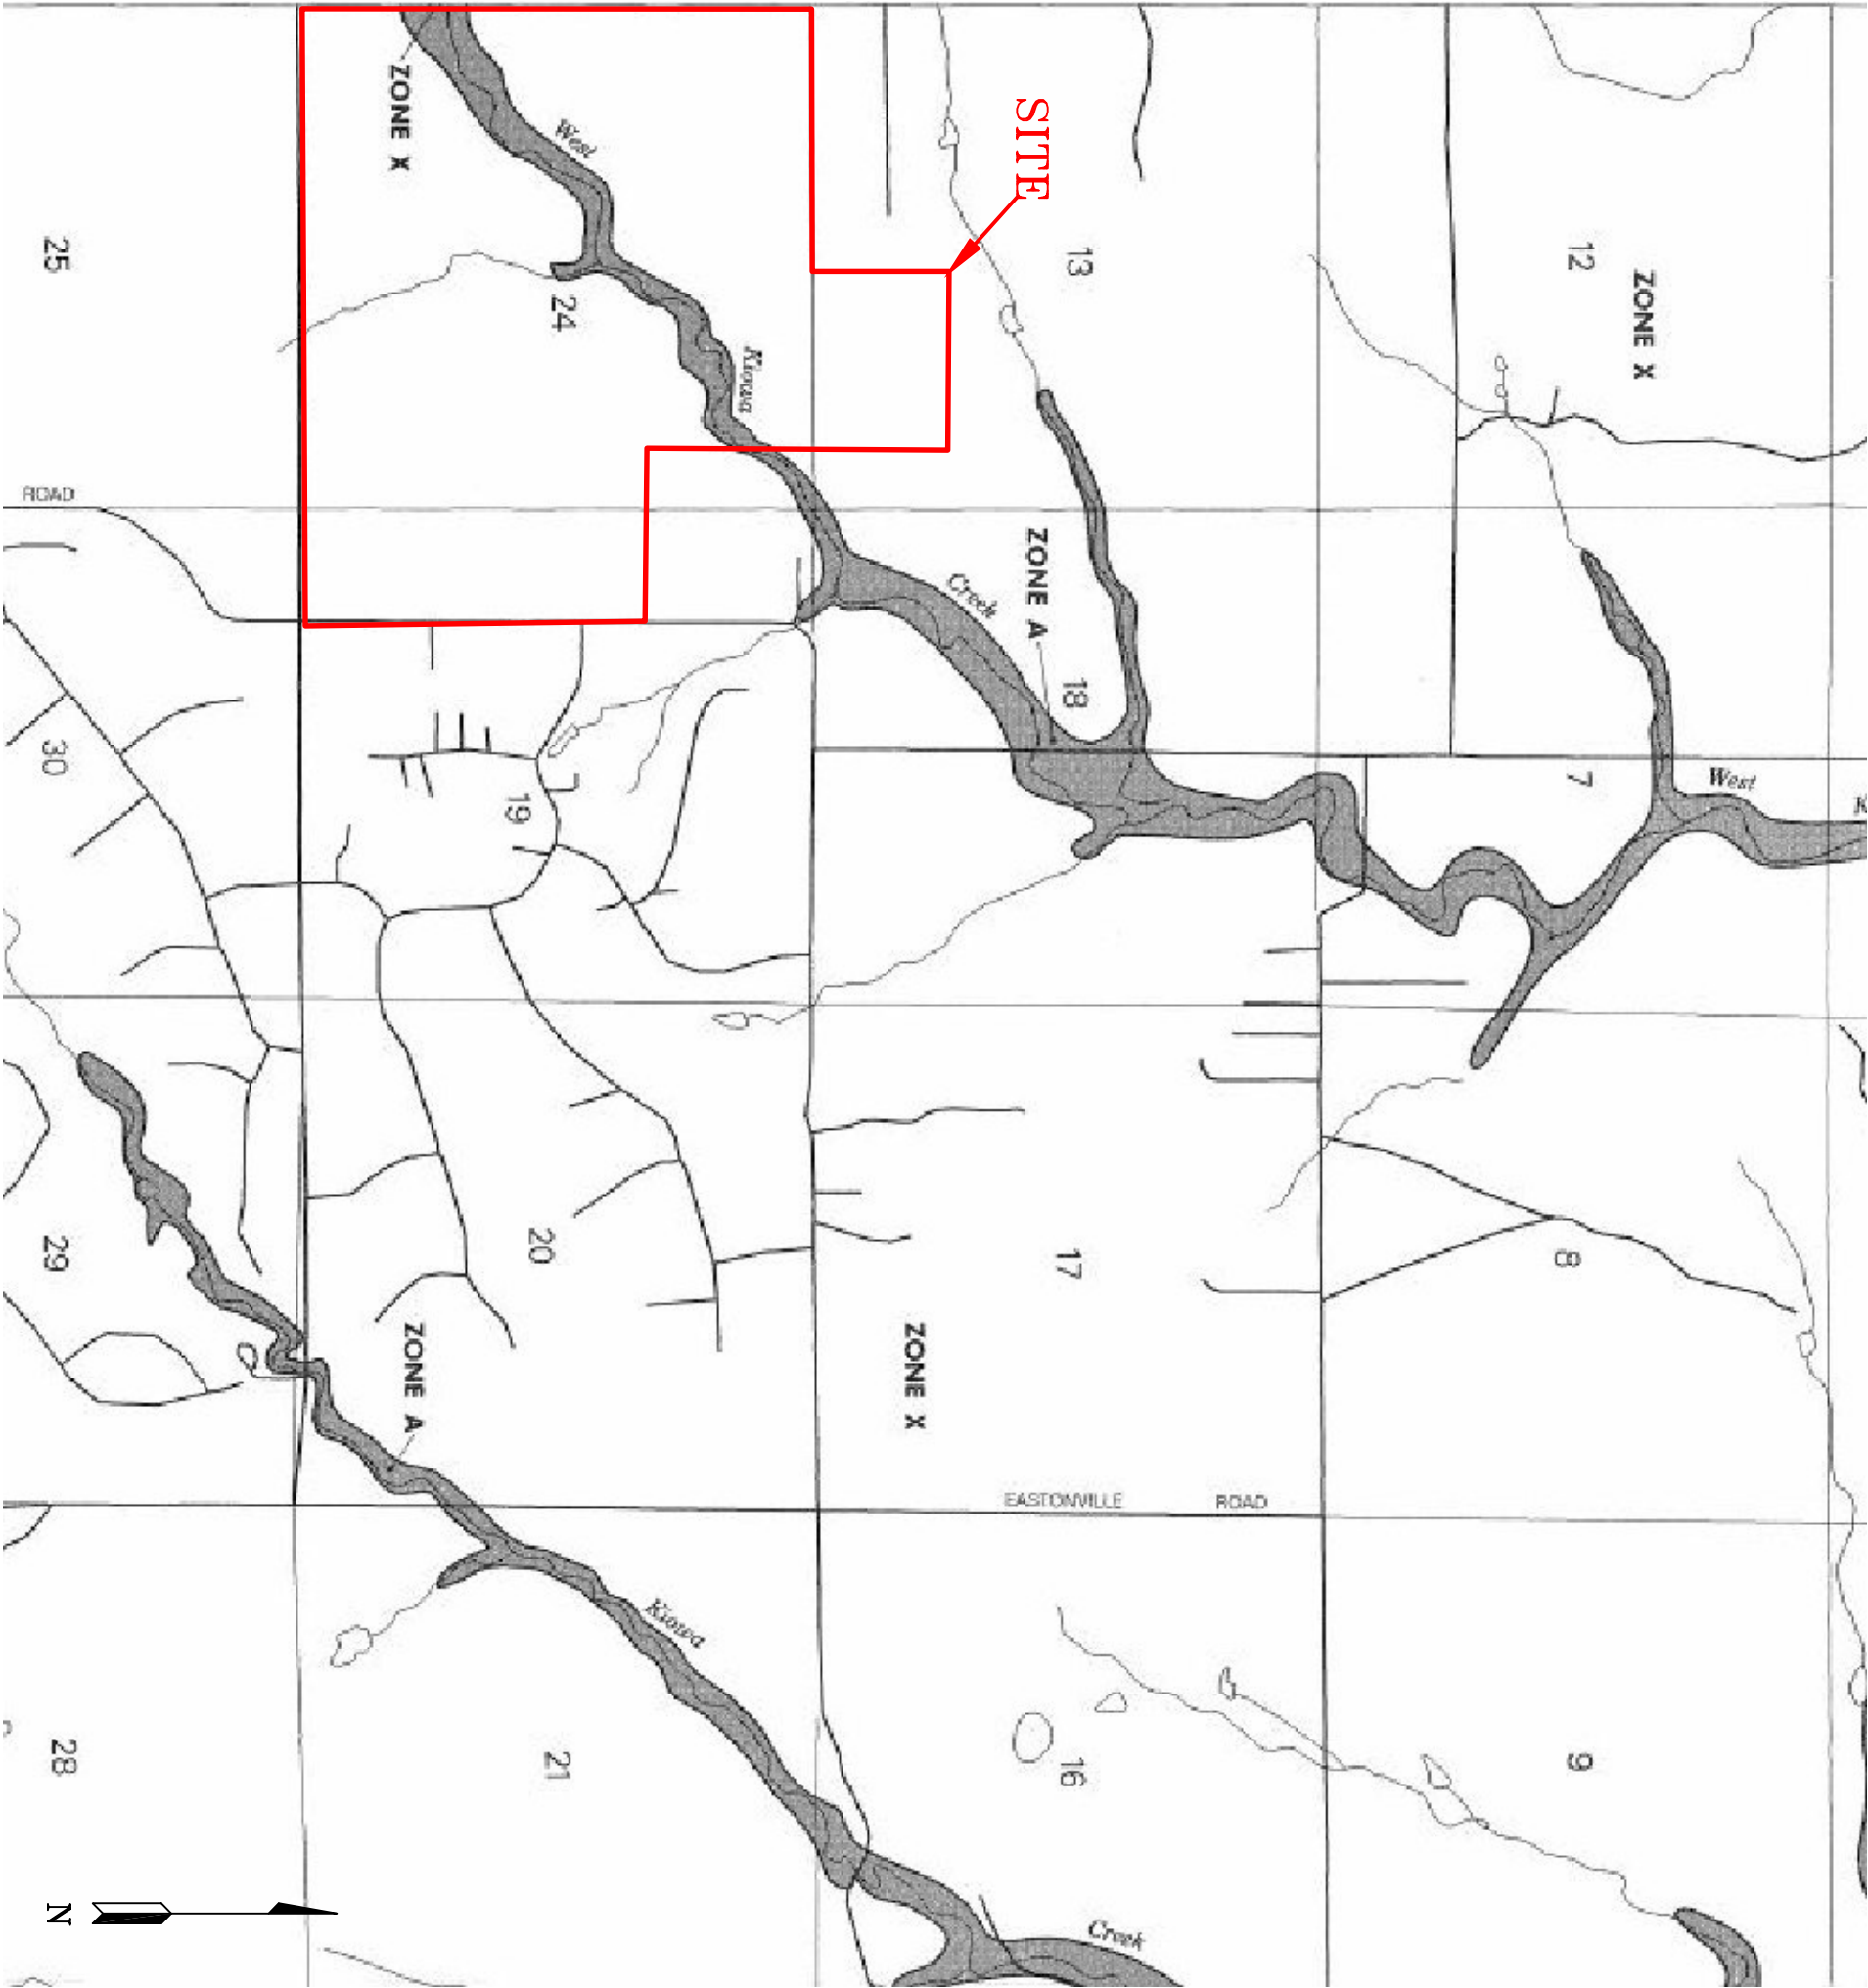
FLOODPLAIN MAP
MCCUNE RANCH SUBDIVISION
17480 MERIDIAN ROAD NORTH
EL PASO COUNTY, CO.
FOR: PROTERRA PROPERTIES, LLC

Portions of the site associated with the West Kiowa Creek drainage are mapped within a floodplain zone according to the FEMA Map No. 08041CO350F, dated March 17, 1997 (Figure 7, Reference 6). Water was observed flowing in West Kiowa Creek. The floodplain areas have been designated as open space and/or can be avoided by construction. Additionally, areas of seasonal and potentially seasonal shallow groundwater were observed across the site. In these areas, we would anticipate the potential for periodically high subsurface moisture conditions and frost heave potential. These areas lie within low-lying areas along the drainage in the southeastern portion of the site and in the low-lying areas and minor drainages across the site. Water was not observed in any of the minor drainages at the time of our site investigation. These areas can likely be avoided or properly mitigated by development. The floodplain should be avoided by construction unless site-specific floodplain determination and drainage studies are performed. The potential exists for high groundwater levels during high moisture periods and should structures encroach on these areas the following precautions should be followed.

Mitigation: Foundations must have a minimum 30-inch depth for frost protection. In areas where high subsurface moisture conditions are anticipated periodically, subsurface perimeter drains are recommended to help prevent the intrusion of water into areas below grade. Typical drain details are presented in Figure 8. Some of the minor drainage swales can be avoided or regraded. The main drainage that bisects the site is designated as open space and will be avoided. Any grading in these areas should be done to direct surface flow around construction to avoid areas of ponded water. Finished floors must be located at least one foot above floodplain levels. Specific drainage studies and exact floodplain locations are beyond the scope of this report.

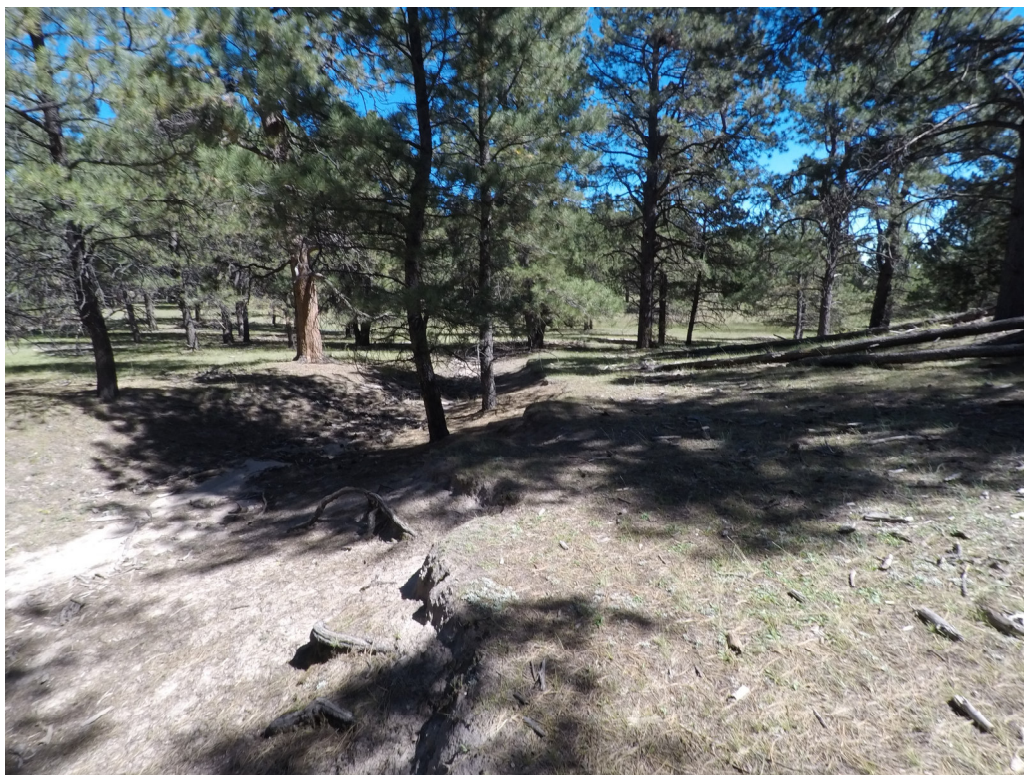
**Looking east along
drainage in the
northern portion of the
site.**

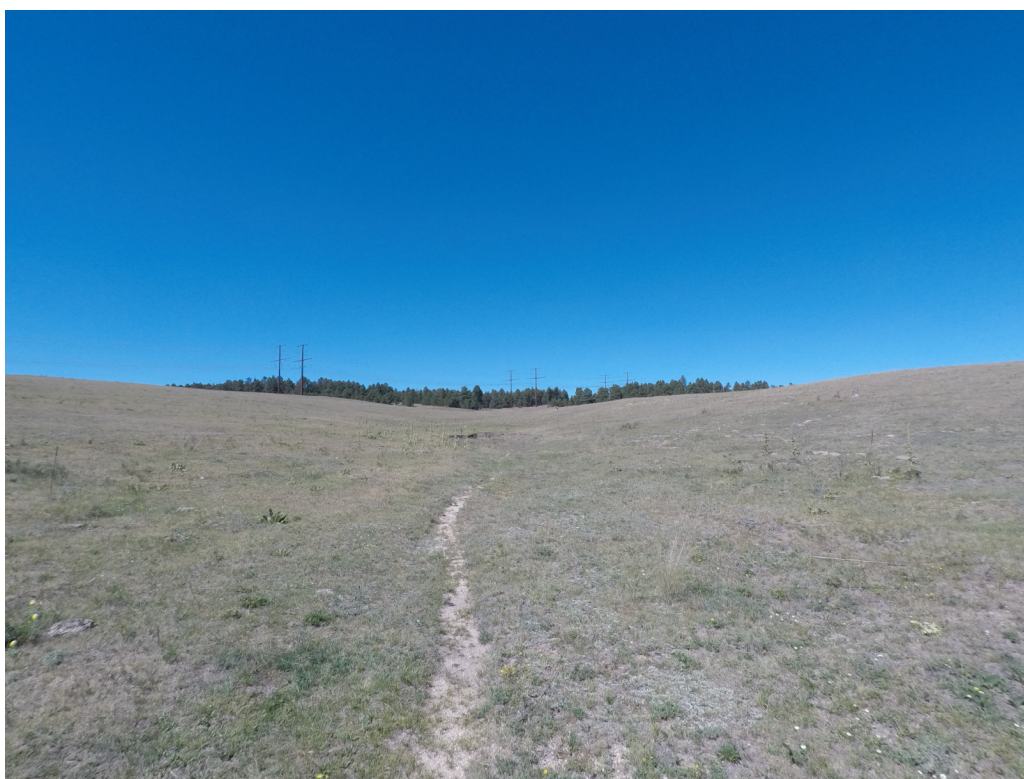
**Looking north along
small drainage in the
western portion of the
site.**

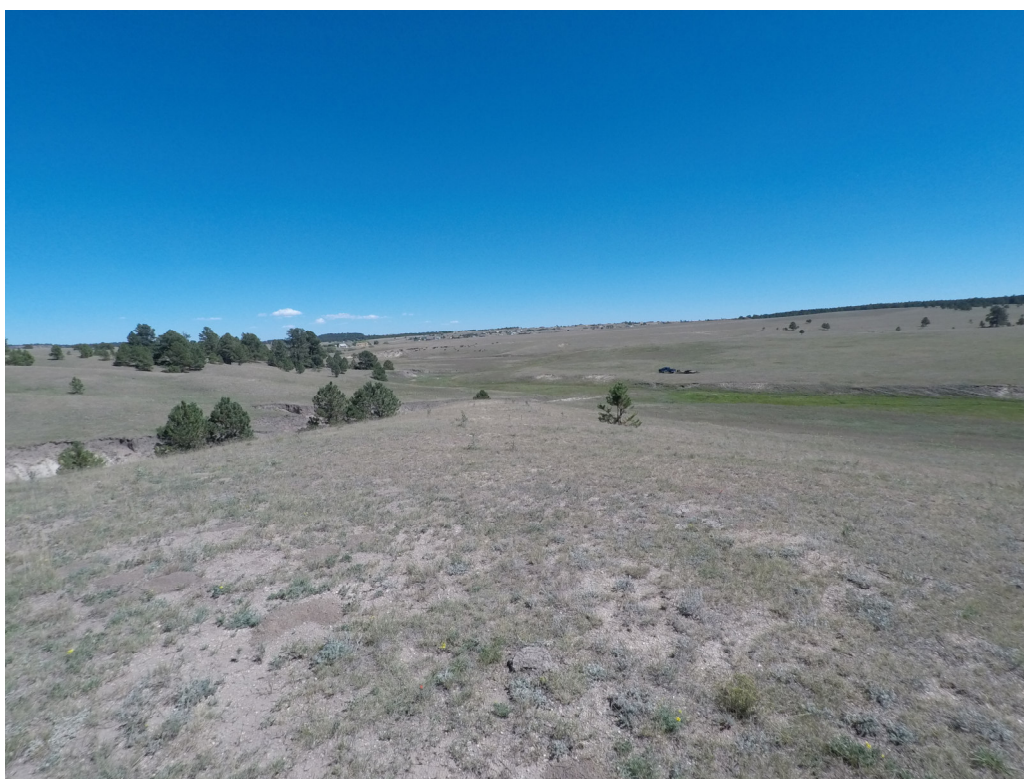
**Looking east towards
W. Kiowa Creek in the
central portion of the
site.**

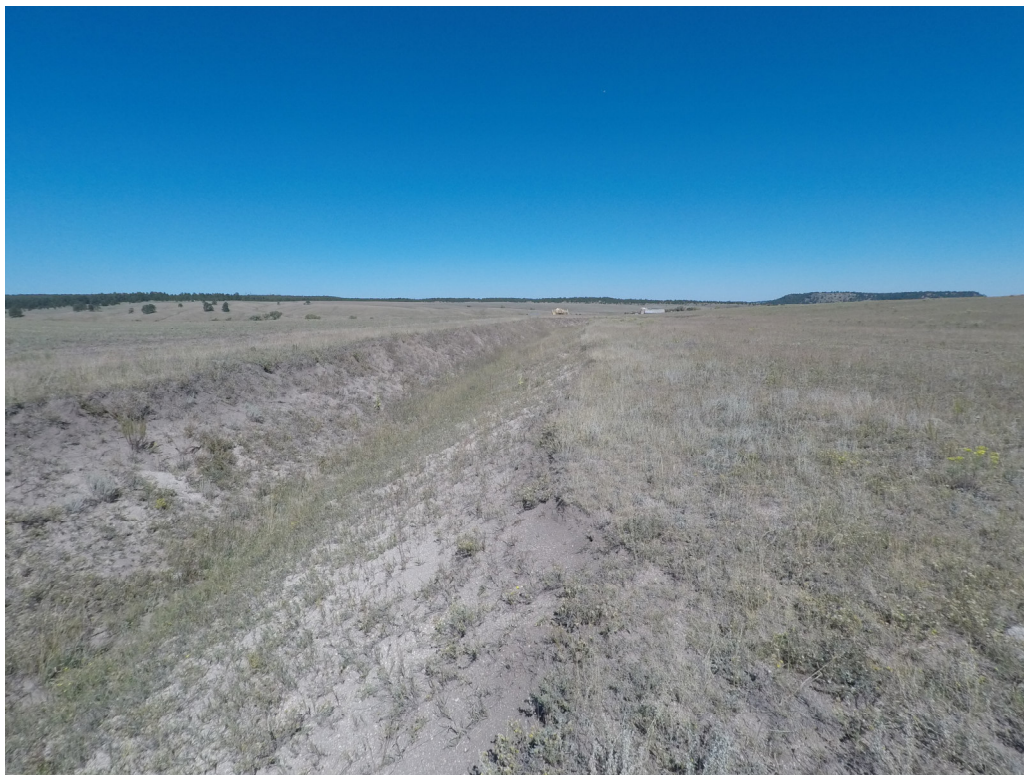
**Looking north along
drainage in the
northeastern portion of
the site.**

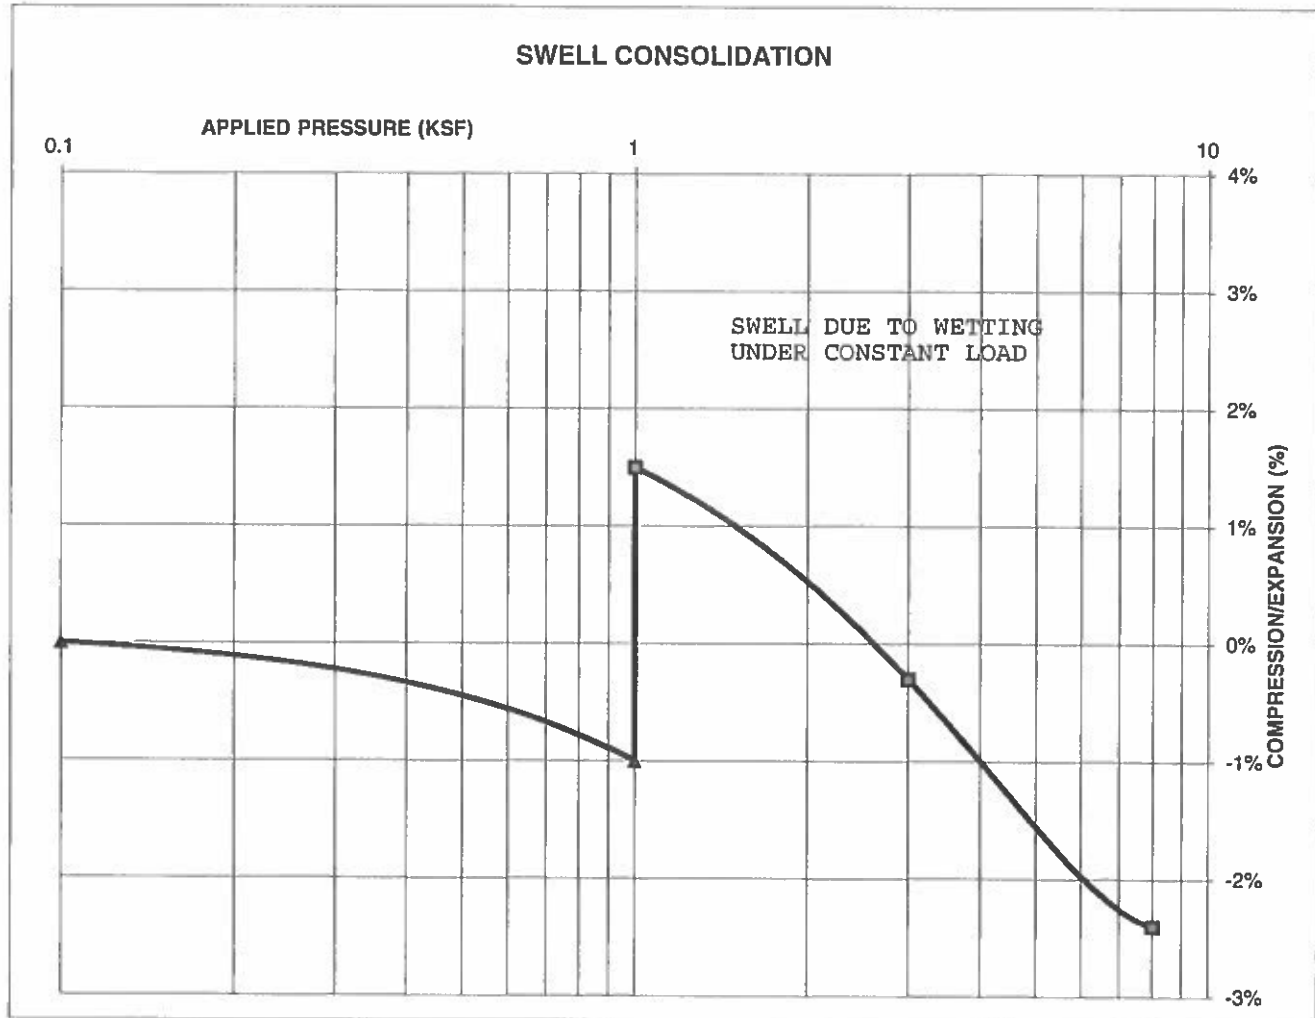
Soil Type 4 is a sandy claystone (CL). This material was encountered Test Boring No. 1 at 12 feet bgs and extended to the termination of the boring (20 feet). The claystone was encountered at hard consistencies and moist conditions. Samples tested had 73 percent of the soil sized particles passing the No. 200 sieve. Swell/Consolidation Testing resulted in a volume change of 2.5 percent, indicating a moderate to high expansion potential.

TEST BORING #	1	DEPTH(ft)	15
DESCRIPTION	CL	SOIL TYPE	4
NATURAL UNIT DRY WEIGHT (PCF)			120
NATURAL MOISTURE CONTENT			13.4%
SWELL/CONSOLIDATION (%)			2.5%

Mitigation: Should expansive soils be encountered beneath the foundation, mitigation will be necessary. Mitigation of expansive soils will require special foundation design. Overexcavation and replacement with non-expansive soils at a minimum of 95% of its maximum Modified Proctor Dry Density, ASTM D-1557 is a suitable mitigation, which is common in the area. Another alternative in areas of highly expansive soils is the use of drilled pier foundation systems. Typical minimum pier depths are on the order of 25 feet or more and require penetration into the bedrock material a minimum of 4 to 6 feet, depending upon building loads. Floor slabs on expansive soils should be expected to experience movement. Overexcavation and replacement has been successful in minimizing slab movements. The use of structural floors should be considered for basement construction on highly expansive clays. Final recommendations should be determined after additional investigation of each building site.
