**SOIL, GEOLOGY, GEOLOGIC HAZARD,
AND WASTEWATER STUDY,
FLYING HORSE NORTH
PUD SUBMITTAL
EL PASO COUNTY, COLORADO**

Pulpit Rock Investments No. 2
6385 Corporate Drive, Suite 200
Colorado Springs, Colorado 80919

February 22, 2016

Entech Job No. 160118
AAprojects/2016/160118 county soil geo ww

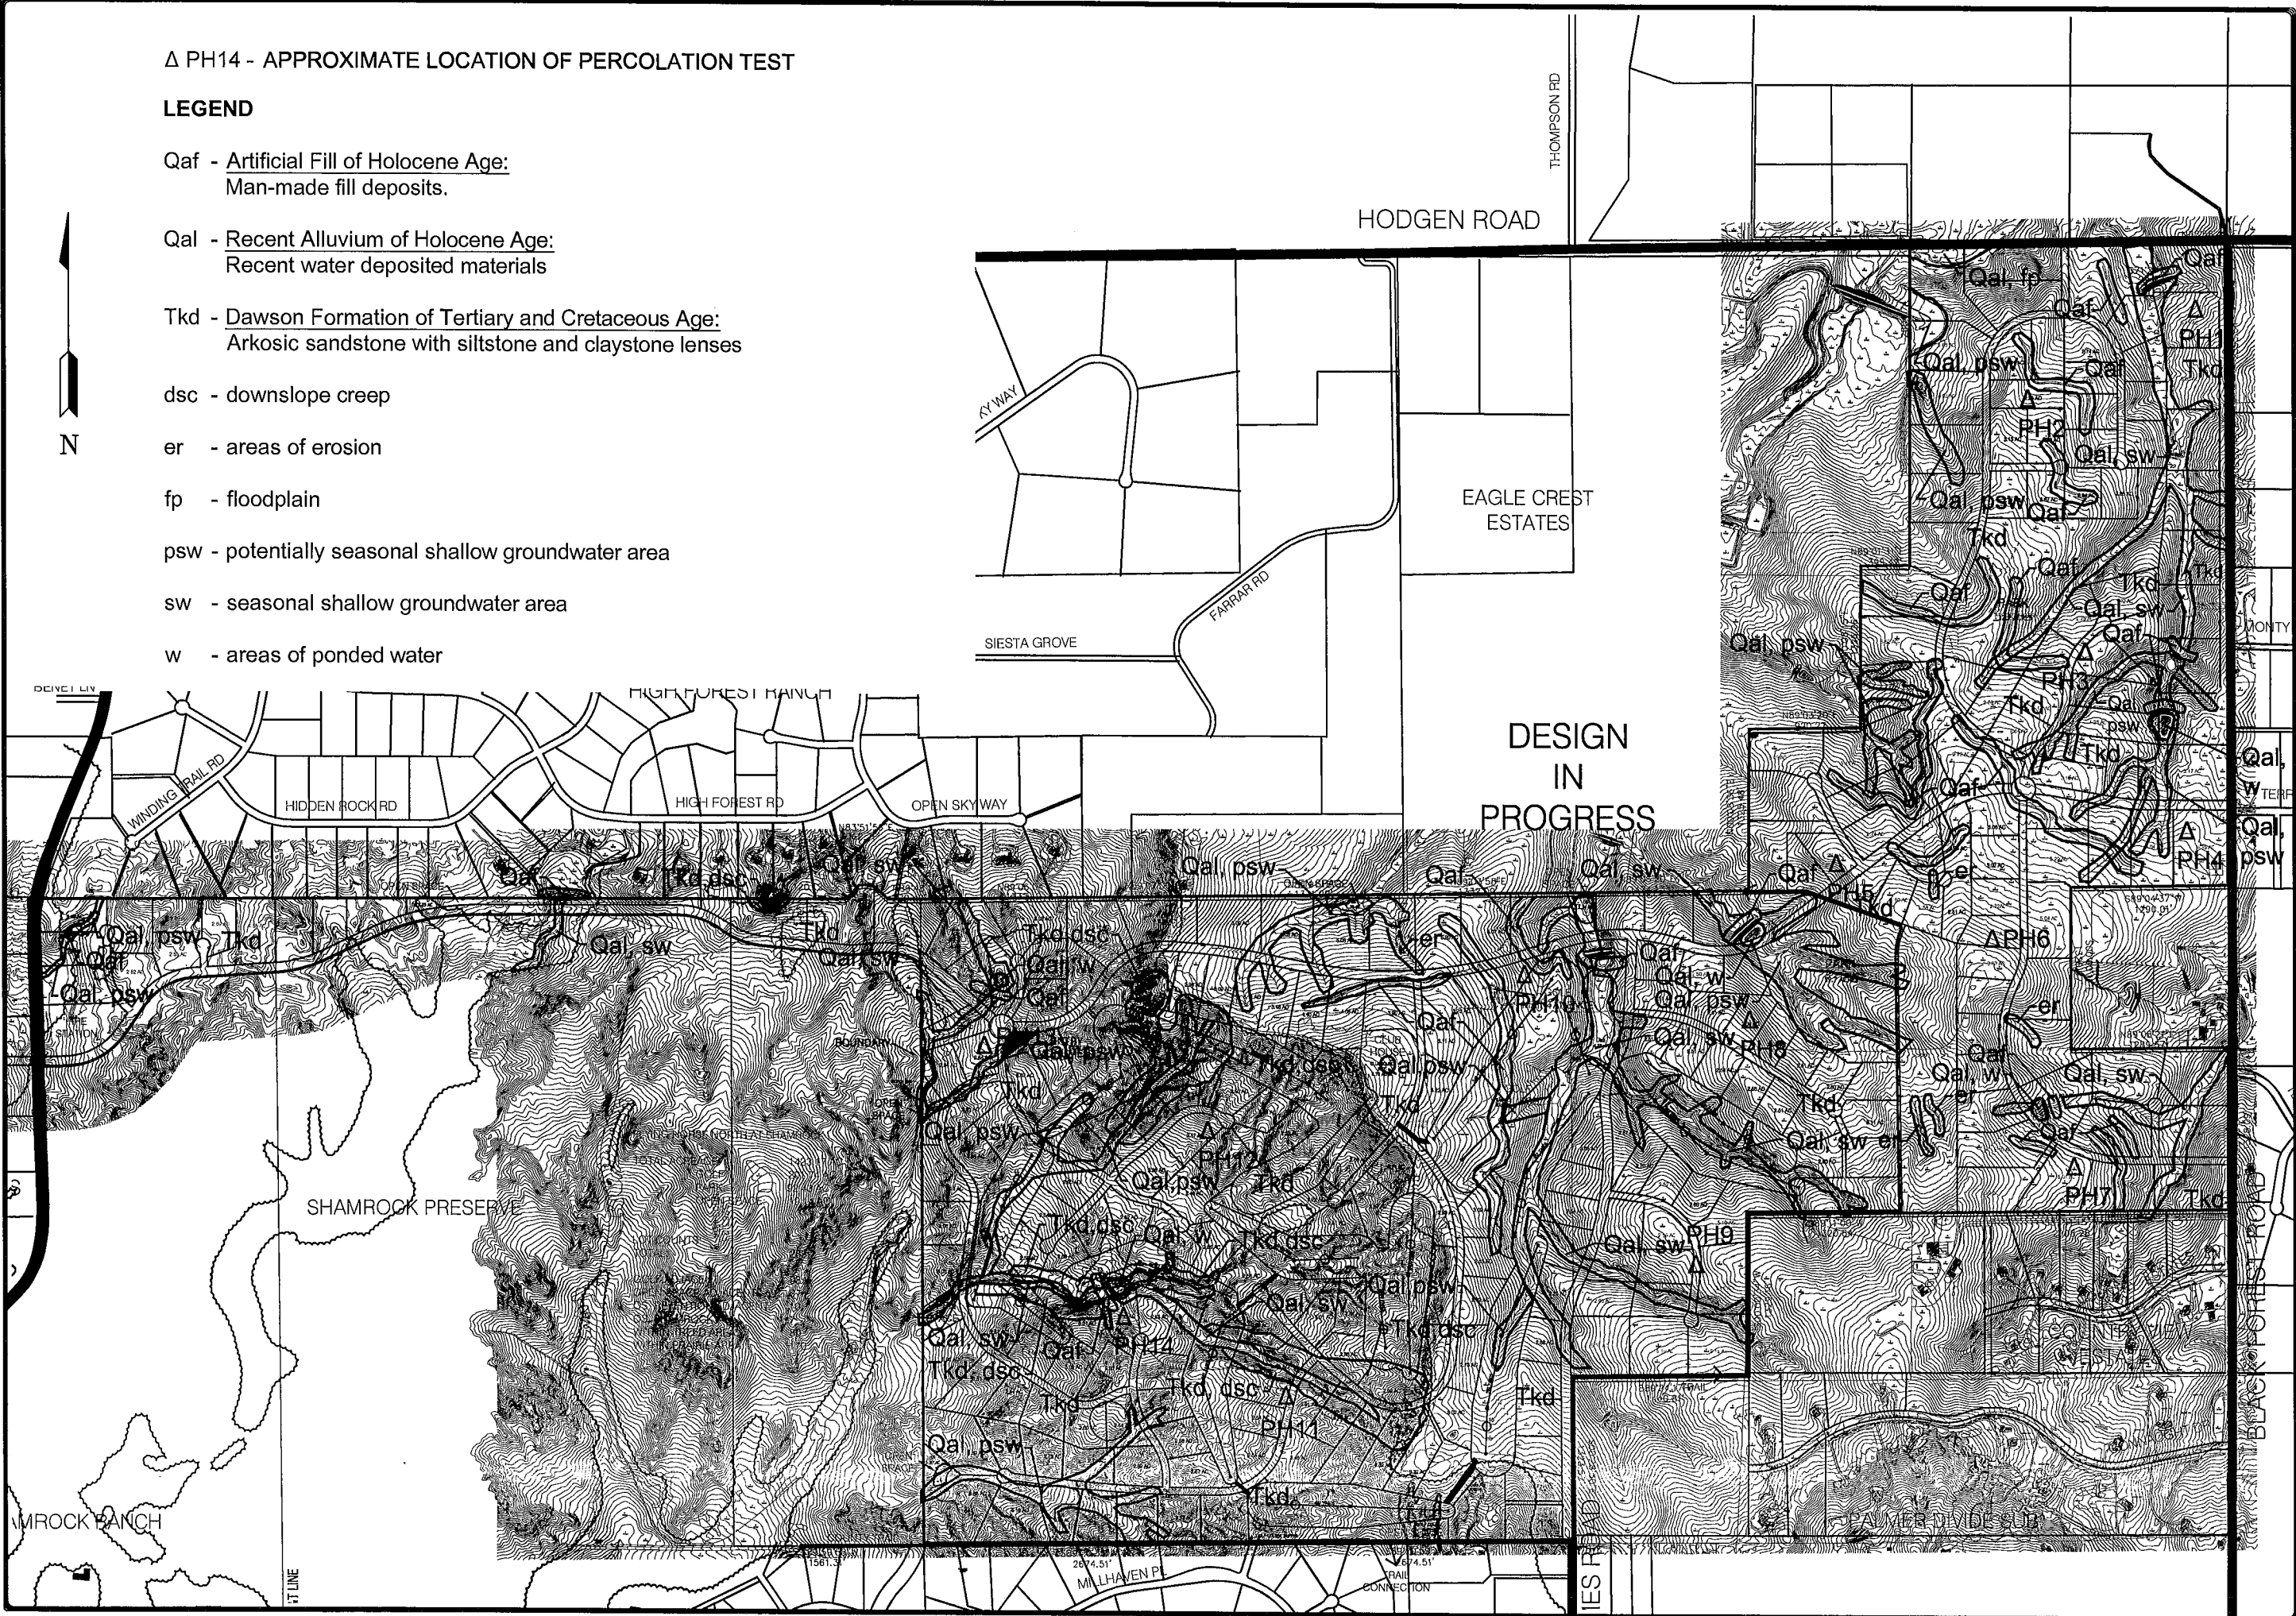
GEOLOGY/ENGINEERING GEOLOGY MAP
FLYING HORSE NORTH
EL PASO COUNTY, CO.

As mentioned previously, detailed mapping has been performed on this site to produce an Engineering Geology Map (Figure 6). This map shows the location of various geologic conditions of which the developers should be cognizant during the planning, design and construction stages of the project. These hazards and the recommended mitigation techniques are as follows:

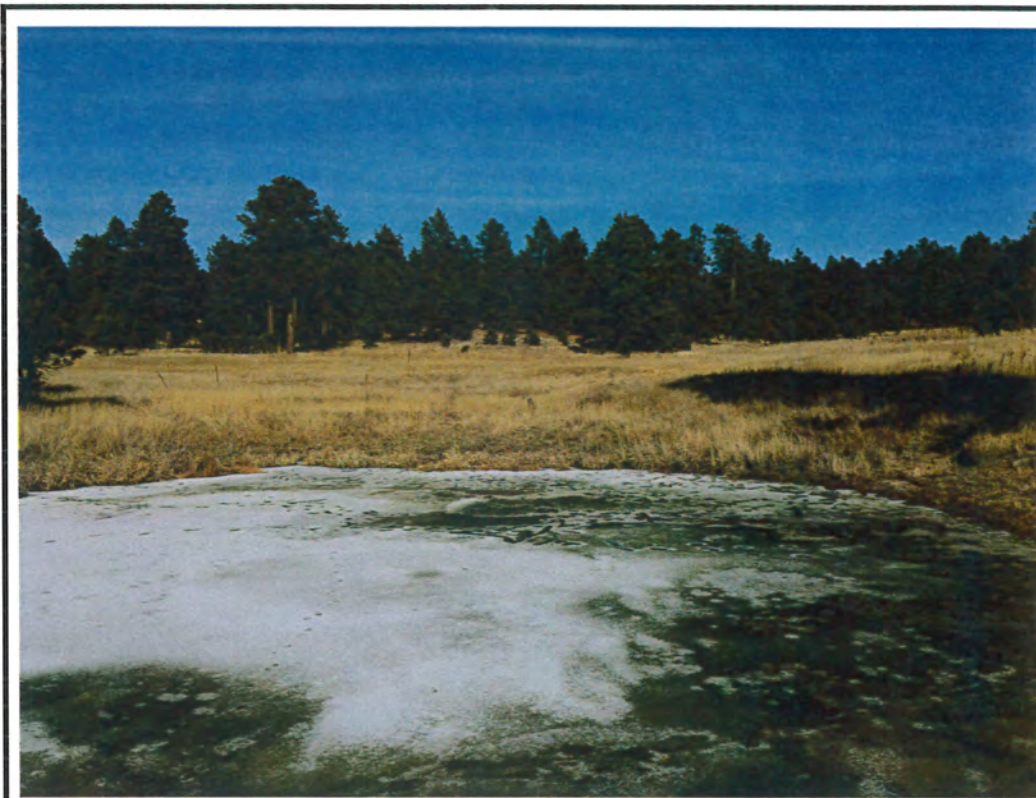
**Looking north at pond
in northwest portion of
the site.**

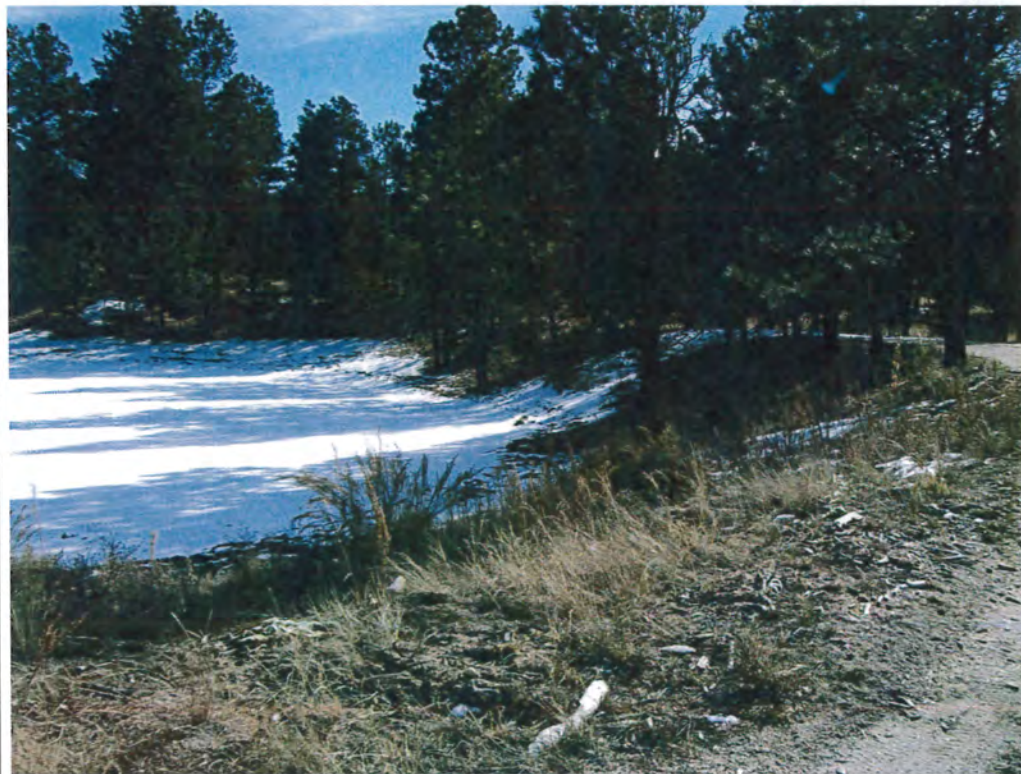
**Looking south at dam
in southwest portion of
the site.**

Mitigation: The earthen dams lie within defined drainages and should be avoided as building sites. The erosion berms can either be avoided or penetrated by foundations. The fill on this site is considered uncontrolled for construction purposes. Any uncontrolled fill encountered beneath foundations will require removal and recompaction at a minimum of 95% of its maximum Modified Procter Dry Density, ASTM D-1557.

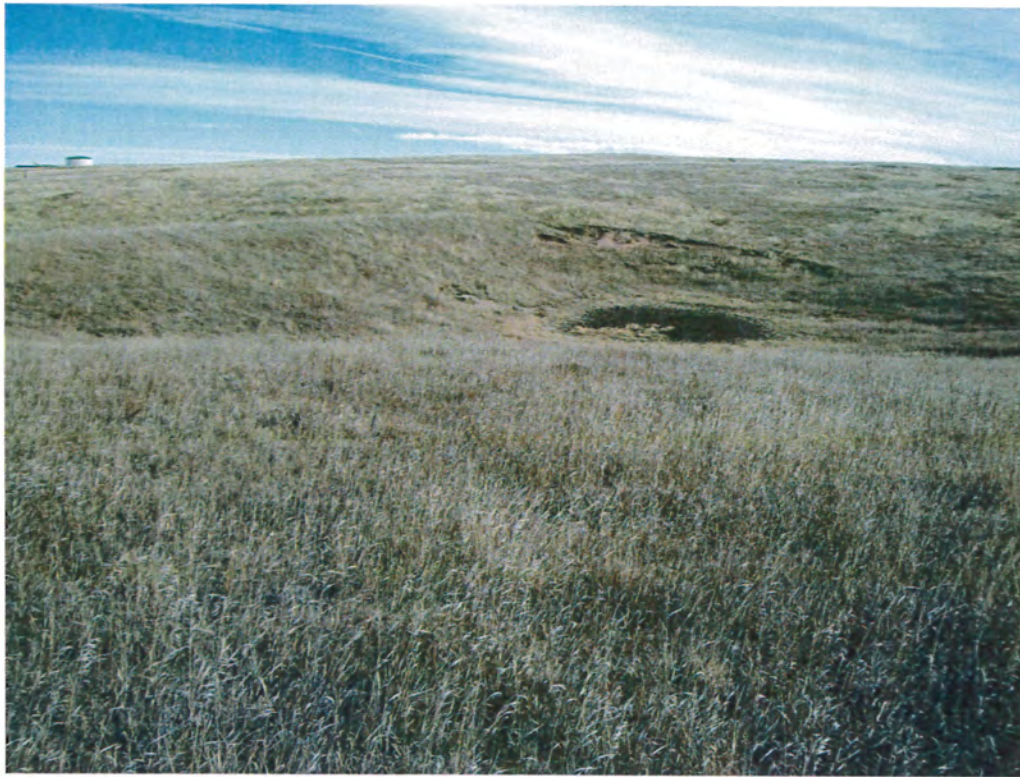
Looking northeast at dam in north central portion of the site.

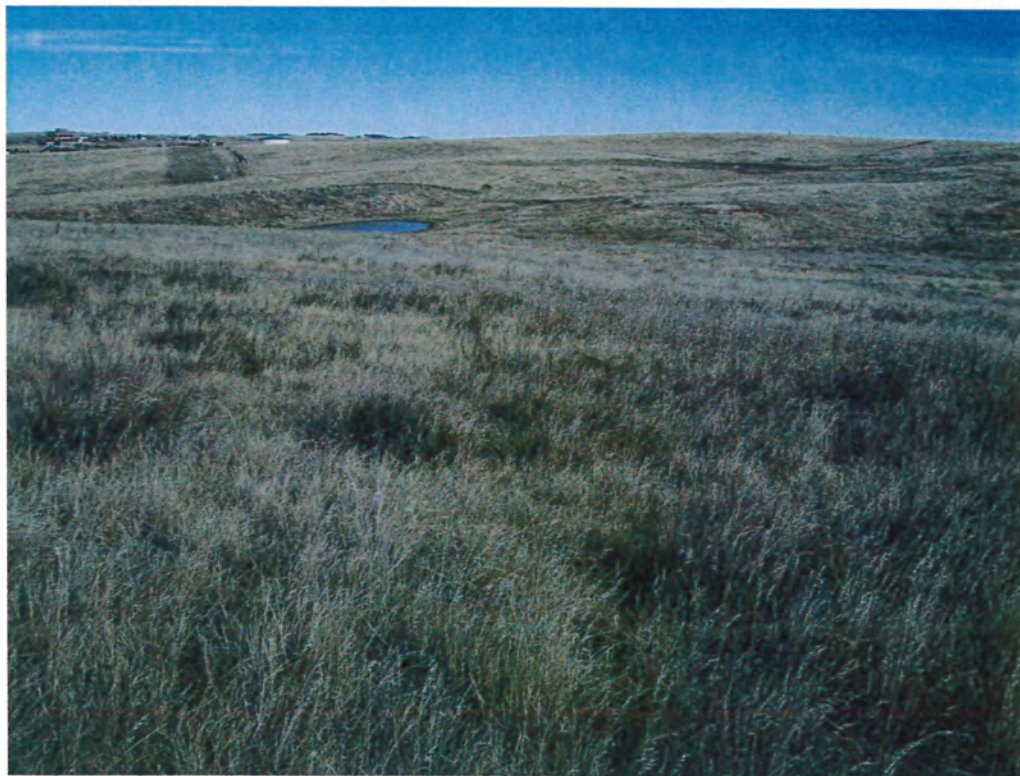
Looking north at dam in north central portion of the site.

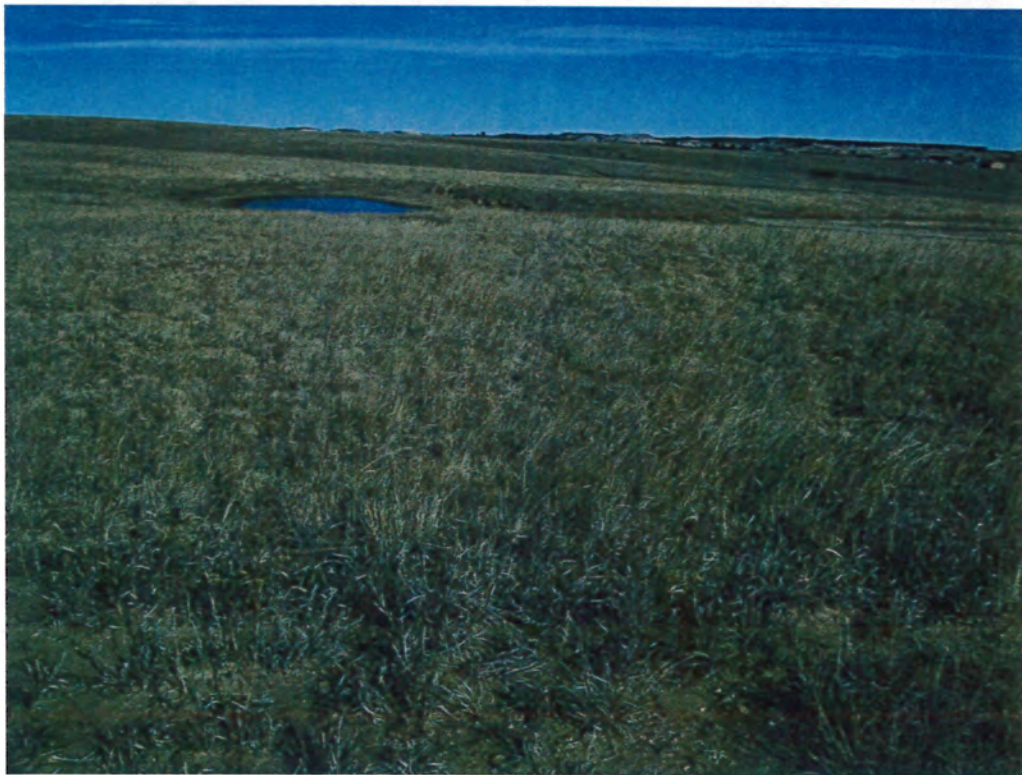
**Looking northeast at
dam in southeast
portion of the site.**

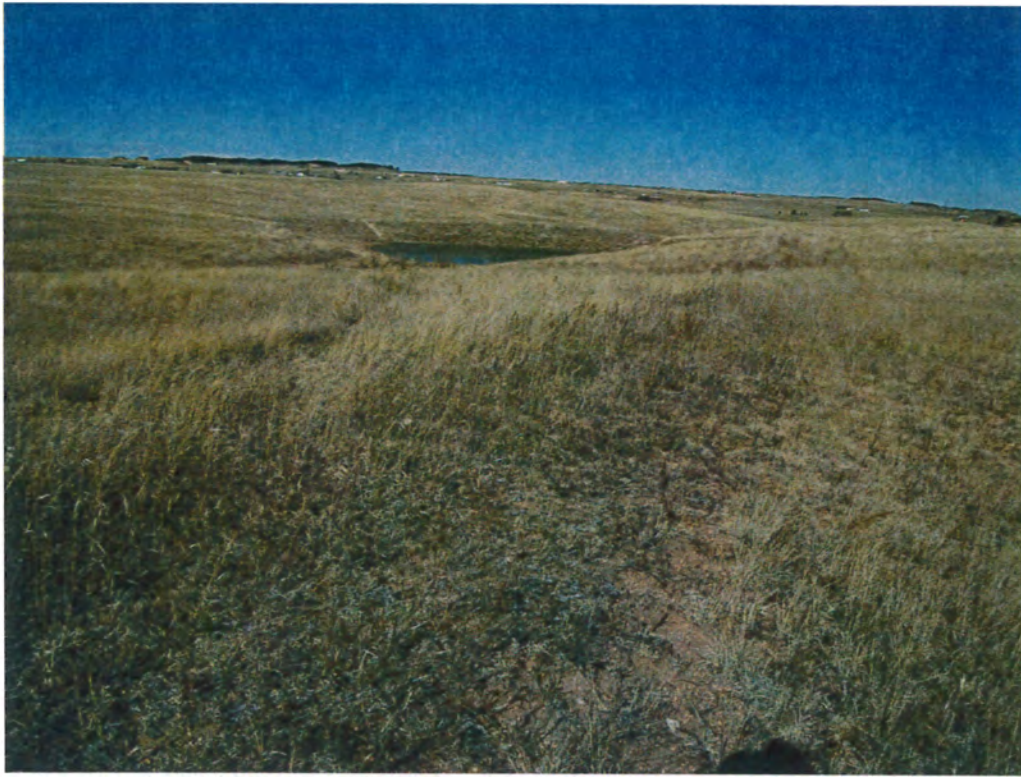
**Looking northwest at
dam in east portion of
the site.**
