October 8, 2018
Revised: March 30, 2021

Richmond American Homes
4350 South Monaco Street
Denver, Colorado 80237

Subject: Geologic Hazard Evaluation and Due Diligence Geotechnical Investigation
Haven Valley (formerly Patriot Village)
Alturas Drive and Cable Lane
Security-Widefield, Colorado
CTL|T Project No. CS18980-115

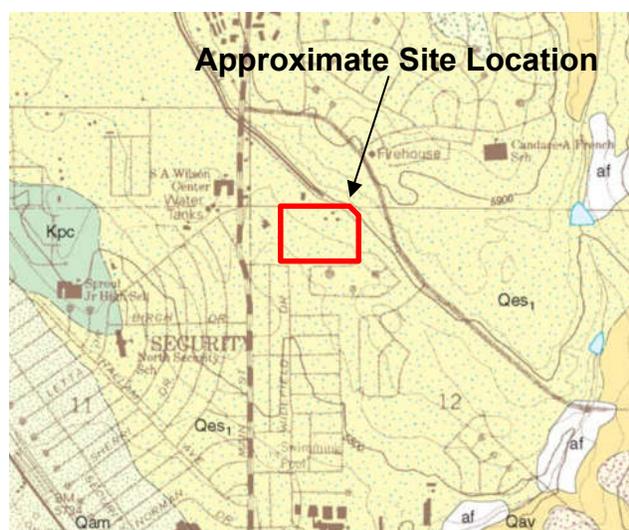
Geologic Map

The site is mapped as late Pleistocene-age eolian sand (wind-deposited sediment) consisting of very pale-brown, pale-brown, and light yellowish-brown sand with silt deposited as sand sheets, overlying the Dawson Formation. The Dawson Formation typically consists of sandstone interbedded with claystone in this area. Our subsurface investigation and observations generally confirm the mapping, although bedrock was not encountered to the depths explored of 20 and 30 feet. A map of the site specific surficial geologic conditions is shown on Figure 1.

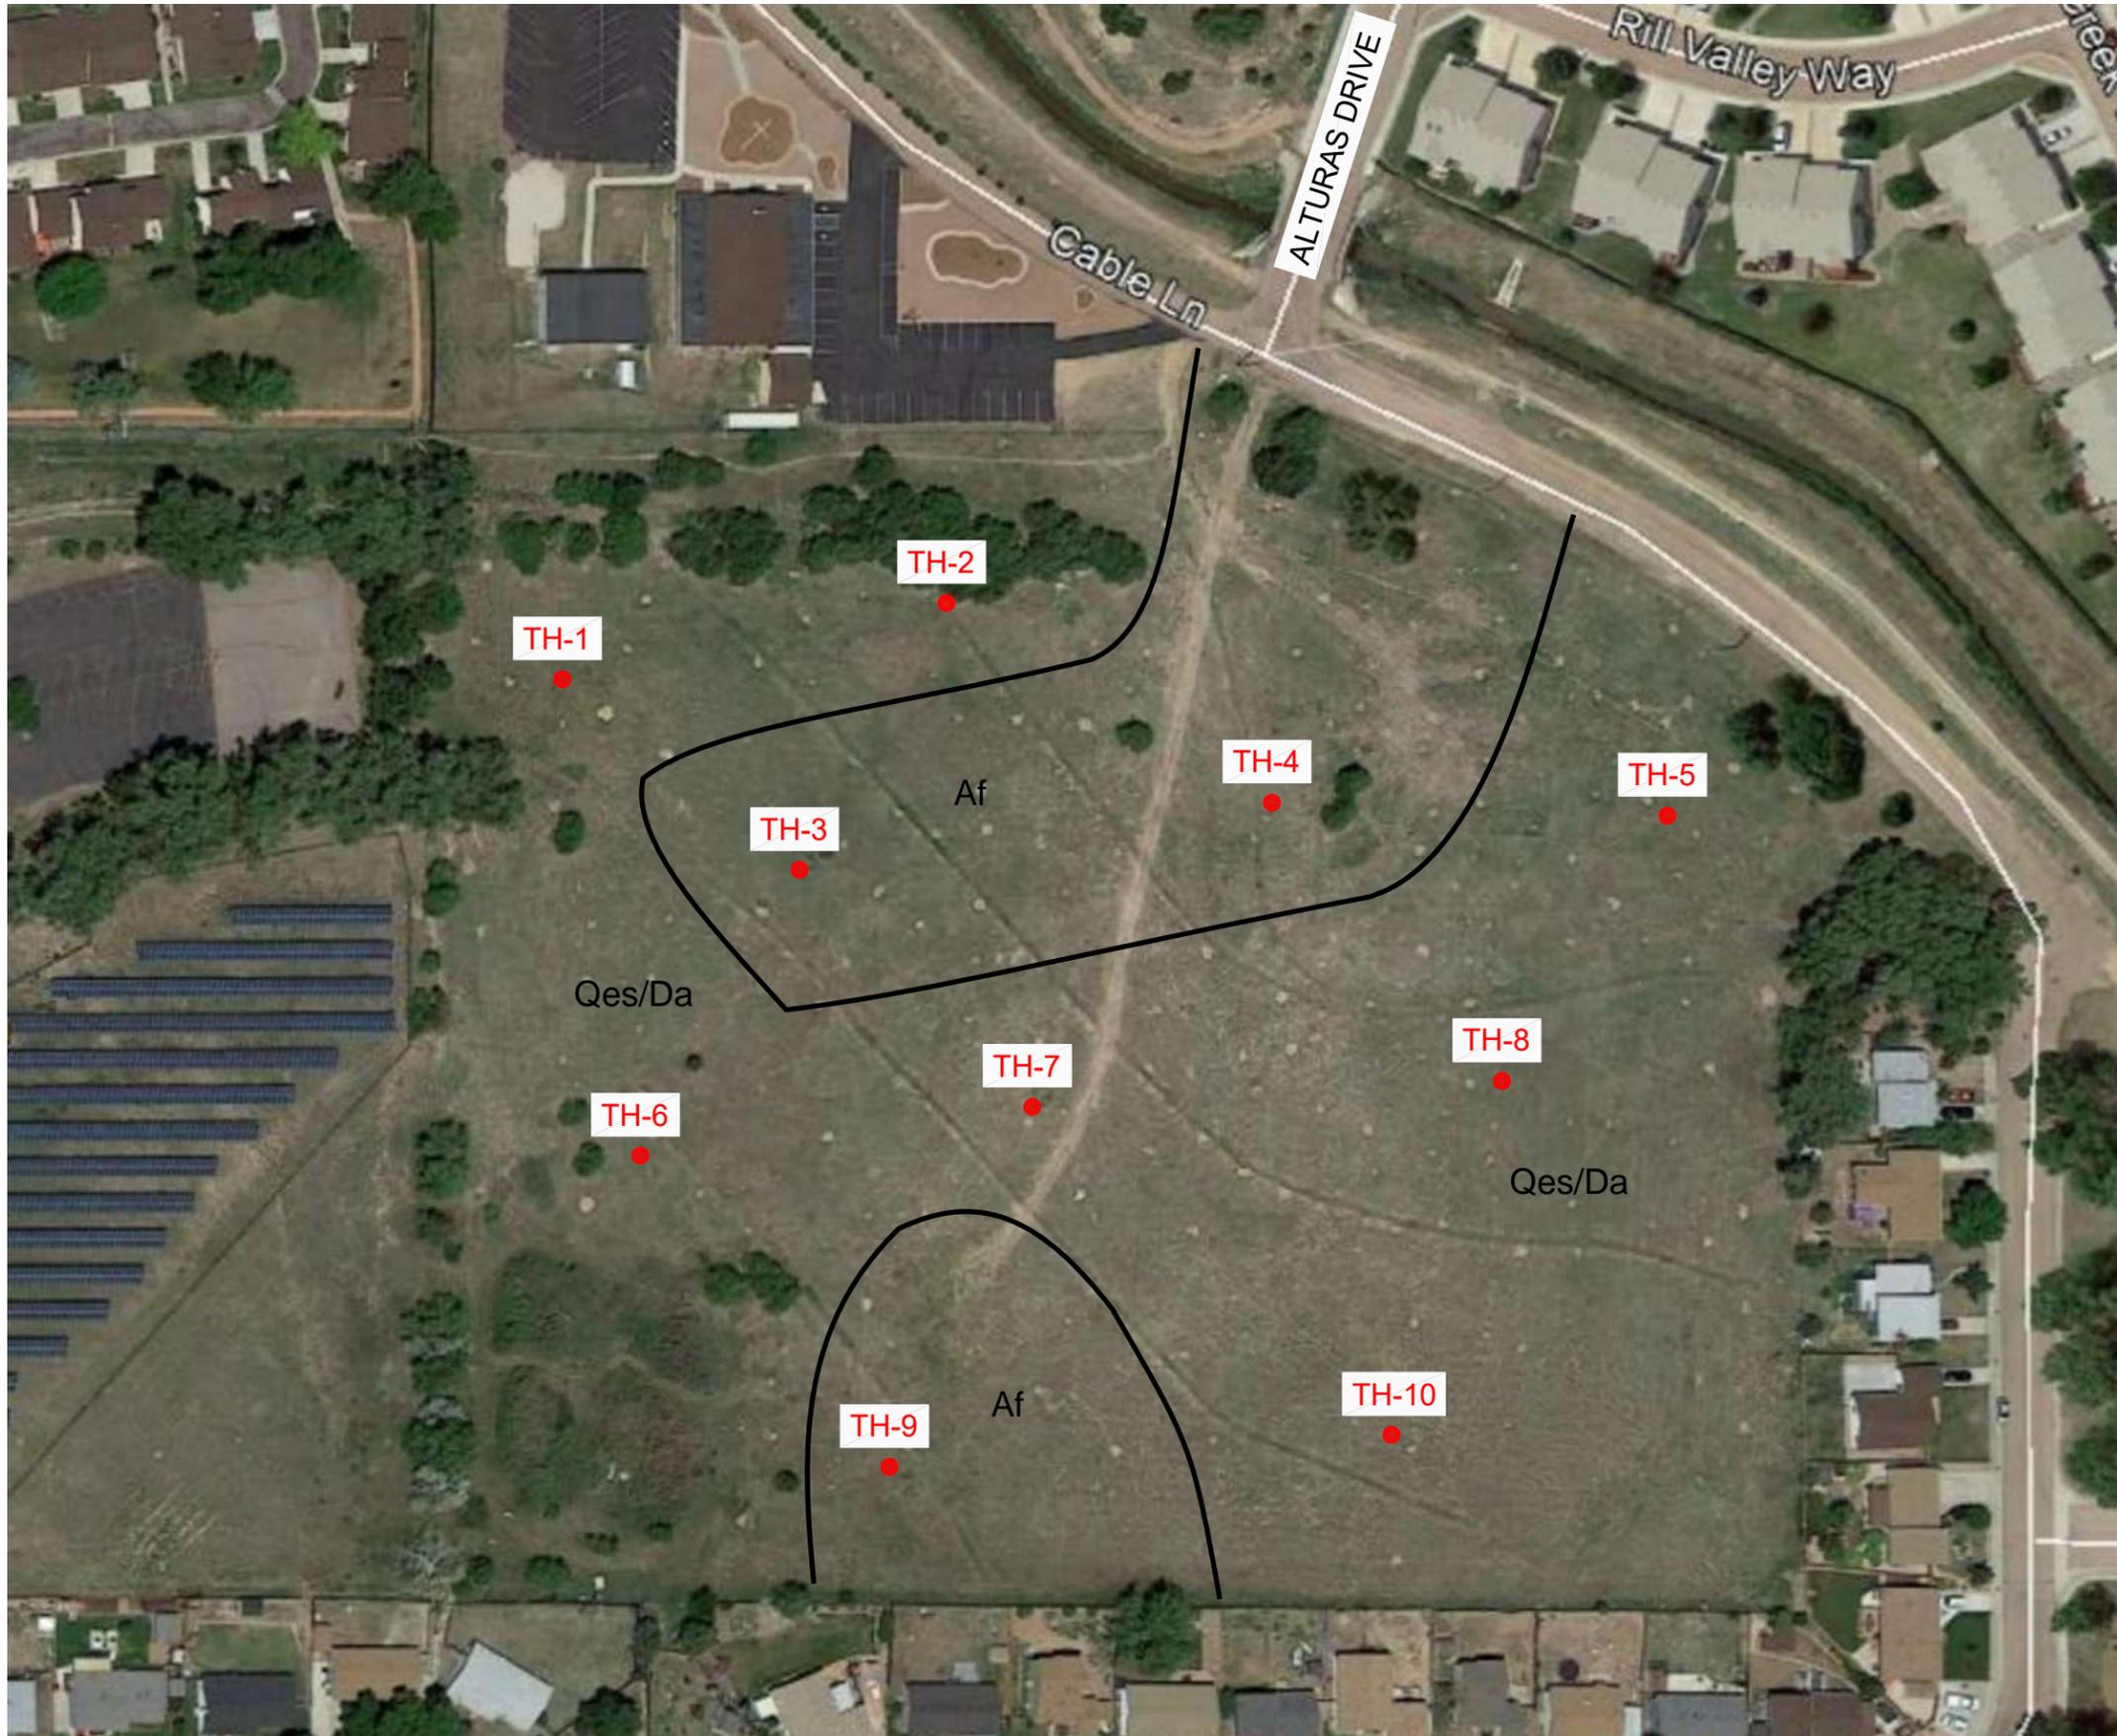
**Location of
Exploratory
Borings**

Approximately 6 feet of silty to very silty sand fill was encountered from the ground surface in three of the borings (TH-3, TH-4, and TH-9). Field penetration resistance test results indicated the sand fill was medium dense. One sample of the fill contained 36 percent silt and clay-sized particles (passing the No. 200 sieve).

The site has been previously disturbed, and there were structures located at the northeast corner of the site. Aerial photos indicate the structures were razed between 2006 and 2011. We encountered fill in three of the borings. Two of these borings were near the previous structures and one boring was near the southwest corner of the site. The approximate extents of undocumented fill are shown on Figure 1. The remainder of the site has likely been surficially disturbed and there is evidence of contouring to control surface water. Undocumented fill should be removed and re-worked or replaced, according to the recommendations set forth in the **Fill Placement and Compaction** section of this report. Design-level geotechnical studies should be undertaken to confirm the presence of fill and depths of fill and to provide recommendations for reworking. If documentation of the fill, such as density test records are found, we should review them to determine if they are adequate for the proposed construction.

Because of the lack of documentation regarding the placement and compaction of the existing fill, we must consider this material to be of suspect quality and unsuitable to underlie the proposed structures, in its current condition. The existing fill should be excavated to expose the underlying natural soils and if free of deleterious materials, reused as new, densely compacted fill to achieve desired building pad elevations and site grades.

Conditions encountered in our exploratory borings and laboratory testing suggest conventional spread footing foundations are appropriate. Suspect quality fill was encountered in three of the ten borings. These borings were generally spread across the site. The depth of fill encountered was about 6 feet from the existing ground surface. This material should be removed and compacted as new fill, prior to placing site grading fill, or construction of the residences.

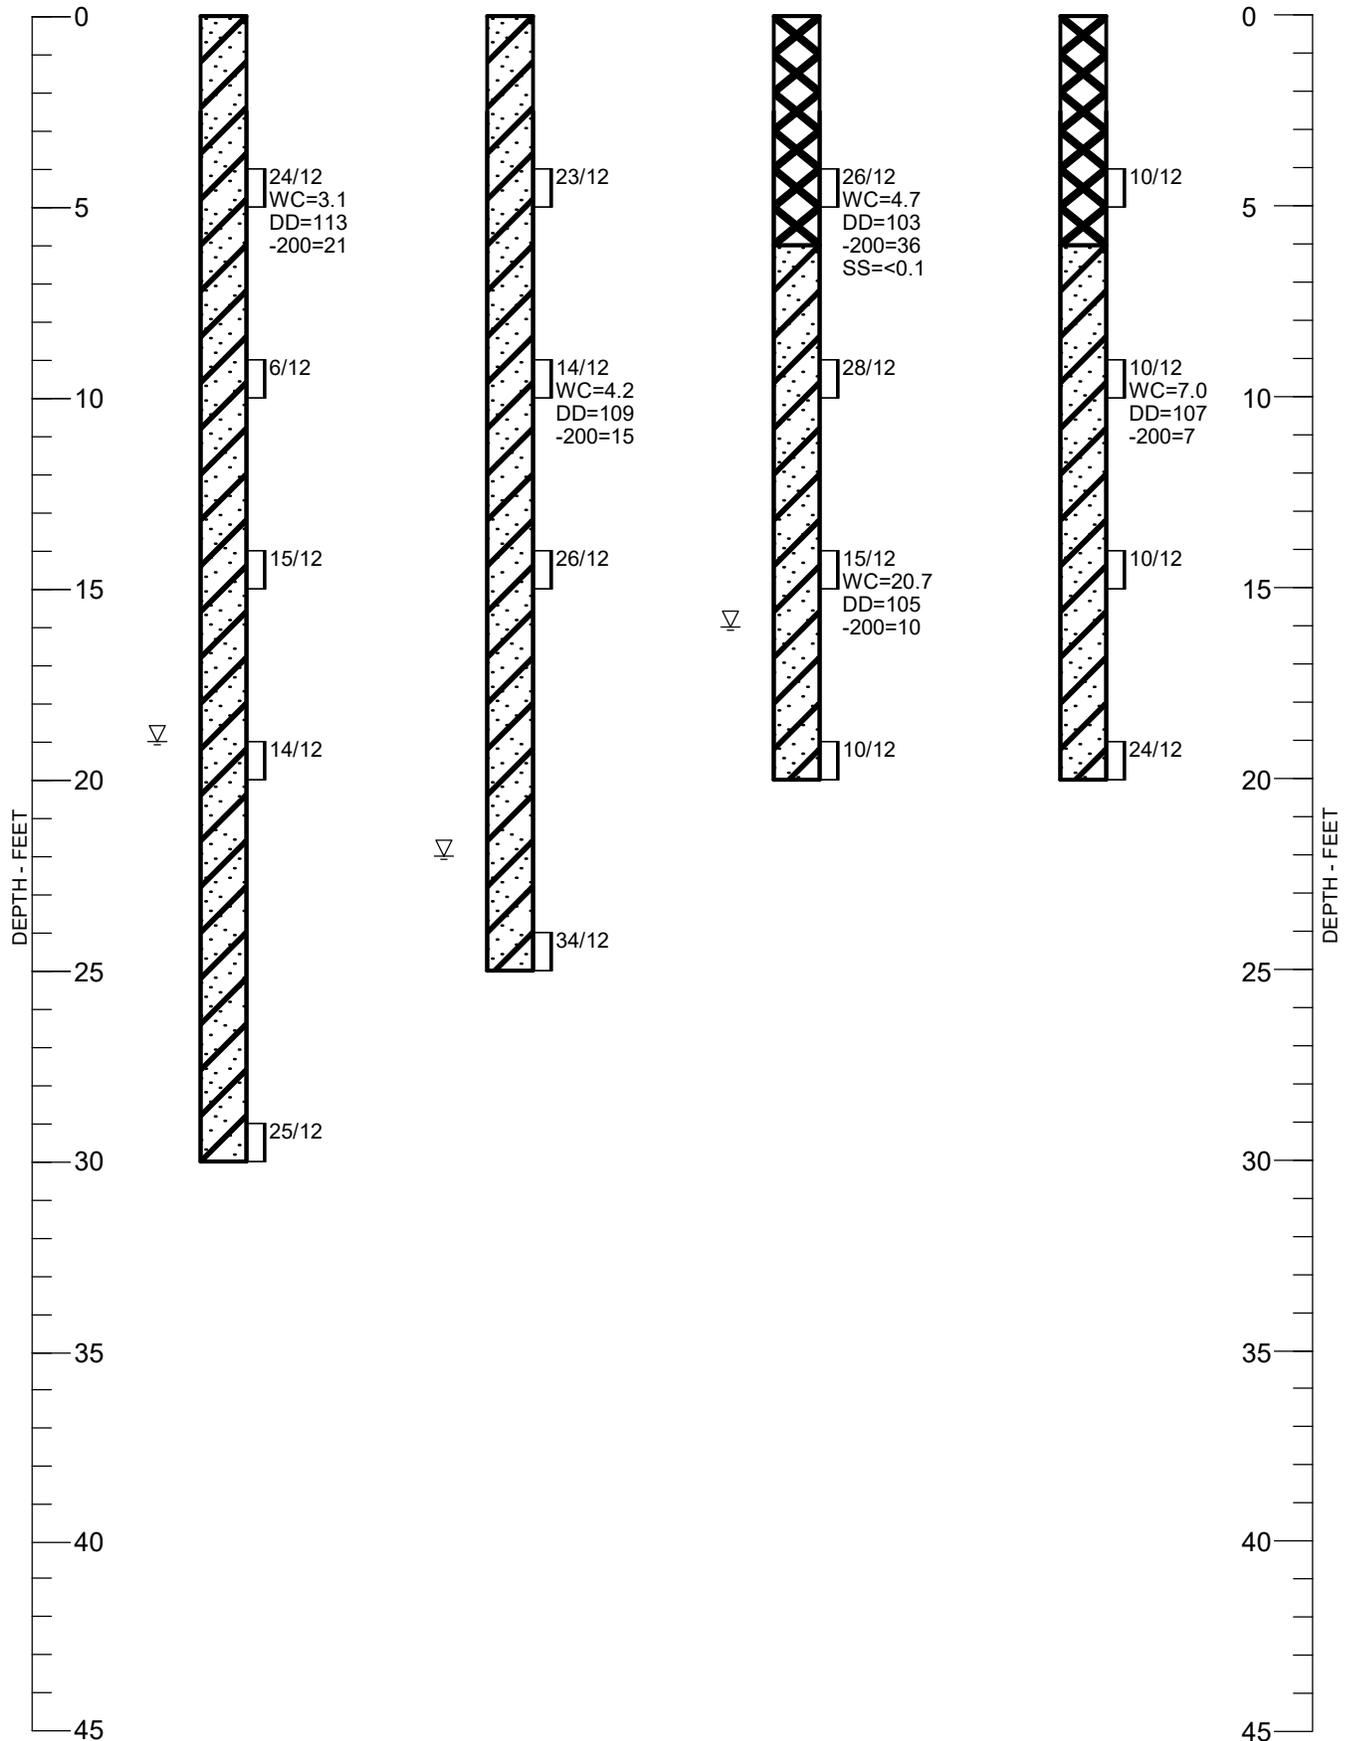
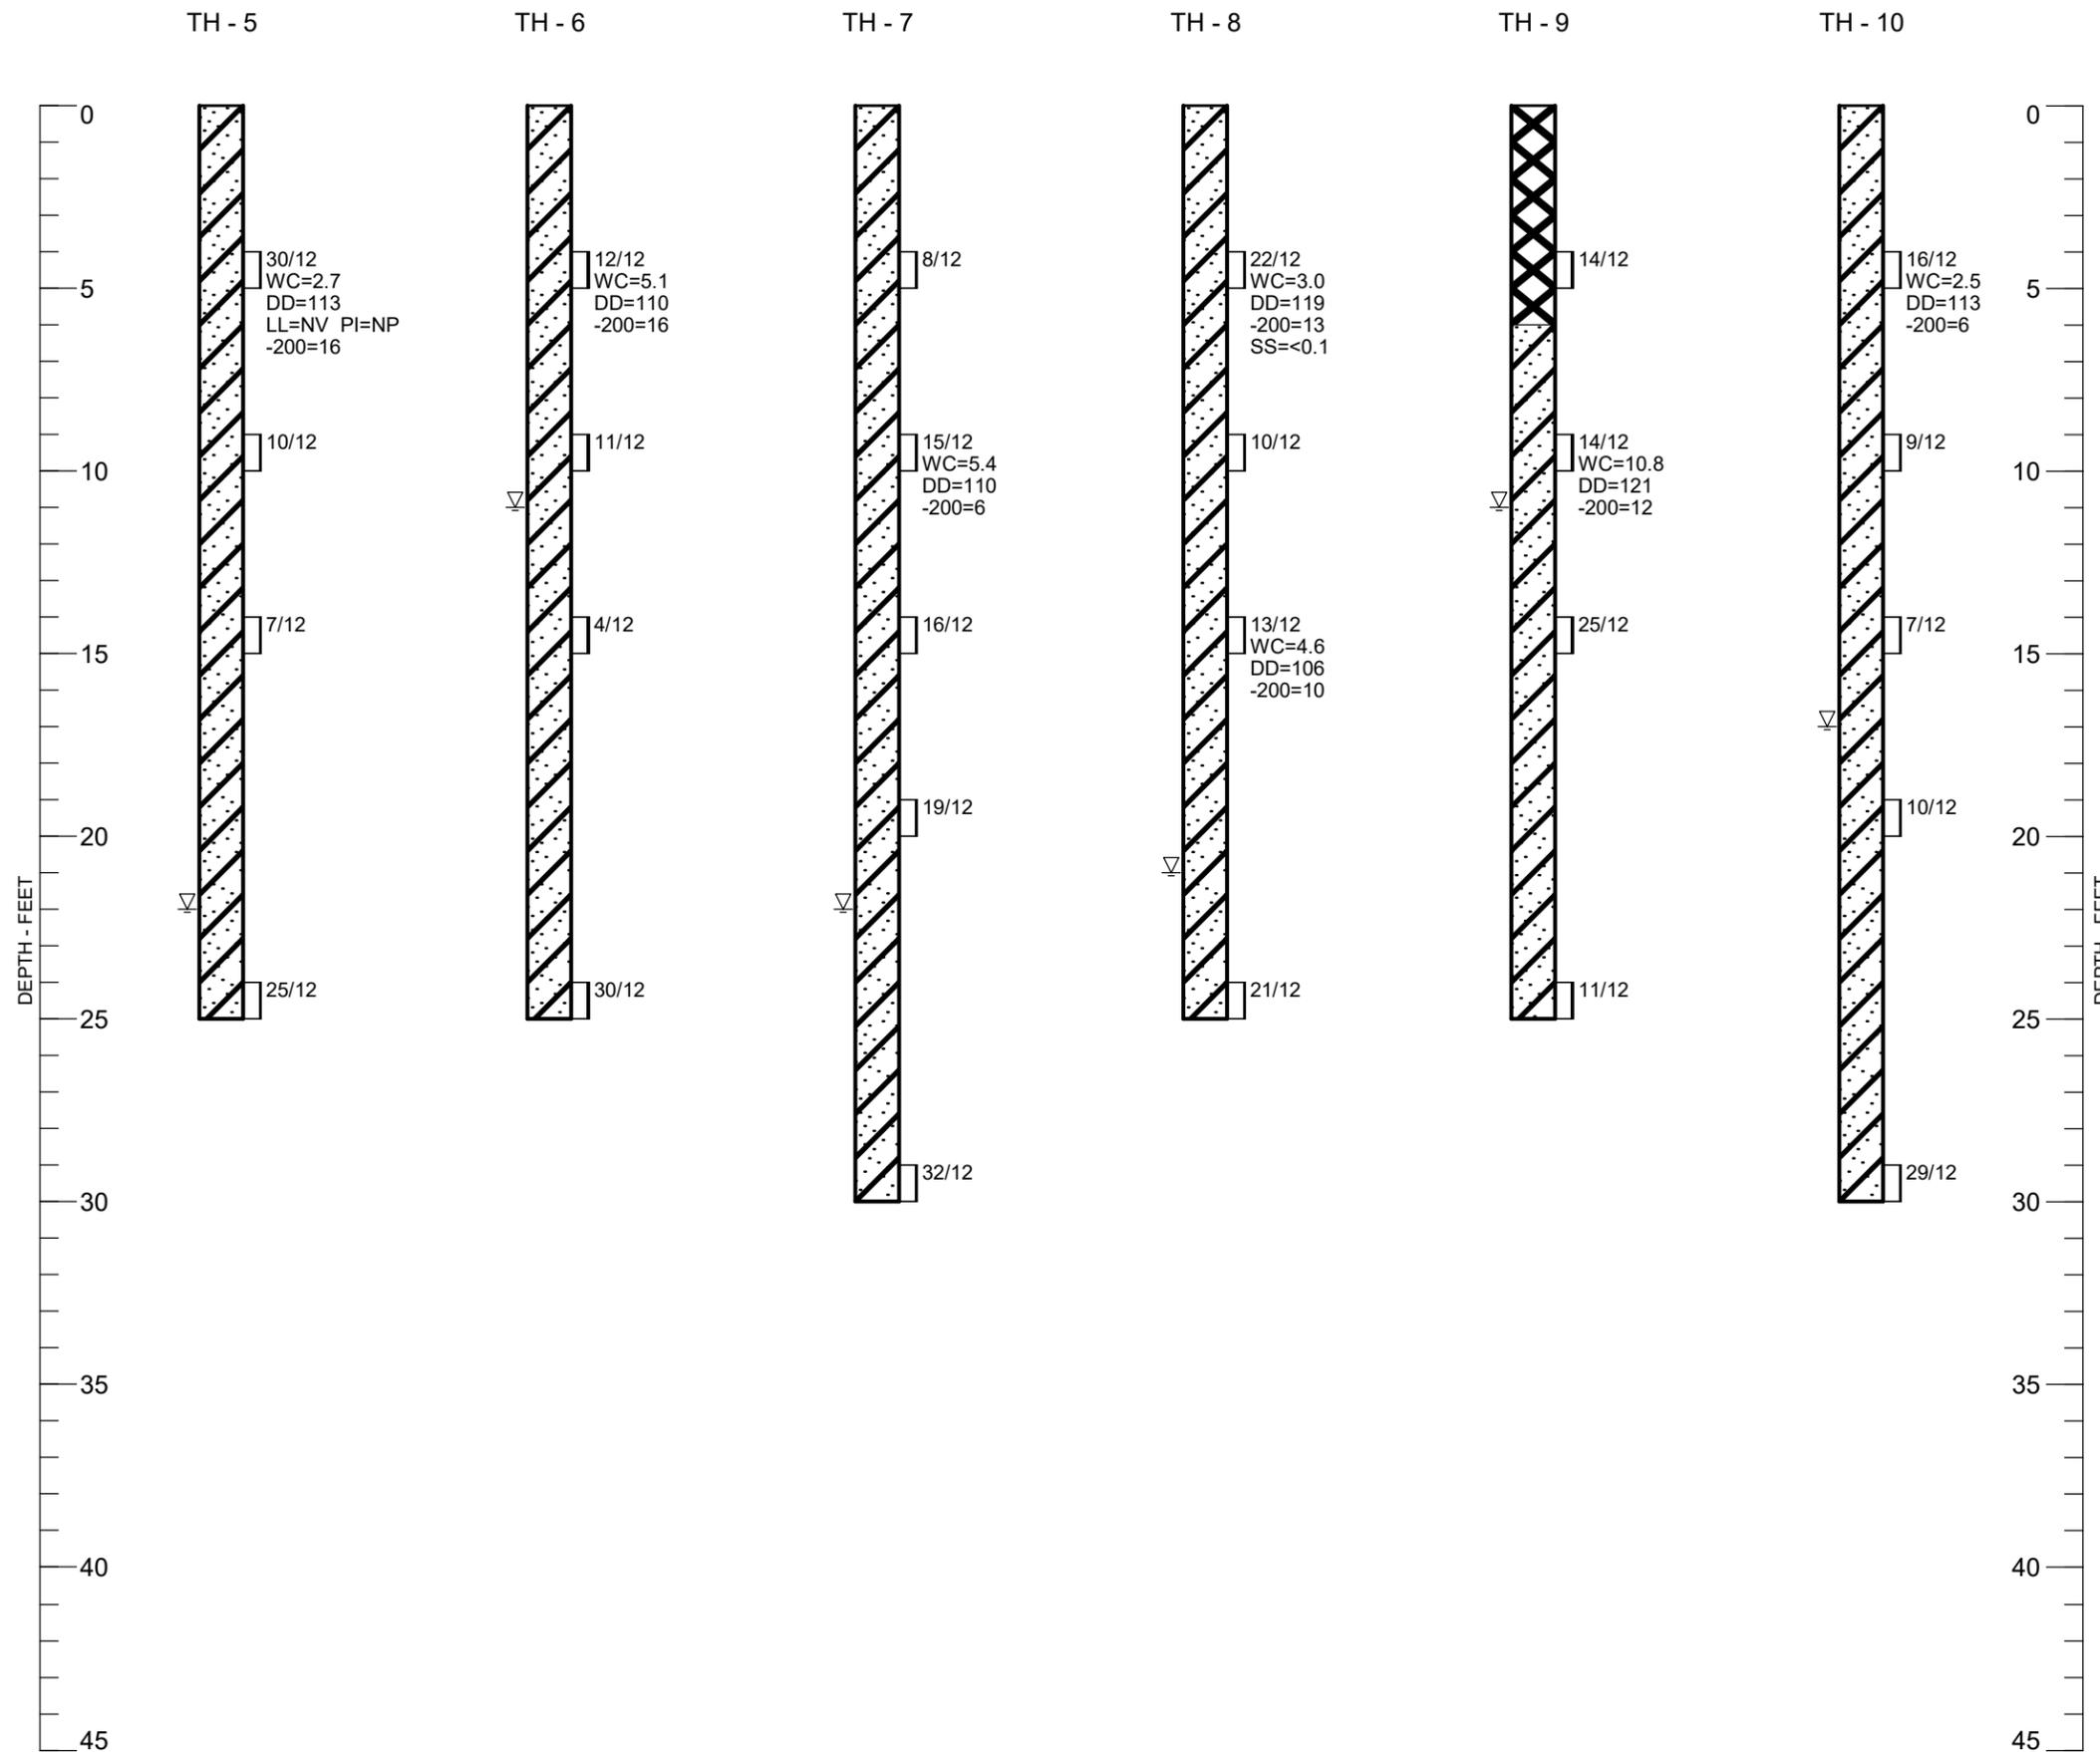
**Summary Logs of
 Exploratory
 Borings**

Natural, slightly silty to silty sand was encountered at the ground surface in seven of the borings and below the fill in three of the borings. The sand was loose to dense. Eleven samples of the sand tested in our laboratory contained 6 to 21 percent silt and clay-sized particles (passing the No. 200 sieve).

At the time of drilling, groundwater was encountered in nine of the borings at depths of 11 to 22 feet below the existing ground surface. The shallower depths were measured in borings TH-6 and TH-9, at the southwest corner of the site. When water levels were checked again six days after the completion of drilling operations, groundwater was not present in any of the test holes. Between 2 and 16 feet of caving had occurred in the test holes when measured six days after the completion of drilling. The groundwater elevation should be expected to rise (typically less than about 5 feet)
