**PRELIMINARY GEOTECHNICAL INVESTIGATION
AND GEOLOGIC HAZARDS EVALUATION
LATIGO TRAILS FILINGS 9 AND 10, 78 LOTS
SOUTHWEST OF EASTONVILLE ROAD
AND LATIGO BOULEVARD
EL PASO COUNTY, COLORADO**

Project No. CS19409-115

August 3, 2021
Revised March 31, 2022

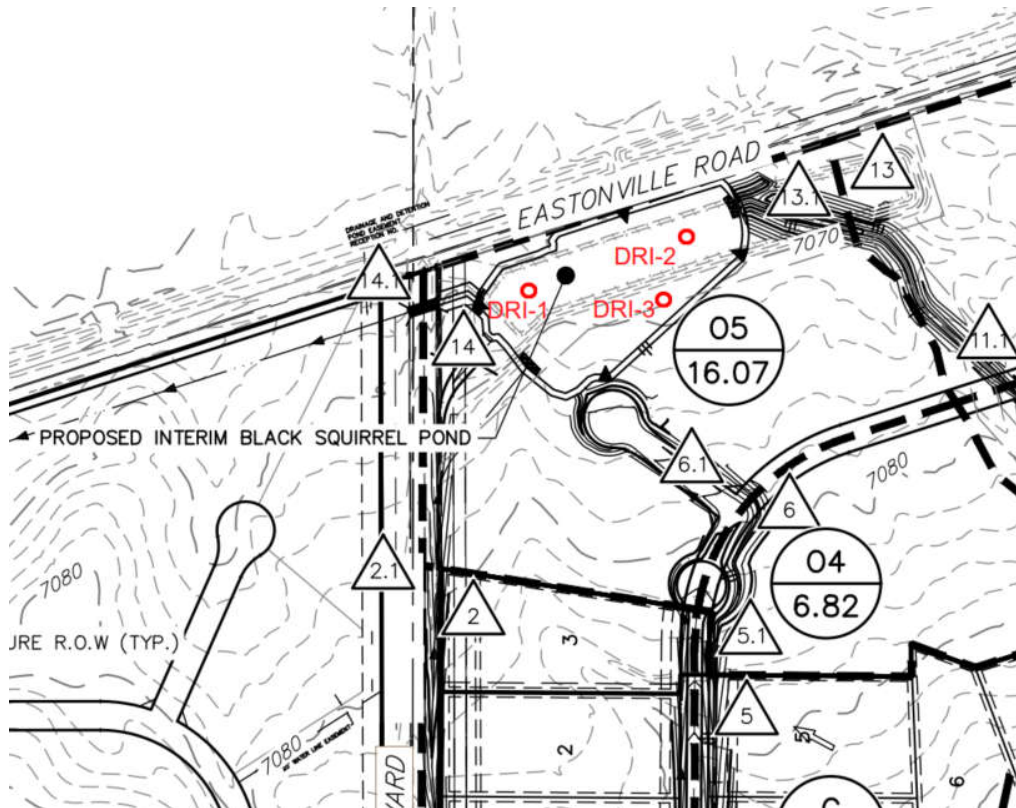
We performed double-ring infiltrometer (DRI) tests at three locations to obtain estimated infiltration rates. The approximate locations of the DRI tests are shown below. The DRI tests were conducted in substantial accordance with ASTM D3385–09, and consisted of driving two, open metal rings with different diameters (inner and outer) into the soils, partially filling the rings with water, and measuring the time for the water level to drop. The outer ring had a diameter of about 22.5 inches and the inner ring had a diameter of about 11.5 inches and was centered inside the larger ring. The rings were driven by hammering uniformly around the rings while using wood planks. We tamped disturbed soils and added hydrated bentonite around the base of the rings prior to adding water. The rings were then partially filled with water such that the water level inside the inner ring matched the water level in the annulus between the larger and smaller rings. The water level was recorded in 5 to 20 minute intervals.

Two tests (DR-1 and DR-2) were performed within the existing basin and results indicated infiltration rates of less than 0.1 inches per hour. We attribute the slow infiltration within the existing basin to compaction of the soils within the bottom of the basin. An additional test (DR-3) was performed outside of the existing basin, but within the area of the proposed basin. The estimated infiltration rates and soil types are presented in the table below.

Using a reduction factor of 3, we recommend a design infiltration rate of 2.5 inches per hour or 1.8×10^{-3} cm/sec.

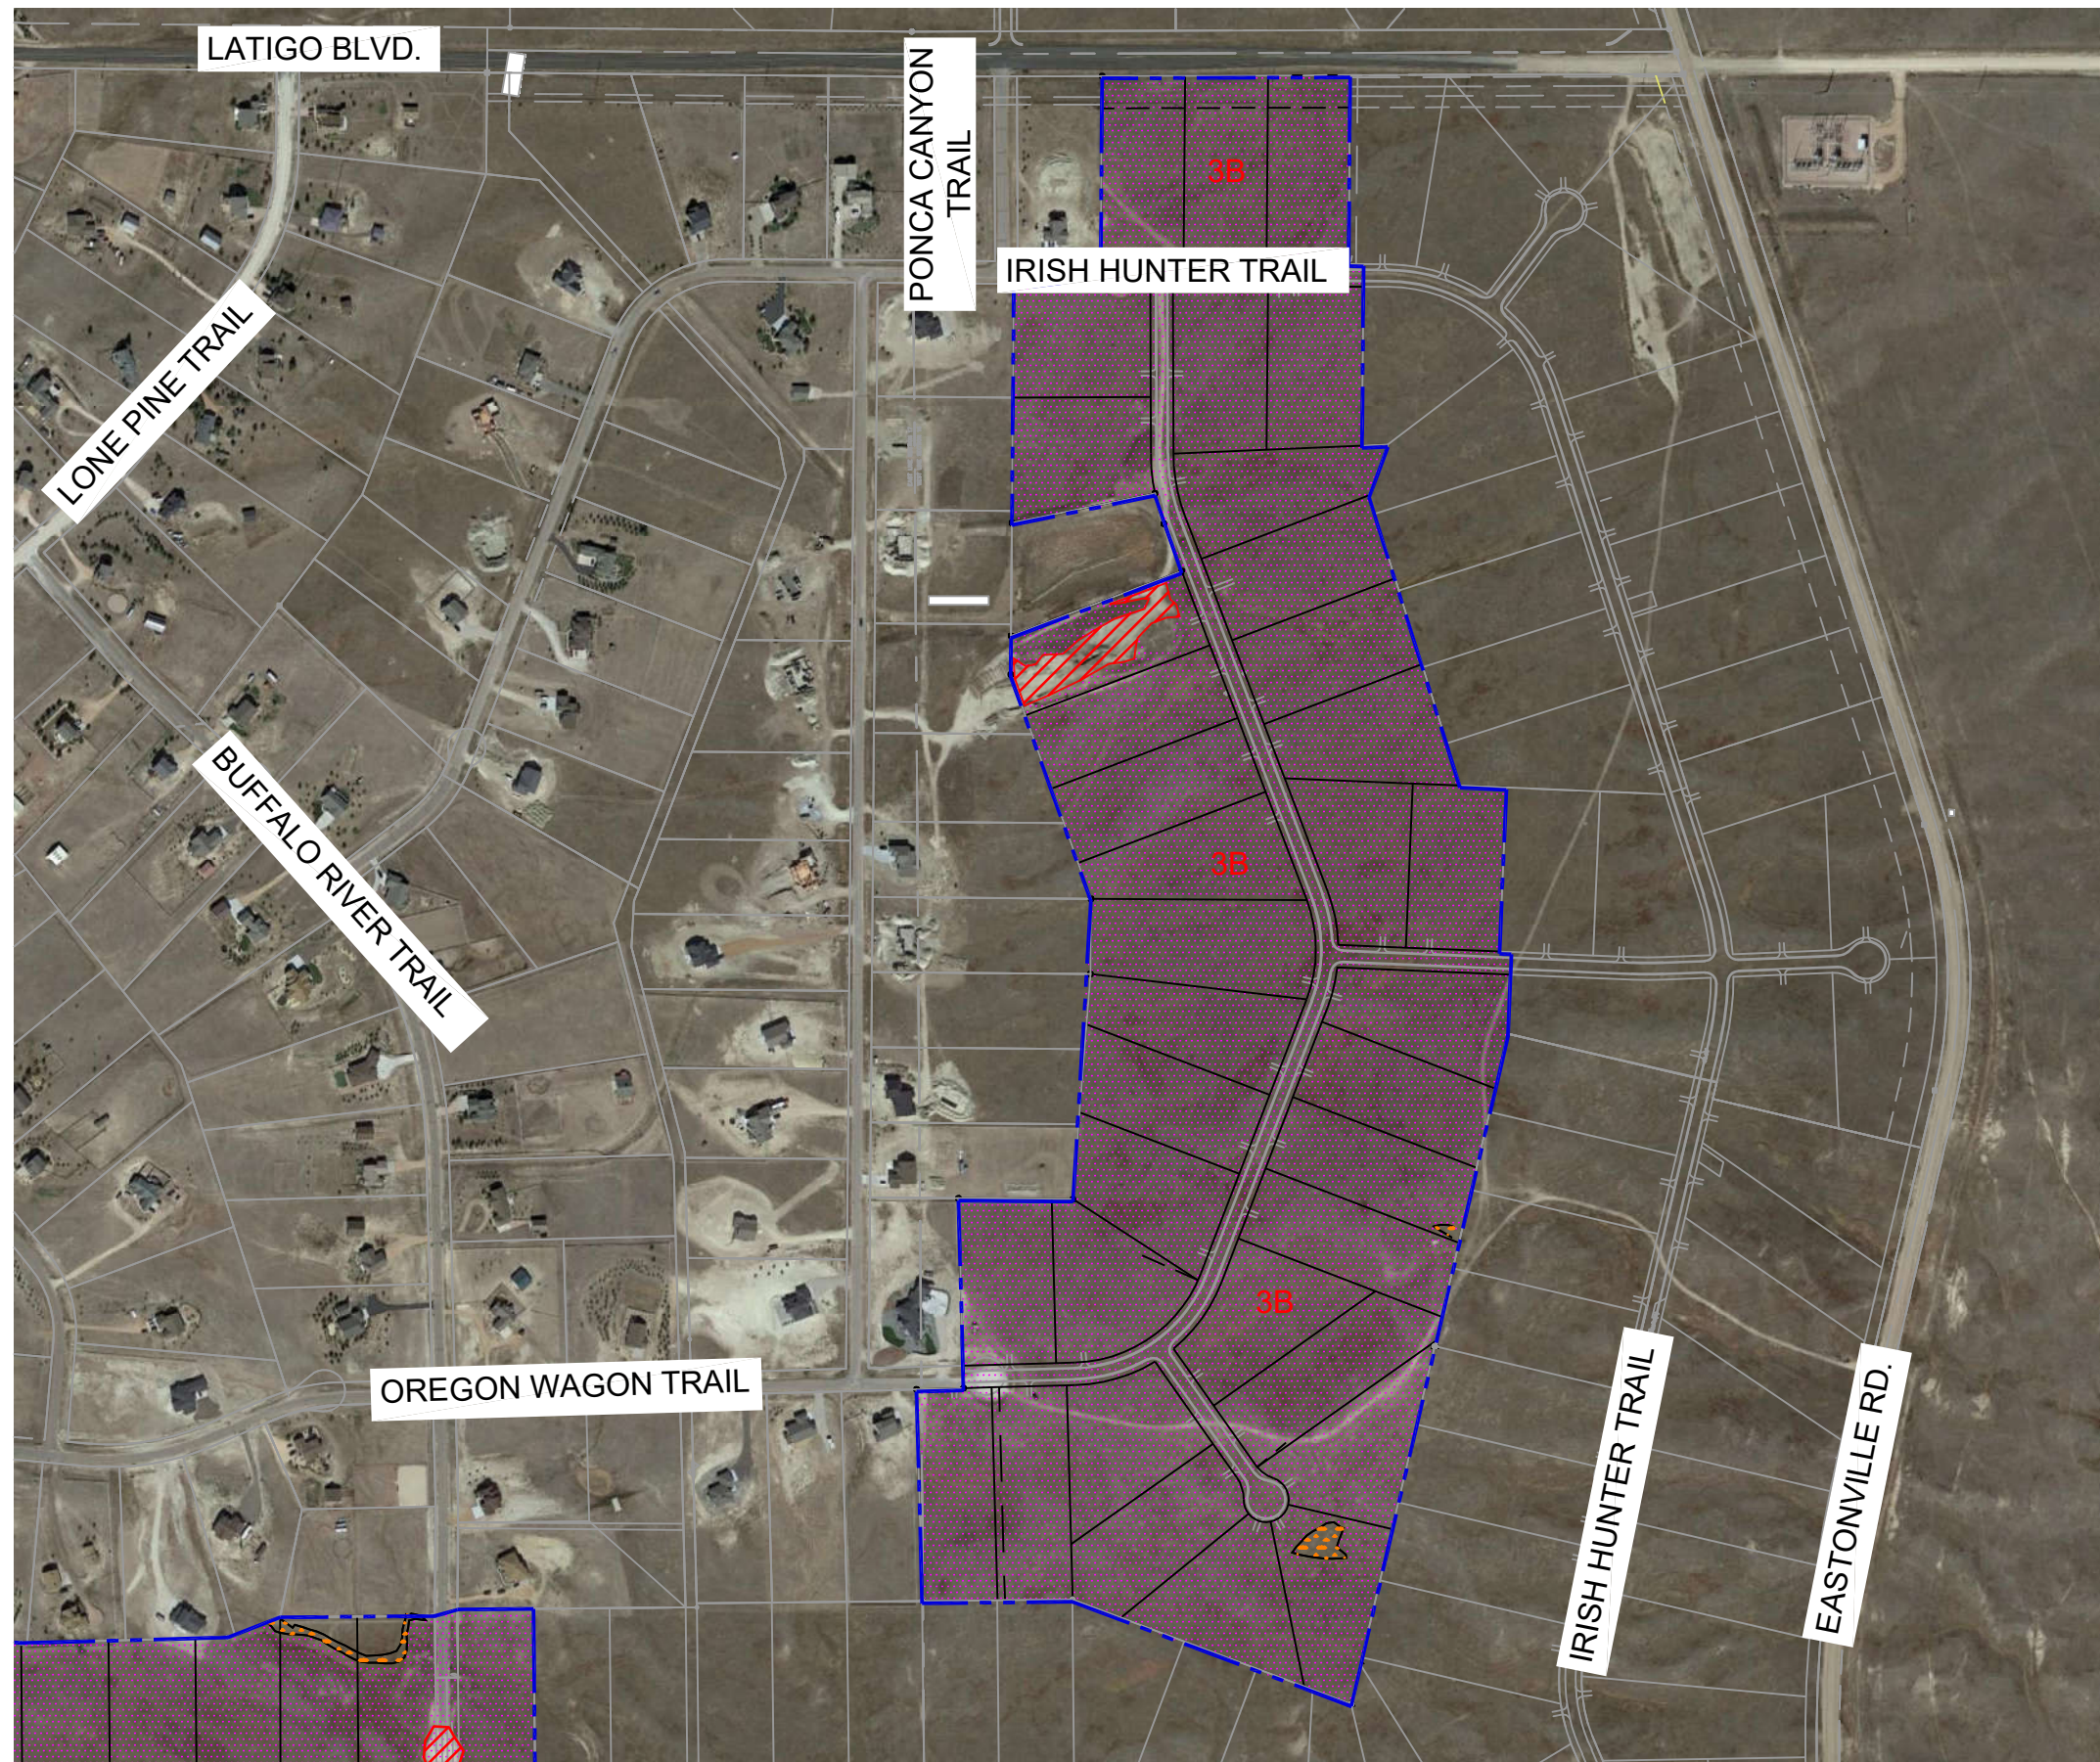
FIGS. 2 and 3 – ENGINEERING GEOLOGIC CONDITIONS

SEASONALLY MOIST / WET AREA. SURFACE WATER / RUNOFF MAY DEVELOP IN RESPONSE TO PRECIPITATION.
-

EXPANSIVE AND POTENTIALLY EXPANSIVE SOIL AND BEDROCK ON FLAT TO MODERATE SLOPES (0-12%). EMPHASIS ON POTENTIAL FOR SWELL, DEPTH OF BEDROCK DESIGN OF FOUNDATION AND DRAINAGE.
-

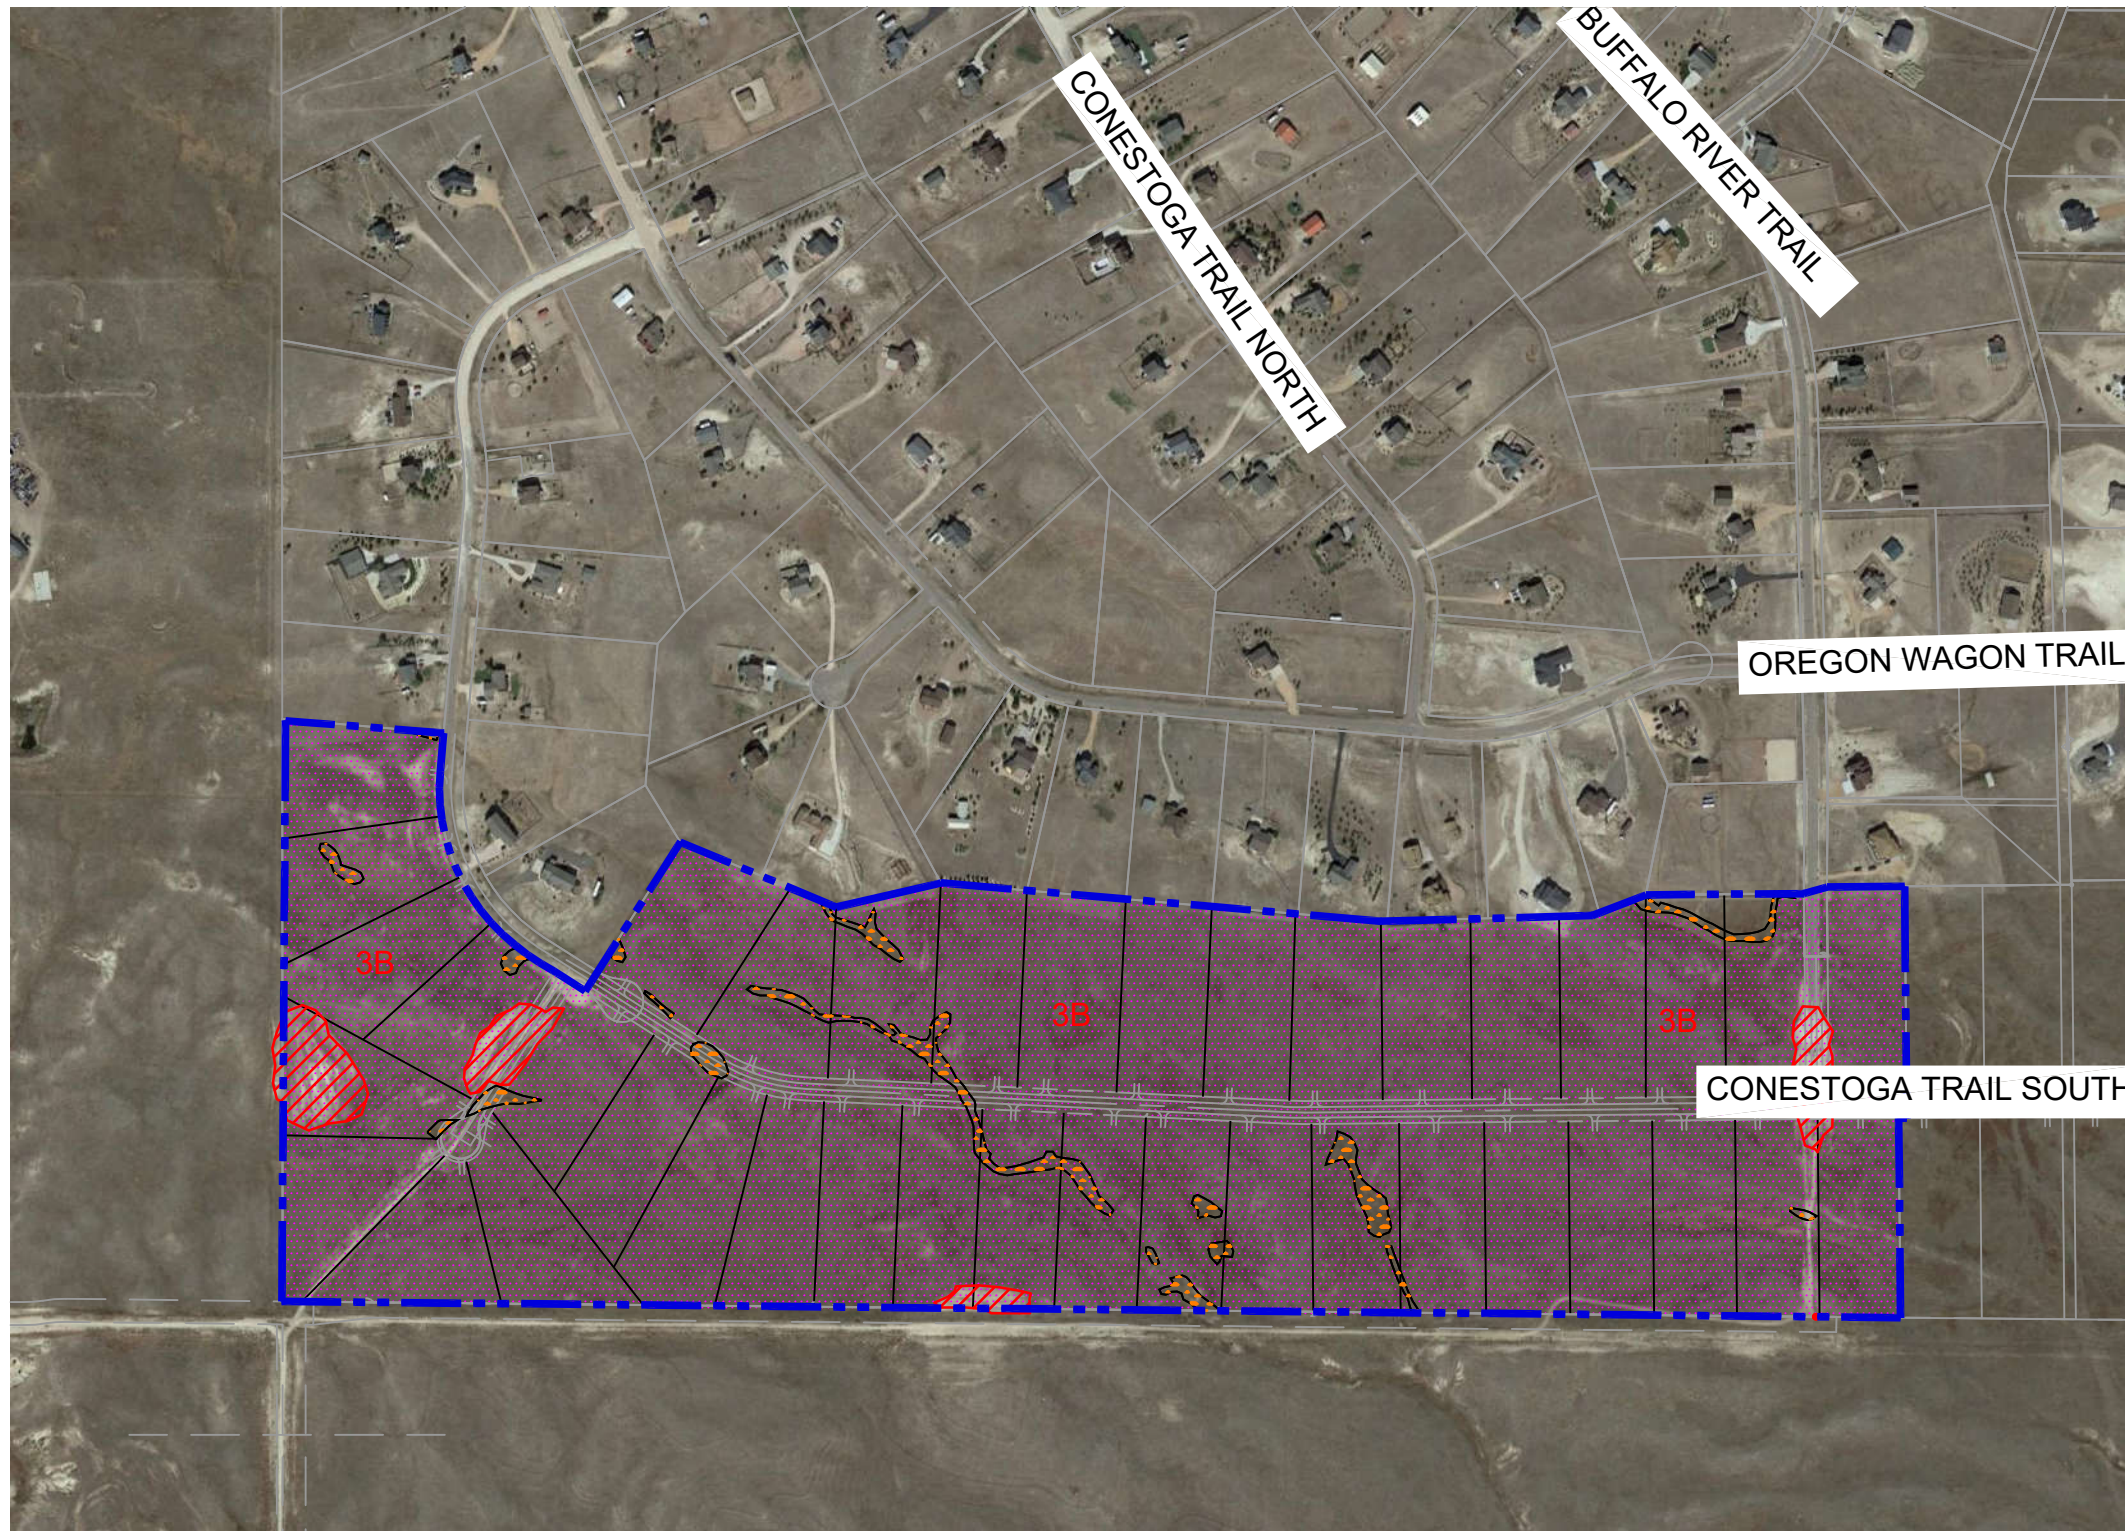
**FILING 10
ENGINEERING
GEOLOGIC
CONDITIONS**

SEASONALLY MOIST / WET AREA. SURFACE WATER / RUNOFF MAY DEVELOP IN RESPONSE TO PRECIPITATION.
-

EXPANSIVE AND POTENTIALLY EXPANSIVE SOIL AND BEDROCK ON FLAT TO MODERATE SLOPES (0-12%). EMPHASIS ON POTENTIAL FOR SWELL, DEPTH OF BEDROCK DESIGN OF FOUNDATION AND DRAINAGE.
-
