**SOILS AND GEOLOGY STUDY  
SCHMIDT WEST – PUD  
MARKSHEFFEL ROAD AND BRUSHTOP ROAD  
EL PASO COUNTY, COLORADO**

Prepared for:  
**Turkey Canyon Quarry, Inc.**  
**20 Boulder Crescent Street, 1<sup>st</sup> Floor**  
**Colorado Springs, Colorado 80903**

June 19, 2026

Entech Job No. 231875

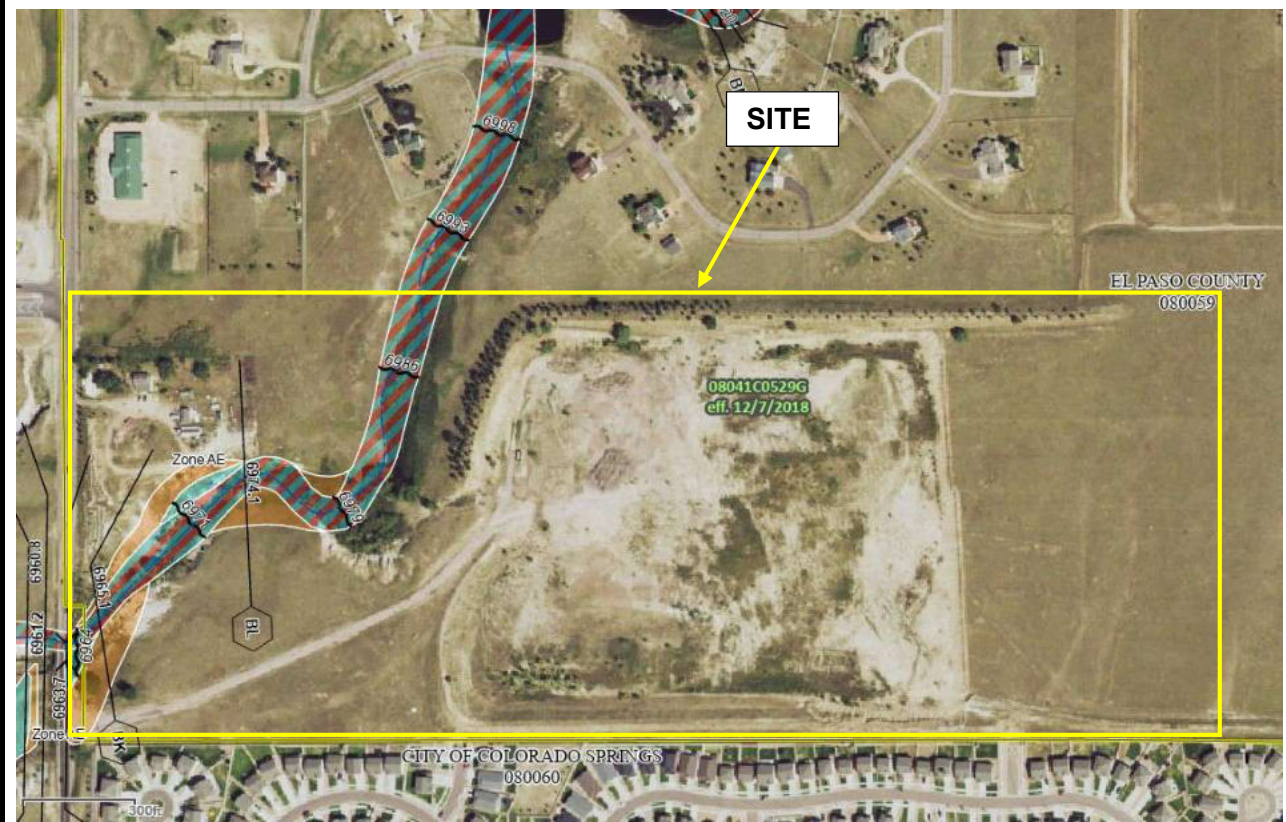
#### **Exhibit 5: FEMA Flood Map**

Groundwater was encountered in two of the eight test borings at depths of 7 to 17.5 feet. Cottonwood Creek in the western portion of the site has been mapped within floodplain zones according to the FEMA Map No. 08041C0529G (Exhibit 5, Reference 9). The floodplain will be avoided by the proposed site development. Water was observed in the creek during our field mapping. The proposed residential development is not anticipated to be affected by the groundwater, however, the potential for perched water conditions onto of the underlying bedrock exists across the site.

Mitigation Foundations must have a minimum 30-inch depth for frost protection. Subsurface perimeter drains are recommended for structures with any useable space below grade. Groundwater is not anticipated to affect the construction of shallow foundations on the site, however, if shallow groundwater is encountered the following drains should be considered. Typical drain details are presented in Figures 4 through 7. Any grading in these areas should be done to direct surface flow around construction to avoid areas of ponded water. Structures should not block drainages. All organic material should be completely removed prior to any fill placement. Finished floor levels must be

located a minimum of one foot above floodplain levels. Additional site investigation should be completed once utility installation and site grading has been completed.

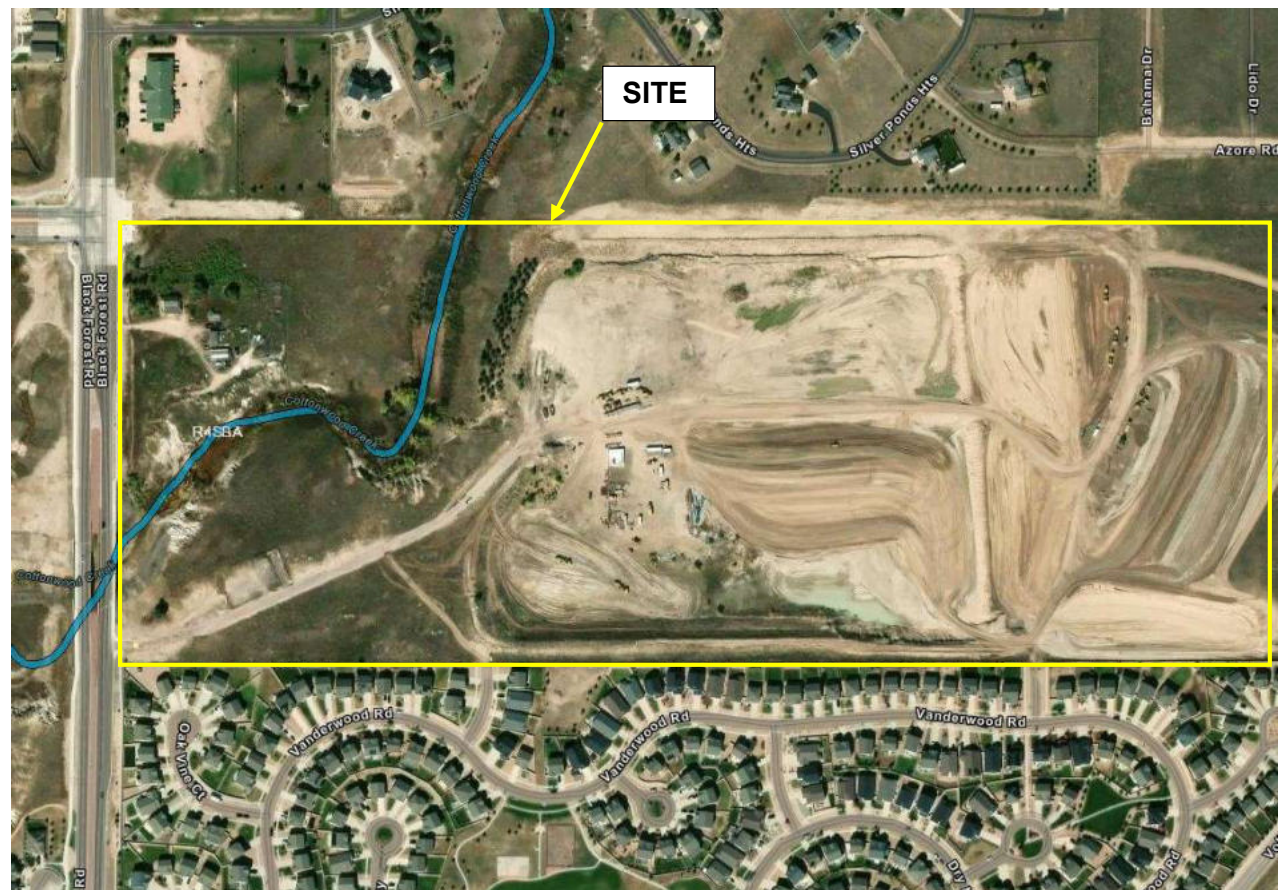
### Exhibit 6: National Wetlands Inventory Map

The Cottonwood Creek along in the western portion of the site and north of the proposed detention pond has been included in the National Wetlands Inventory (Reference 12) as a Freshwater

Wetland habitats classified as **R4SBA** (R – Riverine, 4 – Intermittent, SB – Streambed, C – Temporary Flooded). The wetlands map is shown in Exhibit 6.

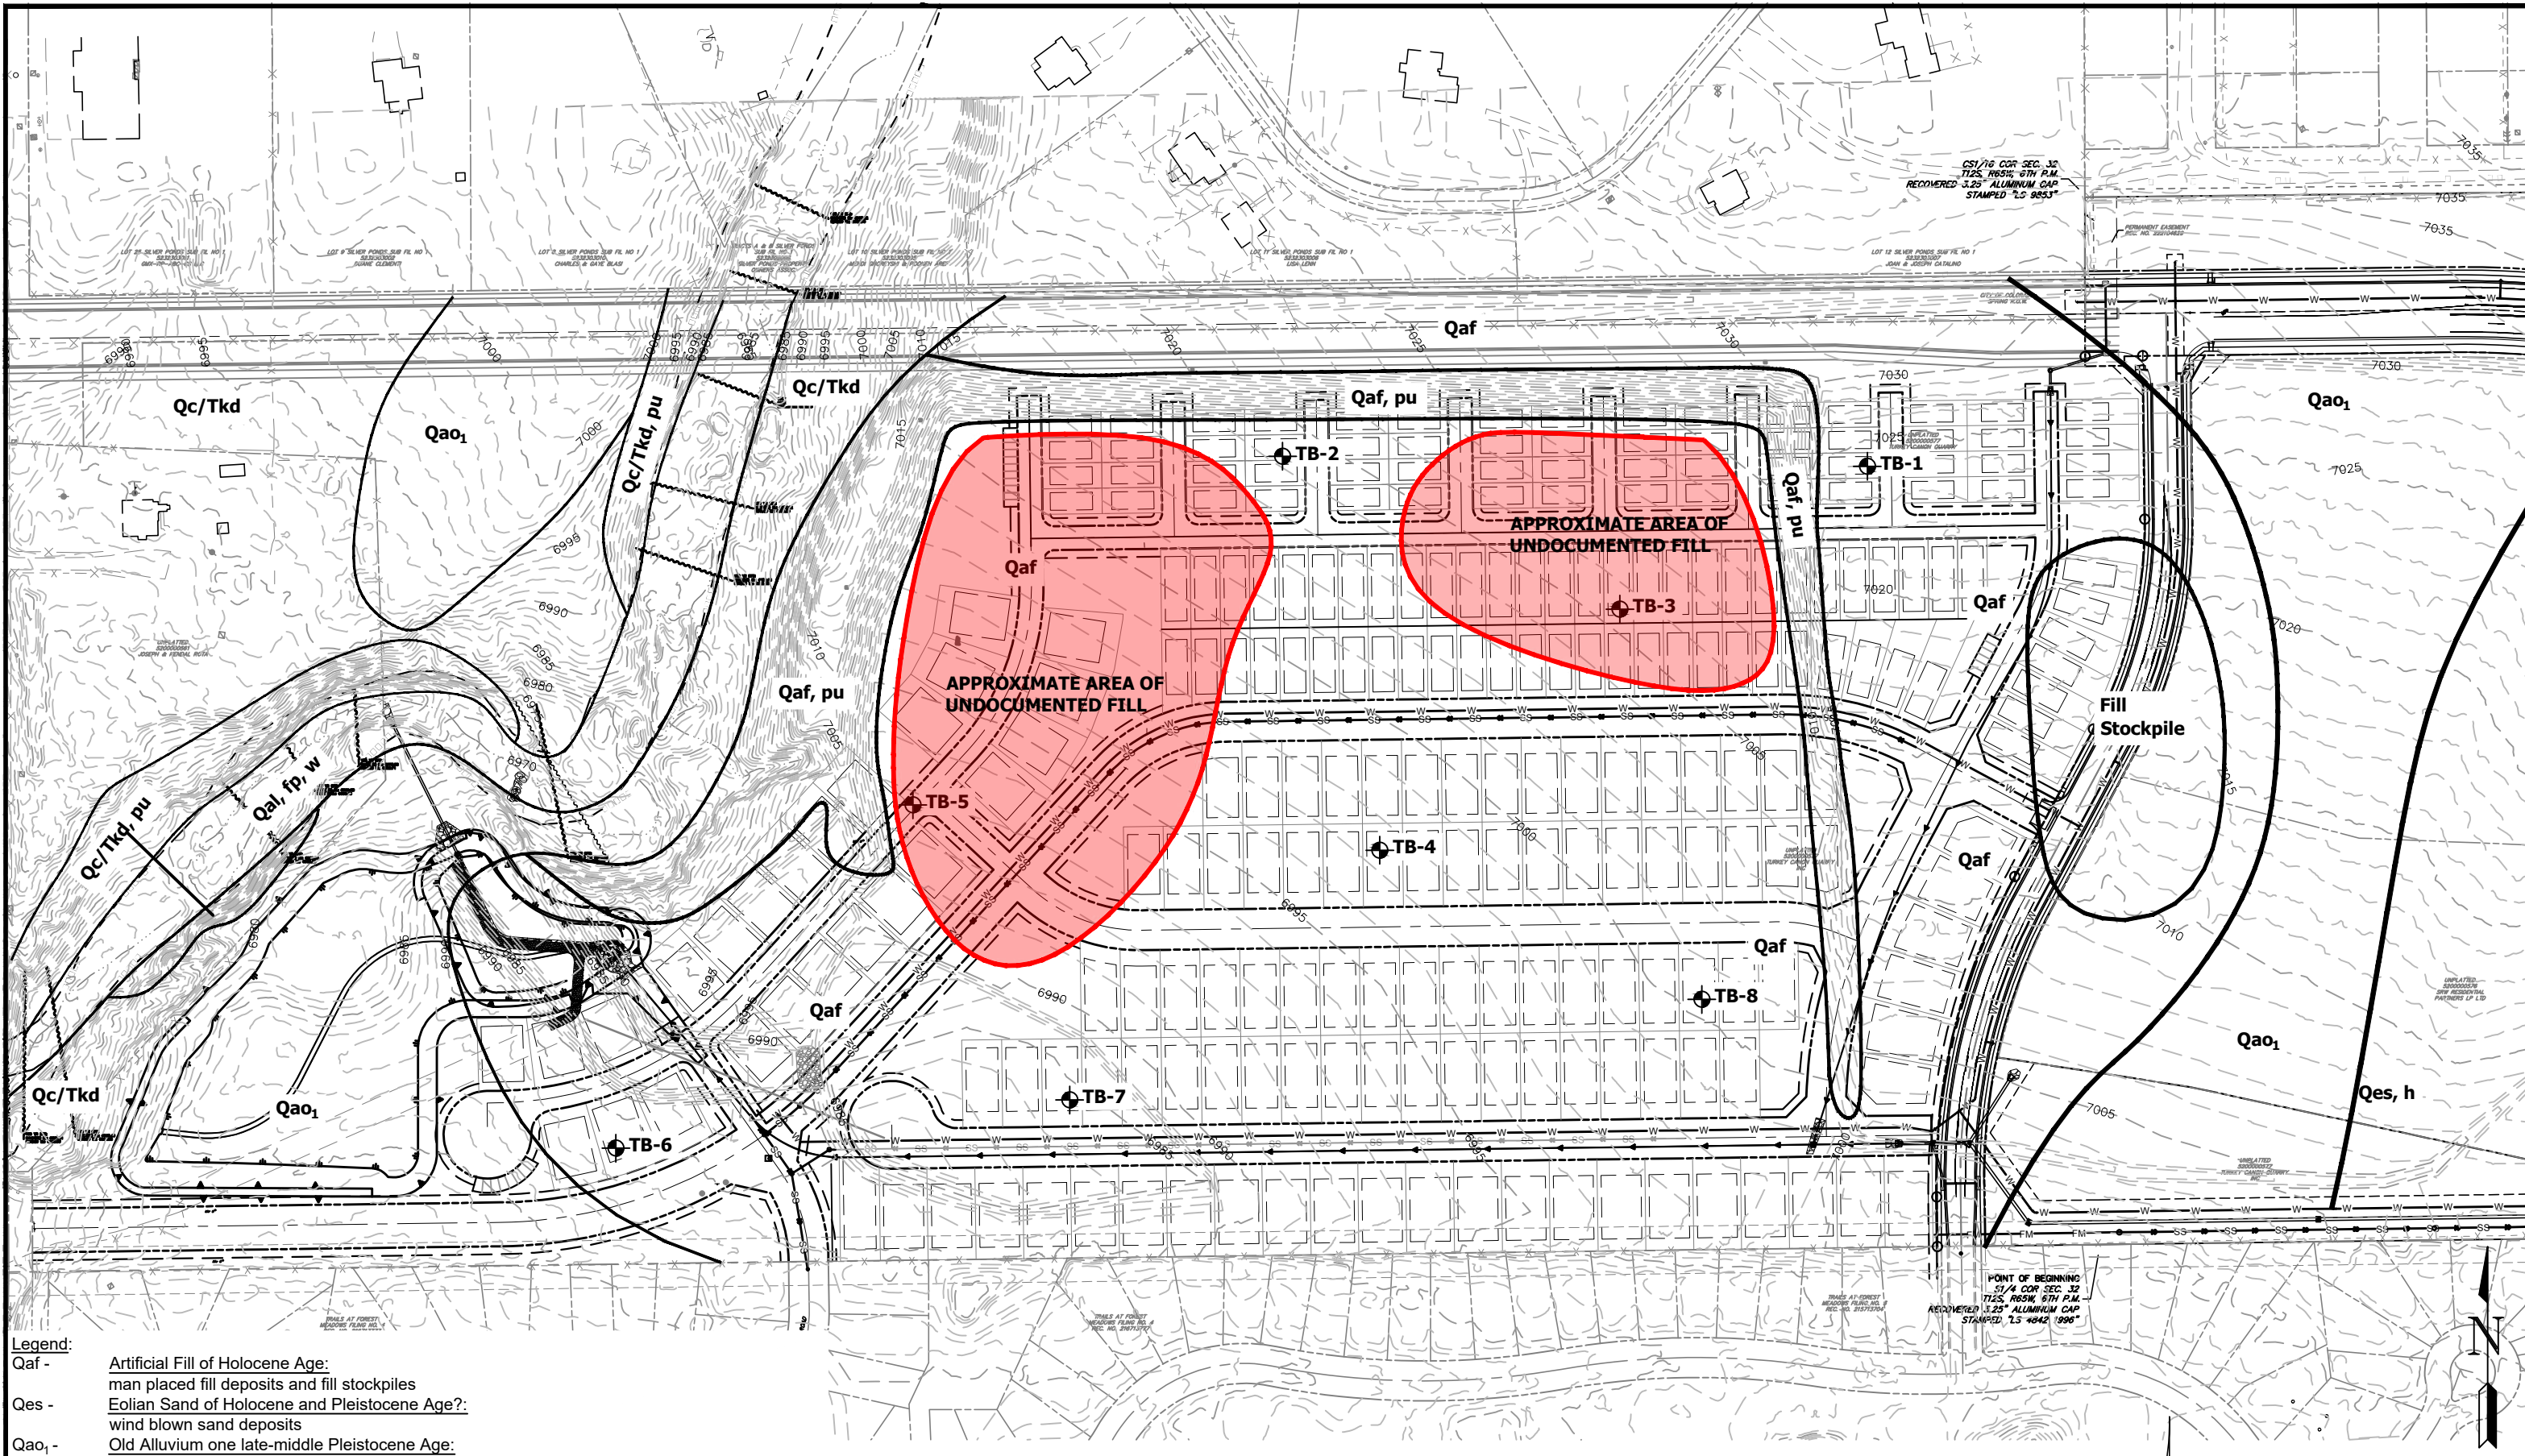
**FIG. 3**

As mentioned previously, detailed mapping has been performed on this site to produce an Engineering Geology Map (Figure 6). This map shows the location of various geologic conditions the developers should monitor during the planning, design, and construction stages of the project. Hazards include areas of artificial fill, loose collapsible soils, potentially expansive soils, potentially unstable slopes, and a mapped floodplain. These hazards and the recommended mitigation techniques include:

Portions of the slopes along Cottonwood Creek and the existing soil berm have been identified as potentially unstable. The slopes are stable in their current state; however considerable care must be exercised in these areas not to create a condition which would tend to activate instability. The potentially unstable slopes along the existing fill berm/slopes will be mitigated during site grading.

Mitigation: The overlot fill is suitable to support the proposed roadway. The stockpiles and any uncontrolled fill or loose soil encountered will require removal and recompaction at a minimum of 95% of the Modified Procter (ASTM D1557) maximum dry density.

Mitigation: Should loose or collapsible soils be encountered beneath foundations, recompaction and moisture conditioning of the upper 2 to 3 feet of soil at 95% of the Modified Procter (ASTM D1557) maximum dry density will be required. Exterior flatwork and parking areas may also experience movement. Proof rolling and recompaction of soft areas should be performed during site work.

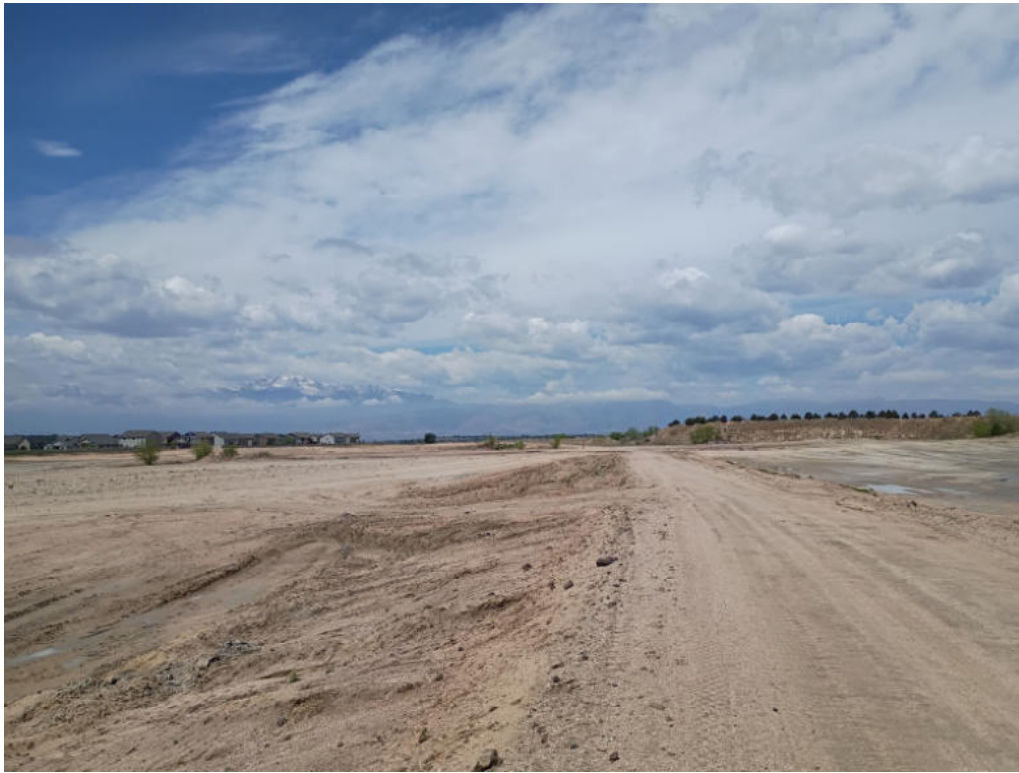
**Looking west from the  
eastern side of the  
site.**

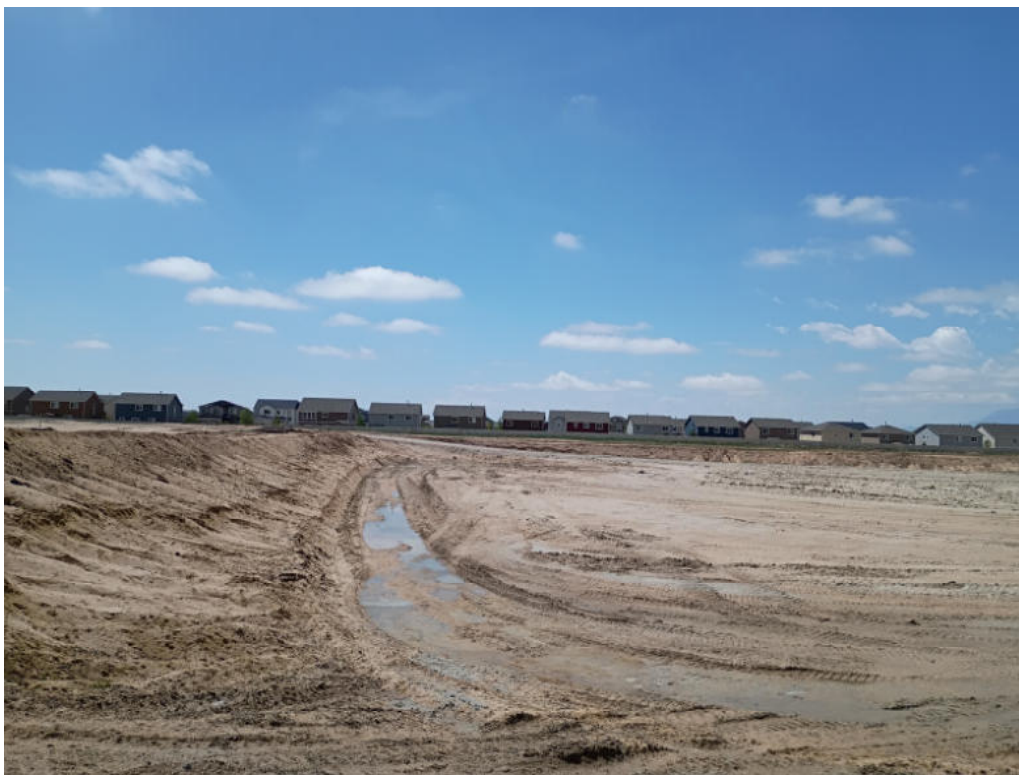
**Looking south from  
the eastern side of the  
site.**

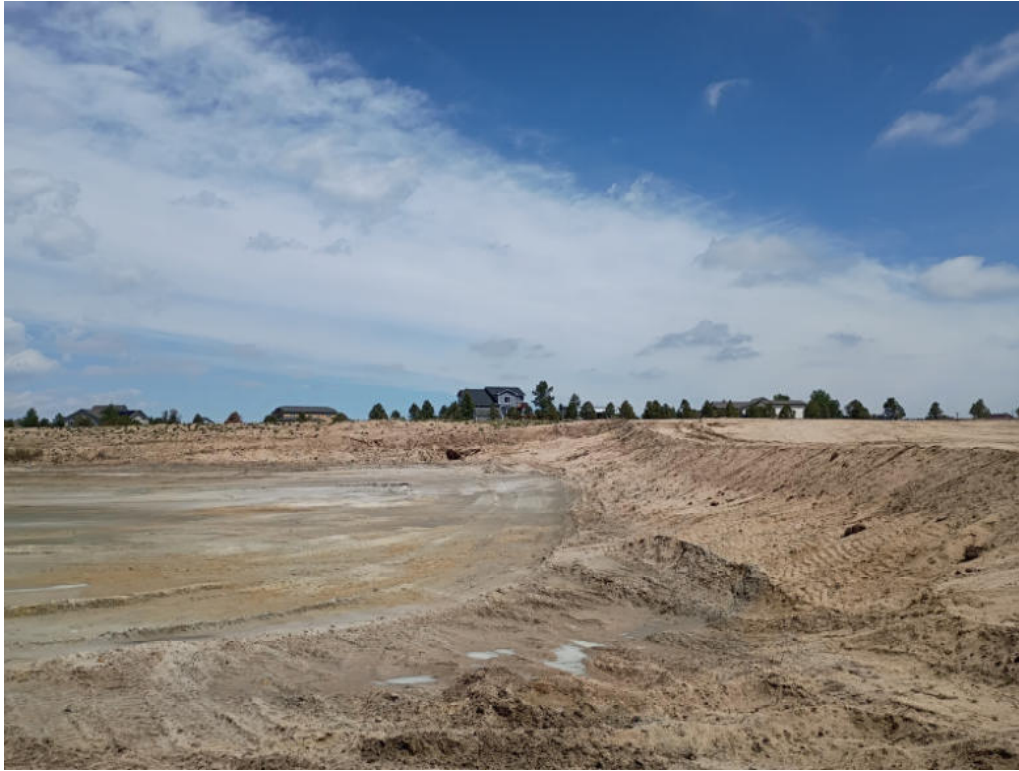
**Looking north from the  
eastern side of the  
site.**

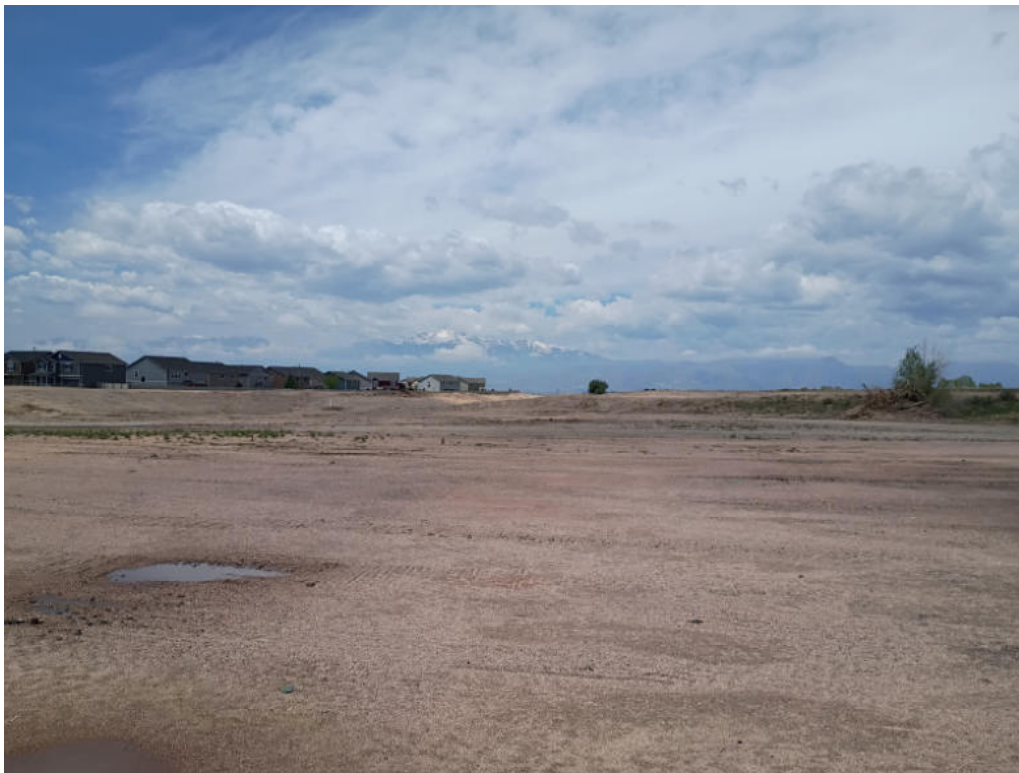
**Looking west from the  
central portion of the  
site.**

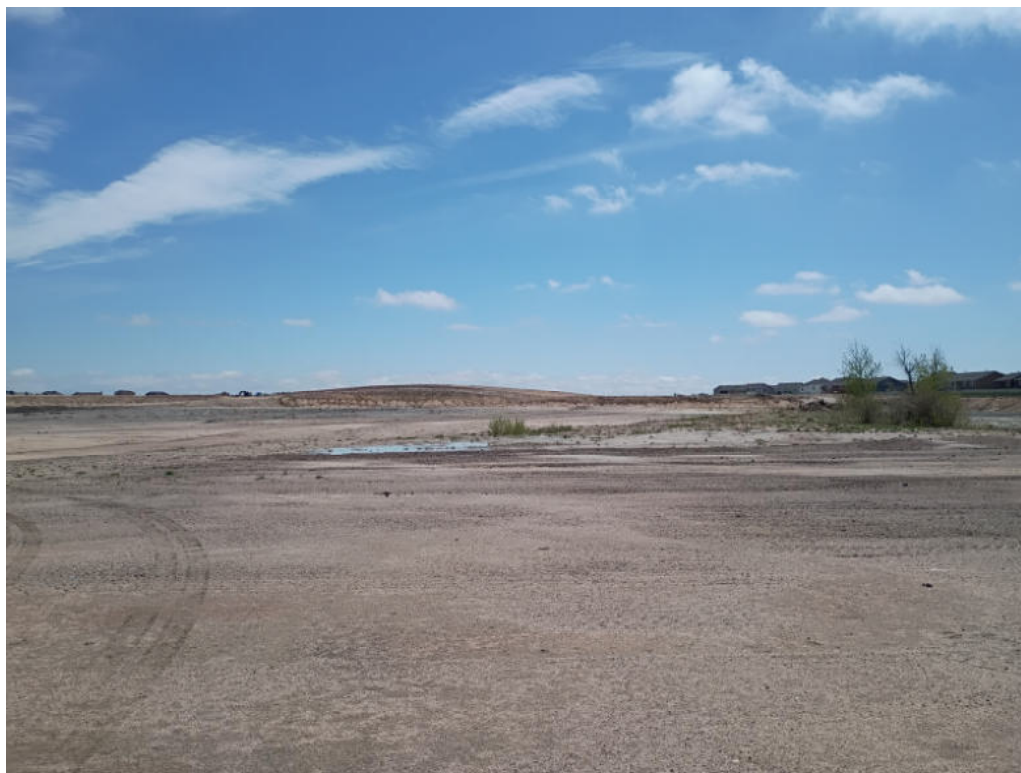
**Looking east from the  
central portion of the  
site.**

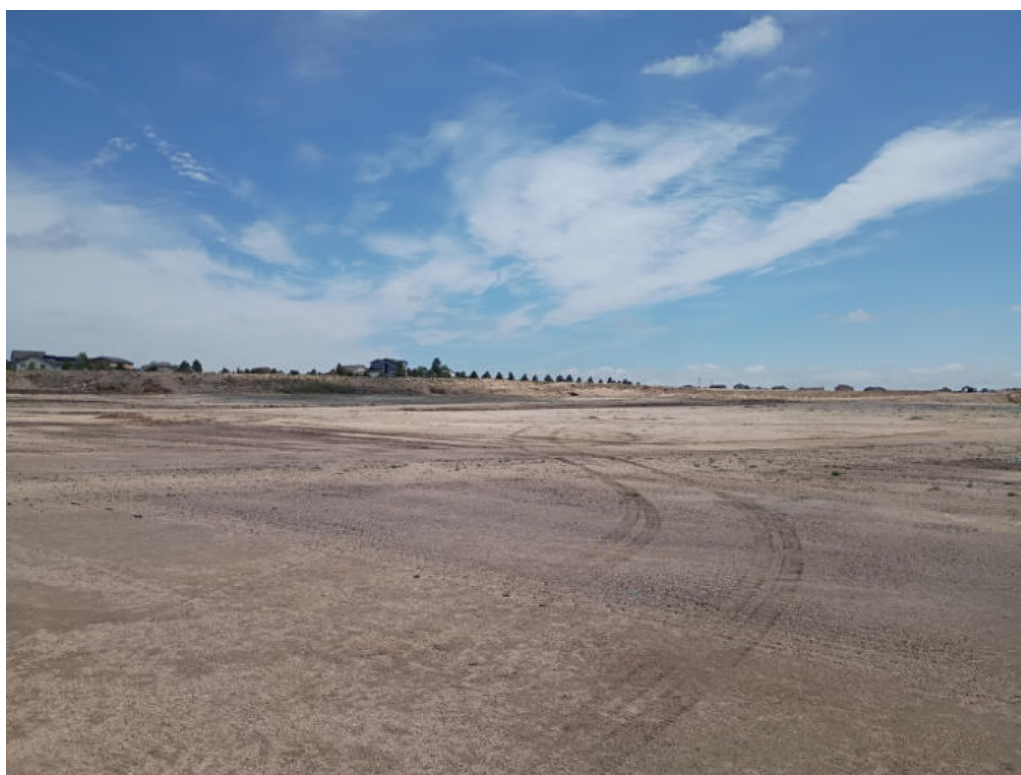
**Looking northeast  
from the central  
portion of the site.**

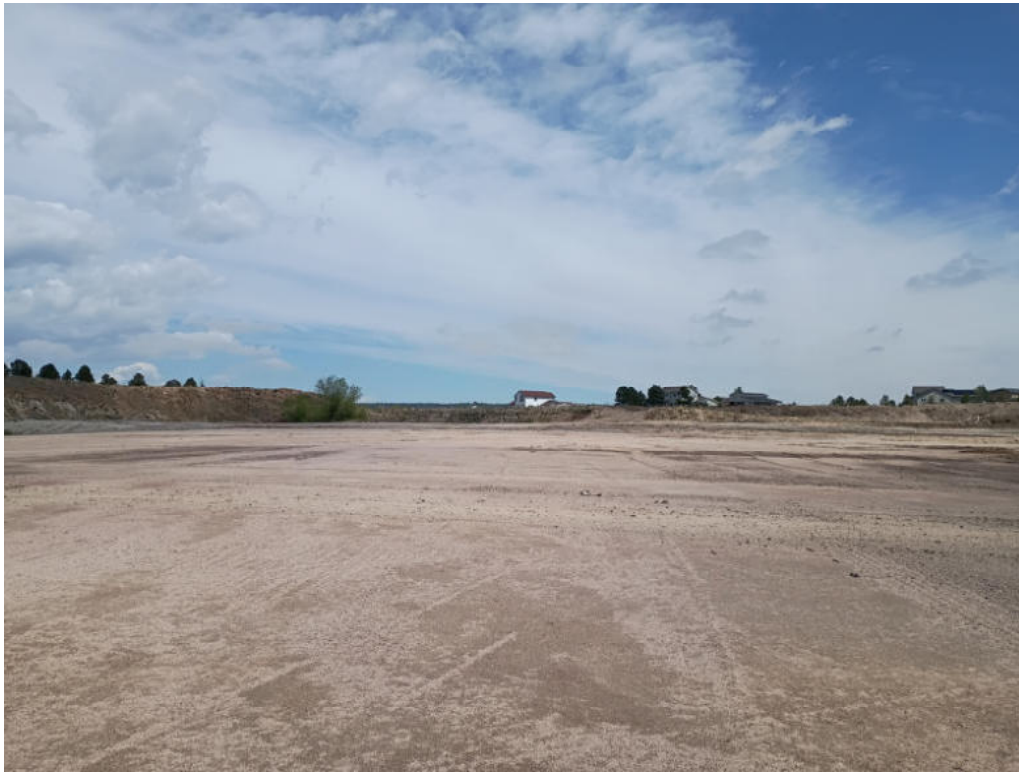
**Looking north from the  
central portion of the  
site.**

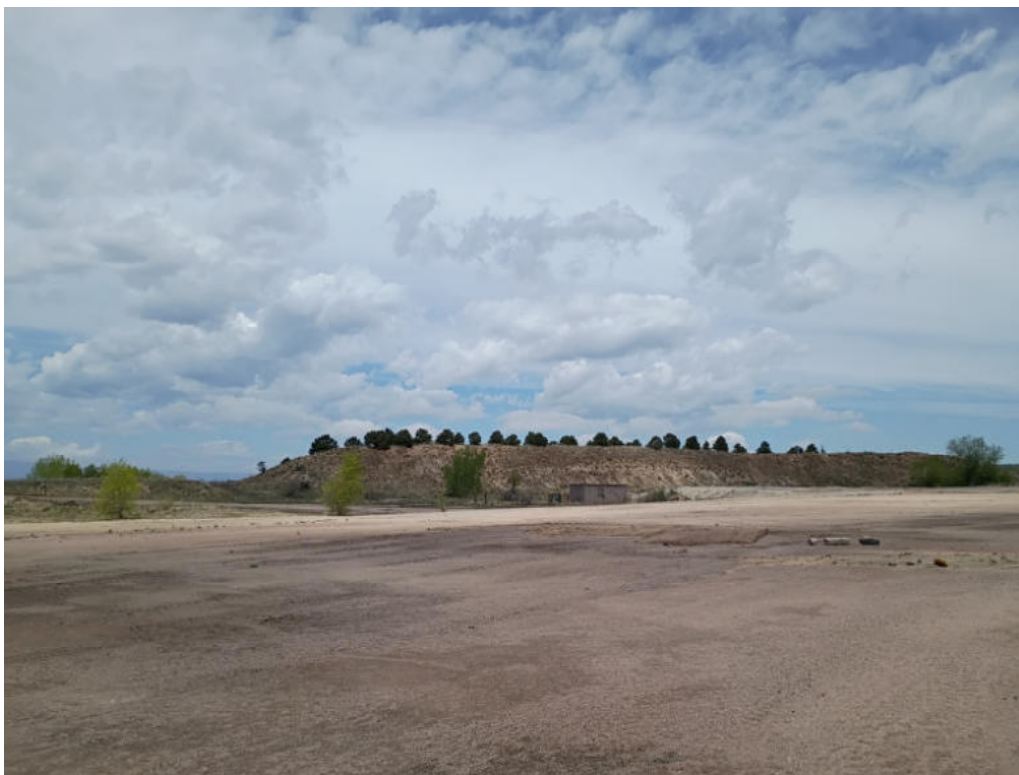
**Looking northwest  
from the central  
portion of the site.**
