**SOIL, GEOLOGY, AND GEOLOGIC HAZARD STUDY  
STERLING RANCH FILING NO. 5  
PARCEL 16  
EL PASO COUNTY, COLORADO**

November 22, 2022

Entech Job No. 222159  
F:/AAProjects/2022/222159 Geohaz

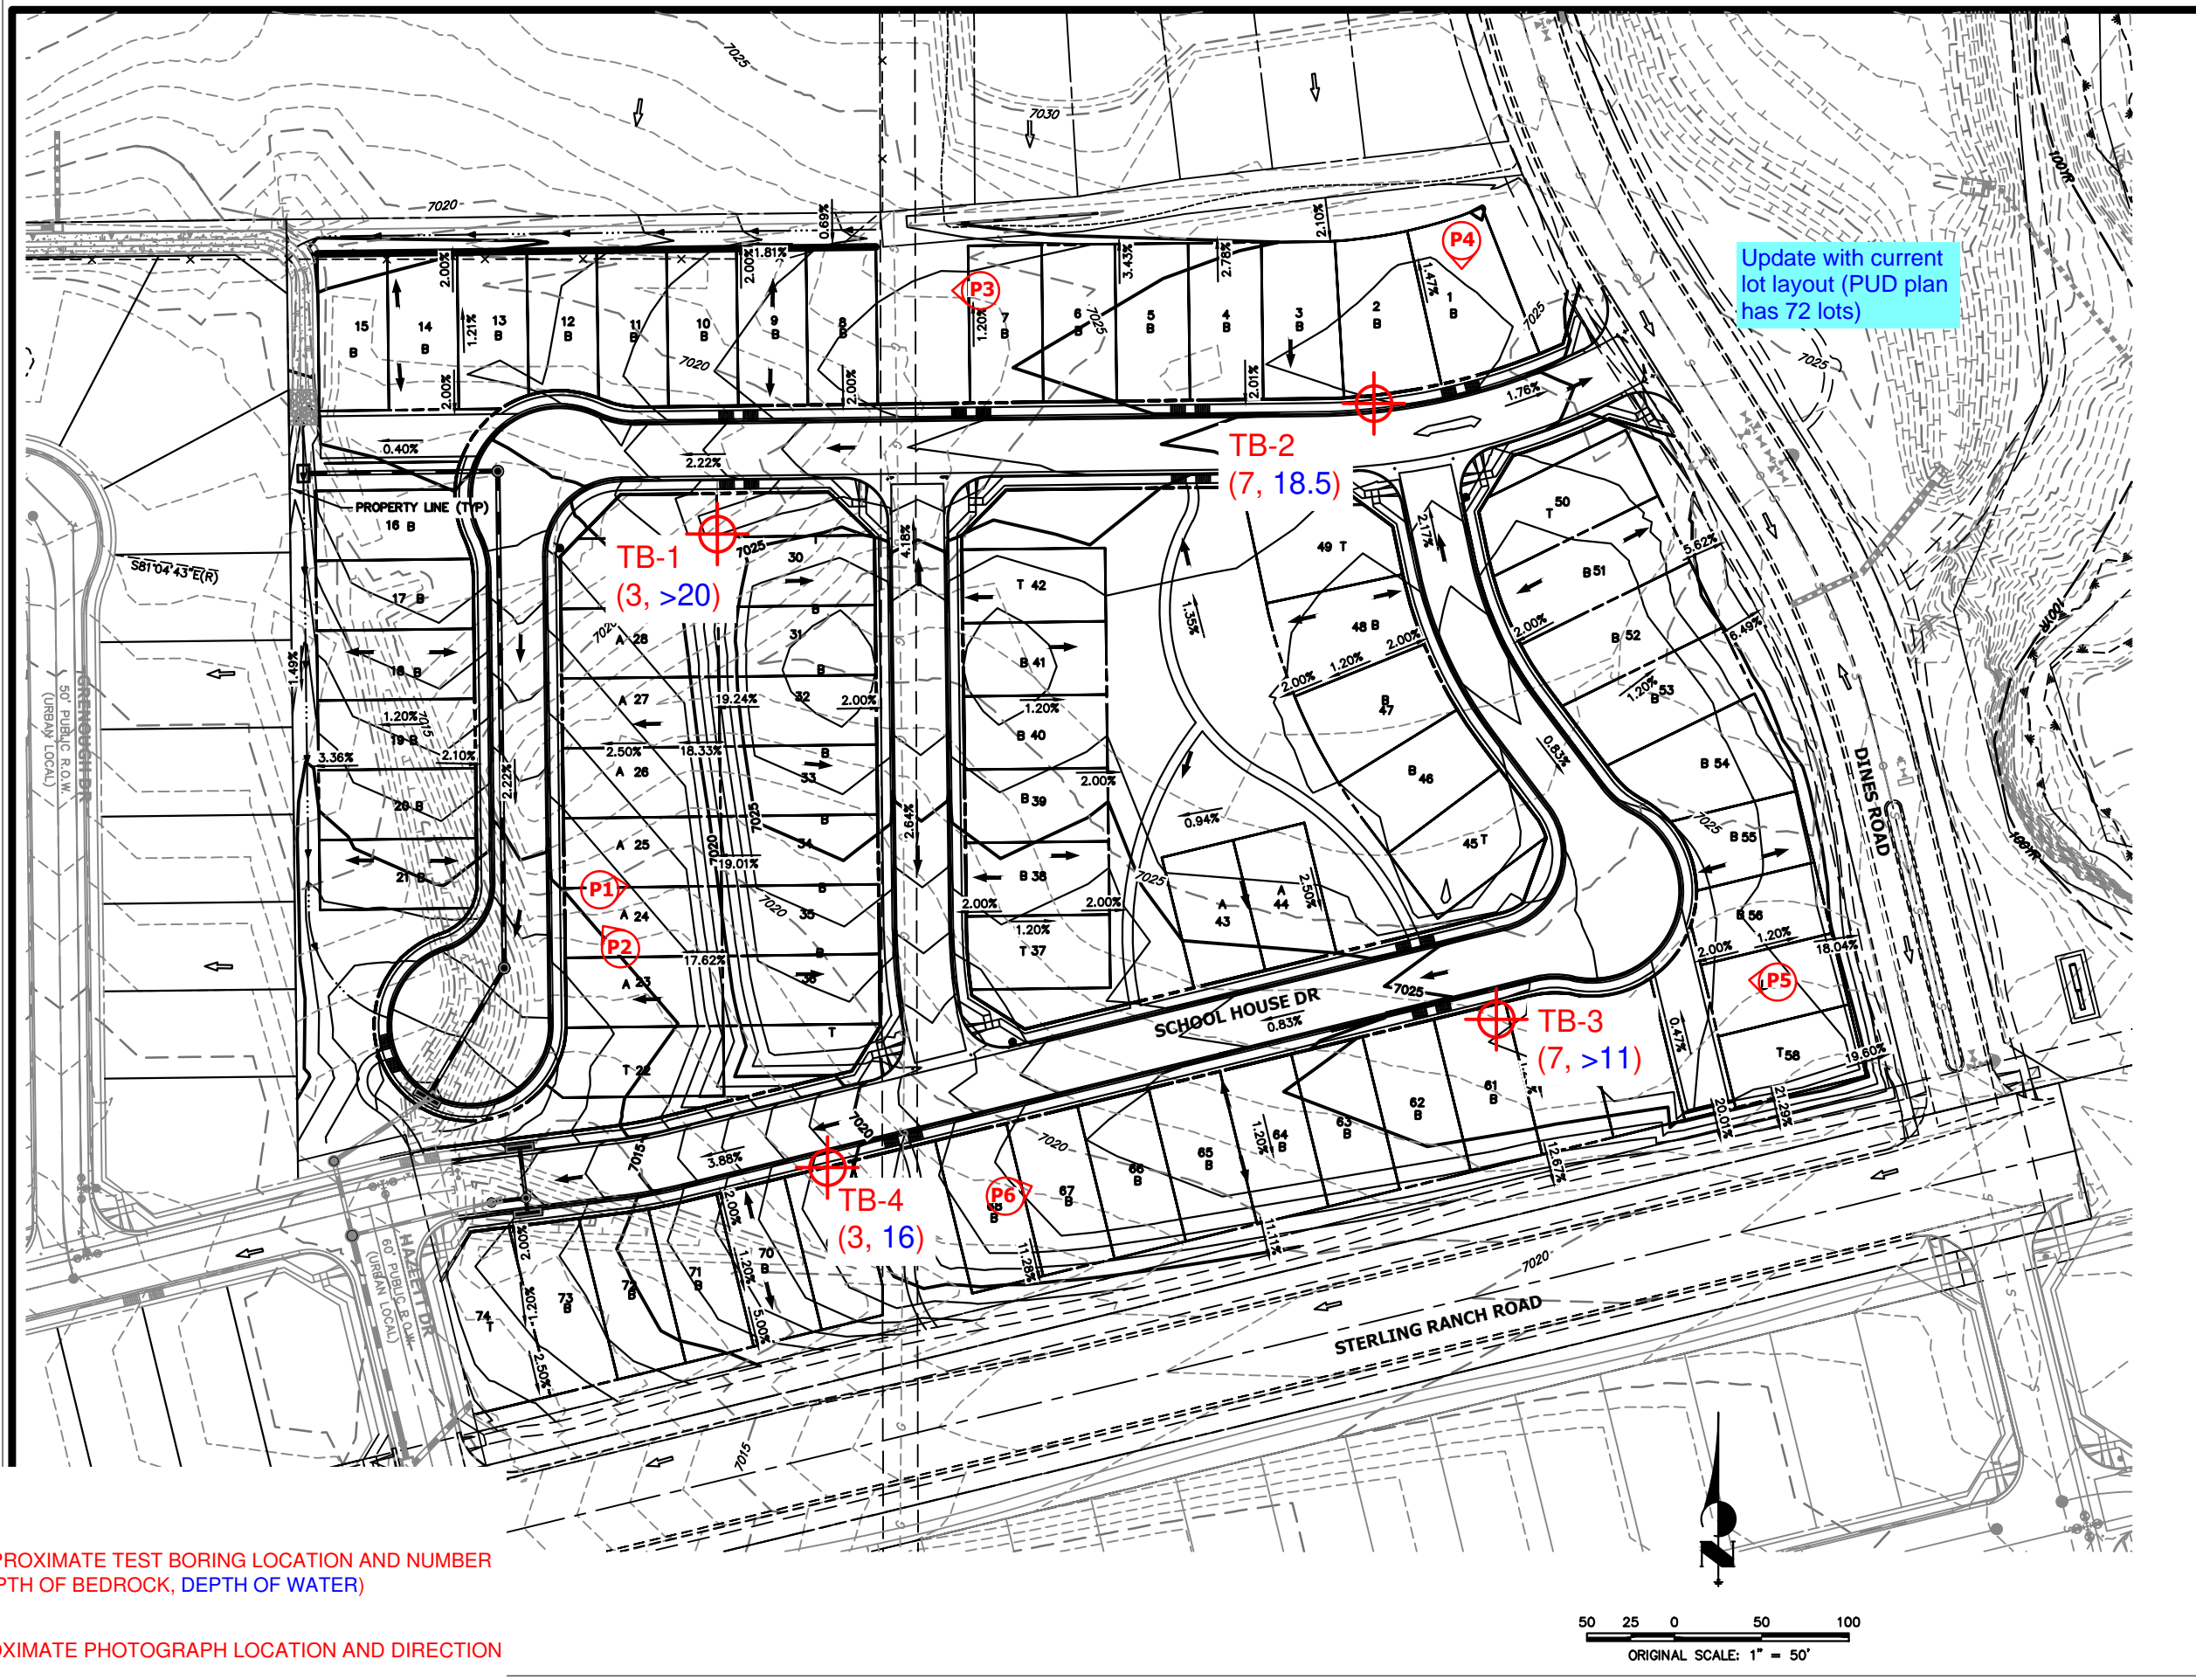
SITE PLAN/TEST BORING LOCATION MAP  
STERLING RANCH FILING NO. 5  
PARCEL 16  
COLORADO SPRINGS, CO.  
FOR: CLASSIC SRJ

Update with current lot layout (PUD plan has 72 lots)

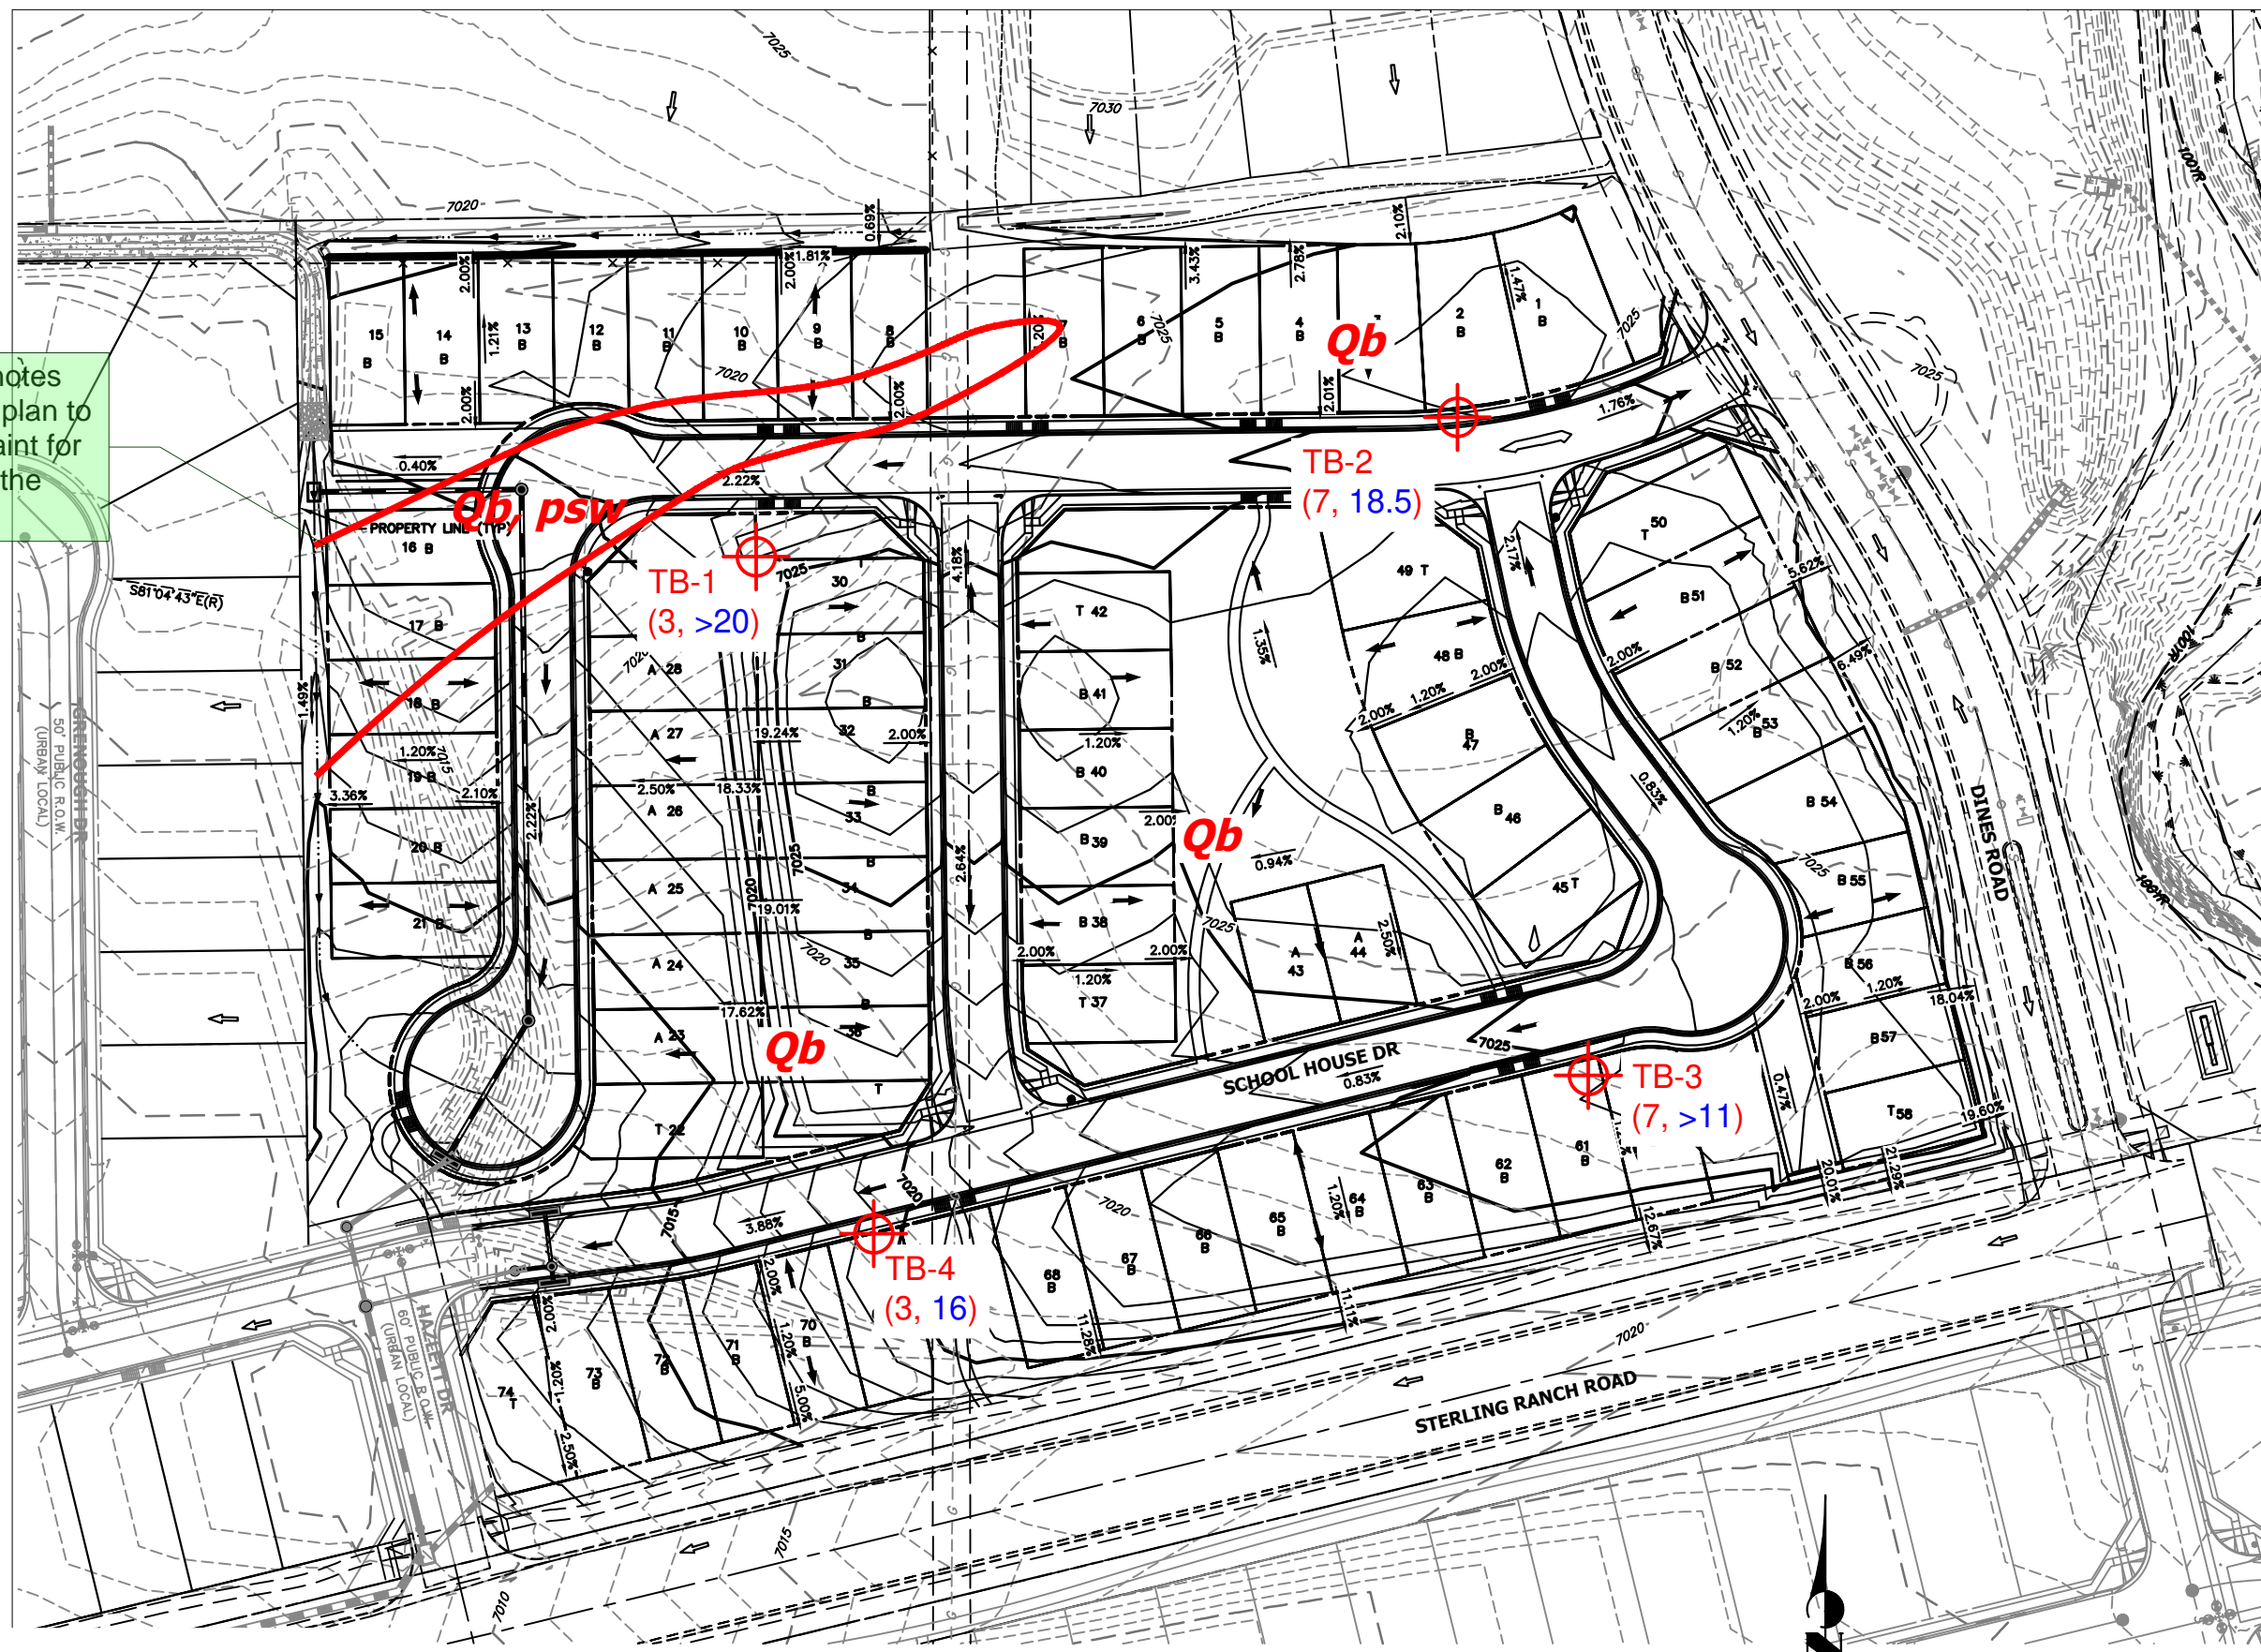
GEOLOGY/ENGINEERING GEOLOGY MAP  
STERLING RANCH FILING NO. 5  
PARCEL 16  
COLORADO SPRINGS, CO.  
FOR: CLASSIC SRJ

As mentioned previously, detailed mapping has been performed on this site to produce an Engineering Geology Map (Figure 7). This map shows the location of various geologic conditions of which the developers and planners should be cognizant during the planning, design and construction stages of the project. The hazards identified on this site include potentially expansive soils, potentially seasonal shallow groundwater areas, and shallow bedrock. The following hazards have been addressed:

Potentially Seasonal Shallow Groundwater: Groundwater depths encountered in the test borings drilled on site are summarized in Table 2. According to the proposed grading plan, the drainage from the northeastern portion of Filing No. 4 will be collected and piped along the west side of the site to a temporary detention pond. Foundations should be kept as high as possible. Areas may experience higher groundwater levels during period of higher

please clarify notes on preliminary plan to identify constraint for these lots and the mitigation....

Mitigation: In these locations, foundations subject to severe frost heave potential should penetrate sufficient depth so as to discourage the formation of ice lenses beneath foundations. At this location and elevation, a foundation depth for frost protection of 30 inches is recommended. Foundations should be kept as high as possible. Areas may experience higher groundwater levels during period of higher precipitation where water can flow through permeable sands on top of less permeable bedrock materials. Subsurface perimeter drains may be necessary to prevent the intrusion of water into areas below grade. Typical drain details are presented in Figure 9. Where shallow groundwater is encountered, underslab drains or interceptor drains may be necessary. Typical drain details are presented in Figure 10 and 11. Where basements are considered, interceptor and underslab drains may be necessary. Structures should not block drainages. Swales should be created to intercept surface runoff and carry it safely around and away from structures. Additional investigation, after grading is completed, is recommended to provide final foundation and subsurface drain recommendations.
