SOIL AND GEOLOGY STUDY

**Esteban Subdivision
3 parcels totaling 496.25 acres
EL Paso County, Colorado**

JOB NO. 190388

April 27, 2023

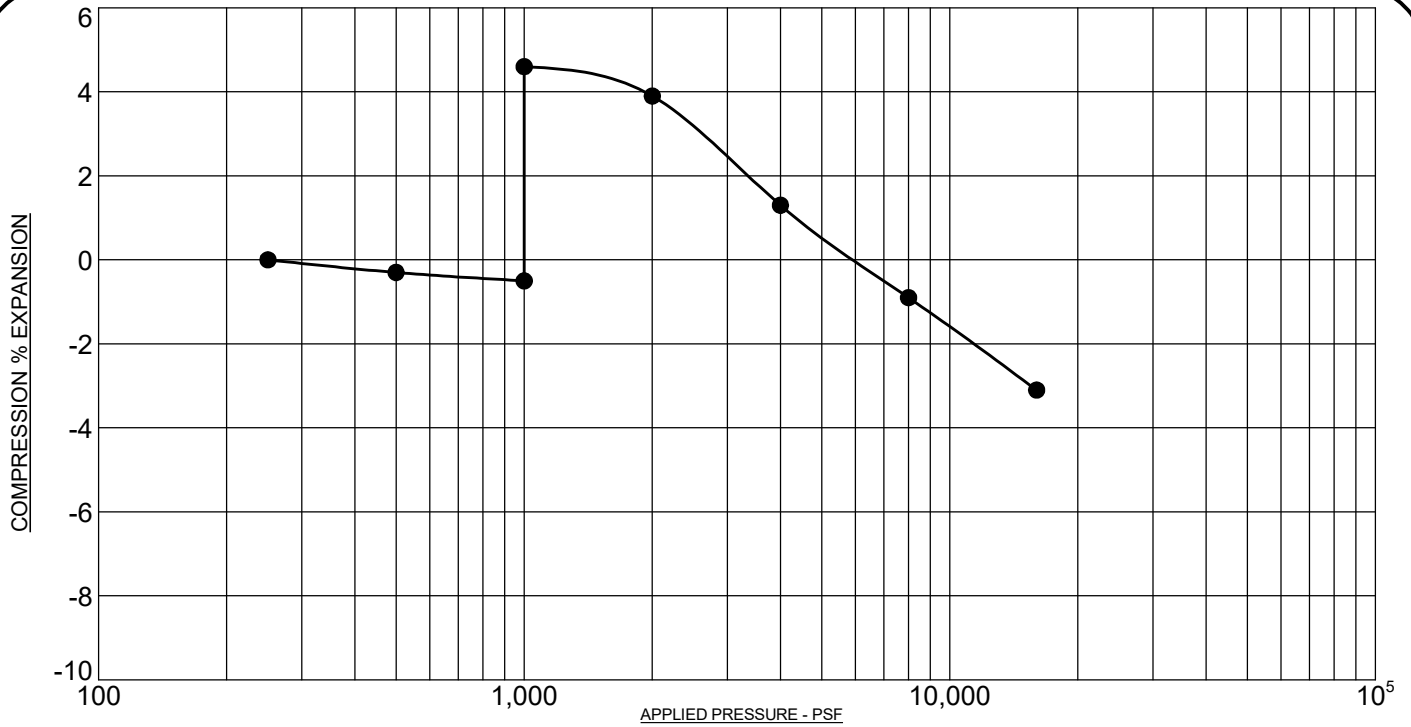
SAMPLE LOCATION: 3 @ 4 FT
 NATURAL DRY UNIT WEIGHT: 112.8 PCF
 NATURAL MOISTURE CONTENT: 14.9%
 PERCENT SWELL/COMPRESSION: 5.1

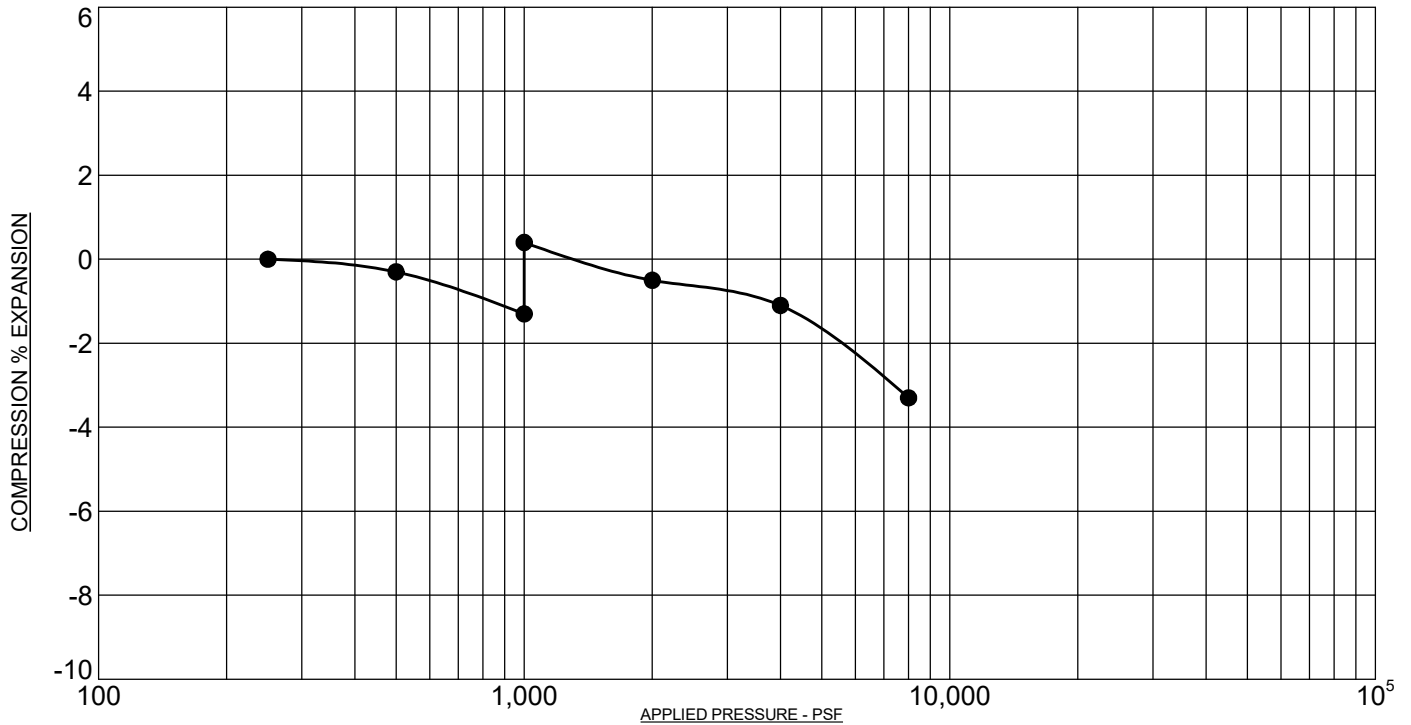
SAMPLE LOCATION: 14 @ 14 FT
 NATURAL DRY UNIT WEIGHT: 102.5 PCF
 NATURAL MOISTURE CONTENT: 23.7%
 PERCENT SWELL/COMPRESSION: 1.7

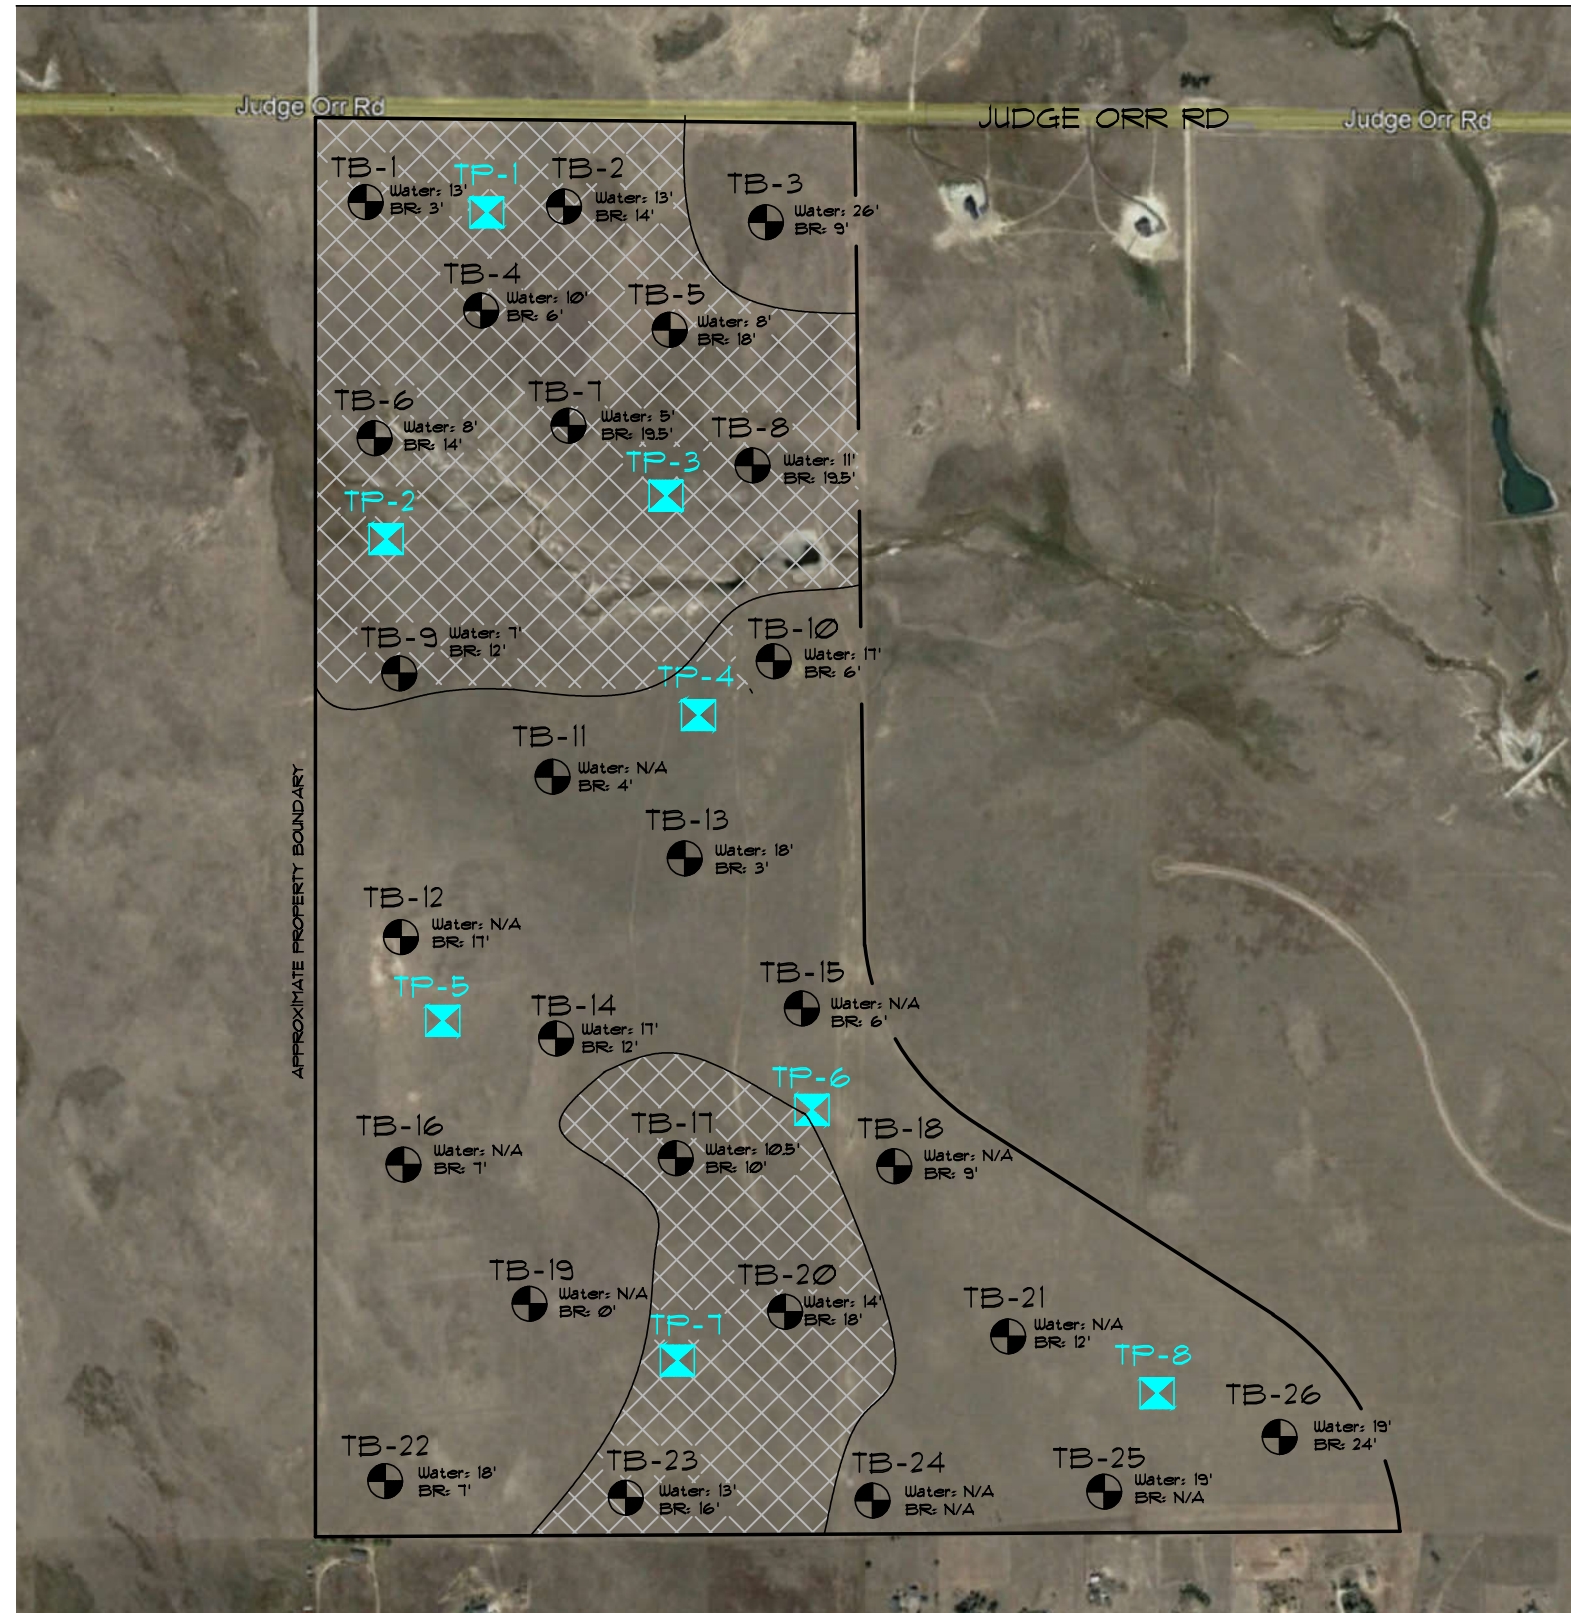
SHEET No. FIG-31

Based on our knowledge of the area and engineering design and construction techniques commonly employed in the El Paso County area at this time, it is our opinion that basements should be restricted in areas where groundwater was encountered at 15 feet or shallower. Additional recommendations are presented in **Section 8.4**. Shallow groundwater conditions are anticipated to be found at the time of the site-specific subsurface soil investigations.

Drilling occurred in March, generally when seasonal groundwater levels are considered slightly higher than the winter months (November through February). The presence of groundwater was observed in 15 of the test borings and 1 of the test pits performed for this investigation. Groundwater measurements are limited to the time of years measured and are considered snapshots only. The depth of groundwater was erratic due to the presence of the existing drainageway and the varying soil conditions on-site. Groundwater and/or perched water should be anticipated on a majority of the lots within the subdivision

The feasibility of basement construction should be evaluated prior to the site-specific subsurface soil investigation for each lot. Seasonal variations in underground water conditions are expected due to the unnamed drainageway. It is assumed underground water beneath the subject site predominates in fractured weathered consolidated sedimentary bedrock located at depth. If shallow underground water conditions are encountered during the site-specific subsurface soil investigations and/or open excavation observations, mitigations may include restricting basement construction, raising the grade of the residence and/or a combination of surface and subsurface drainage systems, vertical drainboard, etc.
