SOIL AND GEOLOGY STUDY

**Esteban Subdivision
3 parcels totaling 496.25 acres
EL Paso County, Colorado**

JOB NO. 190388

April 27, 2023

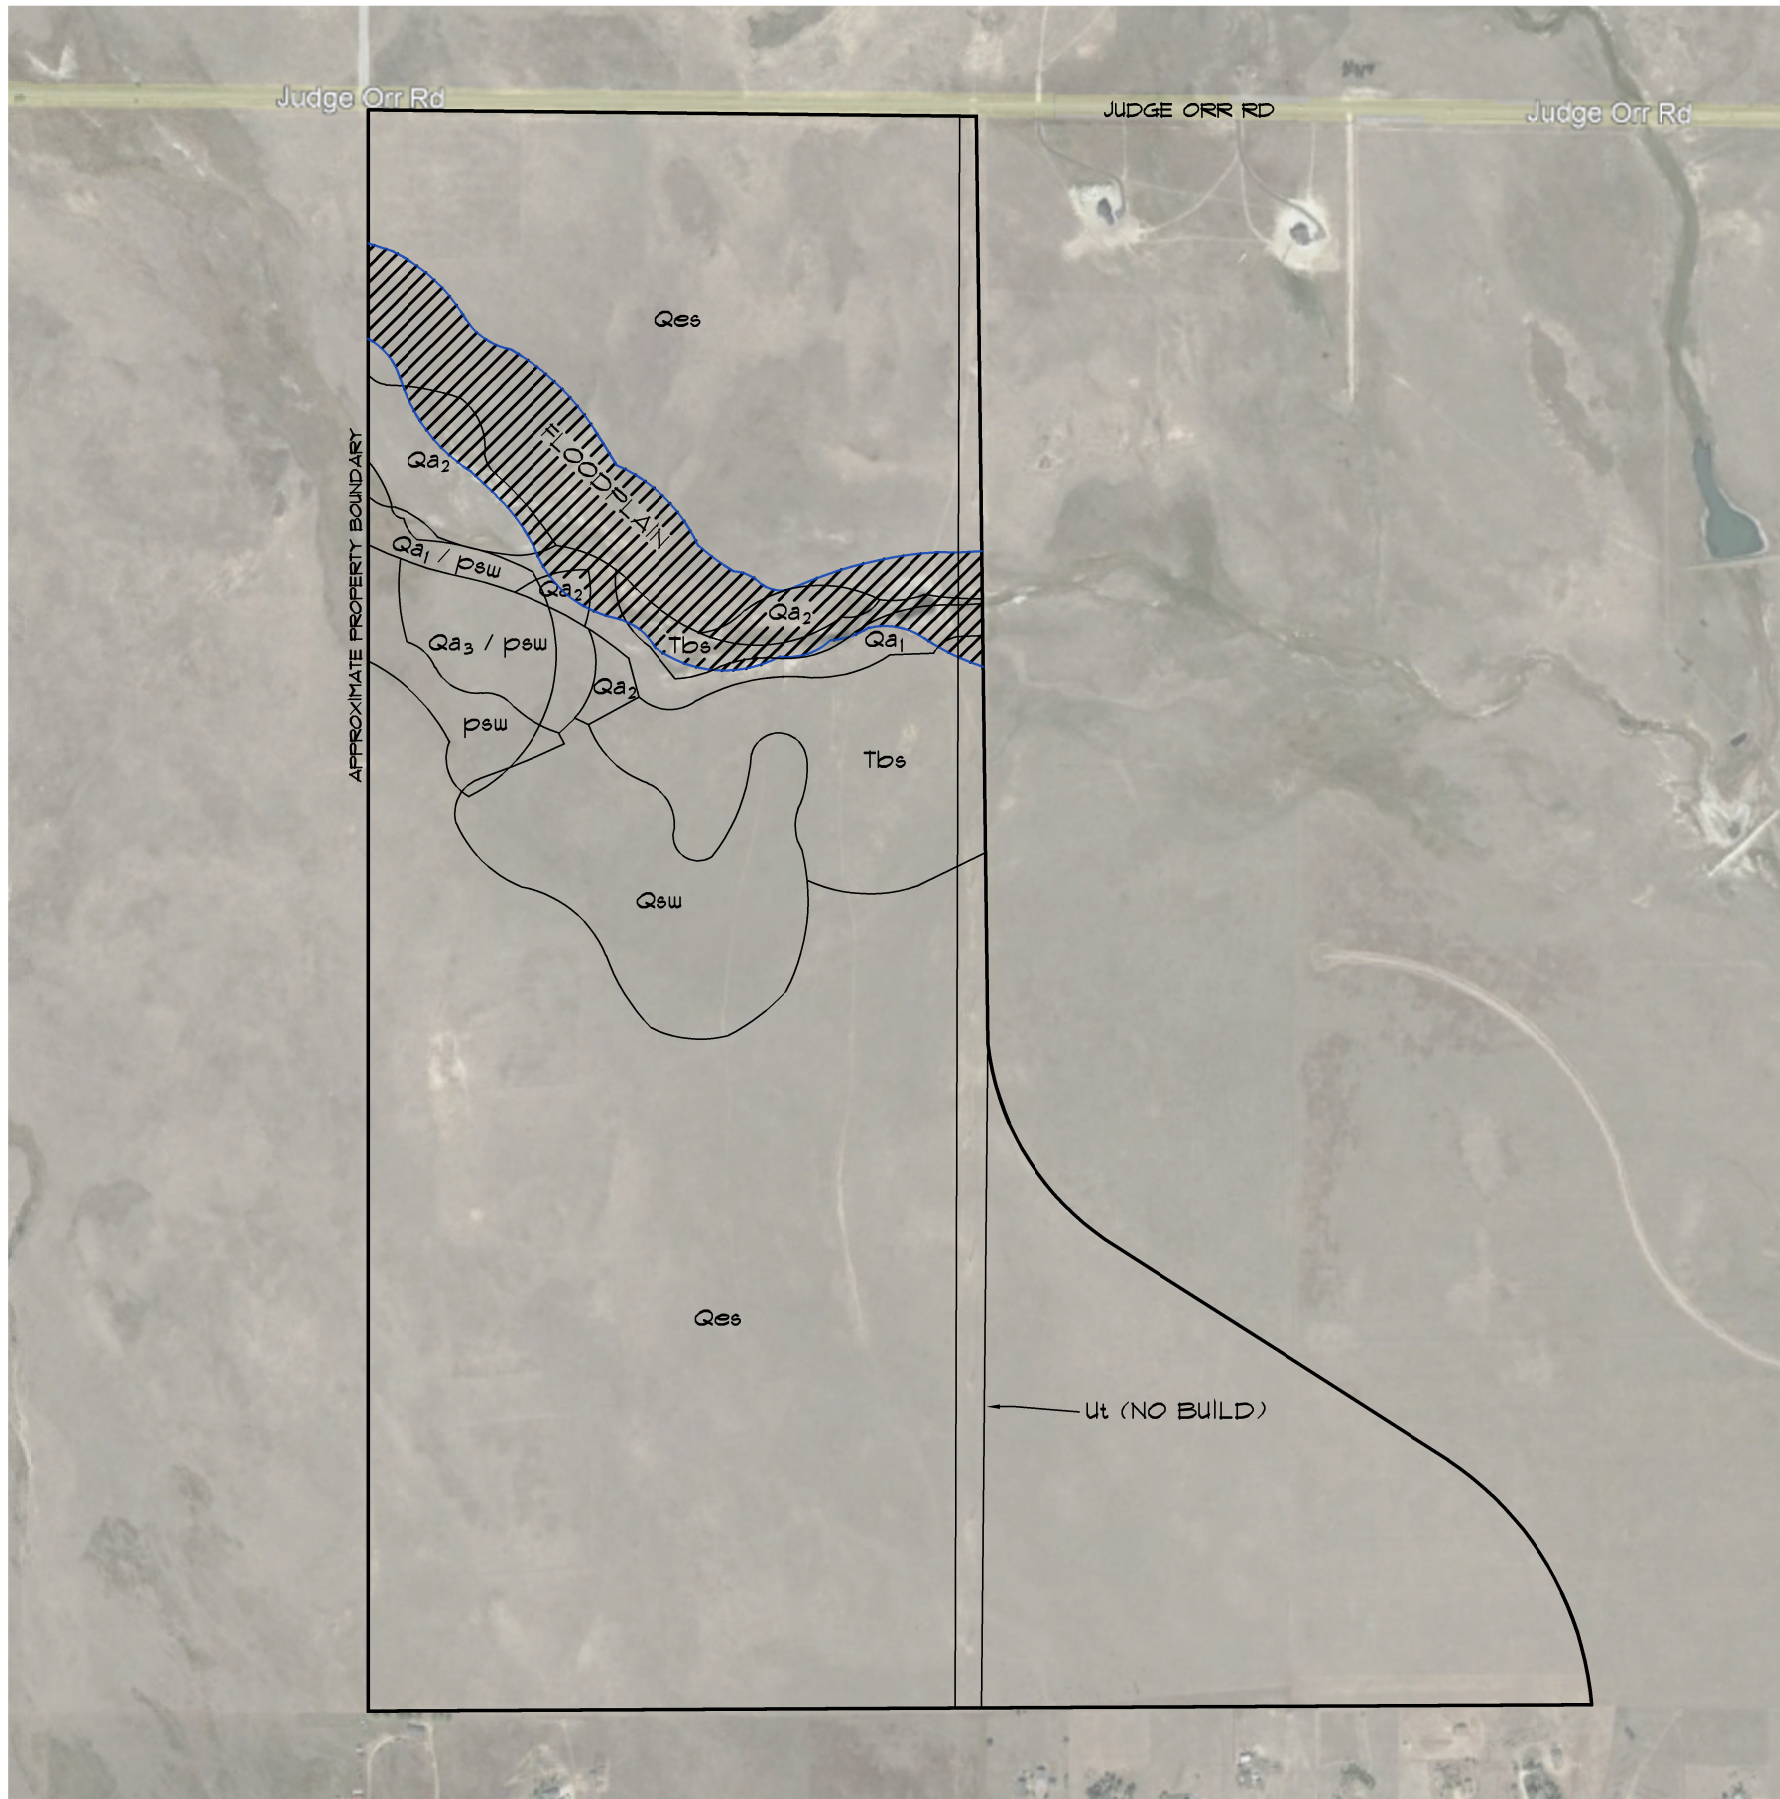
FIG-28

Based on our field observations and review of relevant geologic maps, we identified the geologic conditions (listed below) affecting the development, as shown on the Engineering and Geology Map, Figure 28.

- *psw* – *potential seasonally wet* - areas that may collect surface water during high moisture events.

Ut - Utility Easement - Existing overhead utility easement. This area is to be a "No Build Zone" for single-family residences and OWTs

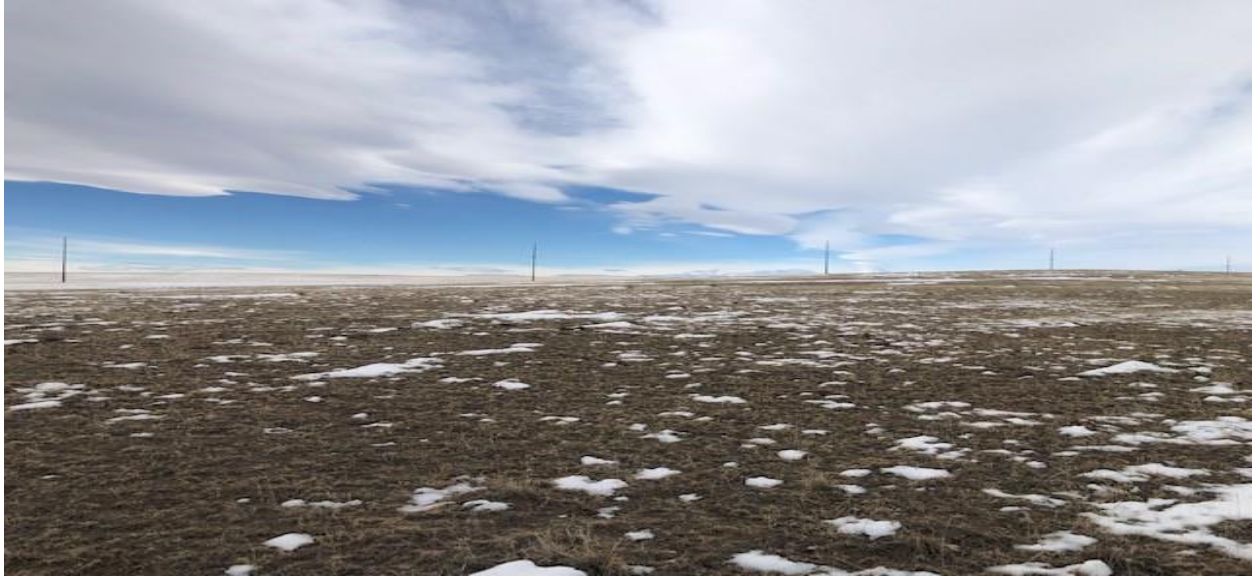
Utility easement, looking east
