February 15, 2022

ENTECH
ENGINEERING, INC.

Re: Soil, Geology, and Geologic Hazard Study
McDermott Subdivision, Filing 1
12930 Herring Road
Parcel No. 52080-00-030
El Paso County, Colorado

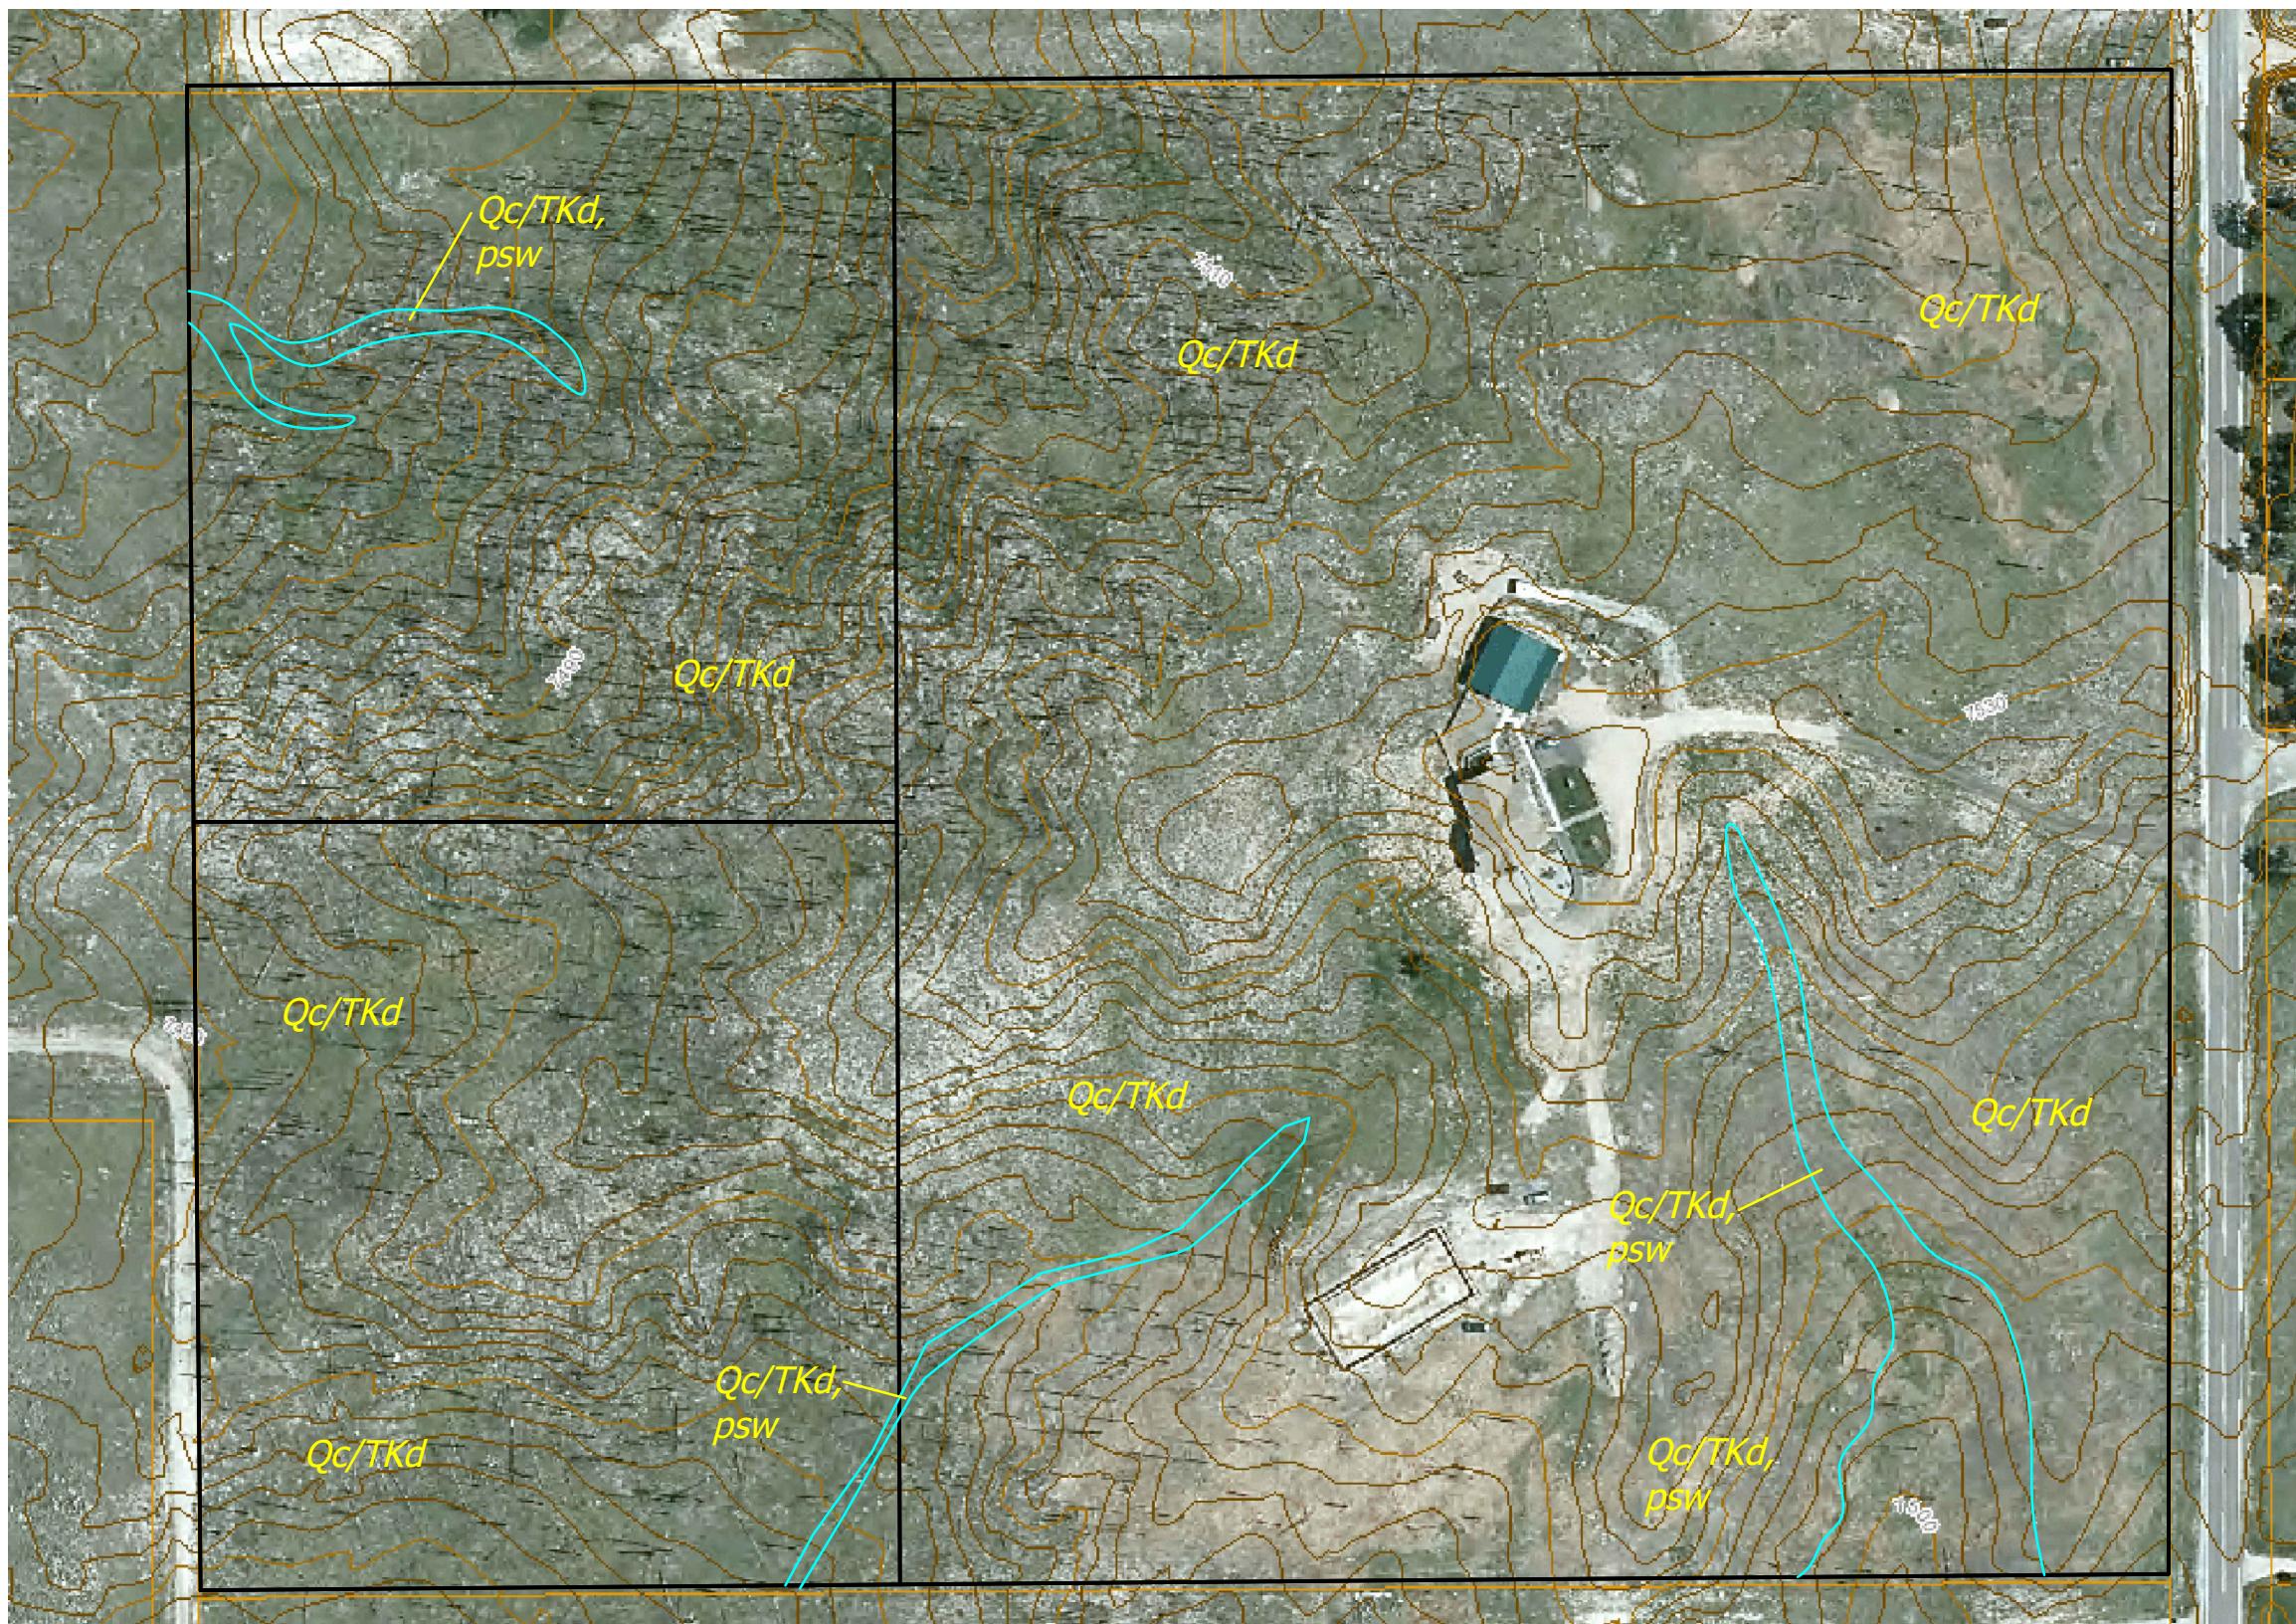
GEOLOGY/ENGINEERING GEOLOGY MAP
MCDERMOTT SUBDIVISION, FILING 1
12930 HERRING ROAD
EL PASO COUNTY, CO.
FOR: SCOTT MCDERMOTT

The site is not mapped within any floodplains according to the FEMA Map No. 08041CO320G, dated December 7, 2018 (Figure 7, Reference 7). Areas of potentially seasonal shallow groundwater were observed on the site (Figure 6). In these areas, we would anticipate the potential for periodically high subsurface moisture conditions and frost heave potential. These areas lie within low-lying areas and along the drainages in the south-central and south east portions of the site. The potentially seasonal shallow groundwater areas are located in the south-central portion and southeast corner of the site. Water was not observed in any of the drainages at the time of our site investigation. These areas can likely be avoided or properly mitigated by development. The potential exists for high groundwater levels during high moisture periods and should structures encroach on these areas the following precautions should be followed.

Areas of potentially seasonal shallow groundwater were observed on the site (Figure 6). In these areas, we would anticipate the potential for periodically high subsurface moisture

conditions and frost heave potential. These areas lie within low-lying areas and along the minor drainages in the southeastern and southern portions of the site. These areas can likely be avoided or properly mitigated by development. The potential exists for high groundwater levels during high moisture periods and should structures encroach on these areas. Subsurface perimeter drains are recommended should structures encroach on this area. Typical drain details are presented in Figure 8. Septic systems are not recommended in these areas due to the potential for shallow groundwater. Any grading in these areas should be done to direct surface flow around construction to avoid areas of ponded water. All organic material should be completely removed prior to any fill placement. Specific drainage studies are beyond the scope of this report. The site is not mapped within any floodplains according to the FEMA Map No. 80841C0320G (Figure 7, Reference 7).

Mitigation: Foundations must have a minimum 30-inch depth for frost protection. In areas where high subsurface moisture conditions are anticipated periodically, subsurface perimeter drains are recommended to help prevent the intrusion of water into areas below grade. Typical drain details are presented in Figure 8. Any grading in these areas should be done to direct surface flow around construction to avoid areas of ponded water. All organic material would be completely removed prior to any fill placement. **Specific drainage studies are beyond the scope of this report.**
