**SOIL, GEOLOGY, AND GEOLOGIC HAZARD STUDY  
THE GARDENS AT NORTH CAREFREE  
AKERS DRIVE AND NORTH CAREFREE CIRCLE  
EL PASO COUNTY, COLORADO**

**Mule Deer Investments, LLC**  
2727 Glen Arbor Drive  
Colorado Springs, Colorado 80920

October 25, 2017  
Revised August 6, 2018

Entech Job No. 171581  
AAprojects/2017/171581 countysoil/geo

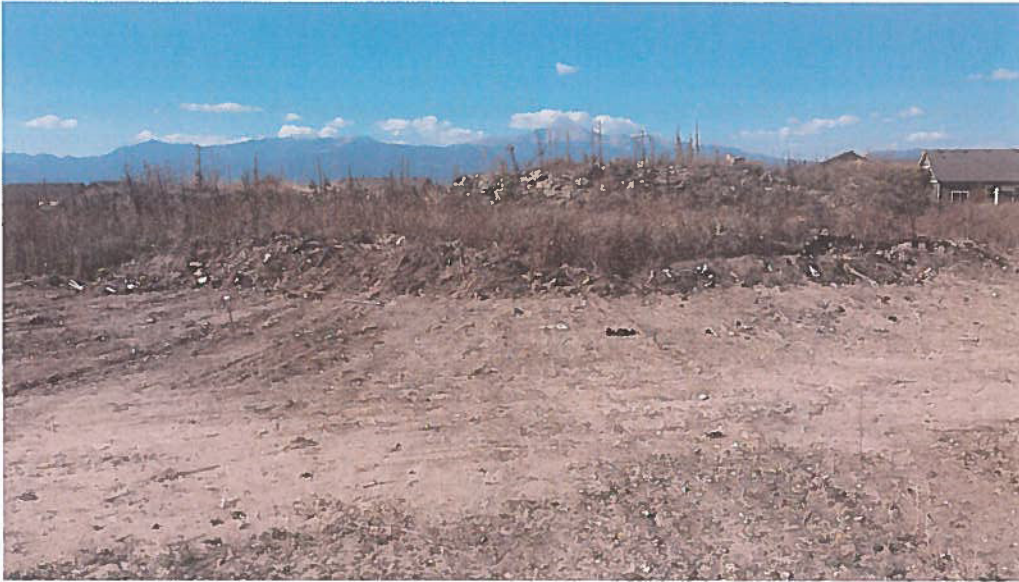
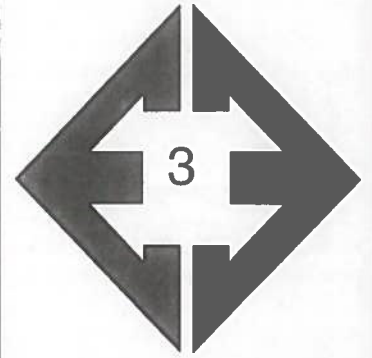
**Qaf Artificial Fill of Holocene Age:** These are recent deposits of man-made fill. The fill piles were observed along the eastern and central portions of the site.

These are recent man-made fill deposits associated with fill piles located across the site. It is our understanding the fill will be removed during site grading.

**Looking towards fill pile in central portion of the site.**

Mitigation: Any uncontrolled fill encountered beneath foundations will require removal and recompaction at a minimum of 95% of its maximum Modified Procter Dry Density, ASTM D-1557.

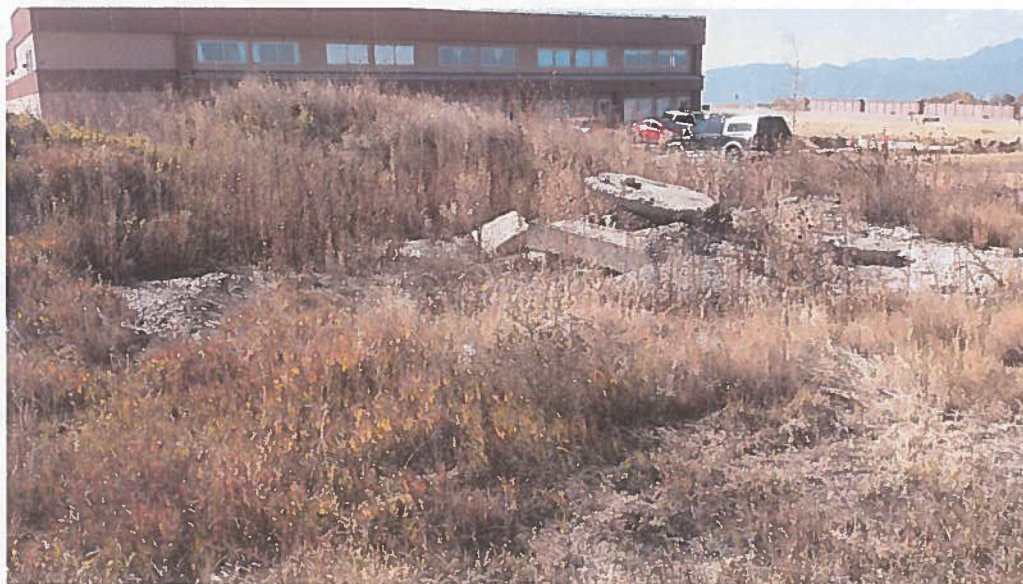
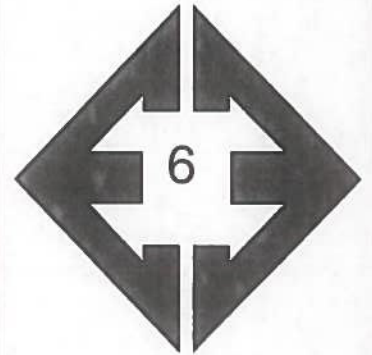
**Looking south at fill pile in southeastern portion of the site.**
