**ENTECH**  
ENGINEERING, INC.

August 7, 2026

Re: Soils and Geology Study  
Arroya Lane Minor Subdivision  
Parcel No. 52220-00-018  
9420 Arroya Lane  
El Paso County, Colorado  
Entech Job No. 261558

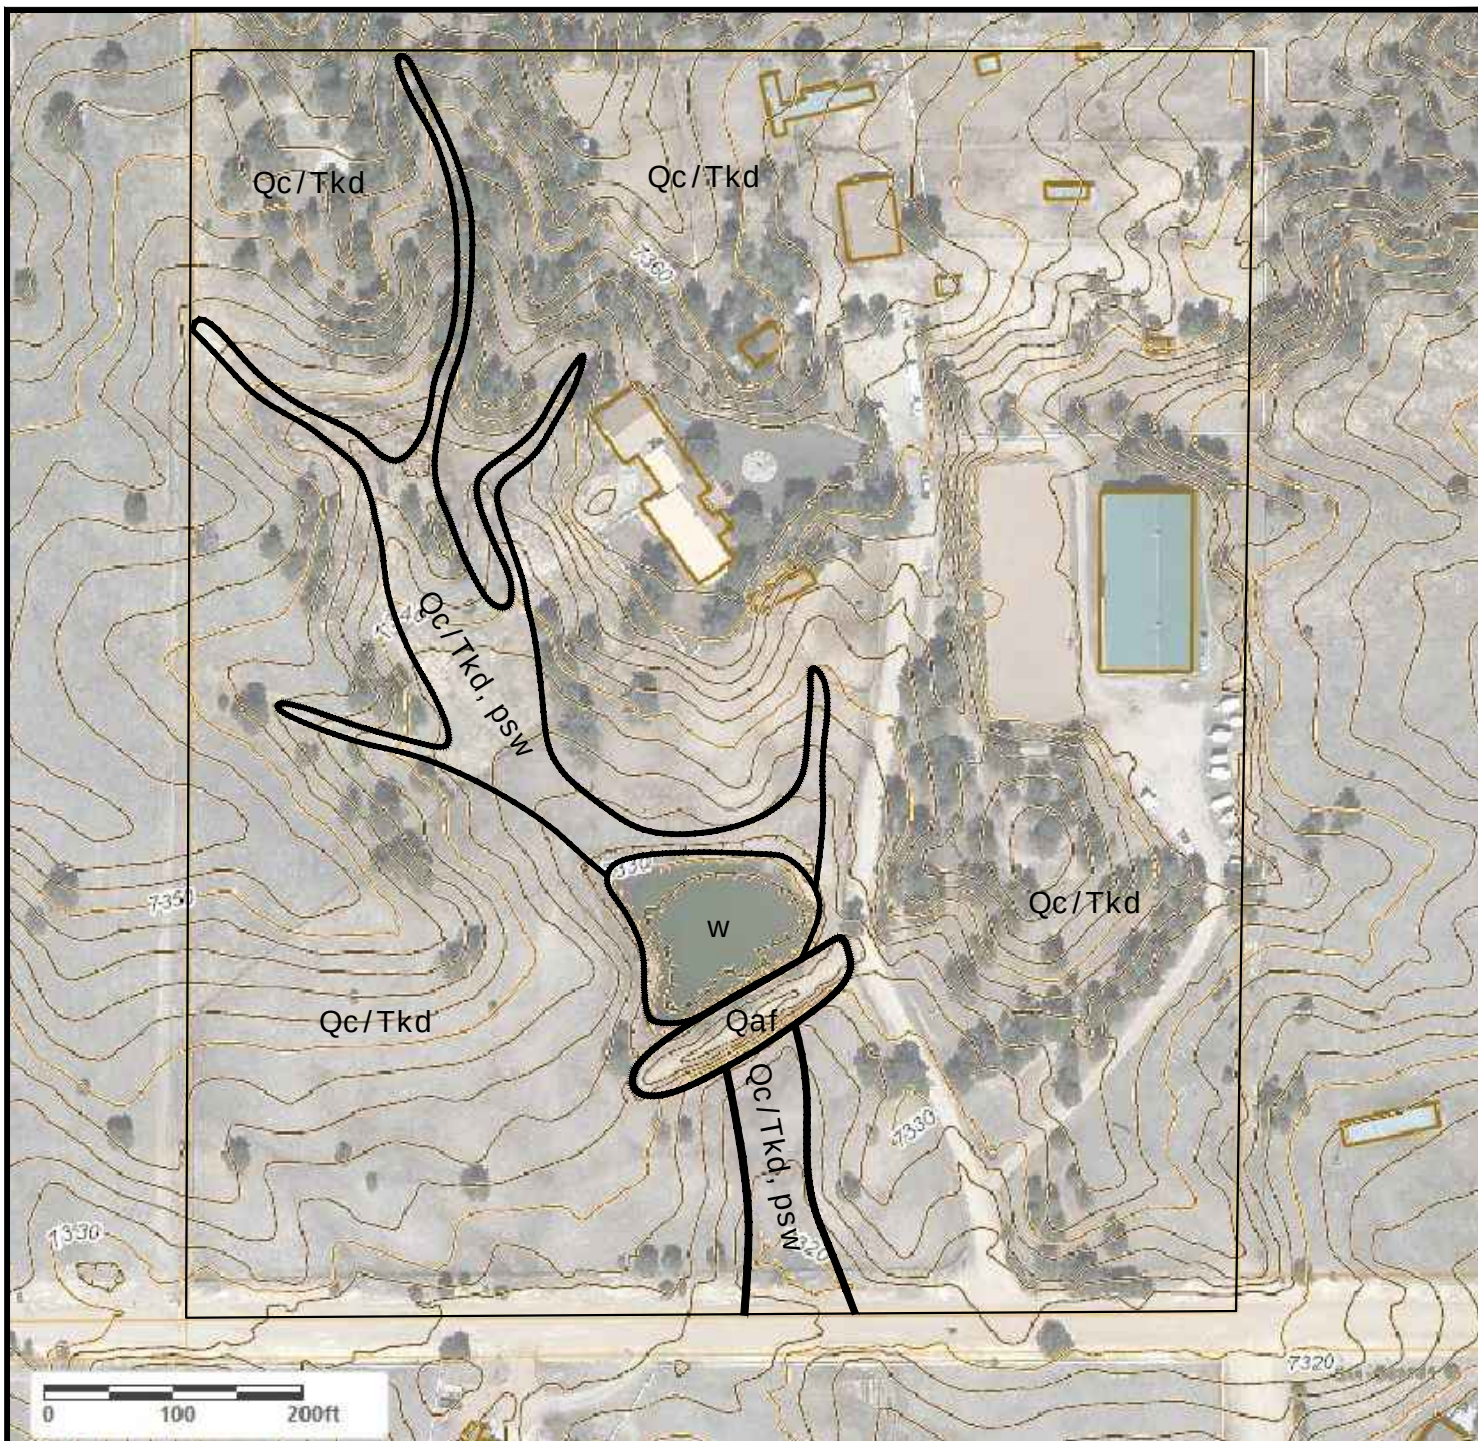
FIG. 2

The Falcon NW Quadrangle Geology Map showing the site is presented in Exhibit 4 (Reference 4). The Geology Map prepared for the site is presented in Figure 2. Two mappable units were identified on this site which are described as follows:

**Qaf Artificial Fill of Quaternary Age:** These are man-made fill deposits associated with the earthen dam for the ponds located in the southern portion of the site. Other areas of fill may exist.

**Qc/Tkd Colluvium of Quaternary Age overlying Dawson Arkose of Tertiary to Cretaceous Age:** These materials consist of silty to clayey sands, cobbles and boulders deposited by the action of sheetwash and gravity. Some alluvial soils deposited by water and residual soil from in-situ weathering exist in this mapping. These soils are overlying the Dawson Formation. The Dawson Formation typically consists of coarse-grained, arkosic sandstone with interbedded lenses of fine-grained sandstone, siltstone and claystone.

The geologic hazards identified on this site include artificial fill, potentially expansive soils, potential seasonal shallow groundwater, ponded water, and the potential for elevated radon levels. The geologic hazards have been addressed below.

Fill associated with the earthen dam in the southern portion of the site exists. Additionally, areas of fill may be encountered adjacent to the existing structures onsite.

Potentially Seasonal Shallow Groundwater: This constraint is associated with the minor drainage swales. In these areas, we would anticipate the potential for periodically high subsurface moisture conditions and possible frost heave potential, depending on the soil conditions.

Mitigation: Uncontrolled fill if encountered in any future foundation area will require penetration or removal and recompaction.

Mitigation: In these locations, foundations in areas subject to severe frost heave potential should penetrate sufficient depth so as to discourage the formation of ice lenses beneath foundations. At this location and elevation, a foundation depth for frost protection of 2.5 feet is recommended. In areas where high subsurface moisture conditions are anticipated periodically, a subsurface perimeter drain will be necessary to help prevent the intrusion of water into areas located below grade.
